Money Graham Dehy Unit Release on 07/11/2022

Incident # nAPP2219350300

Description of Event:

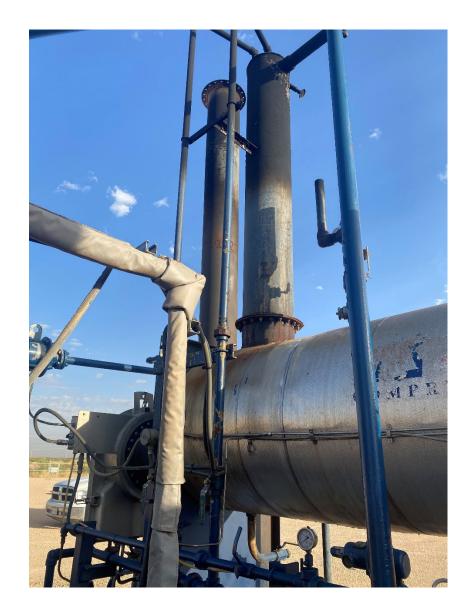
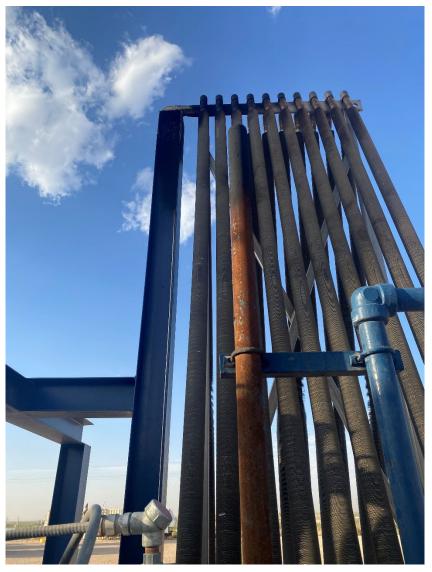
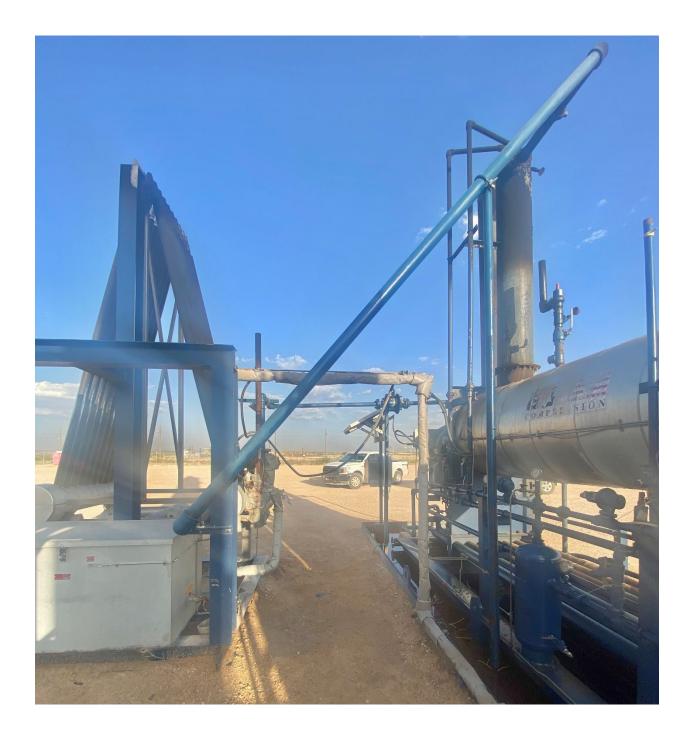
Incident # nAPP2219350300

SCM I&E Tech arrived at the Money Graham CS on the afternoon of July 11, 2022 and discovered a fire around the dehy unit. Fire was observed emitting from the PSV on the reboiler and the PSV on the BTEX unit. The I&E Tech pulled the ESD and shut the facility in. After ESD the fire died off. The essential points of the timeline as reported by the EHS group are as follows:

Two points of release:

Reboiler PSV 1.625" orifice with 12 ounce set point

BTEX PSV 1" Orifice with 12 ounce setpoint
