SITE REMEDIATION AND CLOSURE REPORT

Bradley 8 Fee #3H

Incident ID No. NAPP2113930112

Paragon Environmental LLC

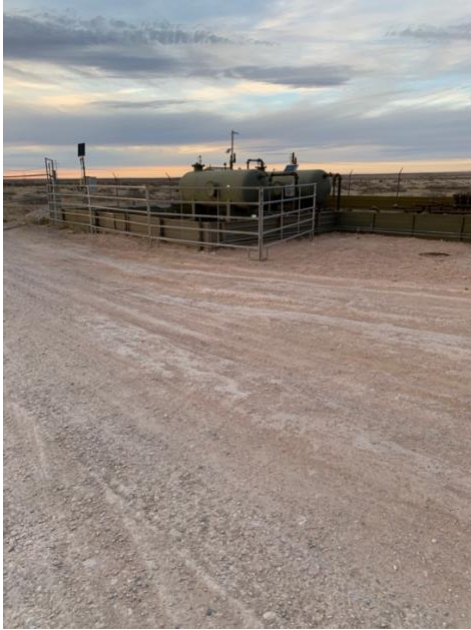
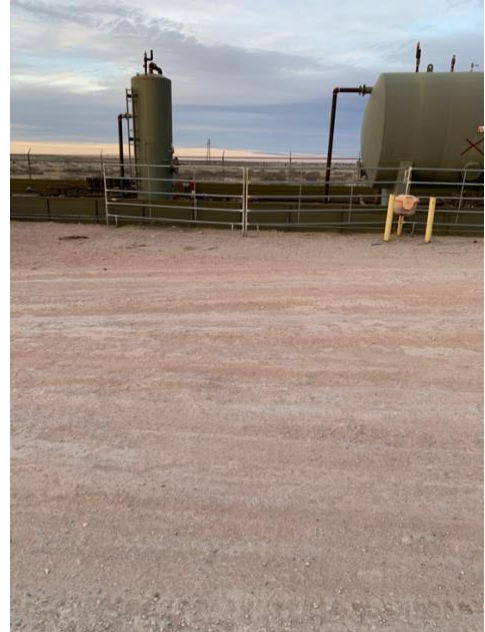
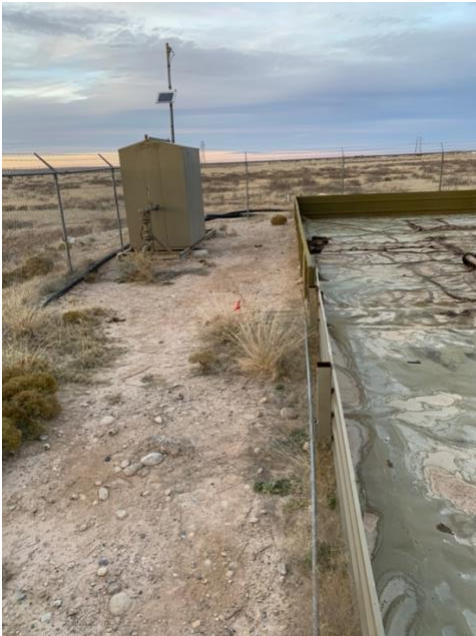
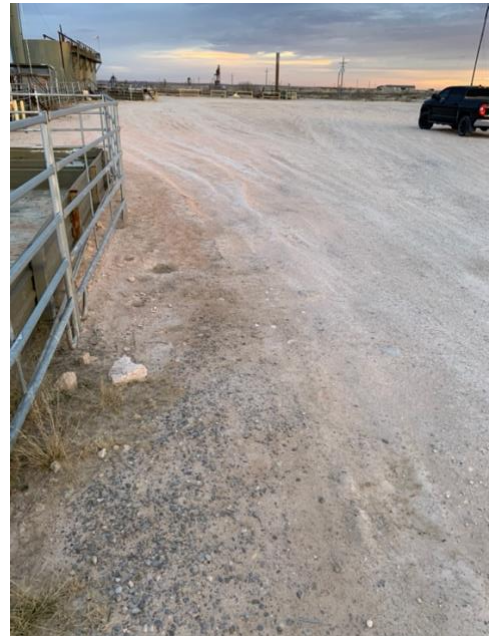
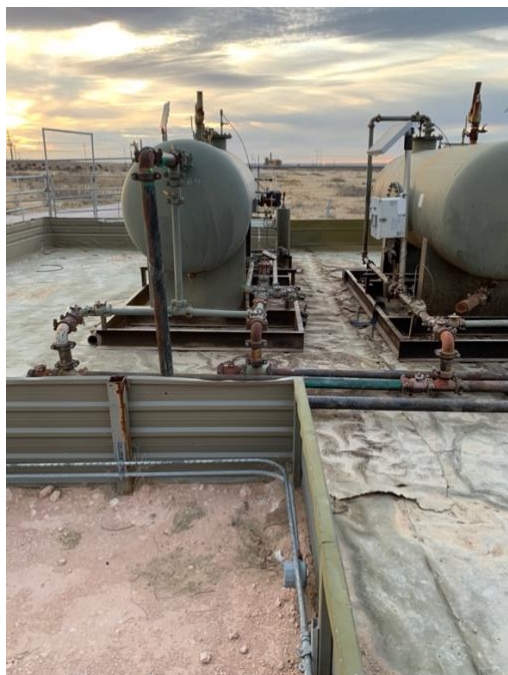
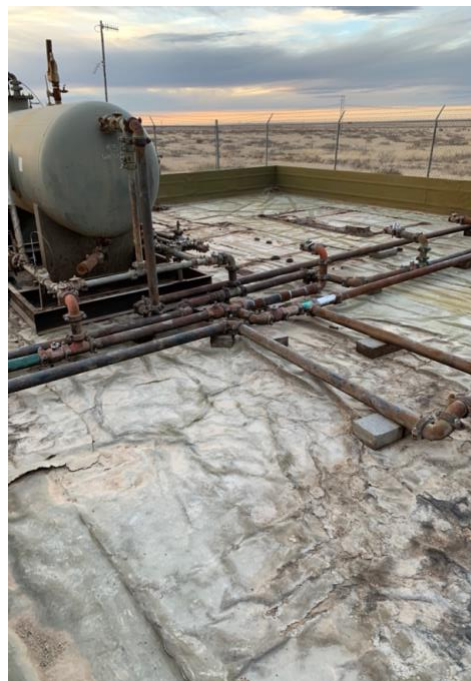
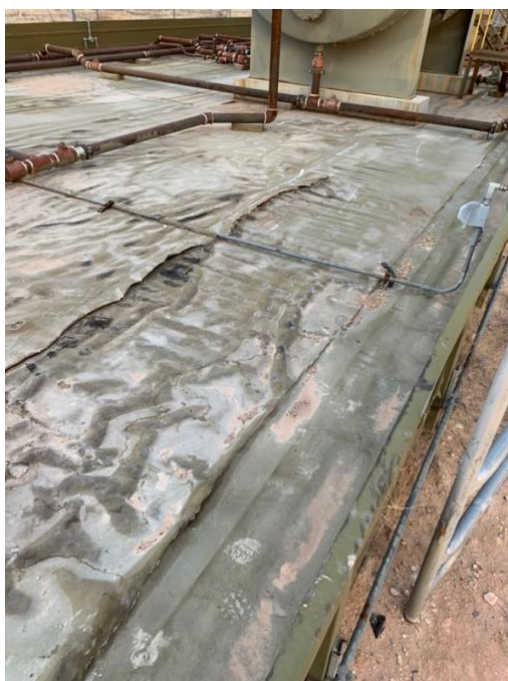
Photographic Documentation

The liner was cleaned by another service company prior to the inspection. The 48-hour notification was given to the state on 2-13-22, see Appendix F. During the inspection, there were no obvious rips or tears in the liner to make me believe that the liner needs any repair or has lost the integrity to contain any spilled fluids. The liner report is on the following inspection sheet.

Based on the Liner Inspection and the composite sample results being below closure criteria no remediation is needed for this incident.
