Release Notification

Site Name Federal I #8	Site Type Gas Well
Date Release Discovered 4/26/22	API# (if applicable) 30-045-30178

Federal I 8

Site Characterization and Remediation Plan

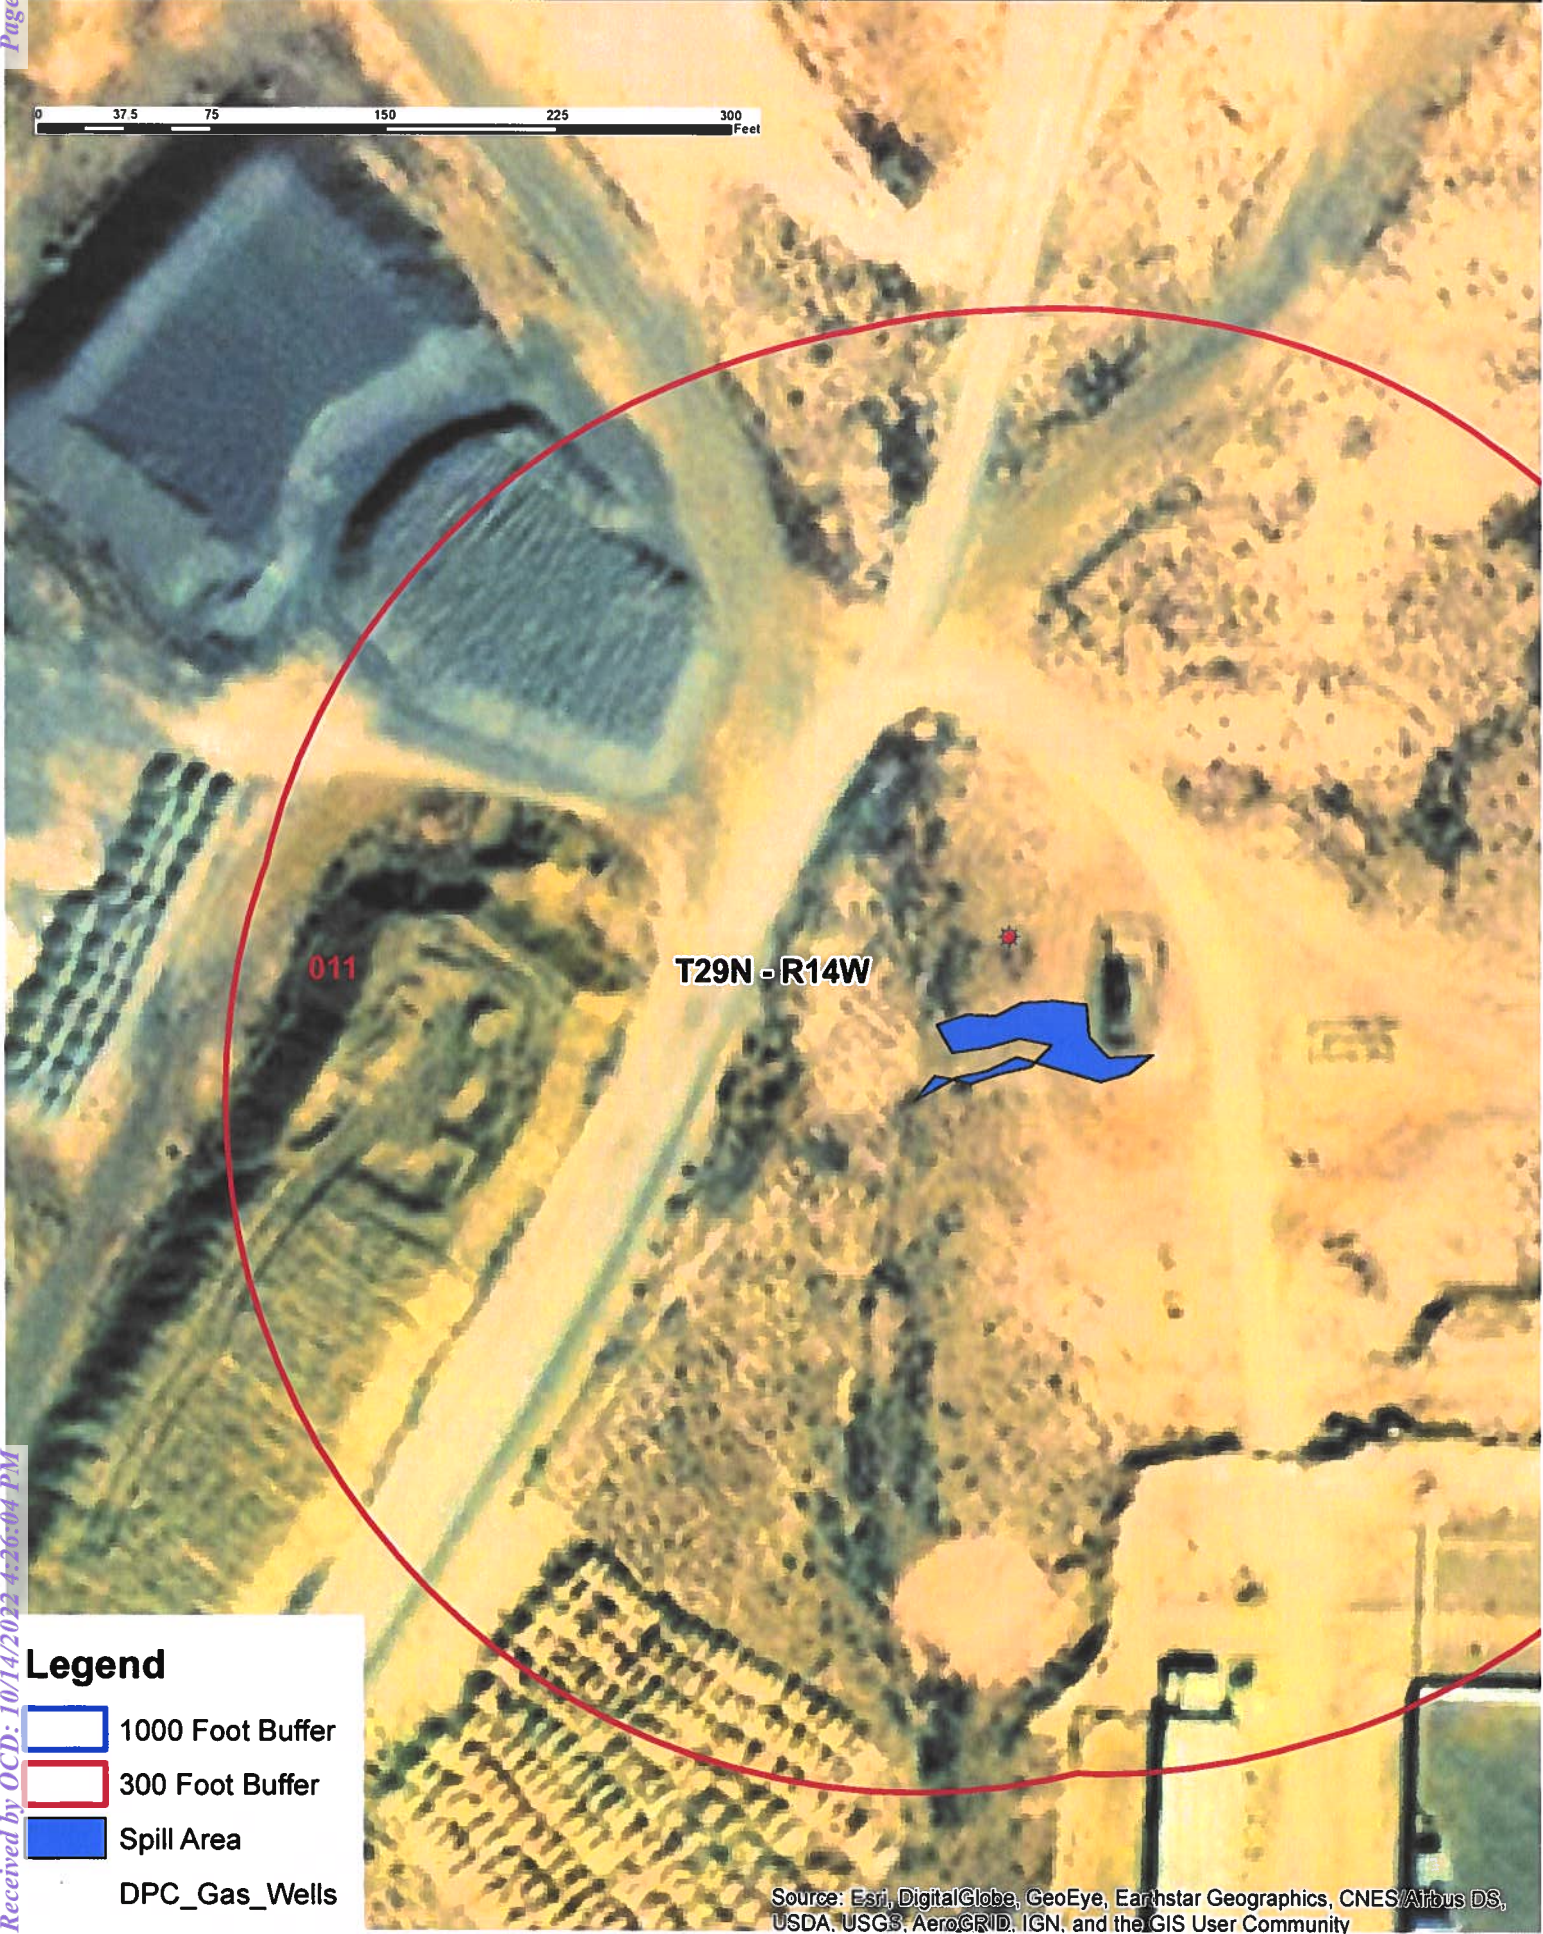
Map 1: Spill Site Map

Map 1 is a map showing the extents of the spill as they were documented when the spill was discovered.

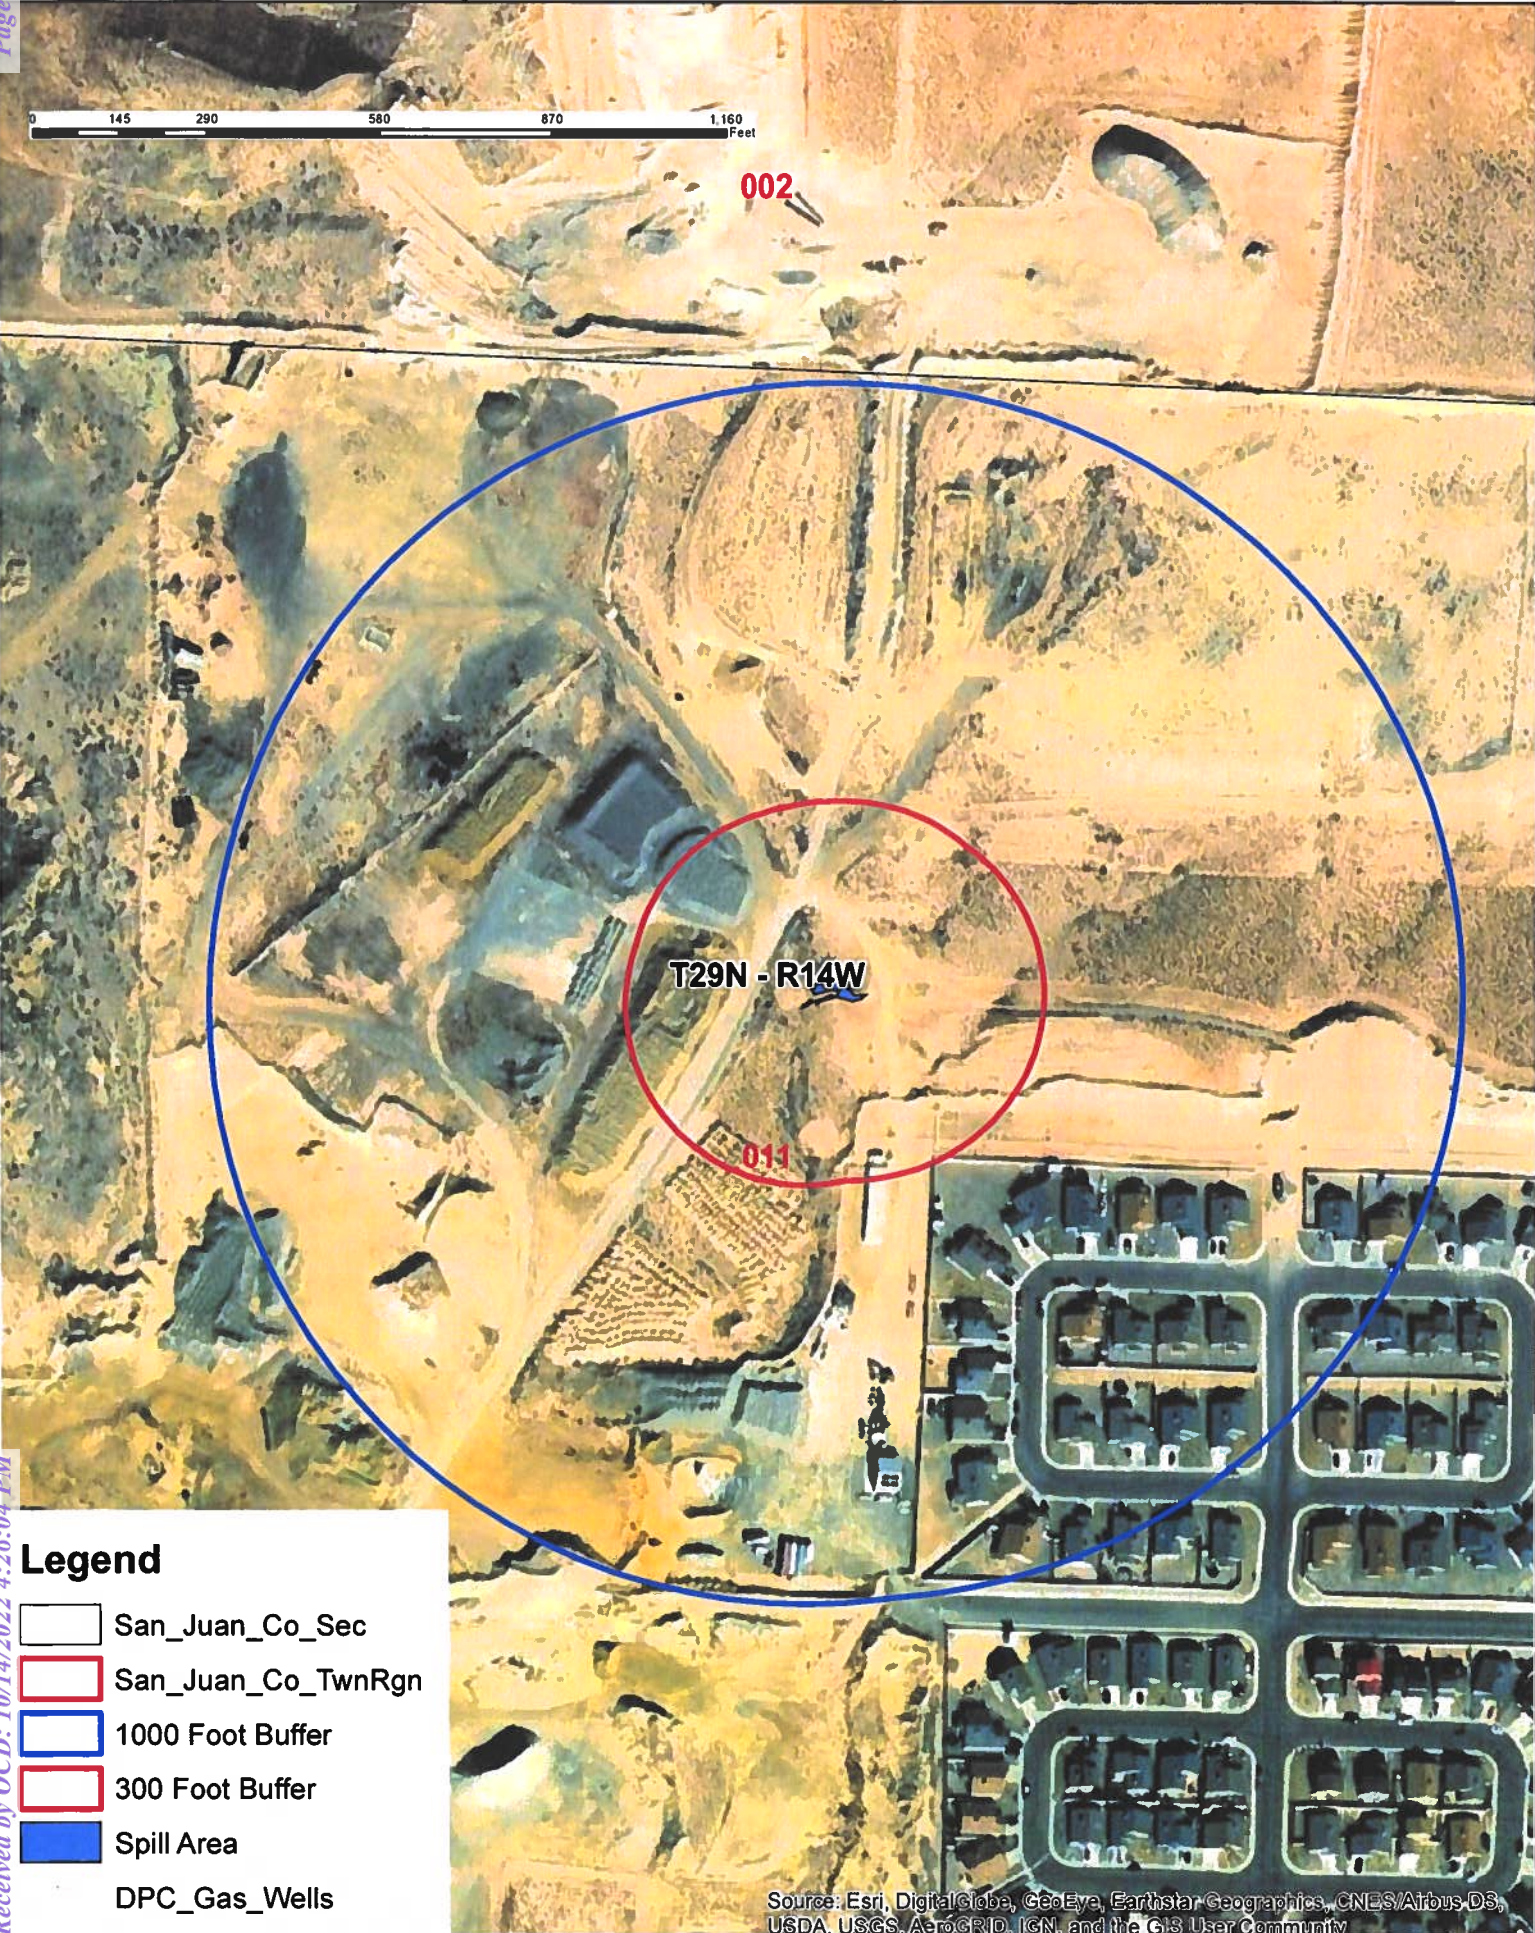
Map 2: Aerial view with buffers

Map 2 is an aerial view of the spill area that includes a 300-foot buffer and 1000-foot buffer. The nearest home is roughly 315 feet away as evidenced by the proximity of the buffer line. Further, there are no watercourses shown on the map.

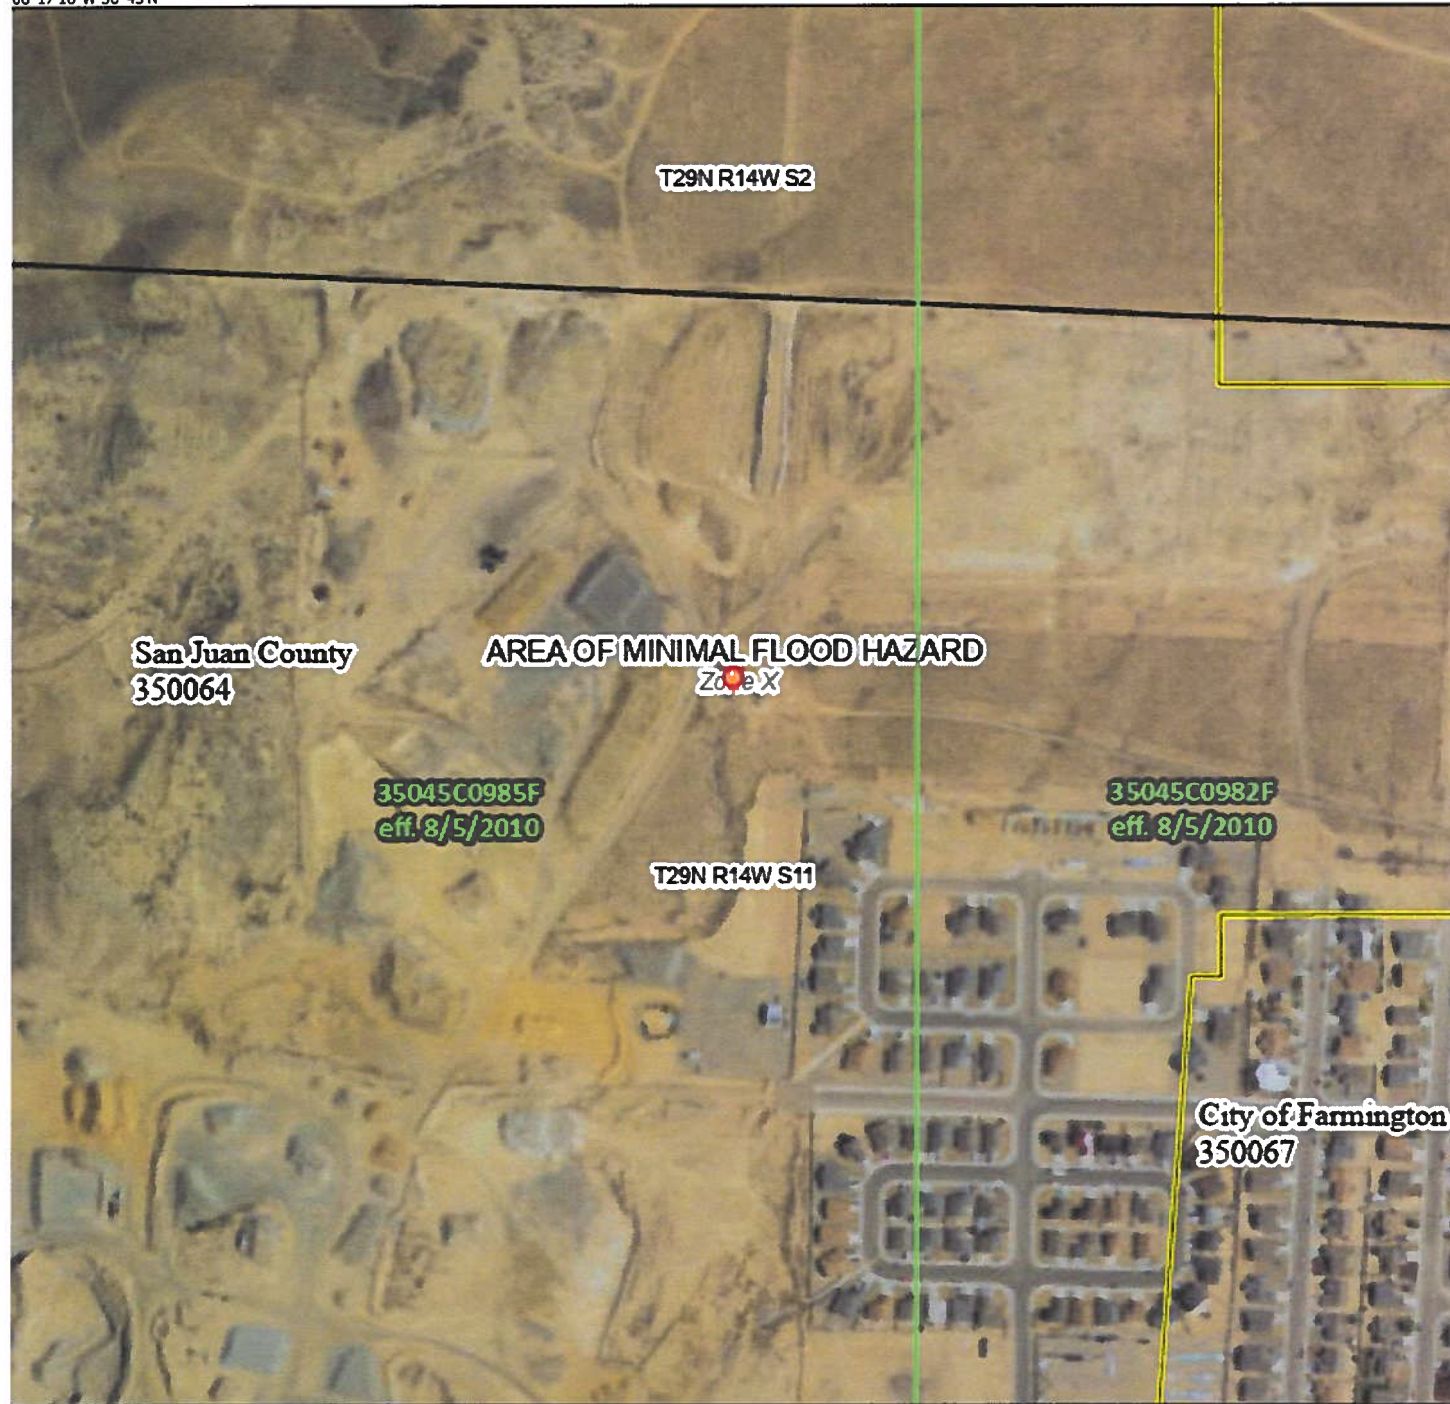
National Flood Hazard Layer FIRMette

Map 4 is a map generated by FEMA that identifies locations within a 100-year flood plain. The map indicates the spill is not within a 100-year flood plain.

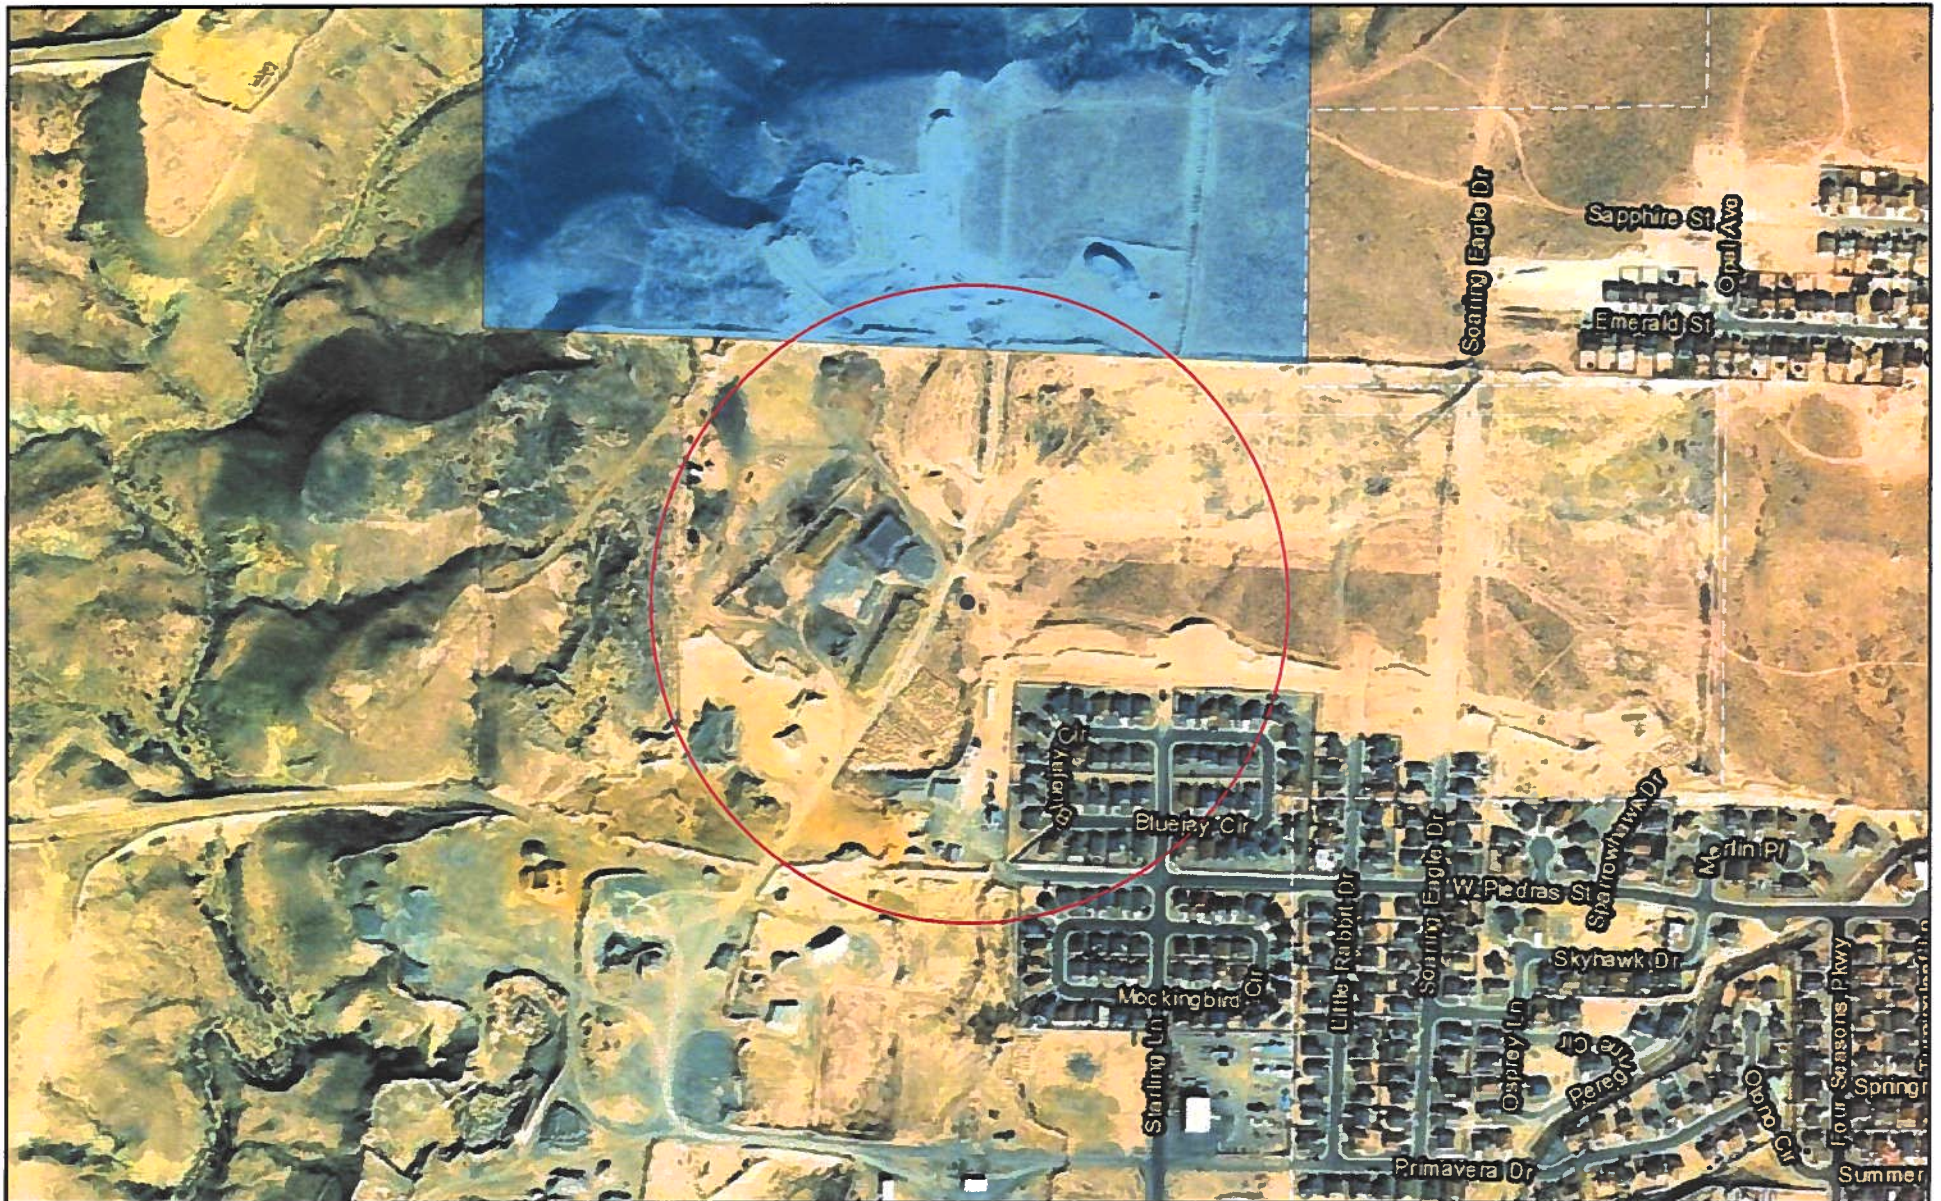
OSE POD Locations Map

Map 6 is a map generated using data from New Mexico State Engineers Office. The data this map plots is for water wells. The red circle drawn on the map is a 1000-foot buffer. No water wells were located within this 1000-foot buffer.

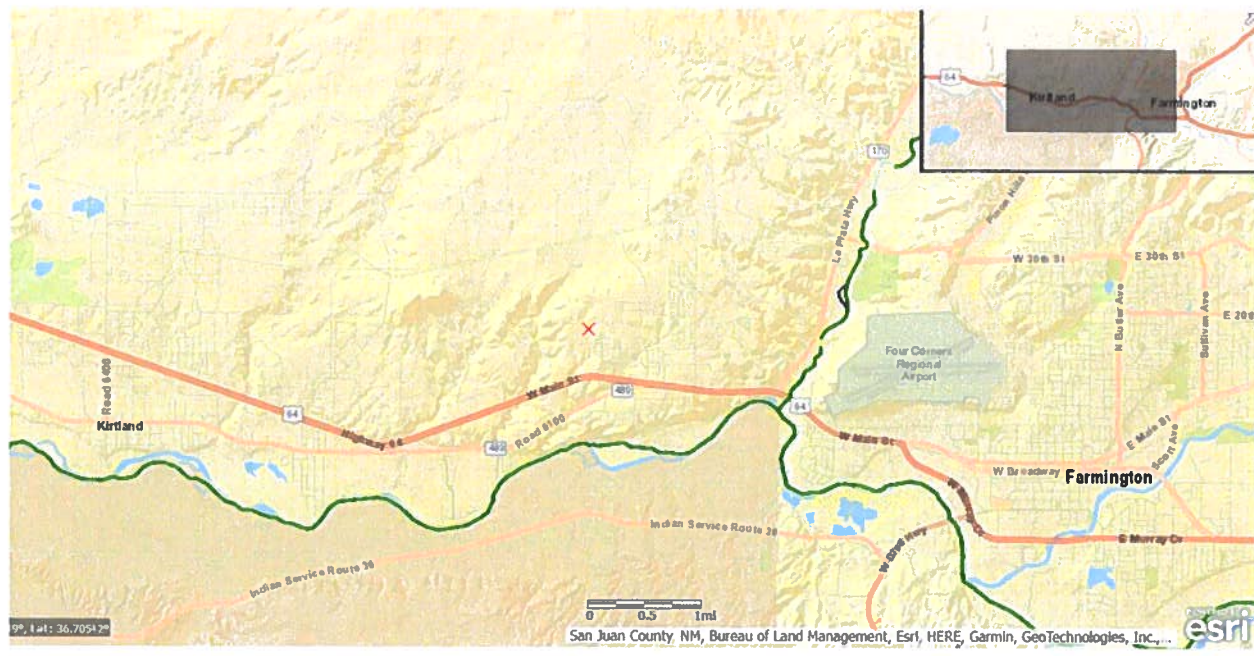
Map 7: Wetlands Map

Map 7 is a snip from the NMED's Wetlands map. There are no wetlands within 300 feet of the spill.

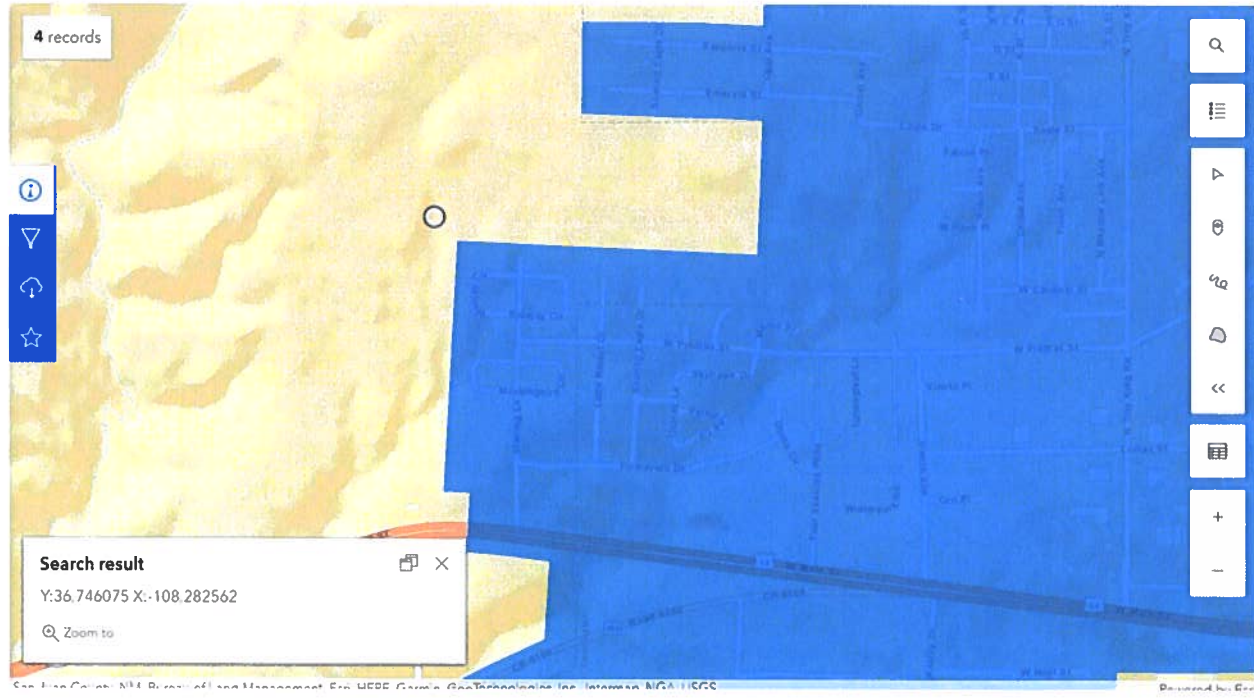
Map 8: Municipal Boundaries

Map 8 is a snip of the City of Farmington's Municipal Boundary. The snip shows the spill is outside of the city boundary.

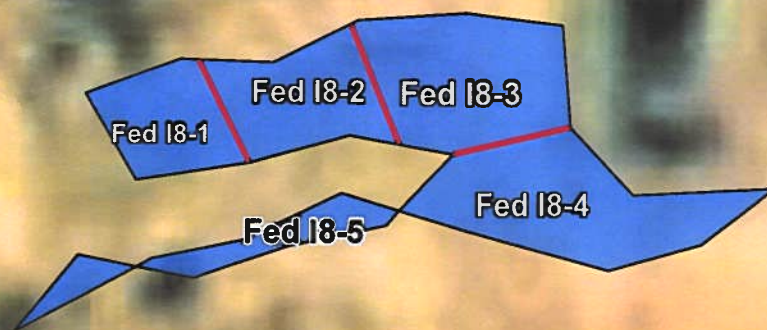
Map 9: Proposed Sampling Zones

Map 9 is a map of the proposed sampling locations.

1. Apply a mixture of gypsum and fresh water to aid in the decontamination process of the soil. In total we propose using 200 lbs of gypsum pearls that will be raked in. After the application of gypsum, we propose watering the contaminated soil with 240 bbls of fresh water. We propose applying water in 80 bbl increments. To aid in treating the soil we propose ripping the soil of the pad so that all compacted, hardened soils will allow water to sink below the root growing zone of local flora. Dugan will not cause any surface disturbance off the well pad.

2. Once the treatment with gypsum and fresh water has been completed Dugan will collect soil samples at a depth of 2 to 4 feet below grade surface. The soils samples will be analyzed in a local lab. The lab will test for Chlorides, BTEX and TPH. The soil samples will be analyzed in a local laboratory.

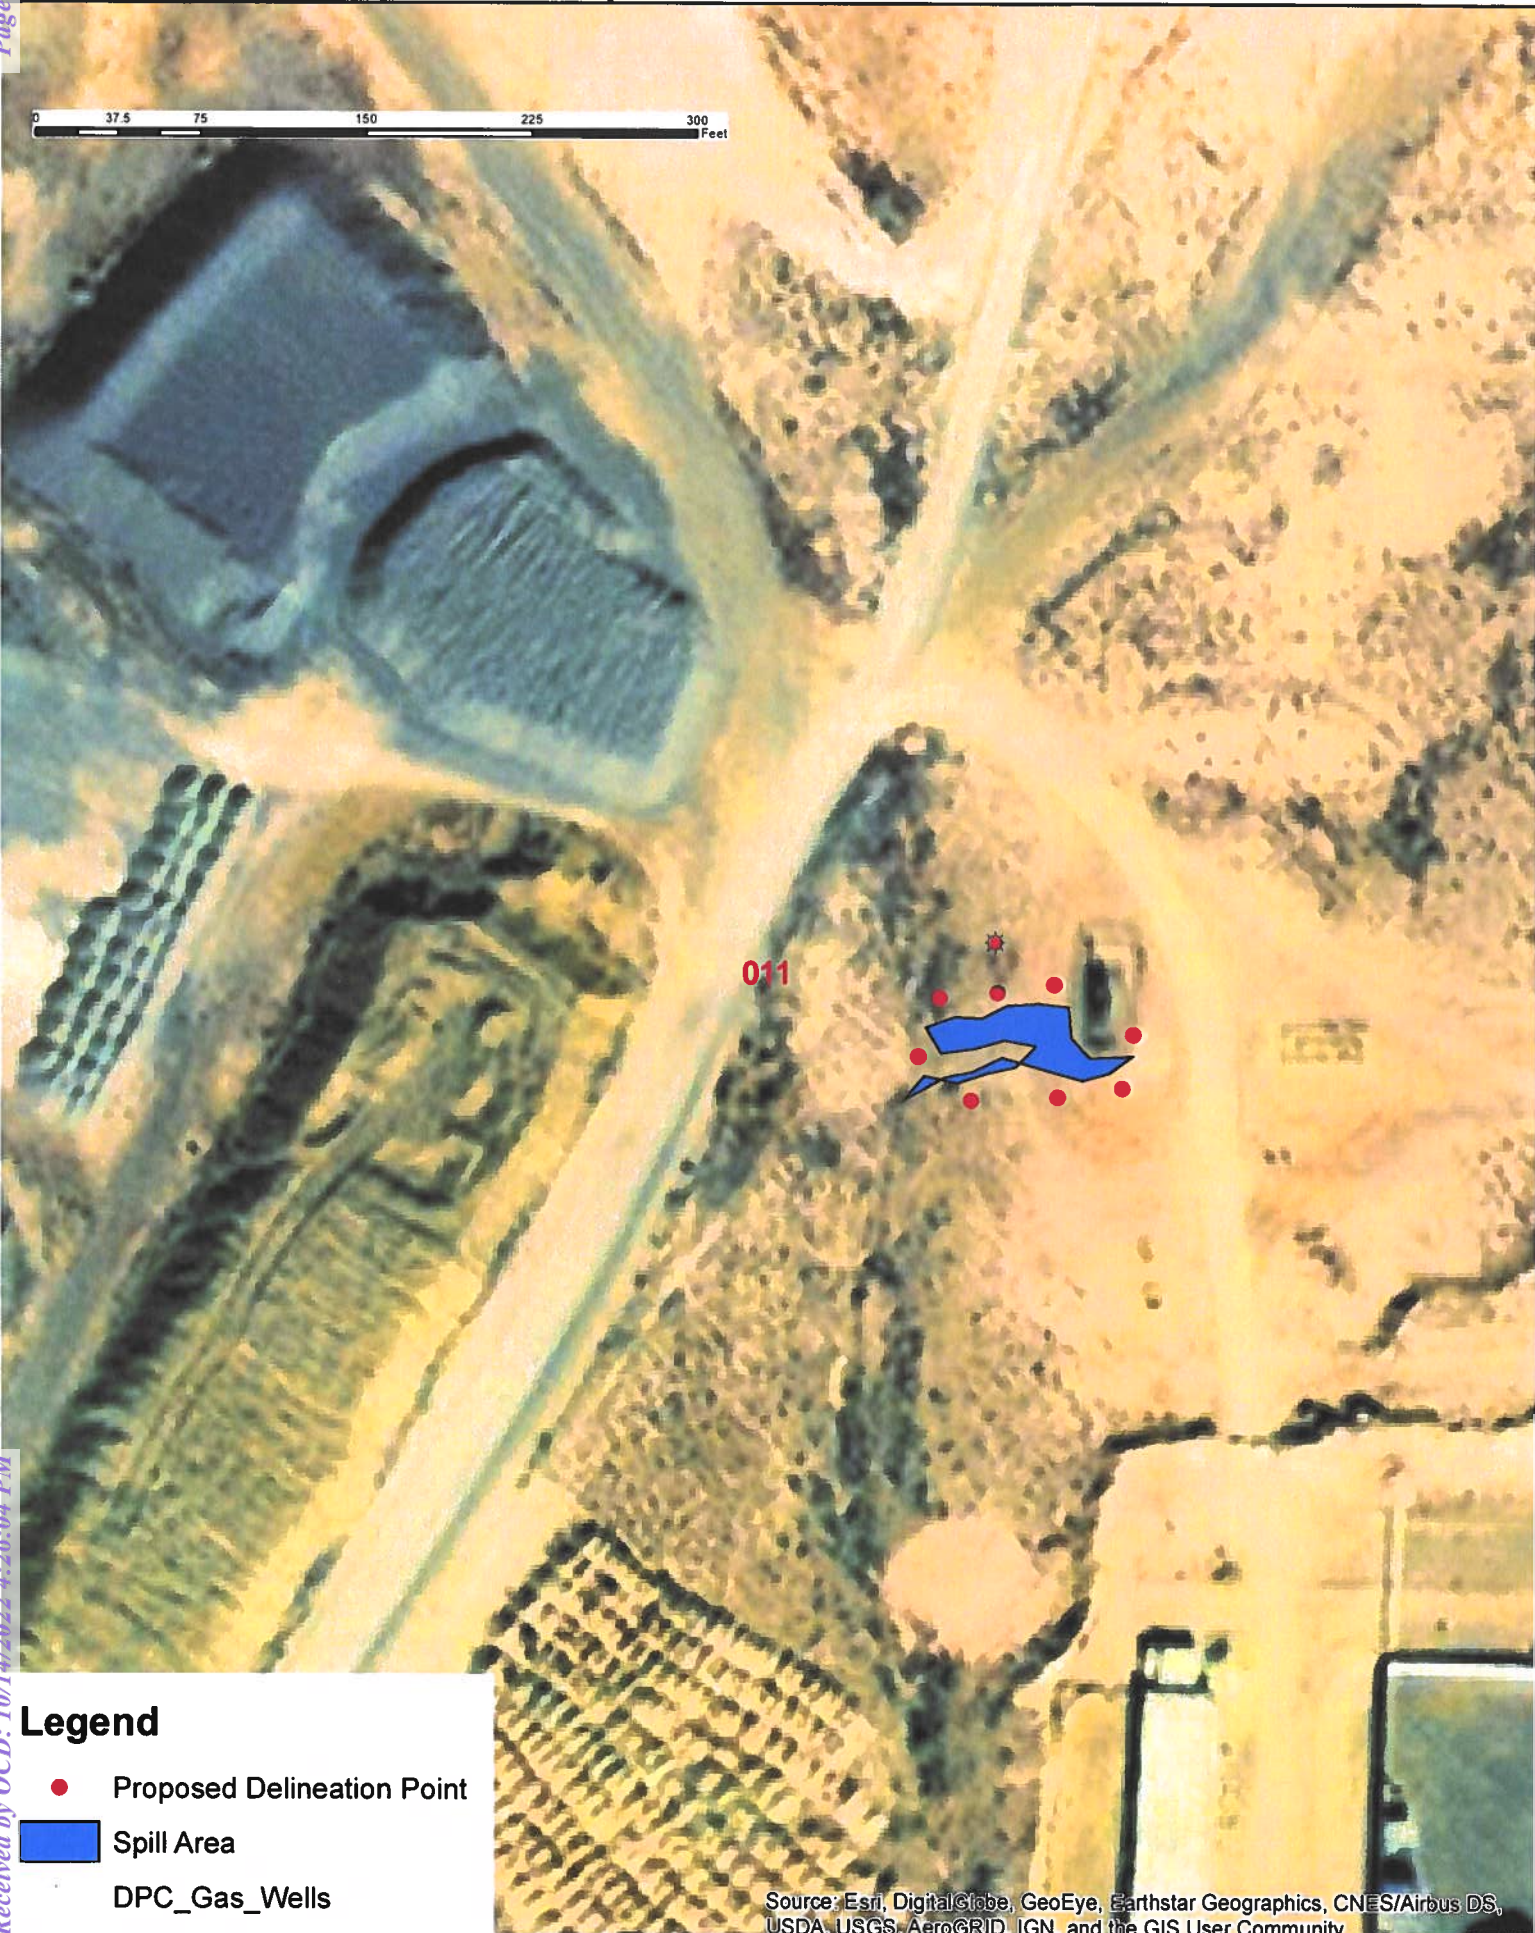
Map 10: Proposed Delineation Points

4. For delineation Dugan will collect soil samples at a depth of 4 feet below grade surface at 8 points on the spill's perimeter. In so doing this should verify the contamination has not spread laterally or vertically.
