February 11, 2022

**Re: Release Characterization and Closure Request  
ConocoPhillips  
Heritage Concho  
Loco Hills SWD Main Line Release  
Unit Letter G, Section 24, Township 17 South, Range 30 East  
Eddy County, New Mexico  
Incident ID# nAB1514733807**

Release Characterization and Closure Request  
February 11, 2022

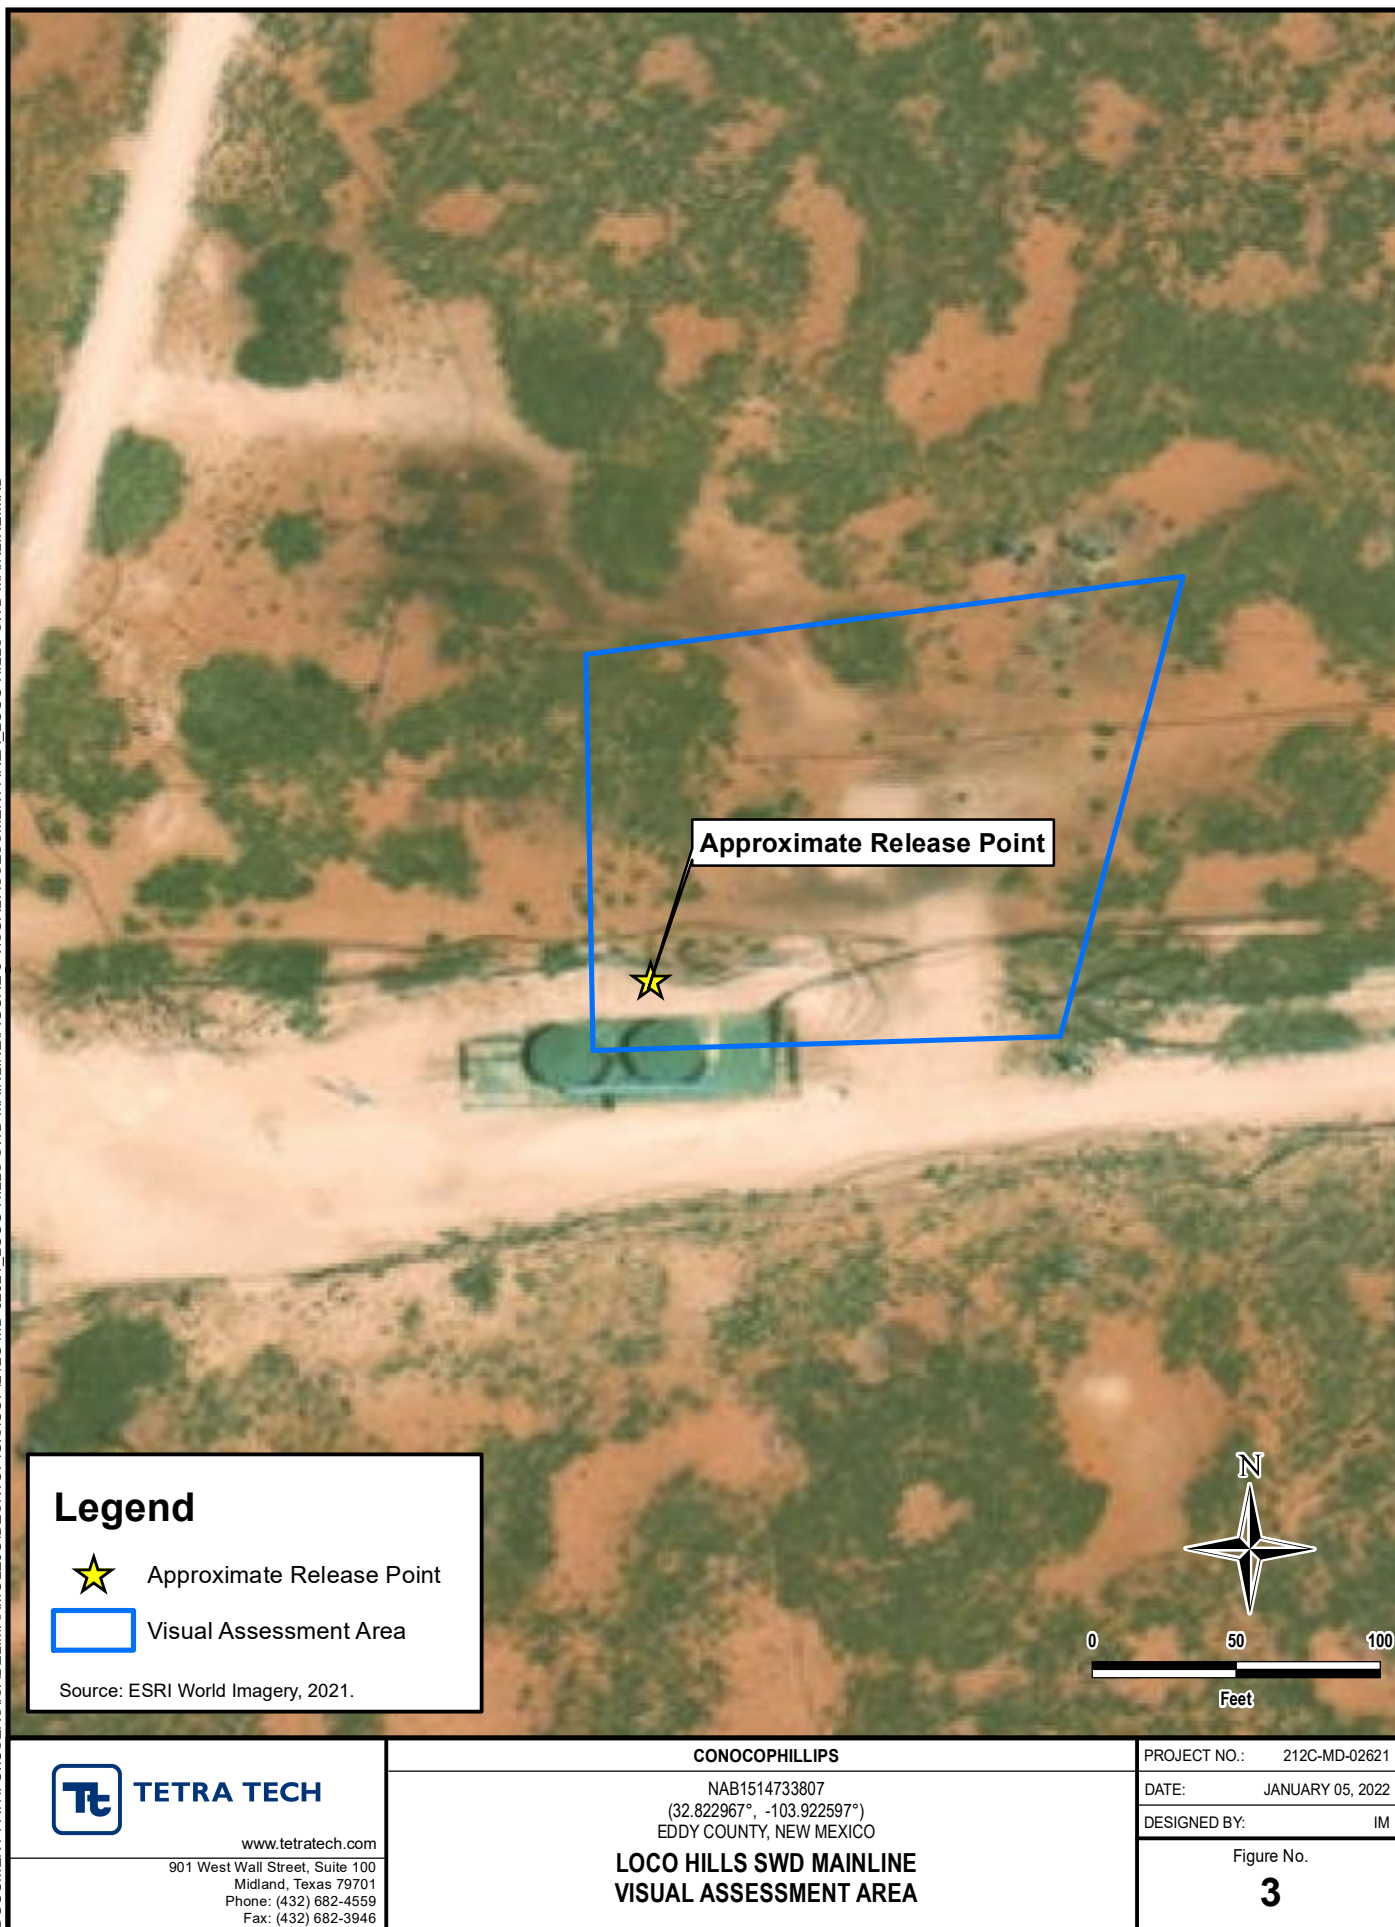
DOCUMENT PATH: C:\USERS\ISABEL.MARMOLEJO\DESKTOP\GIS\COP\212C-MD-02621\_LOCO HILLS SWD MAINLINE\FIGURE 3 VISUAL ASSESSMENT AREA\_LOCO HILLS SWD MAINLINE.MXD

Tetra Tech conducted a visual Site inspection on December 28, 2021 to observe the status of revegetation and obtain photographic documentation of current Site conditions. Based on observations made by Tetra Tech's field personnel and photographic evidence acquired during the site monitoring, vegetation has established in the former release Site. Figure 3 is attached as a reference to depict the area observed during Tetra Tech's site monitoring in December 2021.

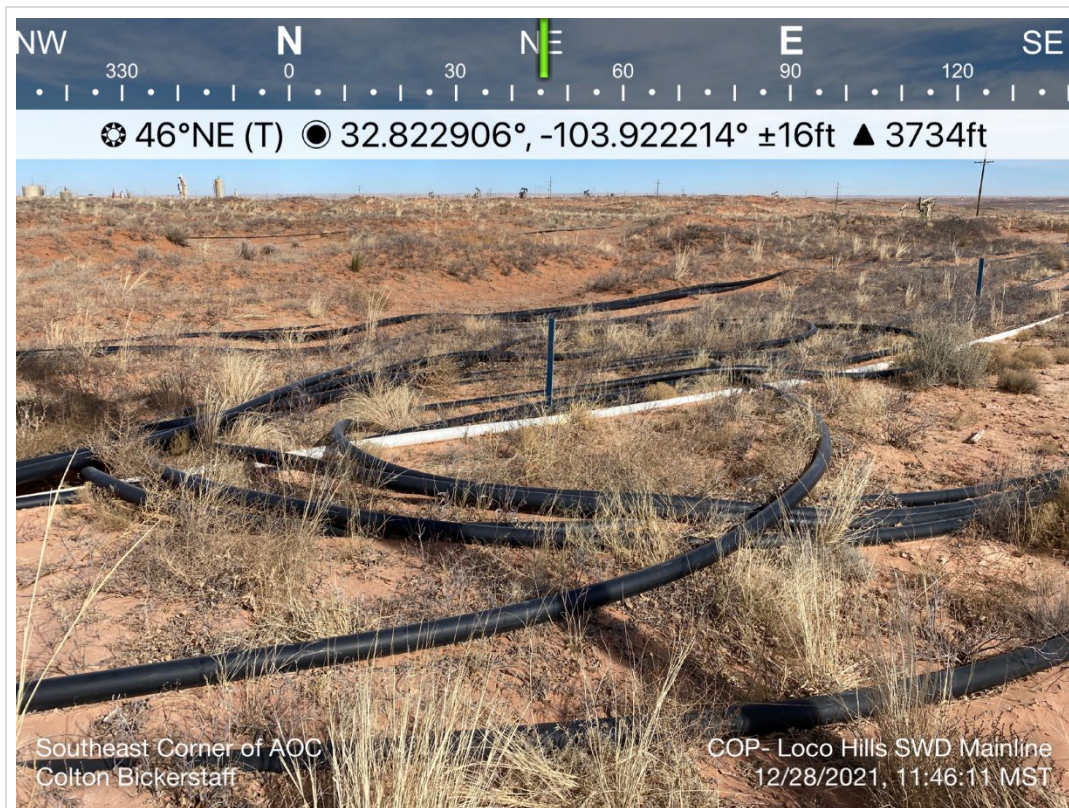
TETRA TECH, INC. PROJECT NO. 212C-MD-02621	DESCRIPTION	View northeast. Southeast corner of visually assessed area.	1
	SITE NAME	Loco Hills SWD Main Line	12/28/2021

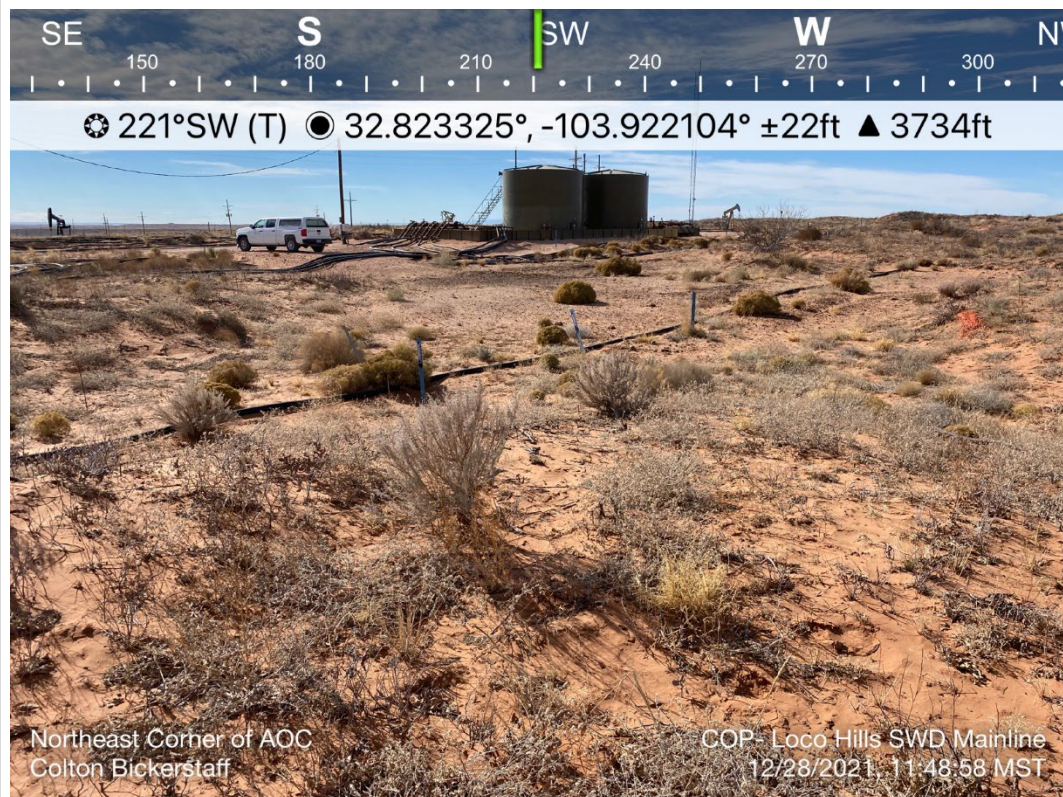
TETRA TECH, INC. PROJECT NO. 212C-MD-02621	DESCRIPTION	View southwest. Northeast of tank battery.	2
	SITE NAME	Loco Hills SWD Main Line	12/28/2021

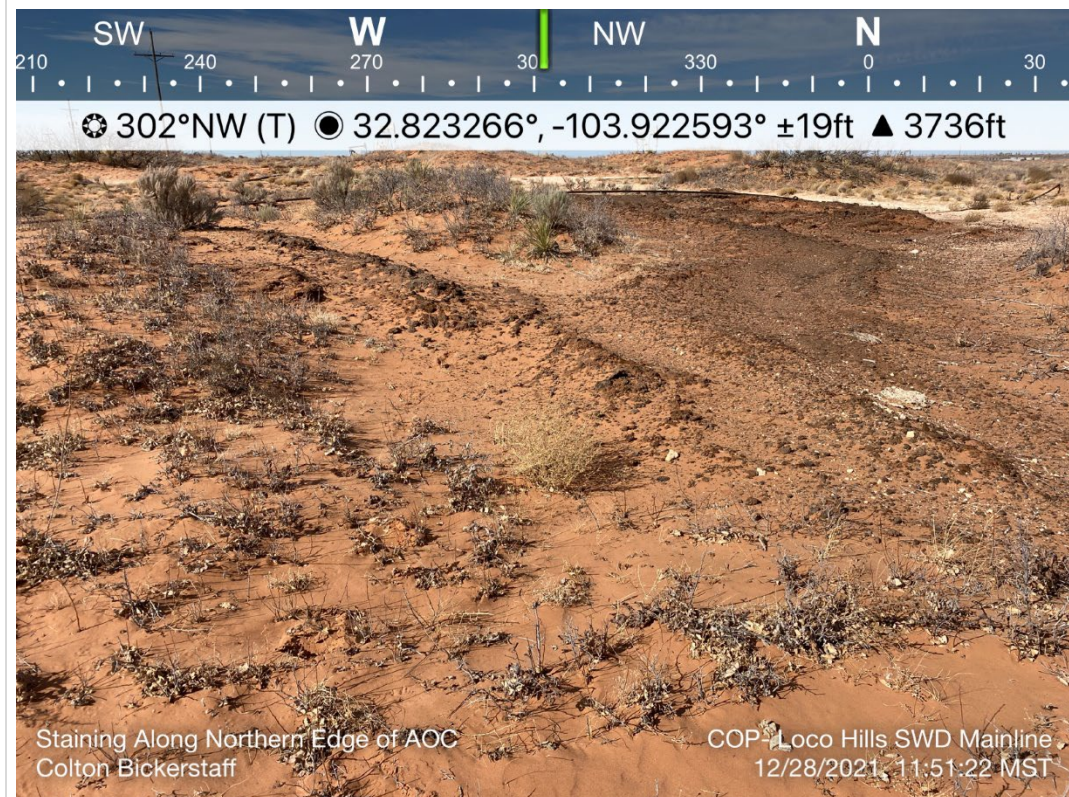
Moderate asphaltic staining was observed during the December 2021 site visit, as shown in the photographic documentation presented in Appendix F. Considering that the May 2015 Concho release being addressed in this report was a produced water release, the asphaltic staining is considered unrelated. A NMOCD file search was conducted, along with an aerial imagery review, to identify the source of the observed asphaltic staining. Firstly, a review of aerial imagery from February 2014 revealed evidence of an apparent hydrocarbon release in the pasture immediately northwest of the May 2015 release extent. Imagery from February 2017 revealed further evidence of possible remedial actions taken at that Site. The historical aerial imagery is presented in Appendix G.

TETRA TECH, INC. PROJECT NO. 212C-MD-02621	DESCRIPTION	View west-northwest. Northwest corner of visually assessed area. Surface staining visible.	4
	SITE NAME	Loco Hills SWD Main Line	12/28/2021

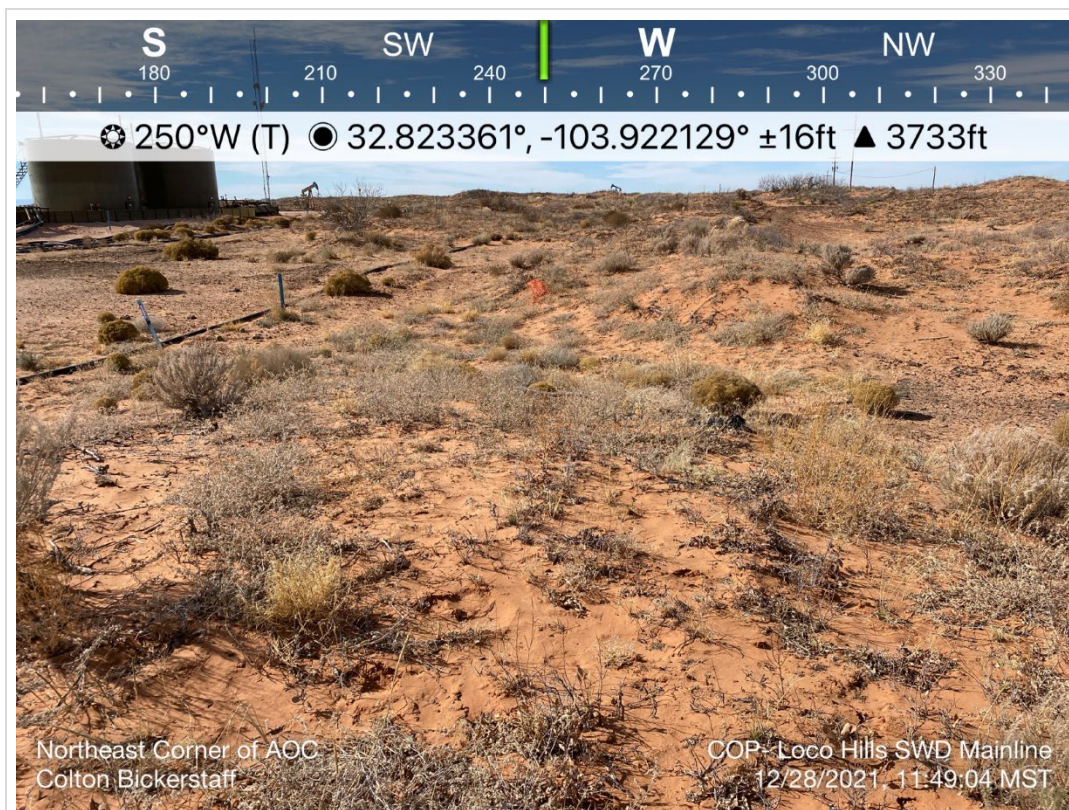
TETRA TECH, INC. PROJECT NO. 212C-MD-02621	DESCRIPTION	View west-southwest. Northeast corner of former release area.	5
	SITE NAME	Loco Hills SWD Main Line	12/28/2021

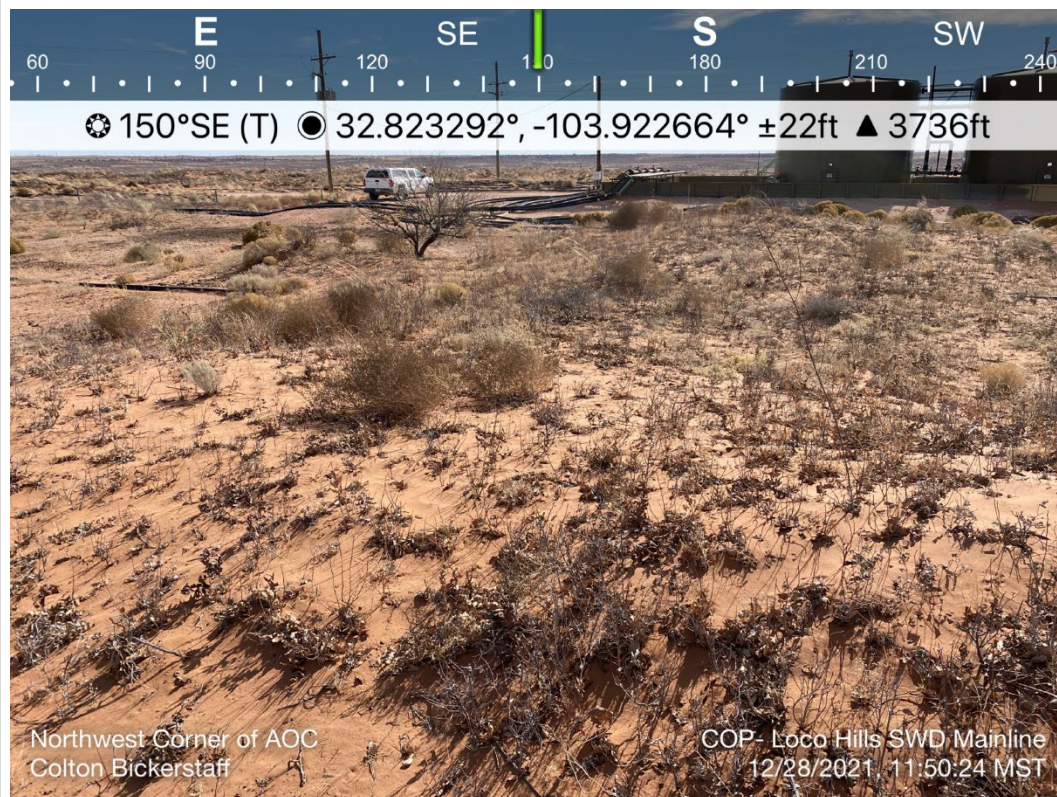
TETRA TECH, INC. PROJECT NO. 212C-MD-02621	DESCRIPTION	View southeast. North of visually assessed area.	6
	SITE NAME	Loco Hills SWD Main Line	12/28/2021

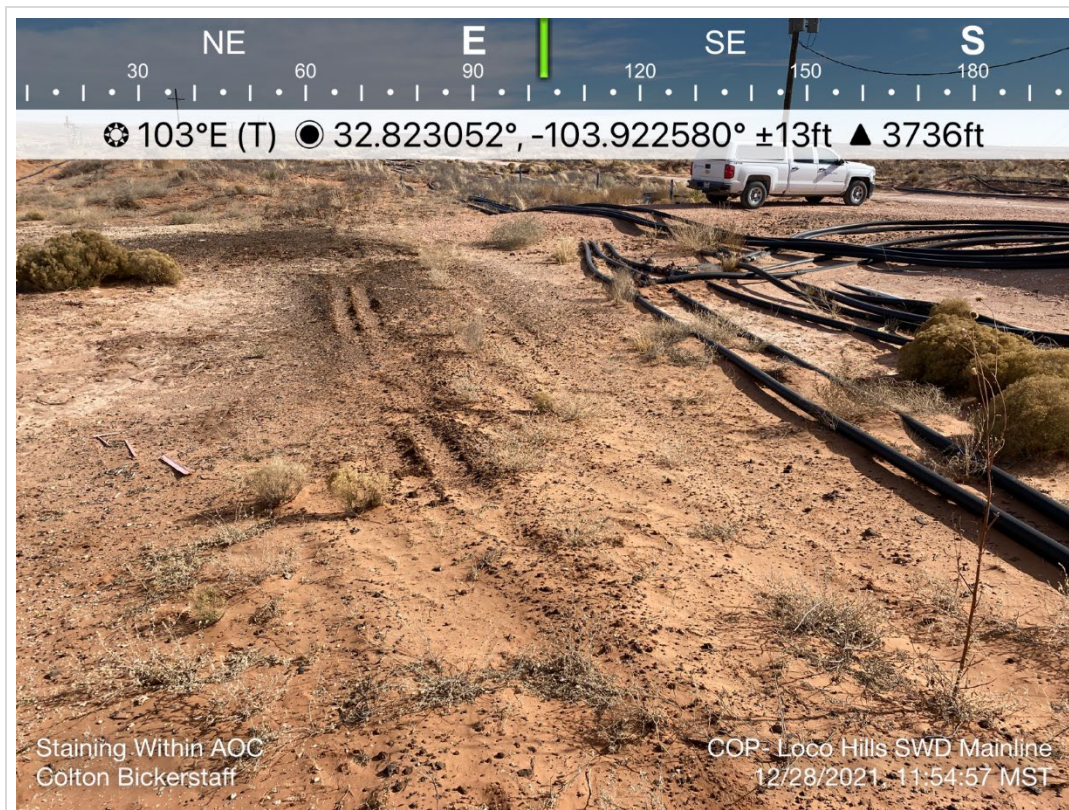
TETRA TECH, INC. PROJECT NO. 212C-MD-02621	DESCRIPTION	View east. Eastern portion of visually assessed area. Surface staining visible.	7
	SITE NAME	Loco Hills SWD Main Line	12/28/2021

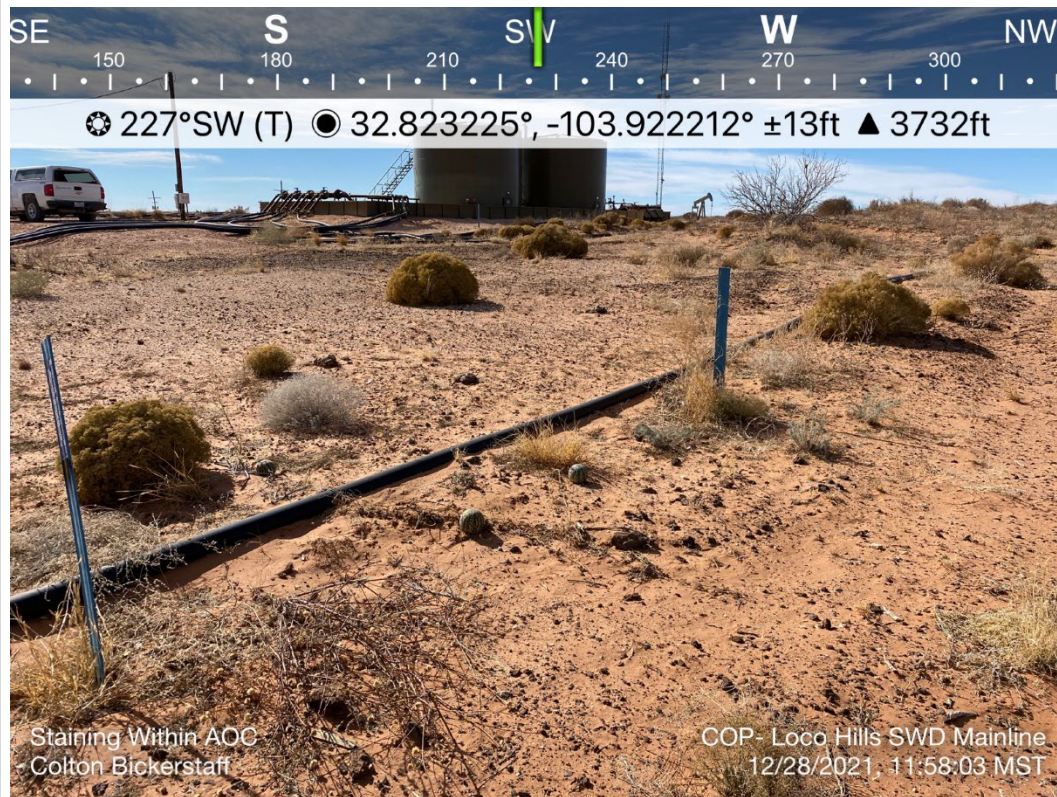
TETRA TECH, INC. PROJECT NO. 212C-MD-02621	DESCRIPTION	View southwest. Northeast of tanks. Surface staining visible.	8
	SITE NAME	Loco Hills SWD Main Line	12/28/2021
