Re: REVISED Release Characterization and Closure Report
ConocoPhillips
War Hammer CTB Release
Unit Letter G, Section 25, Township 26 South, Range 32 East
Lea County, New Mexico
Incident ID# nVV2003557031

REVISED Release Characterization and Closure Report August 15, 2022

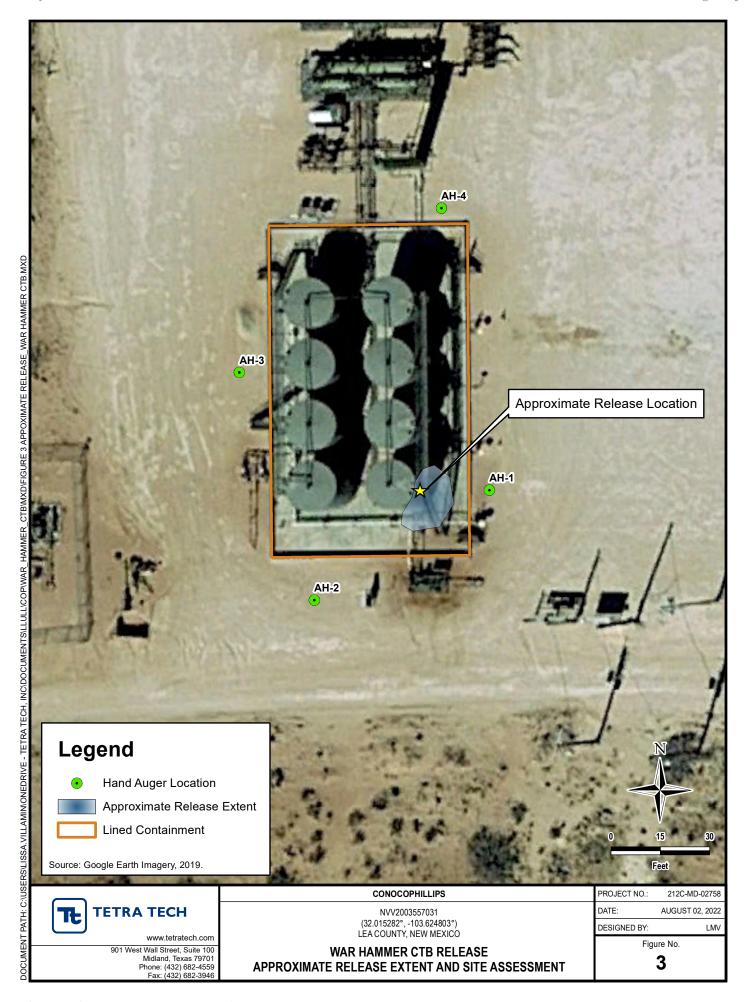
Figure 3 – Approximate Release Extent and Site Assessment Map

The size of the release extent, approximately 215 square feet, was approximated using the volume determination included with the Form C-141. Additionally, T-2030 was observed near the southeastern corner of the secondary containment which confirms the release source found in internal COP documentation. Photographic documentation of site conditions at the time of the site visit is included in Appendix C.

Given the age of the release, in addition to the liner inspection, Tetra Tech personnel were on site on June 30, 2022 to conduct soil sampling to delineate the release horizontally using Table I of 19.15.29.12 NMAC constituents. A total of four (4) hand auger borings were installed around the perimeter of the release extent. The hand auger borings were installed to a depth of 3 feet bgs, and soil samples were collected at depth intervals 0-1' and 2-3' within each boring.

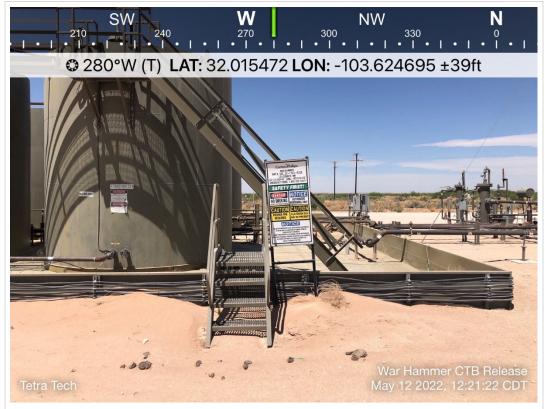
TETRA TECH, INC. PROJECT NO. 212C-MD-02758	DESCRIPTION	View west. Site Signage and location information	1
	SITE NAME	ConocoPhillips War Hammer CTB Release	5/12/2022

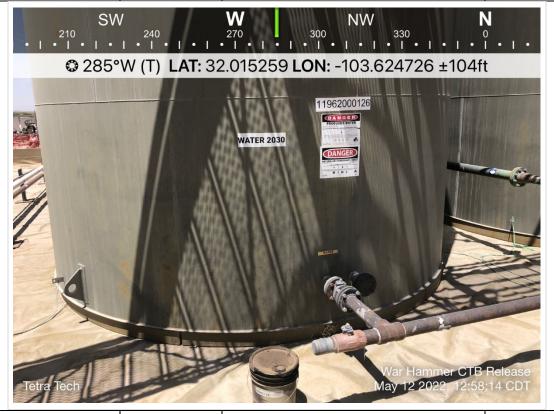
TETRA TECH, INC. PROJECT NO.	DESCRIPTION	View west. Tank T-2030, release source.	2
212C-MD-02758	SITE NAME	ConocoPhillips War Hammer CTB Release	5/12/2022

According to the State of New Mexico Form C-141 Initial Report (Appendix A), the release was discovered on January 8, 2020 (mistakenly reported as January 8, 2019). The release occurred as the result of equipment failure, specifically a pin hole leak on a ball valve. COP internal documentation indicates that the source for the release was a 2-inch ball valve on water tank 2030 (T-2030).

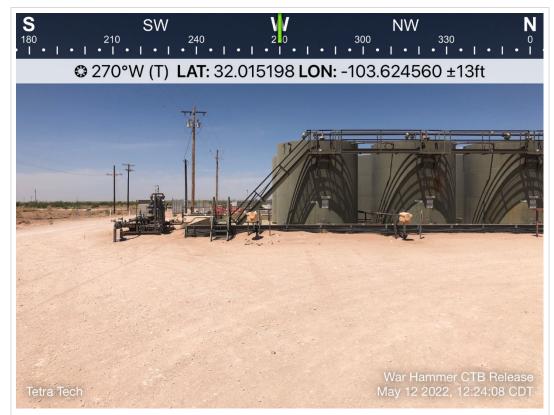
TETRA TECH, INC. PROJECT NO. 212C-MD-02758	DESCRIPTION	View west. Area east of the release and source location. Outside the lined secondary containment.	3
	SITE NAME	ConocoPhillips War Hammer CTB Release	5/12/2022

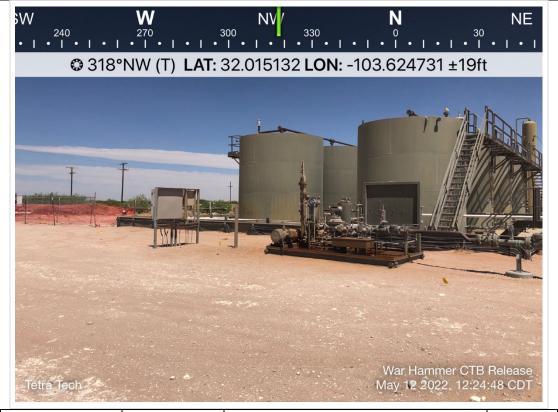
TETRA TECH, INC. PROJECT NO.	DESCRIPTION	View northwest. Area south of the release and source location. Outside the line secondary containment.	4
212C-MD-02758	SITE NAME	ConocoPhillips War Hammer CTB Release	5/12/2022

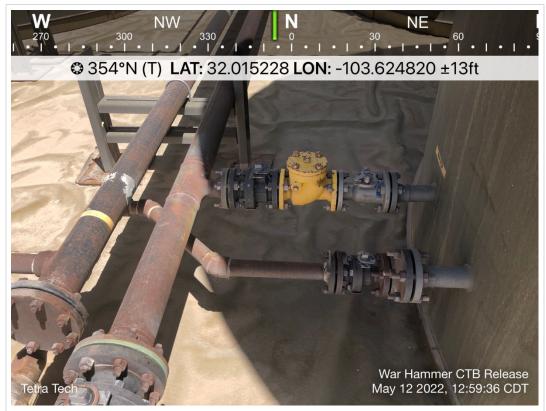
TETRA TECH, INC. PROJECT NO. 212C-MD-02758	DESCRIPTION	Release source; replaced ball valve.	5
	SITE NAME	ConocoPhillips War Hammer CTB Release	5/12/2022

ease - Ball va None of the	 alve had a pin hole e release made it to	leak. Ball valve h ground soil. Rel	as been replaced. lease has been ful	 Remediation cor ly cleaned up.	mpleted via vac truck from secondary		
	War Hamme Discovered Section 25 : State Material Water te as scribe)	War Hammer Discovered 1/8/2019 Section Township 25 26S : □ State ☒ Federal □ Tri Material(s) Released (Select all Volume Released Is the concentrate produced water > Volume Released as Volume Released as Volume Released Scribe) Volume/Weight	Location Section	Location of Release S Longitude (NAD 83 in decimal degrees to 5 dec	Location of Release Source Longitude

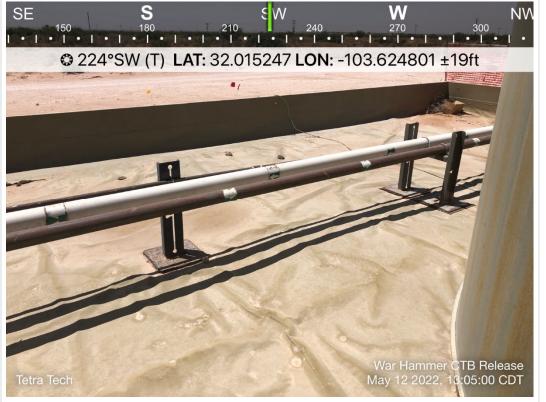
TETRA TECH, INC. PROJECT NO. 212C-MD-02758	DESCRIPTION	View southwest. Inside the secondary containment. No visual evidence of a release within the lined area.	6
	SITE NAME	ConocoPhillips War Hammer CTB Release	5/12/2022

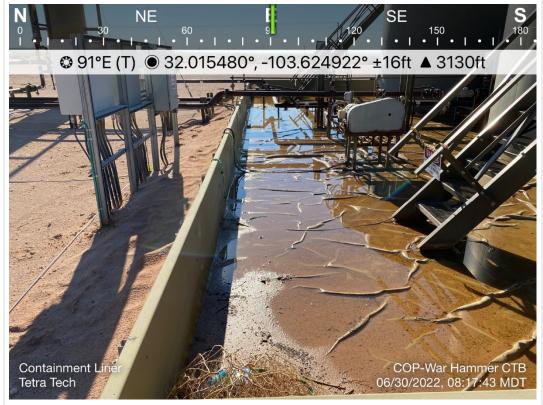
TETRA TECH, INC. PROJECT NO. 212C-MD-02758	DESCRIPTION	View east. Stormwater present in the northern portion of the lined secondary containment during liner inspection.	7
	SITE NAME	ConocoPhillips War Hammer CTB Release	6/30/2022

On June 30, 2022, Tetra Tech personnel performed an inspection of the liner within the secondary containment of the War Hammer CTB. The liner was observed to underlie the entirety of the tank battery secondary containment area. The liner was intact with no visible rips or tears and encompassed by a 2-foot-tall steel wall. The liner extended up the steel "muscle" wall. At the time of the liner inspection, stormwater had accumulated in the lined area due to recent rain events. The standing water lends further evidence to the integrity of the liner as a competent fluid barrier. At the time of the inspection, the liner was intact and had the ability to contain the leak in question. Photographic documentation of the liner inspection is included in Appendix C.

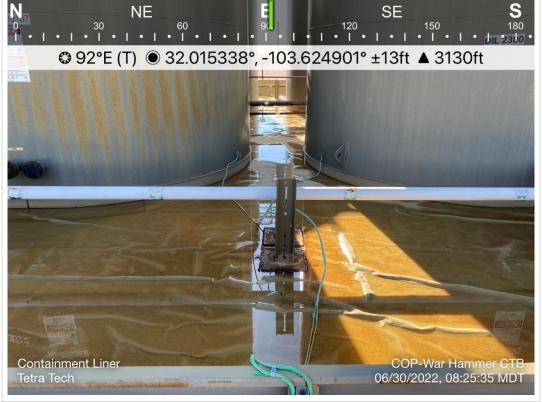
TETRA TECH, INC.	DESCRIPTION	View east. Stormwater present in the central portion of lined secondary containment during liner inspection.	8
PROJECT NO. 212C-MD-02758	SITE NAME	ConocoPhillips War Hammer CTB Release	6/30/2022

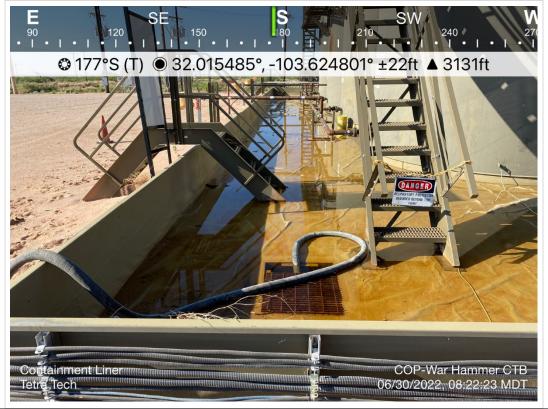
TETRA TECH, INC.	DESCRIPTION	View south. Stormwater present in the eastern portion of lined secondary containment during liner inspection.	9
PROJECT NO. 212C-MD-02758	SITE NAME	ConocoPhillips War Hammer CTB Release	6/30r/2022

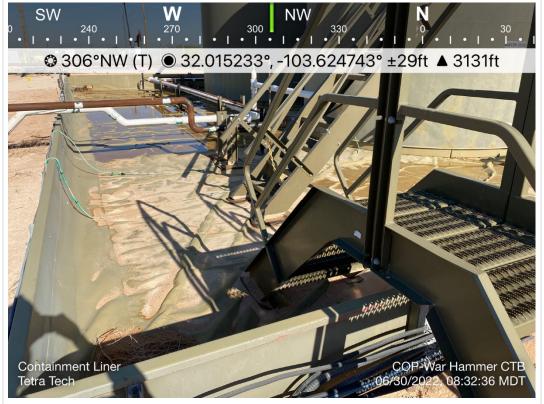
TETRA TECH, INC. PROJECT NO. 212C-MD-02758	DESCRIPTION	View northwest. Southern portion of lined secondary containment during liner inspection.	10
	SITE NAME	ConocoPhillips War Hammer CTB Release	6/30/2022

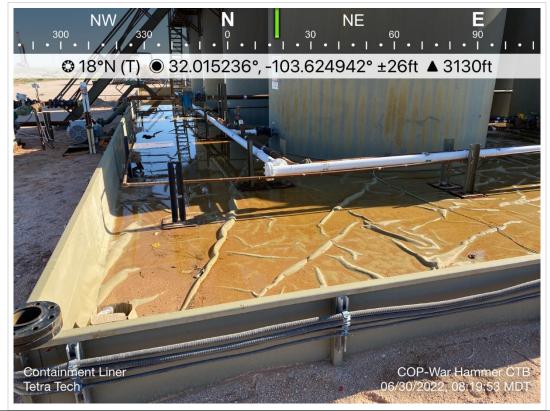
TETRA TECH, INC. PROJECT NO.	DESCRIPTION	View north-northeast. Stormwater present in the western portion of lined secondary containment during liner inspection.	11
212C-MD-02758	SITE NAME	ConocoPhillips War Hammer CTB Release	6/30/2022
