SITE INFORMATION

Report Type: Closure Report 1RP-5088

| Site: | Cabo Blanco State #001H | | | | | |
| Company: | COG Operating LLC | | | | | |

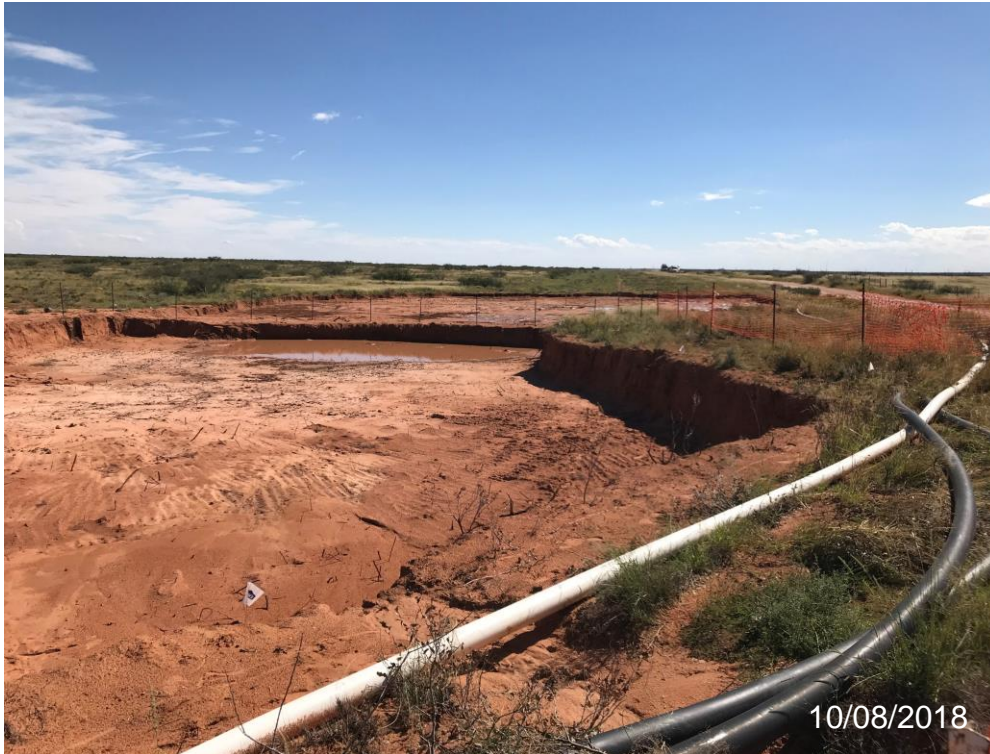
View South – Excavated Area of Bottom hole 1-8

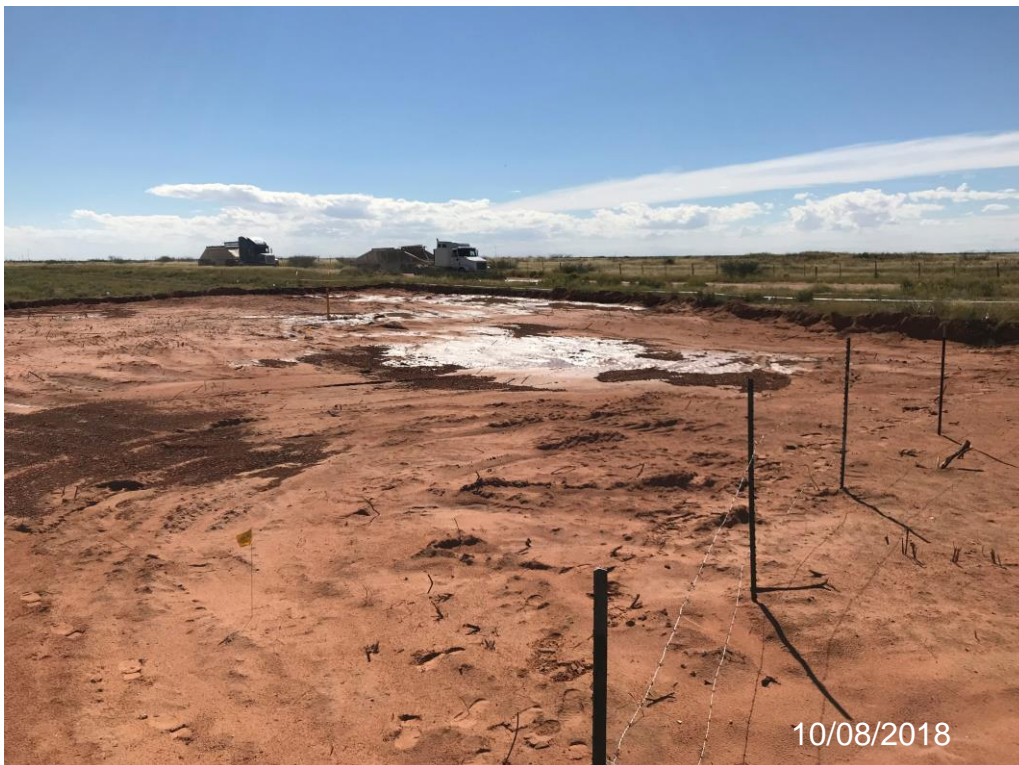
View South –Excavated Areas of Area of Bottom Hole 1-6

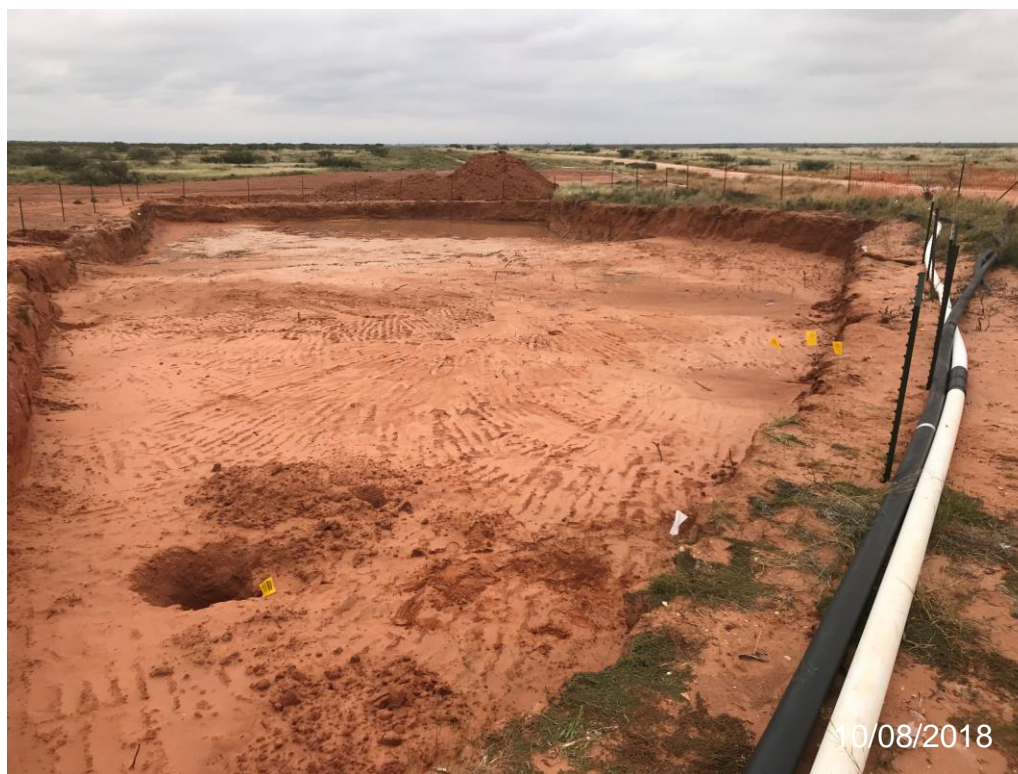
View South – Excavated Area of Bottom hole 6 & Bottom Hole 7

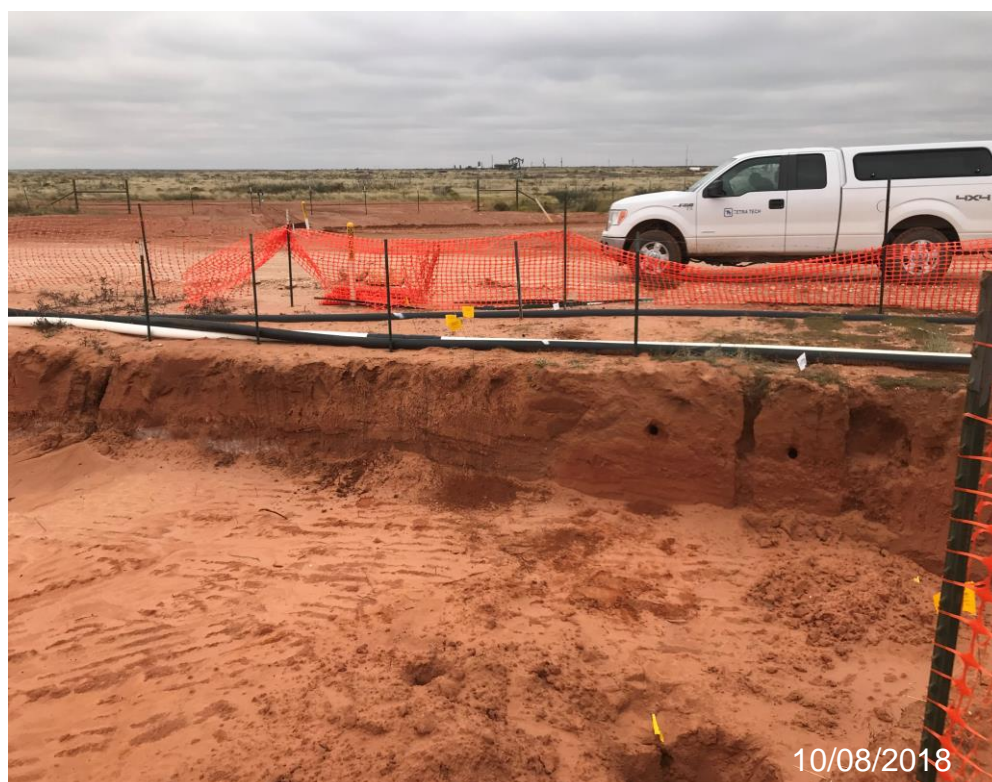
View West – Area of SW-12

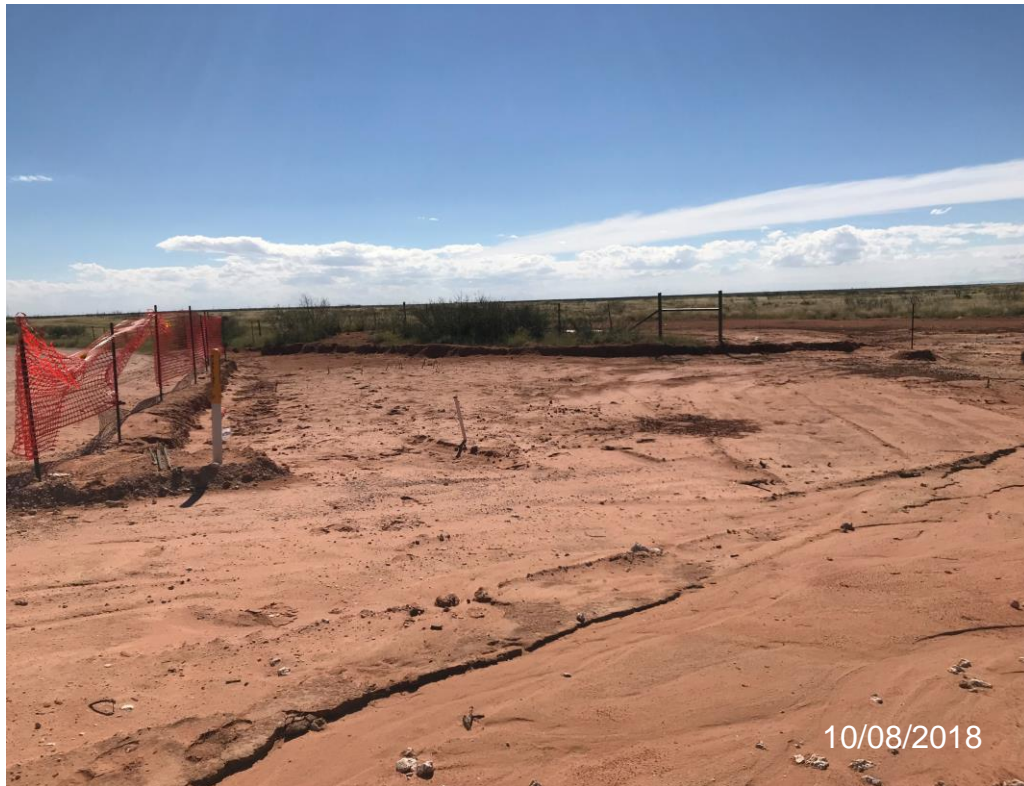
View West – Excavated Area of Bottom Hole 10-11

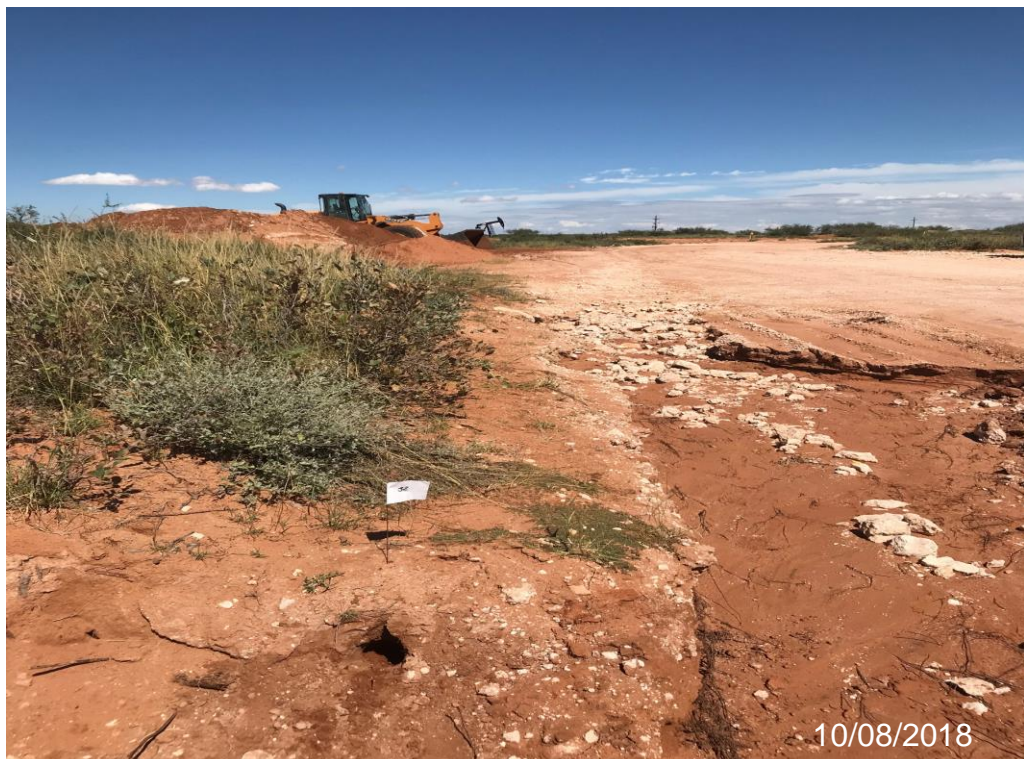
View North – Excavated Area of Bottom Hole 9

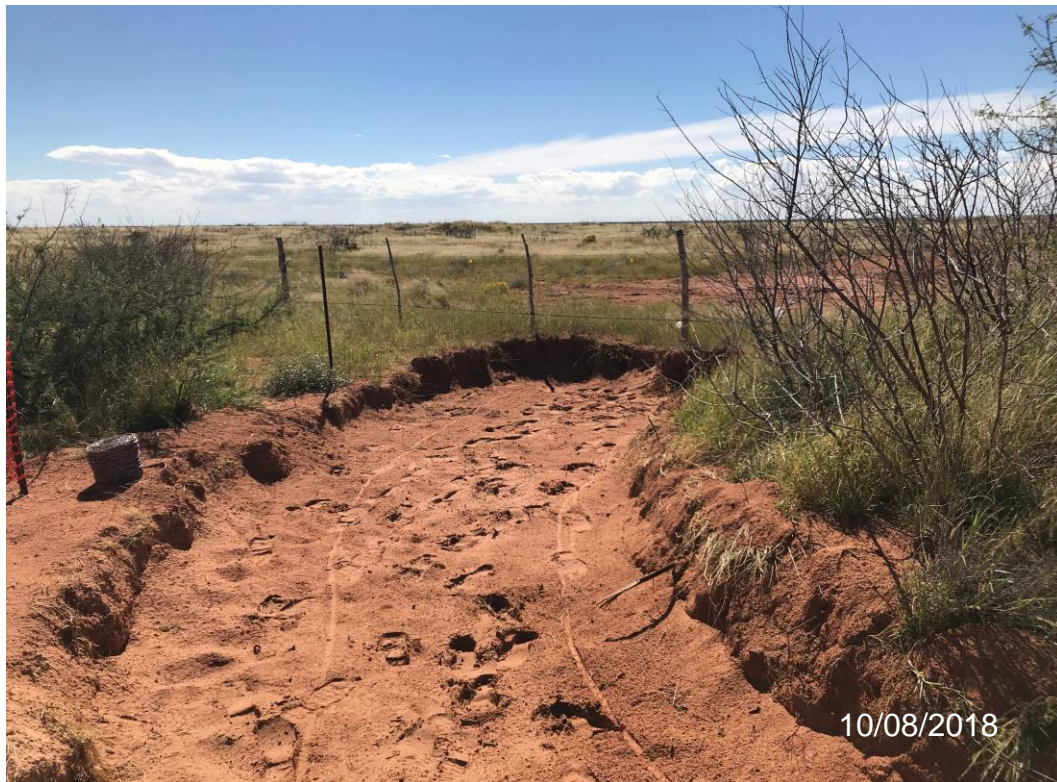
View South – Excavated Area of Bottom hole 12
