Closure Report

Site Description

Site Name:	Sopapilla State #001H
Company:	COG Operating LLC
Legal Description:	U/L M, Section 2, T23S, R33E
County:	Lea County, NM
GPS Coordinates:	N 32.32763° W 103.55012°

Sopapilla State #1H Battery (11/6/15 and 2/3/16)

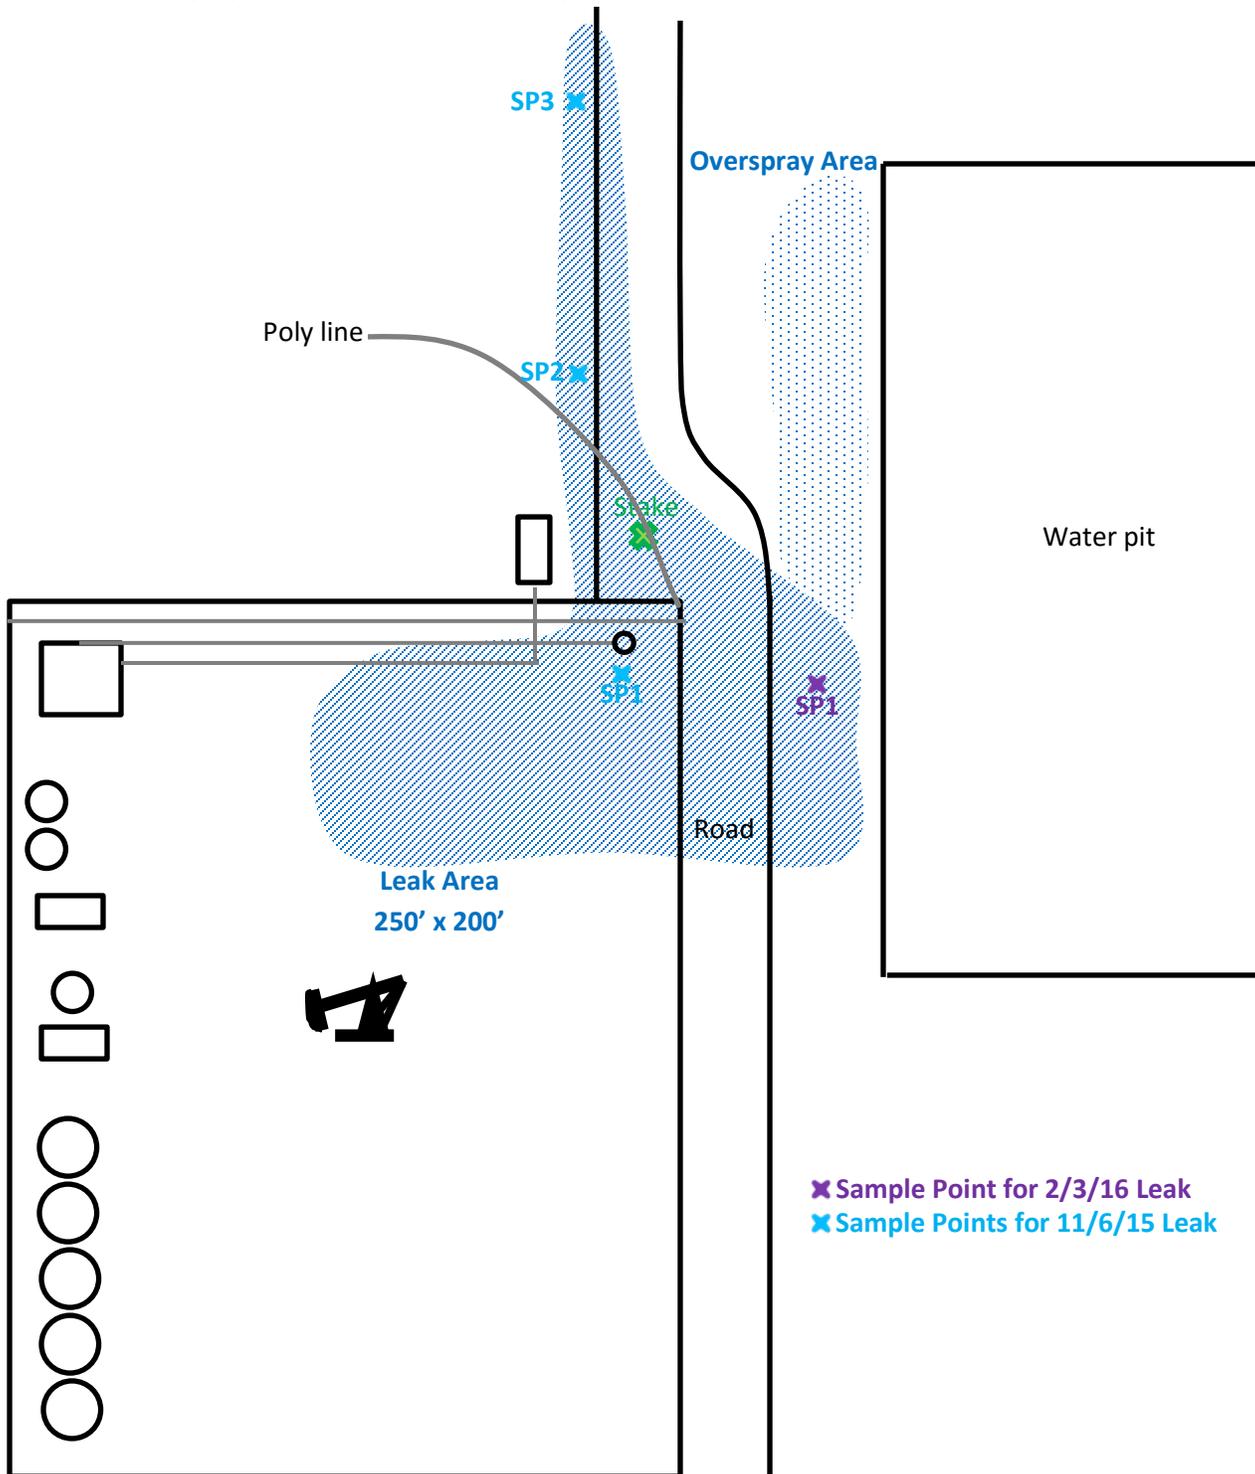
x Sample Point for 2/3/16 Leak
x Sample Points for 11/6/15 Leak

U/L M, Section 2, T23S, R33E

Remediation Parameters:	The spill areas around S1 & S2 from the 11/6/15 spill will be excavated to a depth of 6 inches to 1 foot. The area around S3 for the 11/6/15 spill will be excavated to a depth of 1.5 feet. The area around S1 for the 2/3/16 spill will be surface scraped.	
Remediation Activities:	09/20/2016 to 09/26/2016	
Plan Sent to OCD:	08/05/2016	Email from Cliff Brunson to Jamie Keyes
OCD Approval of Plan:	08/09/2016	Email from Jamie Keyes to Cliff Brunson
Plan Sent to SLO:	08/05/2016	Email from Cliff Brunson to Amber Groves
SLO Approval of Plan:	08/18/2016	Email from Amber Groves to Cliff Brunson
