DELINEATION WORKPLAN

COG – TELECASTER 30 FEDERAL #003H (Leak Date: 6/28/18)

RP # 1RP-5114

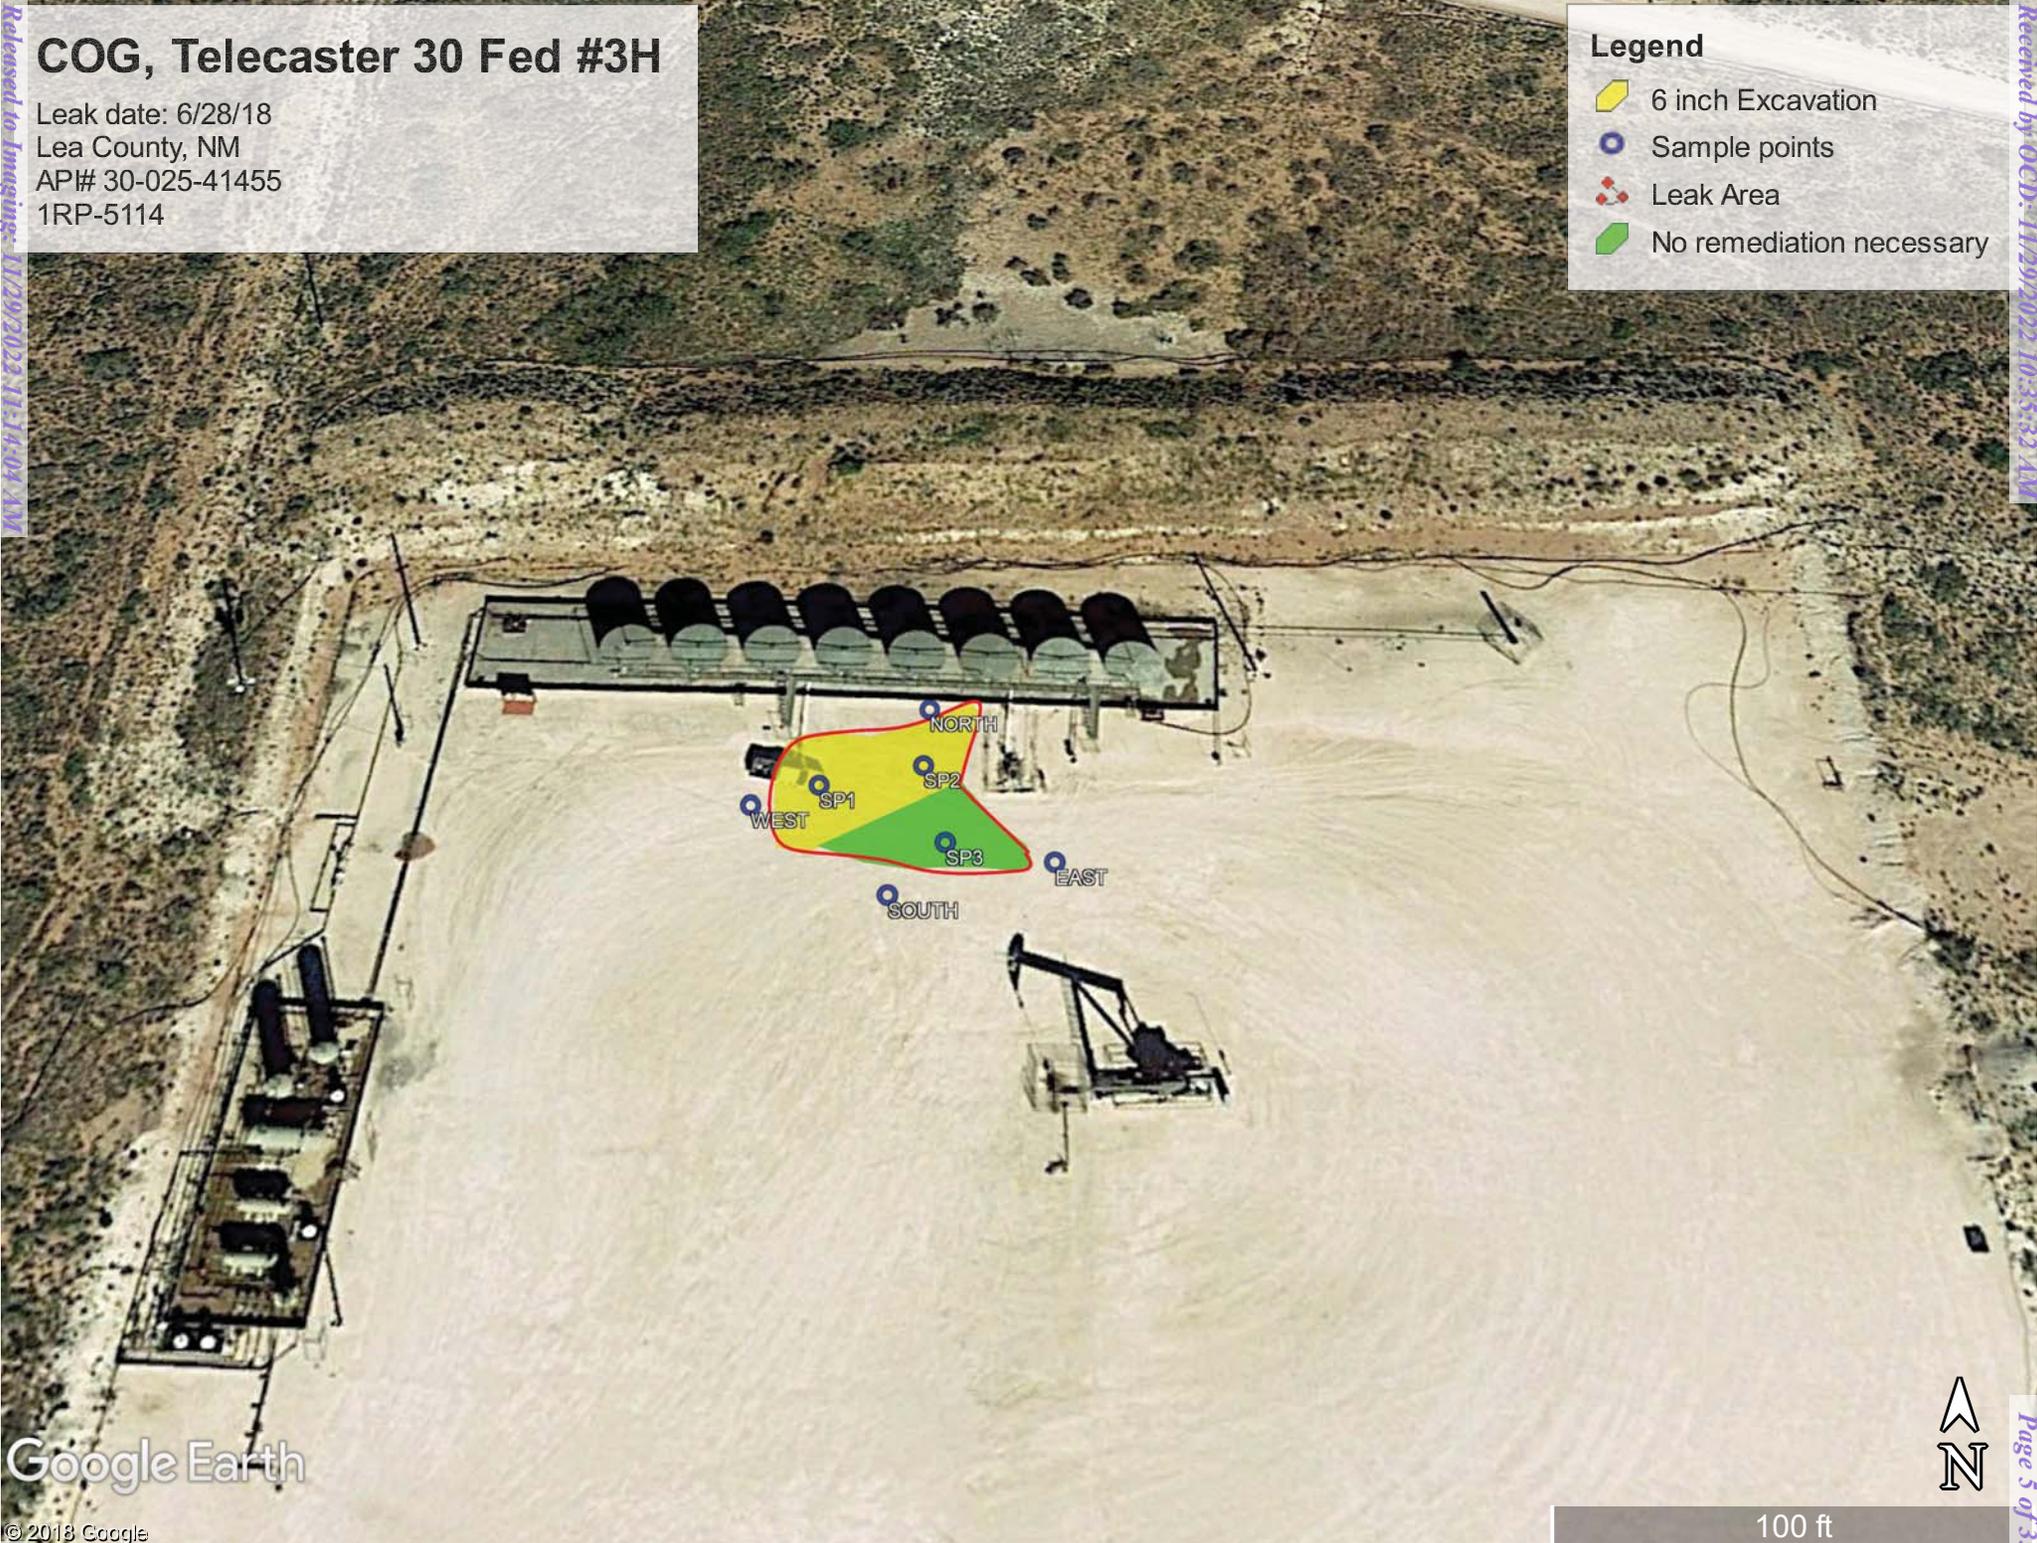
COG, Telecaster 30 Fed #3H

COG will excavate the spill area as depicted on the following site diagram. The leak area near SP1-SP2 (YELLOW shade on diagram) will be excavated to a depth of 6 inches. The leak area near SP3 (GREEN shade on diagram) will require zero remediation.

6 inch Excavation
-

Leak Area
-

No remediation necessary

Sidewall confirmation samples will be collected at no greater than 50 ft. intervals. Estimated volume of material to be removed is 27 cubic yards. The remediation will be completed within 90 days of plan approval.

The entire site will then be backfilled with clean soil and revegetated (if warranted) to the standards of the appropriate regulatory agency or private surface owner.

All excavated materials will be disposed of at an NMOCD-approved disposal facility.

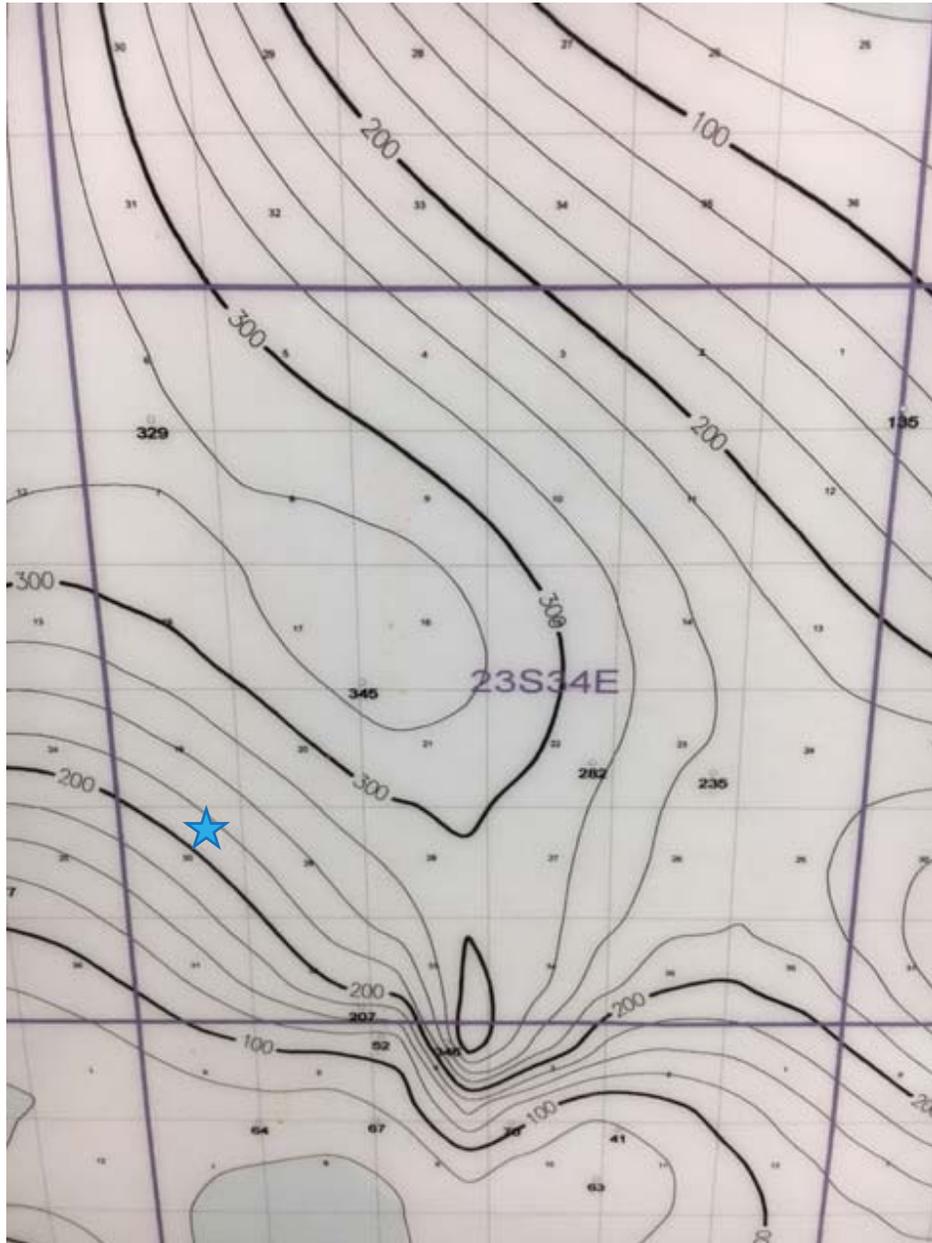
COG, Telecaster 30 Federal #3H

Sample points

SP1, N 32.28218 W-103.50723

SP2, N 32.28220 W-103.50714

SP3, N 32.28213 W-103.50712

NORTH, N 32.28225 W-103.50714

SOUTH, N 32.28209 W-103.50717

EAST, N 32.28212 W-103.50703

WEST, N 32.28216 W-103.50728
