Closure

Our Ref.: 12565619-NMOCD-1

November 10, 2022

Site Closure Report
Snapping Pump Release Site
Plains Pipeline, L.P.
Incident Identification Number: nAPP2128551283
D-12-26S-31E, Eddy County, New Mexico

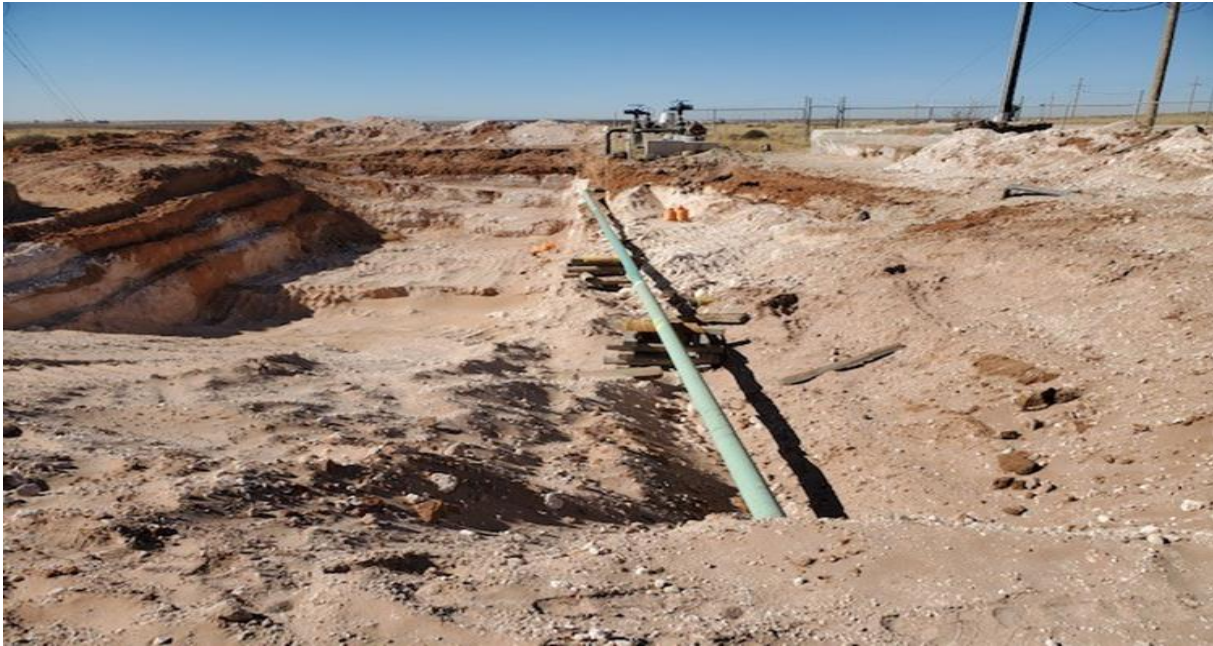
Photo 1 View to the west of the remedial excavation.

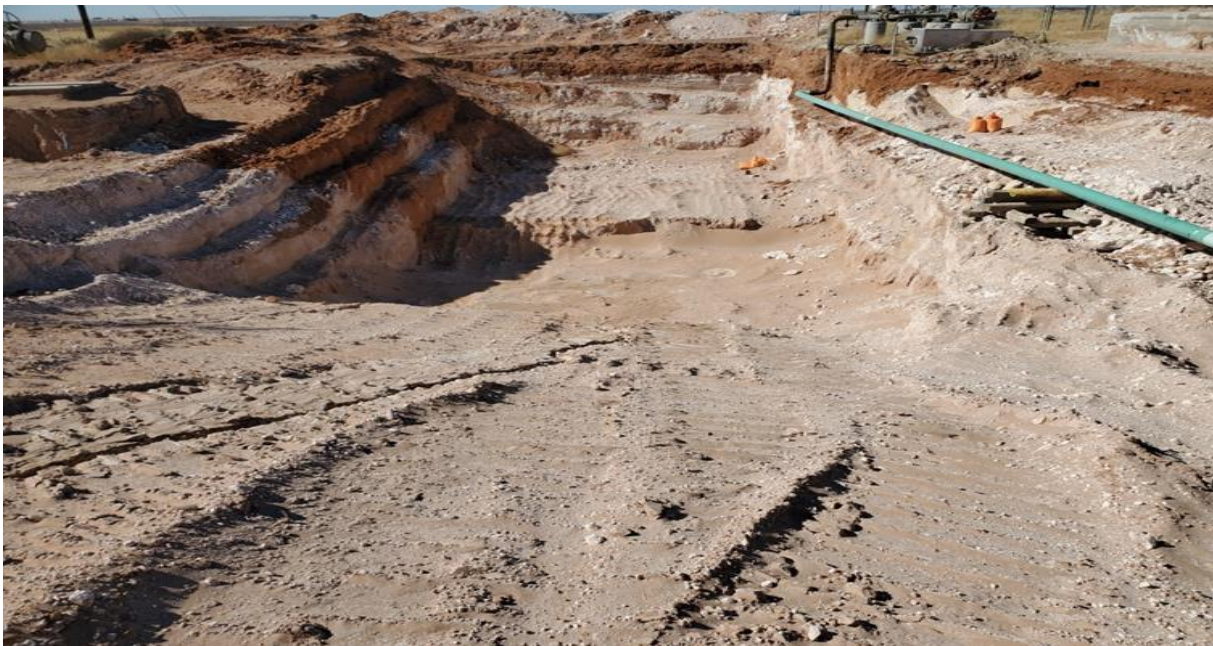
Photo 2 View to the west of the remedial excavation.

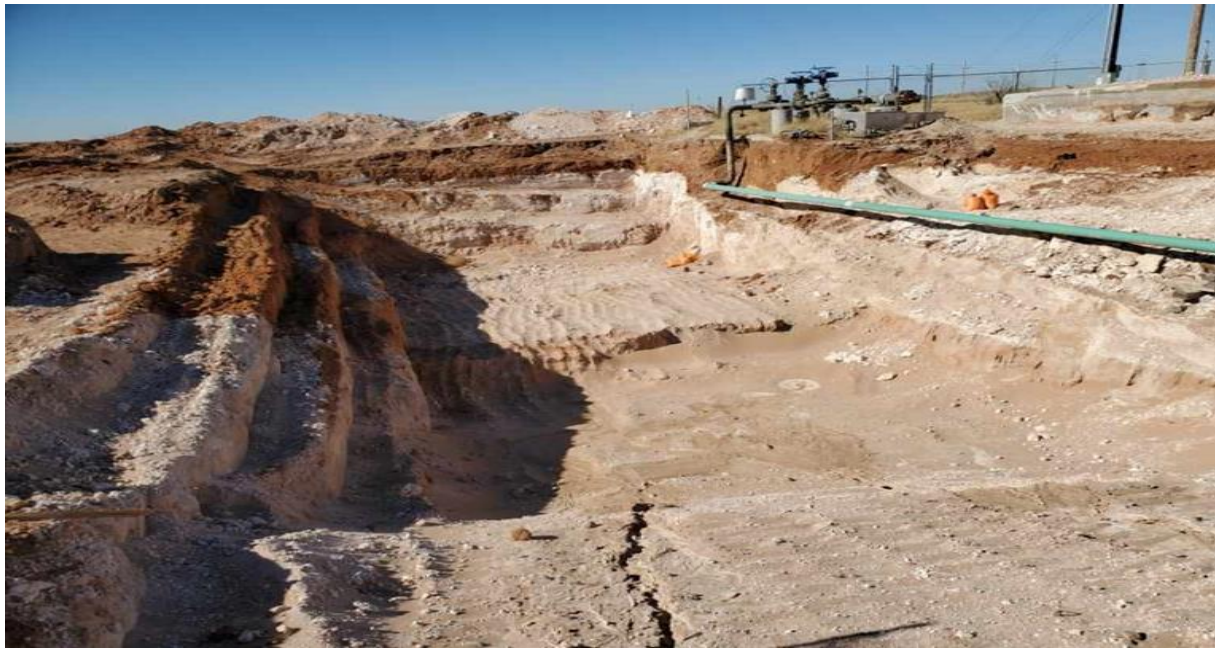
Photo 3 *View to the northwest of the remedial excavation.*

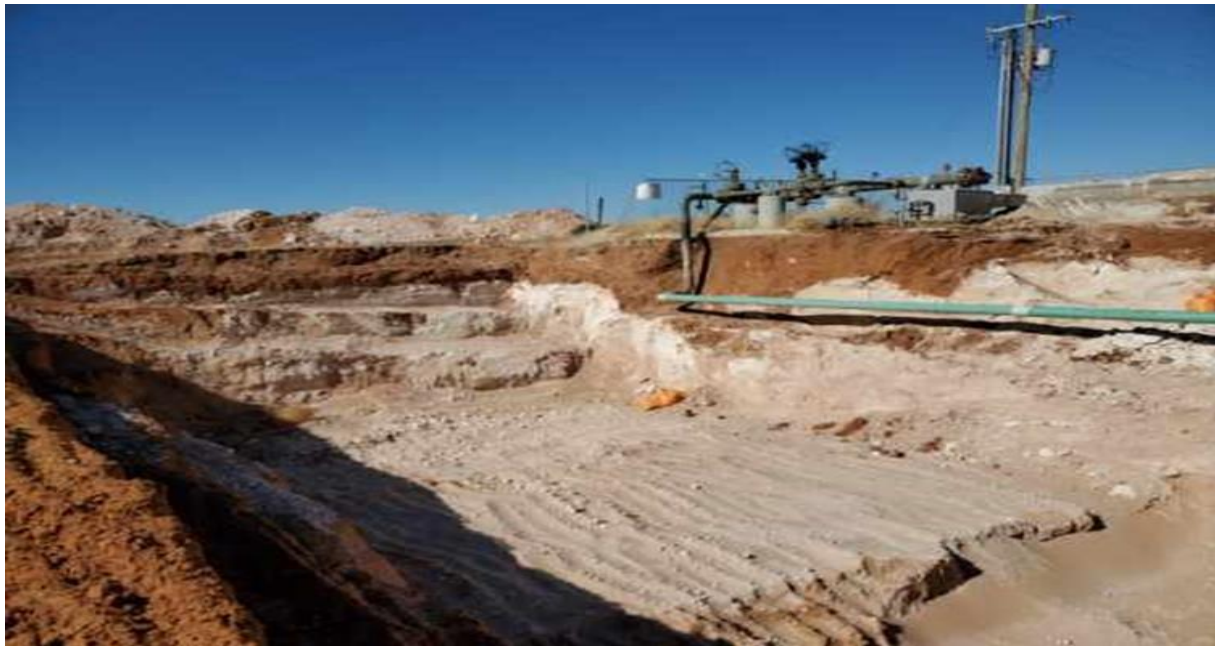
Photo 4 *View to the northwest of the remedial excavation.*

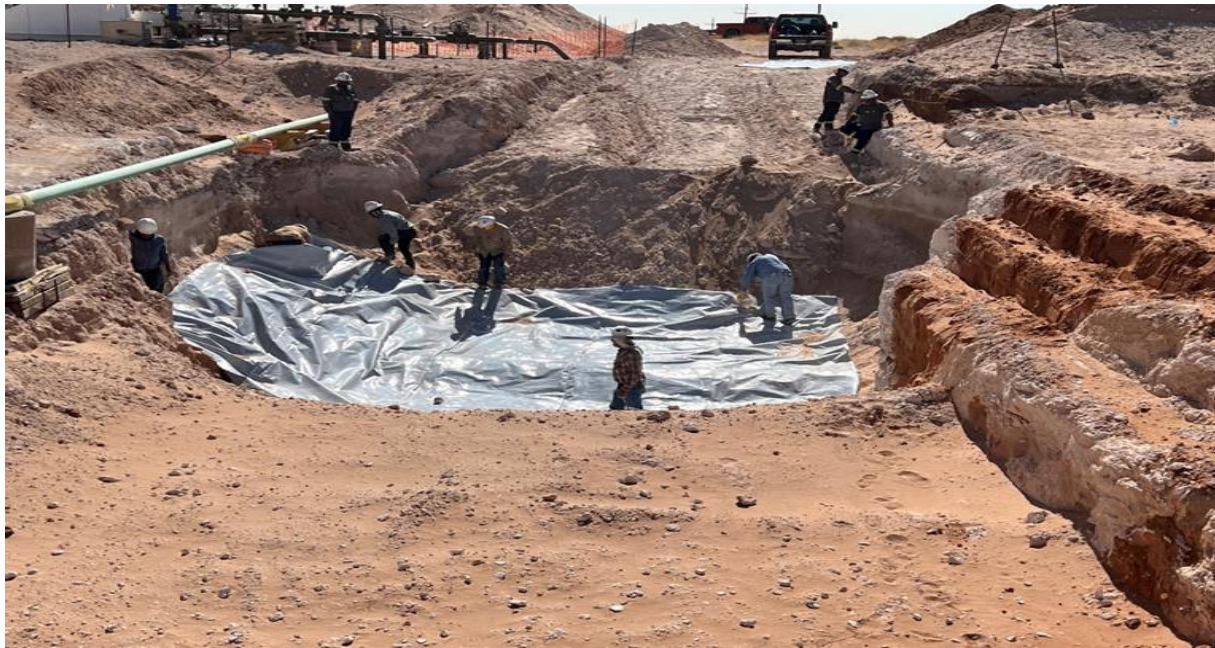
Photo 5 Liner installation during backfill activities.

In accordance with the approved variance, on May 6, 2022, a 20-mil liner was installed at the bottom of the excavation prior to backfilling activities. The liner was approved by the NMOCD to act as a control measure to mitigate the deeper migration of hydrocarbons and provide a barrier to any upward migration of hydrocarbons. Photographic documentation is provided in Attachment C.

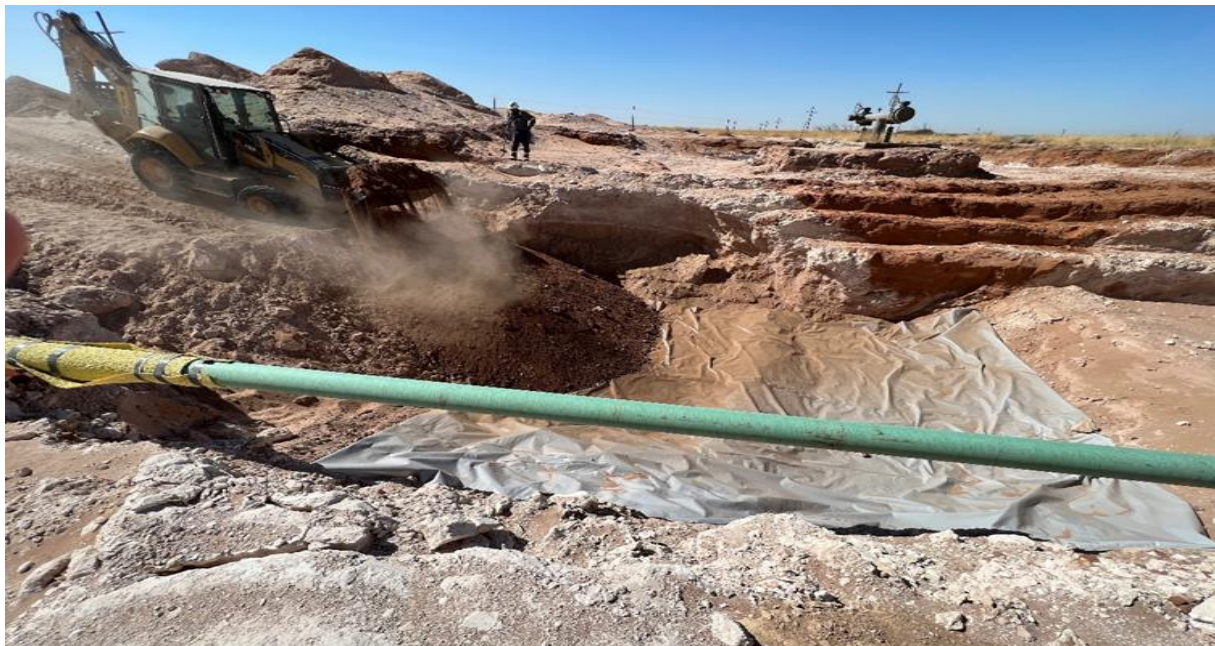
Photo 6 Liner installation and backfill activities.
