RICE *Operating Company*

RE: **2021 Annual Groundwater Report**
Rice Operating Company – BD SWD System
BD F-29 (1R426-16) and F-29-1 (1R426-15): UL/F, Sec. 29, T21S, R37E

ROC - BD F-29 (1R426-16) & F-29-1 (1R426-15)

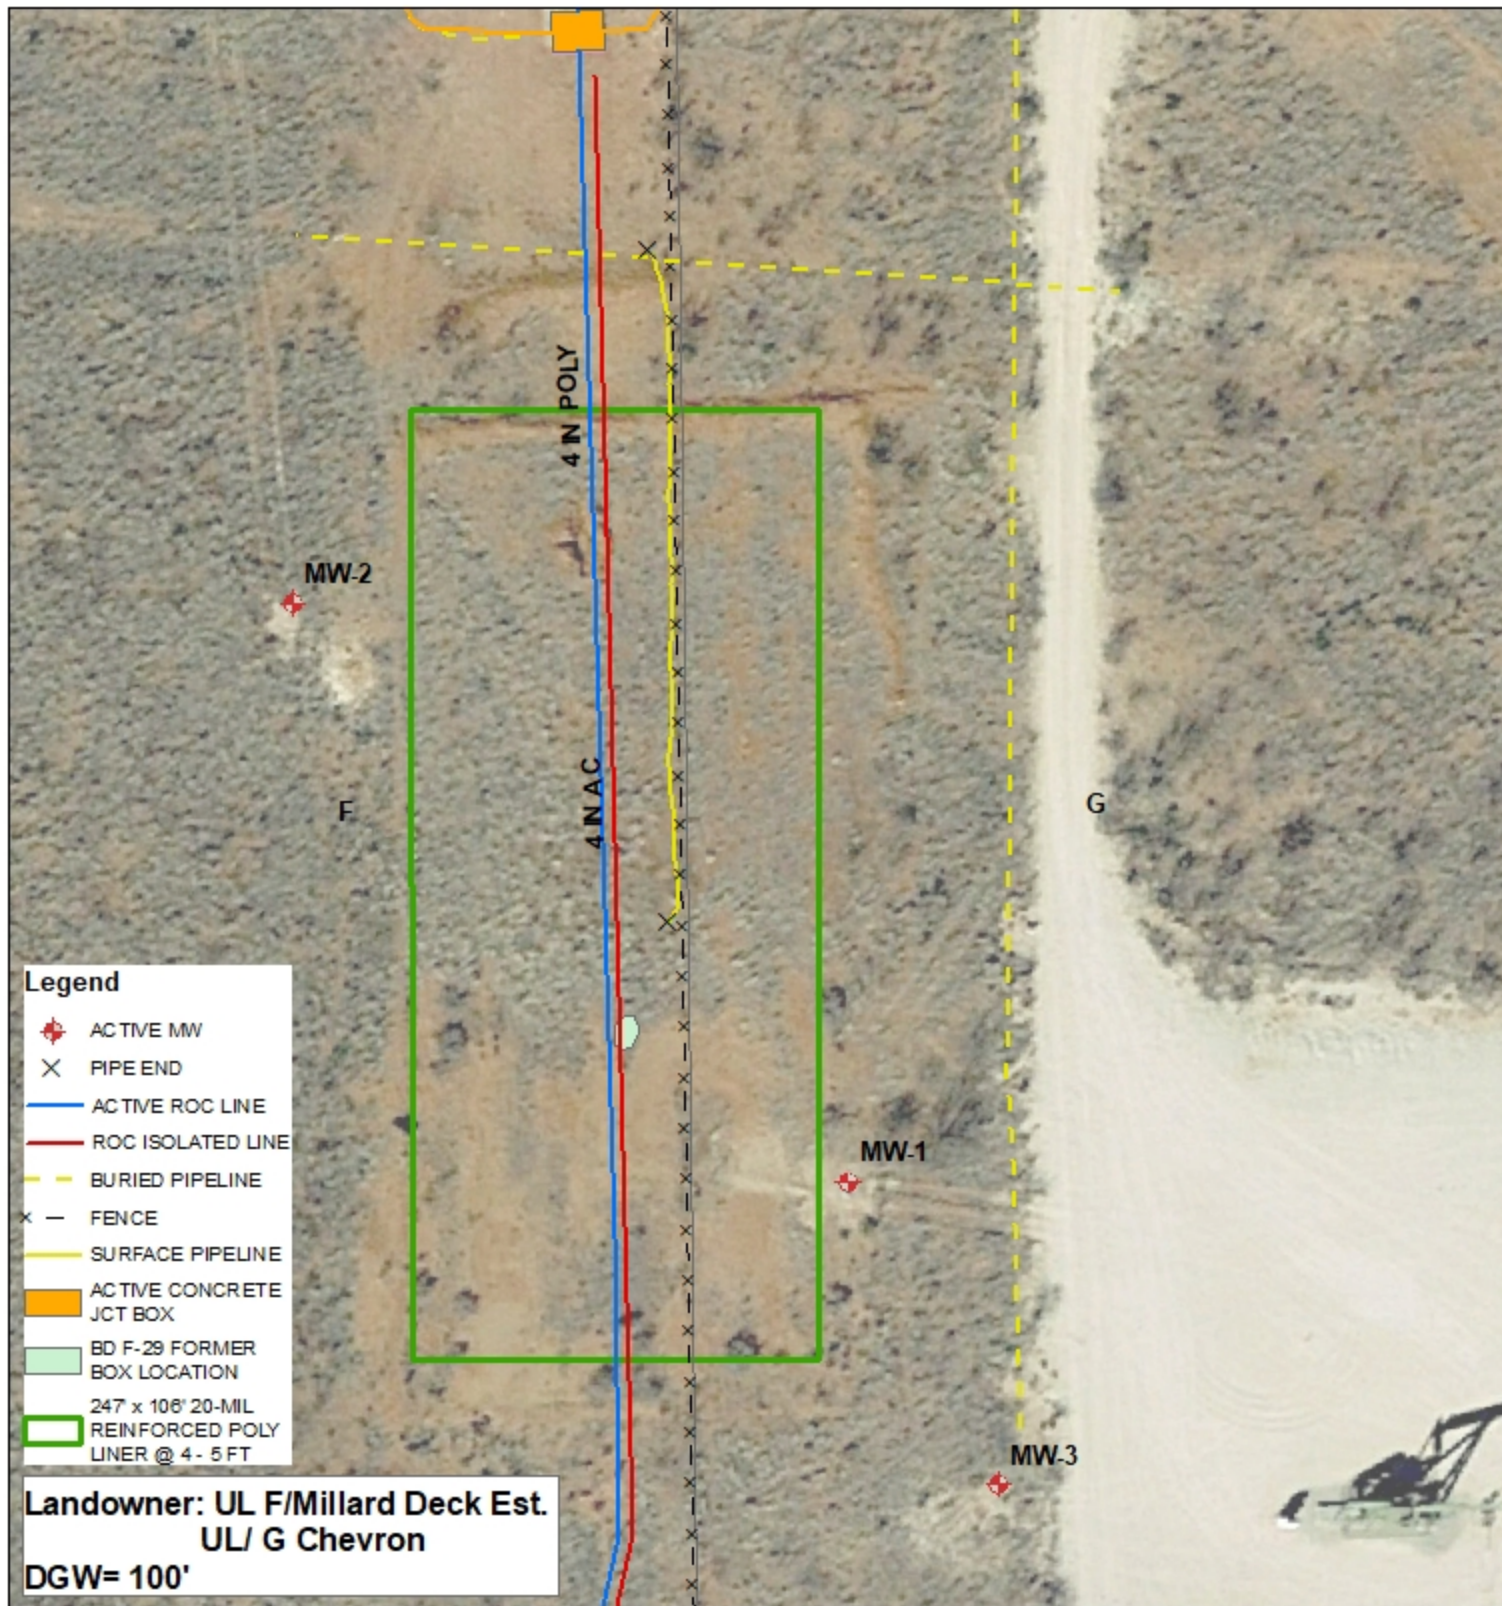
Monitor Well Location

BD
F-29 & F-29-1 JCT
 1R426-16 & 1R426-15
 UL F & G SECTION 29
 T-21-S R-37-E
 LEA COUNTY, NM

GPS: 32.450619 -103.185159
 NAD83 STATE PLANE PROJECTION
 NEW MEXICO EAST ZONE

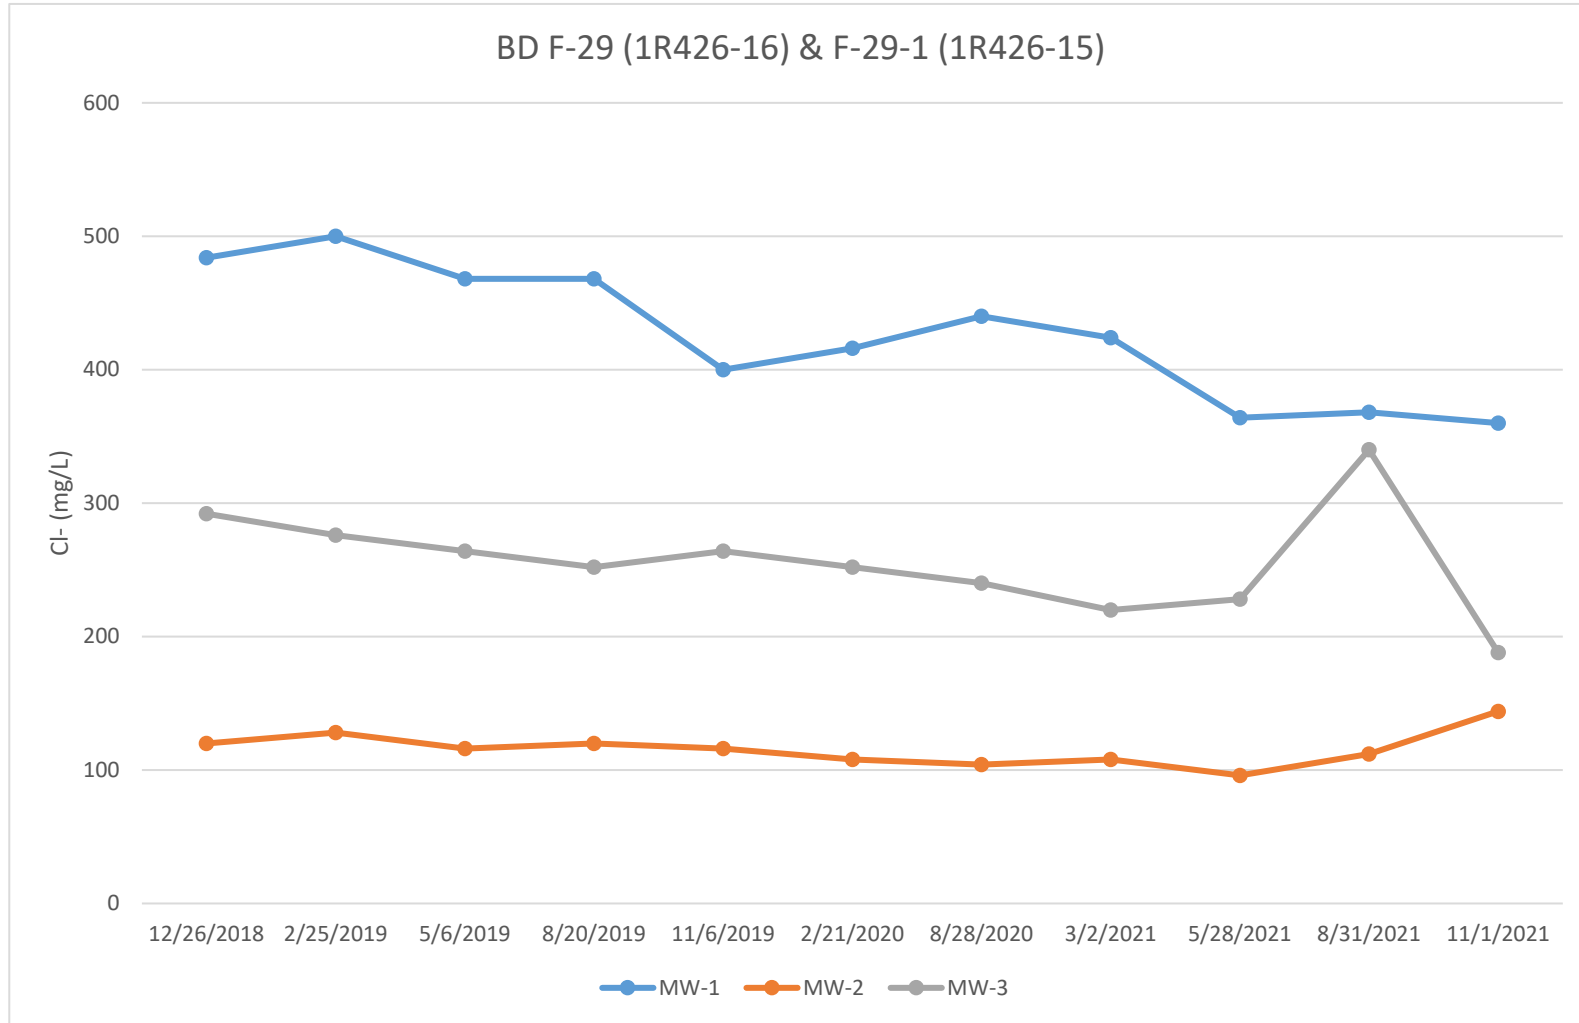
MW	Depth to Water	Total Depth	Well Volume	Volume Purged	Sample Date	Cl	TDS	Benzene	Toluene	Ethyl Benzene	Total Xylenes	Sulfate	Comments
1	99.48	116.15	10.9	35	12/26/2018	484	1,300	<0.001	<0.001	<0.001	<0.003	278	Clear No odor
1	99.45	116.15	10.9	35	2/25/2019	500	1,230	<0.001	<0.001	<0.001	<0.003	251	Clear No odor
1	99.44	116.15	10.9	35	5/6/2019	468	976	<0.001	<0.001	<0.001	<0.003	238	Clear No odor
1	99.42	116.15	10.9	35	8/20/2019	468	1,300	<0.001	<0.001	<0.001	<0.003	211	Clear No odor
1	99.44	116.15	10.9	35	11/6/2019	400	1,200	<0.001	<0.001	<0.001	<0.003	208	Clear No odor
1	99.43	116.15	10.9	35	2/21/2020	416	1,140	<0.0005	<0.0005	<0.0005	<0.002	125	Clear No odor
1	99.4	116.15	10.9	35	8/28/2020	440	1,290	XXX	XXX	XXX	XXX	218	Clear No odor
1	99.37	116.15	10.9	35	3/2/2021	424	1,250	XXX	XXX	XXX	XXX	234	Clear No odor
1	99.4	116.15	10.9	35	5/28/2021	364	1,140	XXX	XXX	XXX	XXX	216	Clear No odor
1	99.38	116.15	10.9	35	8/31/2021	368	1,200	XXX	XXX	XXX	XXX	303	Clear No odor

MW	Depth to Water	Total Depth	Well Volume	Volume Purged	Sample Date	Cl	TDS	Benzene	Toluene	Ethyl Benzene	Total Xylenes	Sulfate	Comments
2	98.22	102.98	0.7	3	12/26/2018	120	550	<0.001	<0.001	<0.001	<0.003	153	Clear No odor
2	98.2	102.98	0.7	3	2/25/2019	128	470	<0.001	<0.001	<0.001	<0.003	134	Clear No odor
2	98.18	102.98	0.7	3	5/6/2019	116	616	<0.001	<0.001	<0.001	<0.003	116	Clear No odor
2	98.13	102.98	0.7	3	8/20/2019	120	570	<0.001	<0.001	<0.001	<0.003	119	Clear No odor
2	98.19	102.98	0.7	3	11/6/2019	116	596	<0.001	<0.001	<0.001	<0.003	121	Clear No odor
2	98.16	102.48	0.7	3	2/21/2020	108	538	<0.0005	<0.0005	<0.0005	<0.002	146	Clear No odor
2	98.14	102.48	0.7	3	8/28/2020	104	617	XXX	XXX	XXX	XXX	109	Clear No odor
2	98.11	102.98	0.7	3	3/2/2021	108	598	XXX	XXX	XXX	XXX	109	Clear No odor
2	98.11	102.98	0.7	3	5/28/2021	96	607	XXX	XXX	XXX	XXX	120	Clear No odor
2	98.1	102.98	0.7	3	8/31/2021	112	620	XXX	XXX	XXX	XXX	167	Clear No odor

MW	Depth to Water	Total Depth	Well Volume	Volume Purged	Sample Date	Cl	TDS	Benzene	Toluene	Ethyl Benzene	Total Xylenes	Sulfate	Comments
3	99.88	108.83	1.4	5	12/26/2018	292	978	<0.001	<0.001	<0.001	<0.003	298	Clear No odor
3	99.87	108.83	1.4	5	2/25/2019	276	991	<0.001	<0.001	<0.001	<0.003	245	Clear No odor
3	99.88	108.83	1.4	5	5/6/2019	264	936	<0.001	<0.001	<0.001	<0.003	240	Clear No odor
3	99.9	108.83	1.4	5	8/20/2019	252	964	<0.001	<0.001	<0.001	<0.003	227	Clear No odor
3	100.03	108.83	1.4	3	11/6/2019	264	871	<0.001	<0.001	<0.001	<0.003	238	Clear No odor
3	99.99	108.83	1.4	3	2/21/2020	252	1,080	<0.0005	<0.0005	<0.0005	<0.002	242	Clear No odor
3	99.97	108.83	1.4	3	8/28/2020	240	1,080	XXX	XXX	XXX	XXX	219	Clear No odor
3	99.96	108.63	1.4	5	3/2/2021	220	994	XXX	XXX	XXX	XXX	316	Clear No odor
3	99.91	108.63	1.4	5	5/28/2021	228	1,070	XXX	XXX	XXX	XXX	292	Clear No odor
3	99.9	108.63	1.4	5	8/31/2021	340	1,130	XXX	XXX	XXX	XXX	301	Clear No odor
