Remediation Plan

Our ref: 11230052-LTR-1

Updated Site Remediation Work Plan
Rodke AOY #1 Release Site
EOG Resources Inc.
Incident ID: nAPP2116941247
A-21-19S-25E, Eddy County, New Mexico

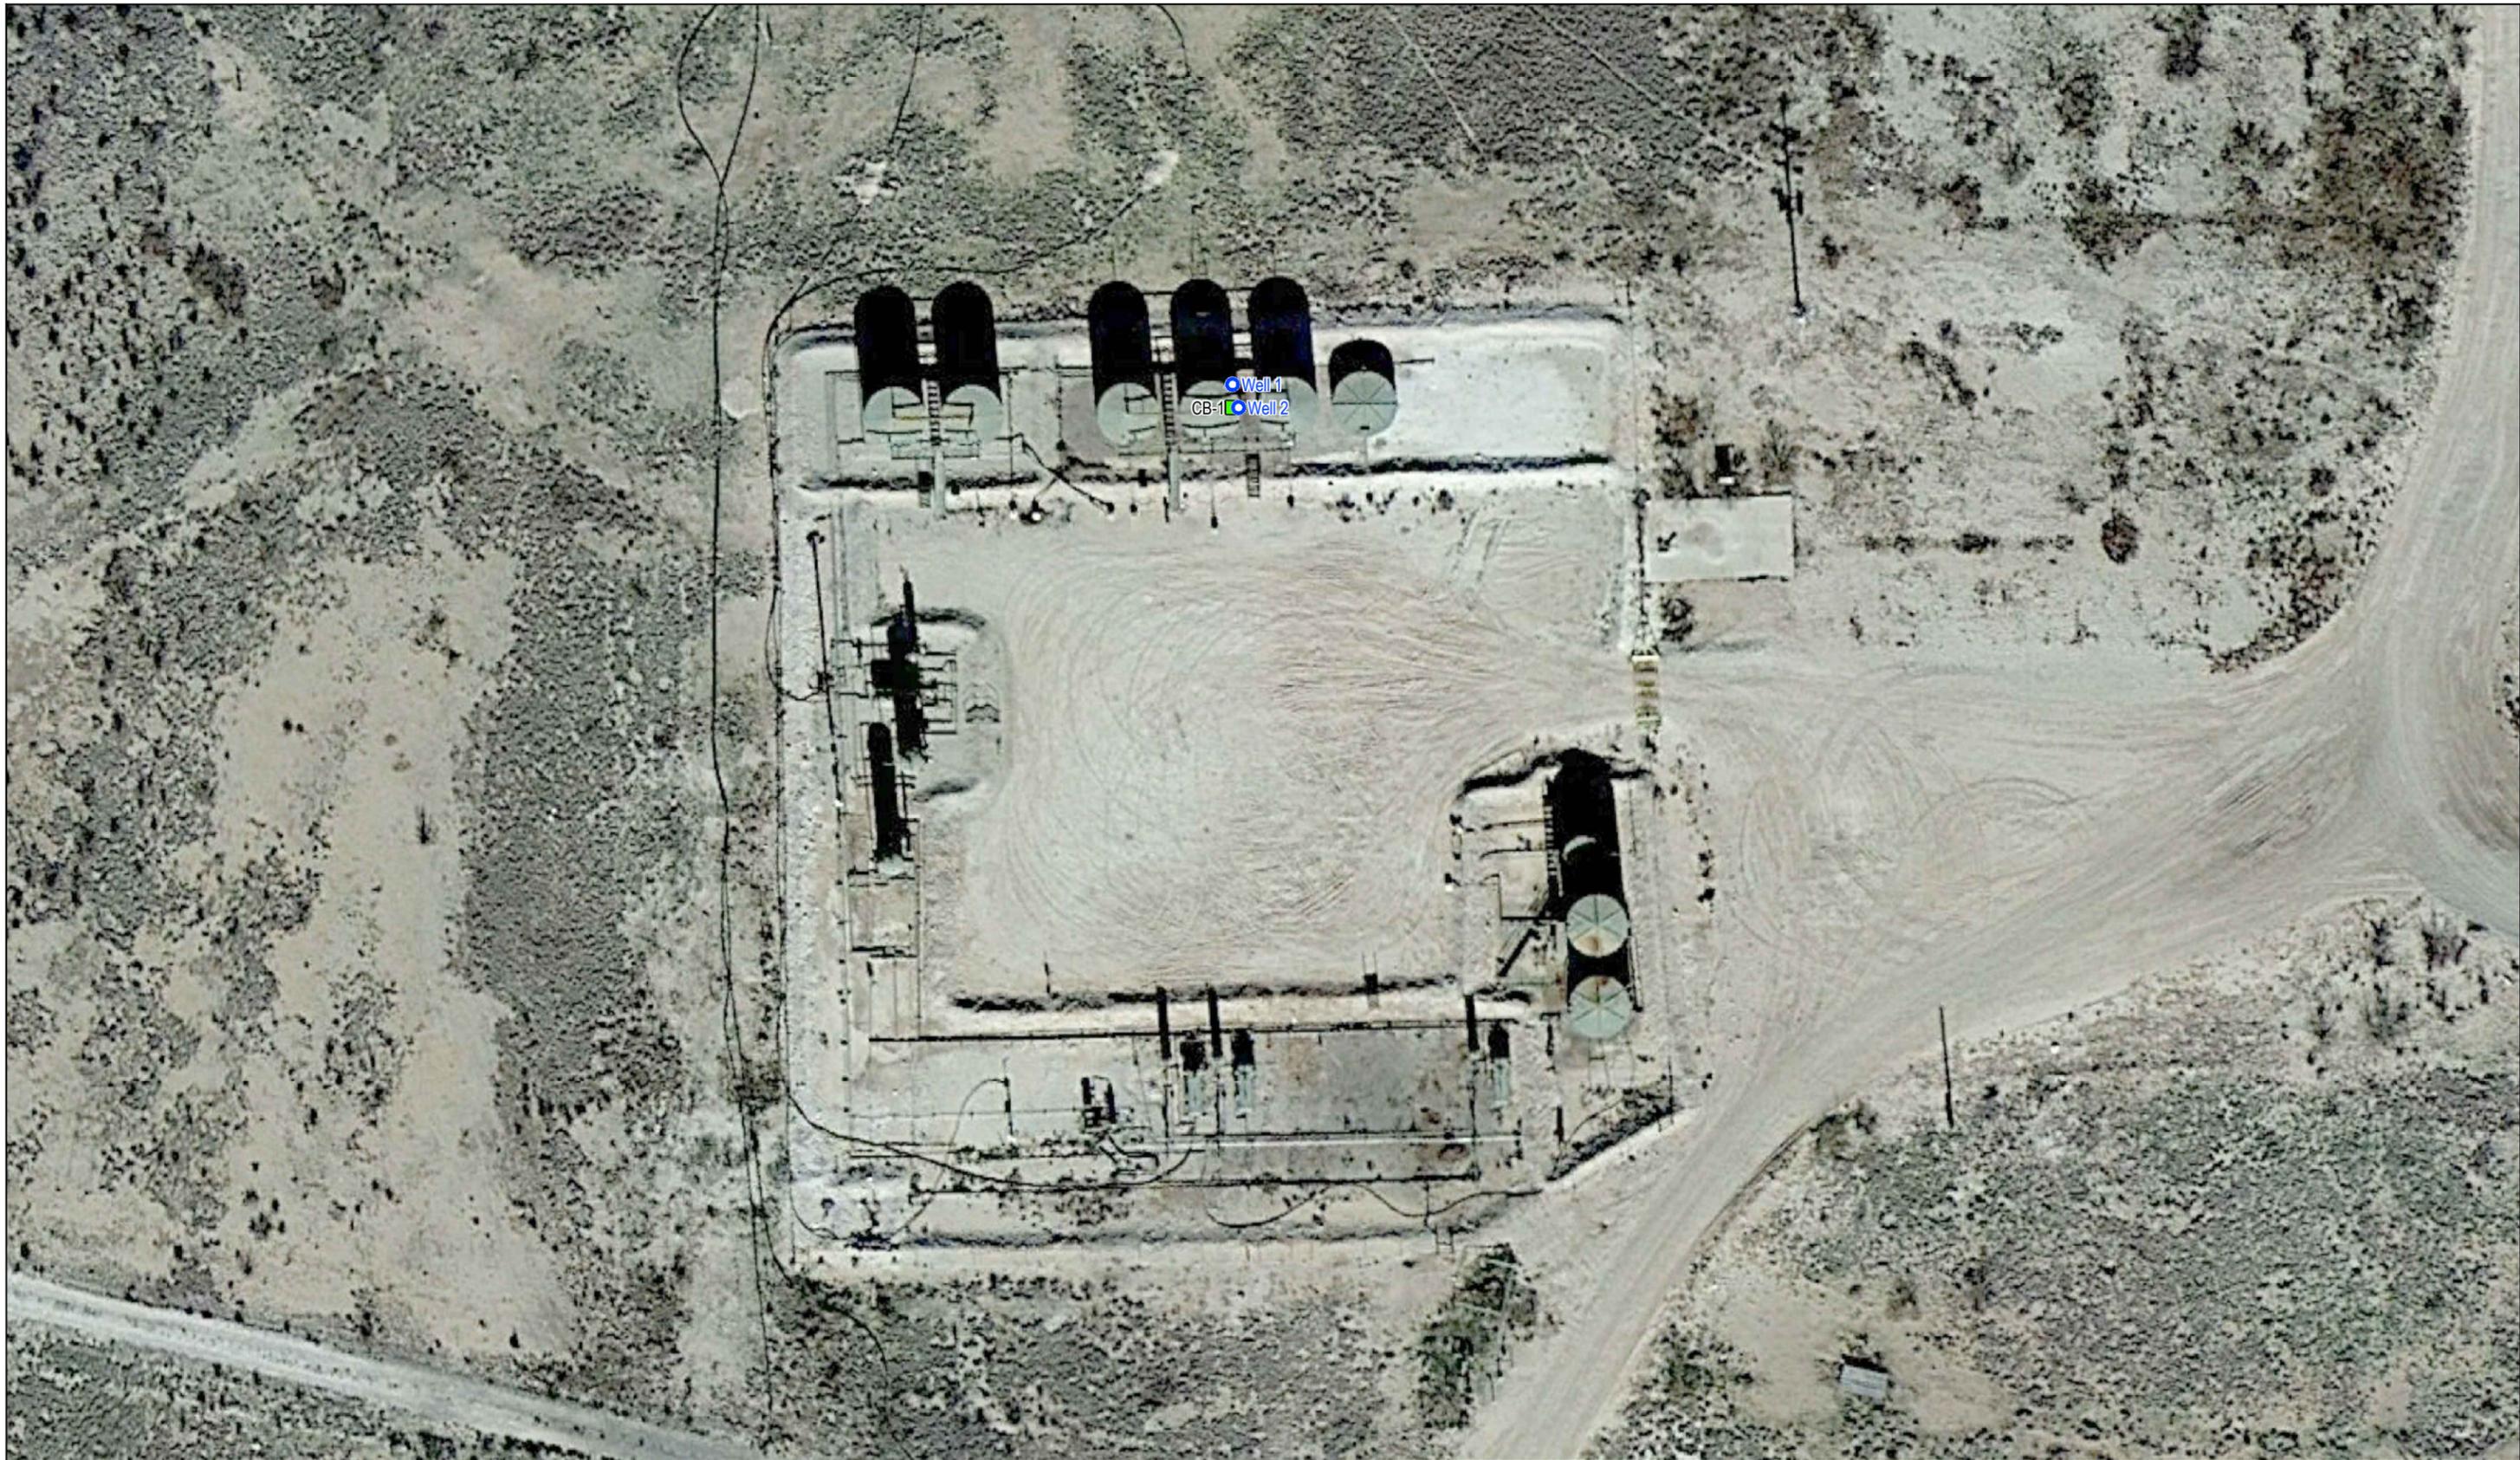
FIGURE 2

GHD Services Inc. (GHD), on behalf of EOG Resources (EOG), submits this Updated Site Remediation Work Plan to the New Mexico Oil Conservation Division (NMOCD) District 2 Office. This Report provides documentation of remedial activities, sampling, and analyses in the affected area at the EOG Rodke AOY #1 Release Site (Site). The Site is located in Eddy County, New Mexico. The GPS coordinates for the release site are 32.648371 N latitude and 104.488160 W longitude. The release occurred on private land owned by Ross Ranch. Figure 1 depicts the Site location. The EOG production facility and other site details are depicted on Figure 2, Site Details Map.

SITE DETAILS MAP

Samples at 45 and 50 feet bgs in the soil boring CB-1 exceeded applicable NMAC Table 1 Closure Criteria for groundwater greater than 100 feet. Figure 2, Site Details Map, depicts the location of the confirmation boring sample. The CB-1 soil boring log is provided as Attachment A. Analytical results are provided in Table 1, on Figure 3, and in the Laboratory Analytical Reports provided in Attachment B.

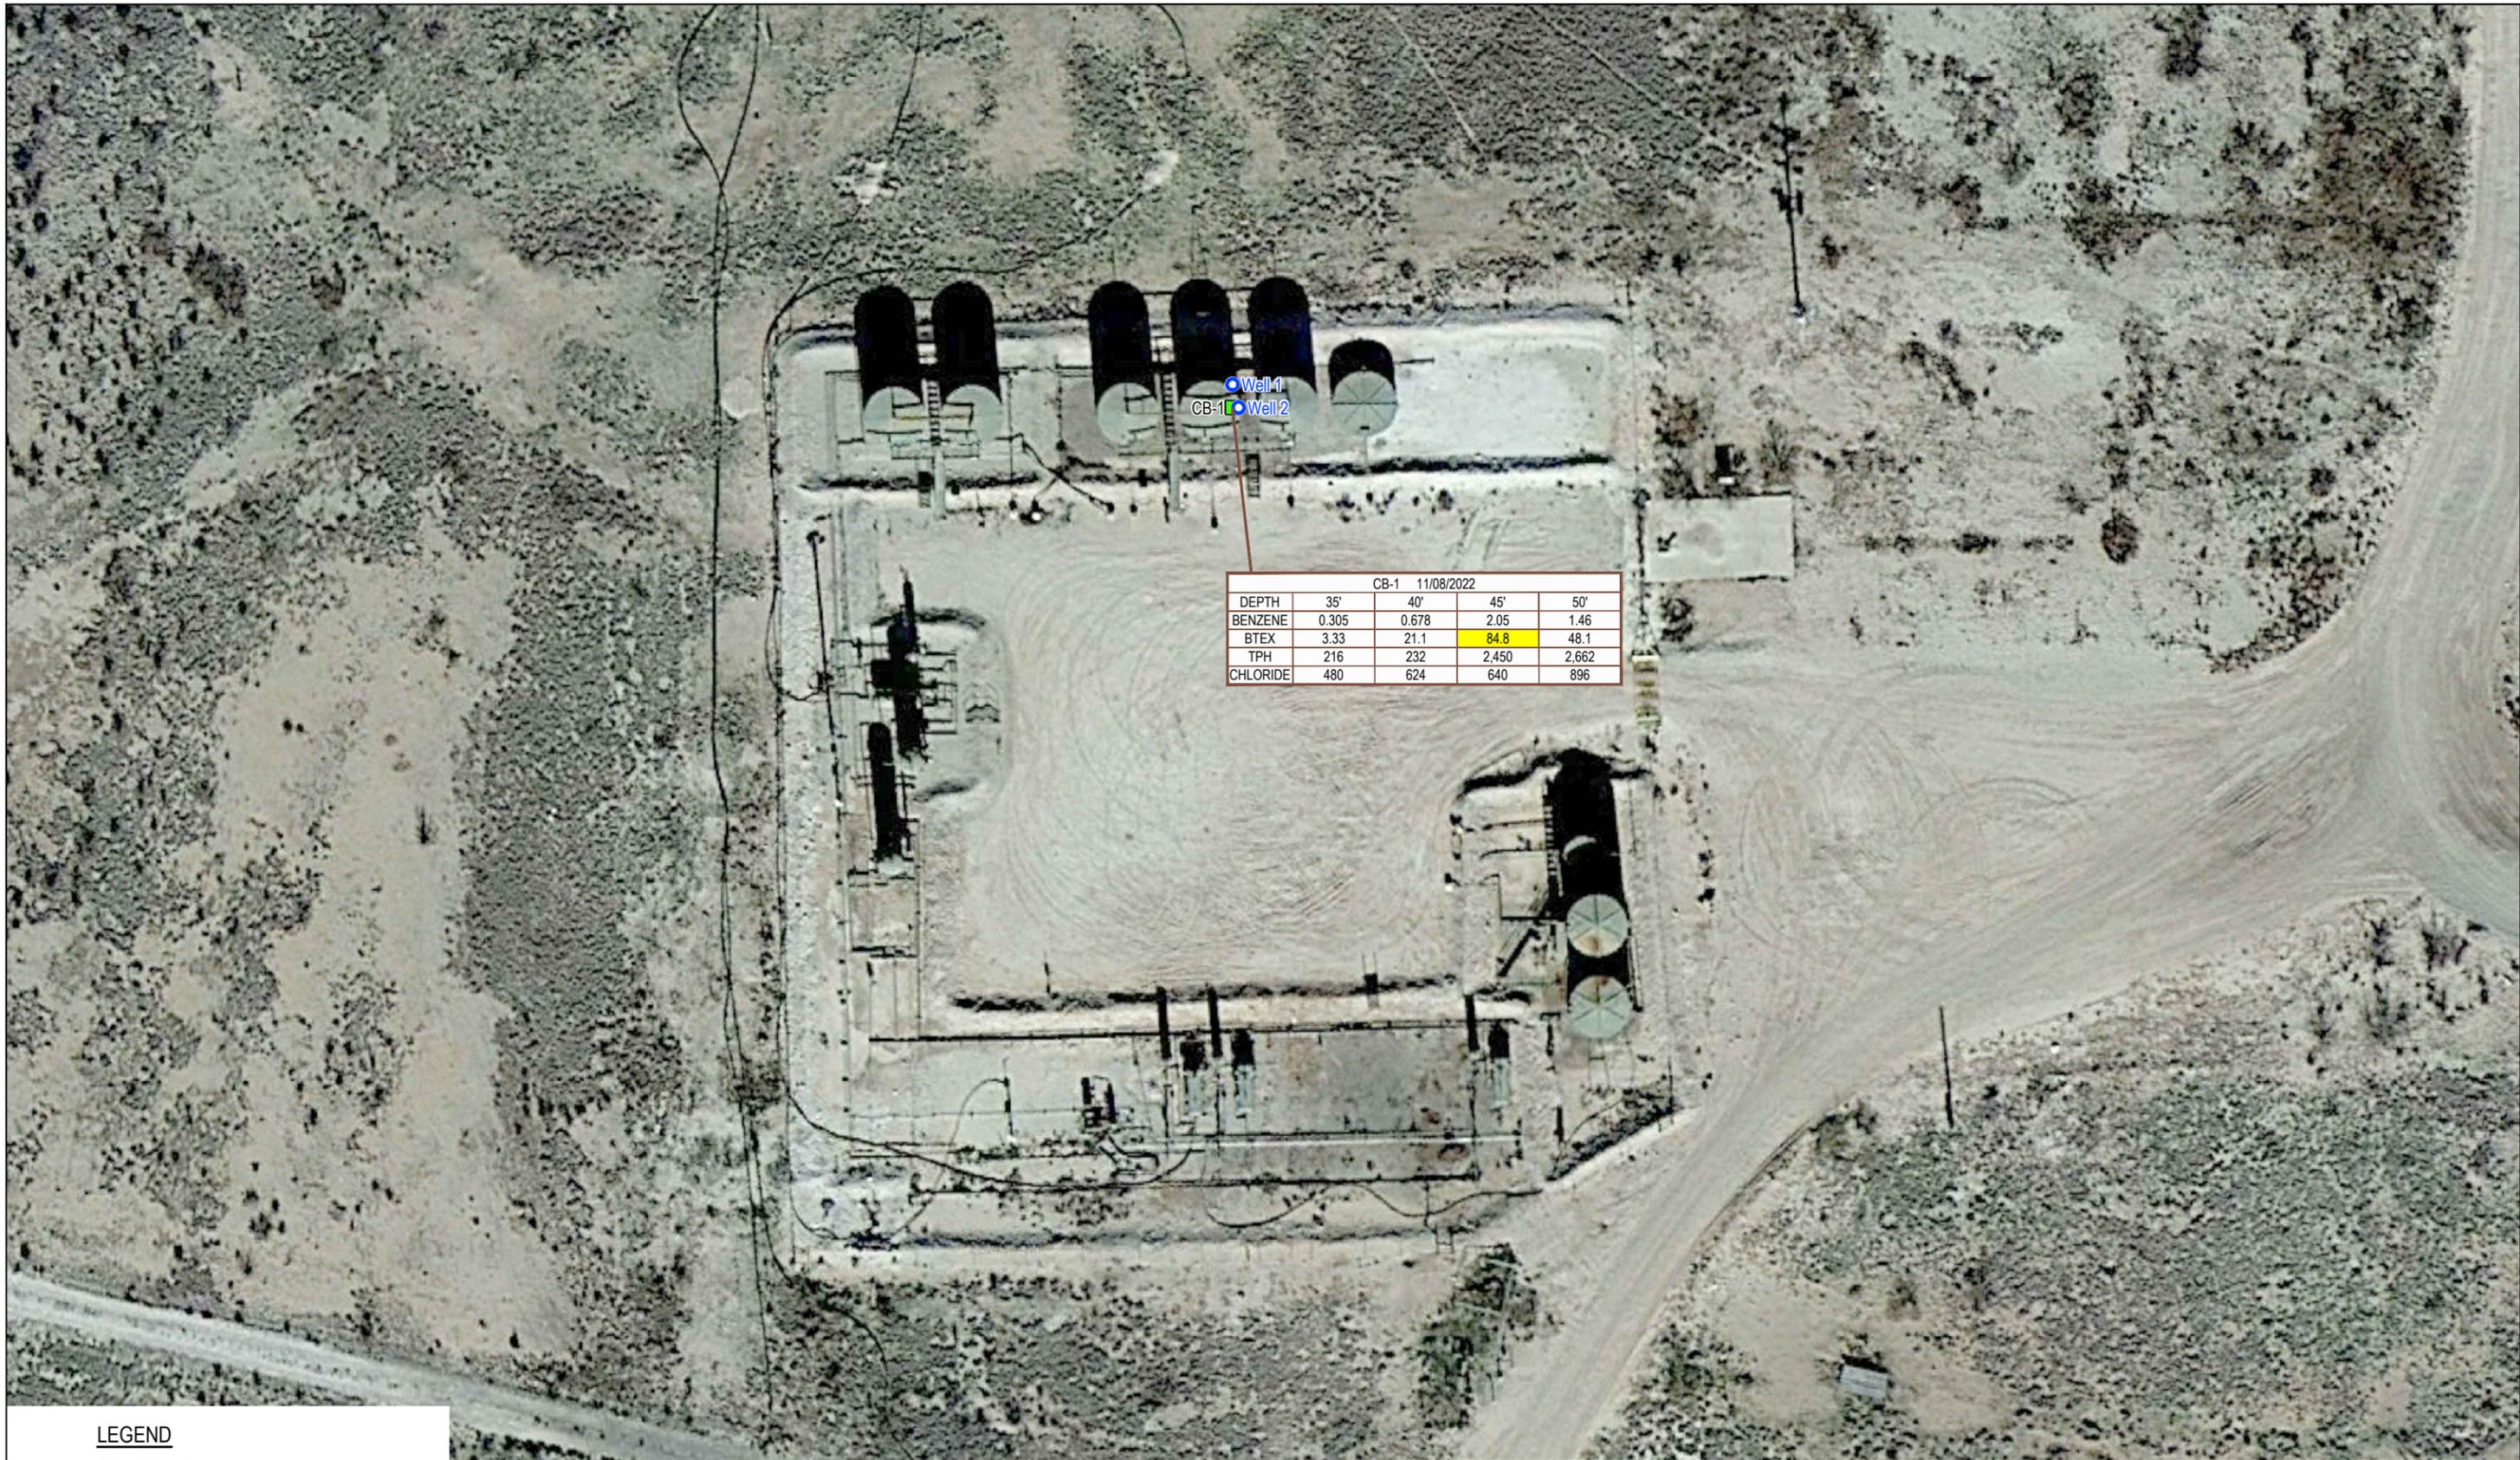
FIGURE 3

CB-1 11/08/2022				
DEPTH	35'	40'	45'	50'
BENZENE	0.305	0.678	2.05	1.46
BTEX	3.33	21.1	84.8	48.1
TPH	216	232	2,450	2,662
CHLORIDE	480	624	640	896

CONFIRMATION SOIL ANALYTICAL

CB-1 exhibited BTEX and TPH GRO and DRO above Table 1 closure criteria to a depth of 45 and 50 feet bgs. None of the other samples submitted for analysis exhibited exceedances above Table 1 closure criteria. Based
