Incident ID	NAPP2215340726
District RP	
Facility ID	
Application ID

**Re: Site Assessment, Remediation, and Closure Report
 Morris Boyd St Com Central Tank Battery
 API No. 30-015-44741
 GPS: Latitude 32.640573 Longitude -104.458957
 UL "N", Sec. 23, T19S, R25E
 Eddy County, NM
 NMOCD Ref. No. NAPP2215340726**

Morris Boyd St Com 4H Battery
API# 30-015-44741
Eddy Coutny, NM
Preliminary Bottom Sample Map

Morris Boyd St Com Battery Photographic Documentation

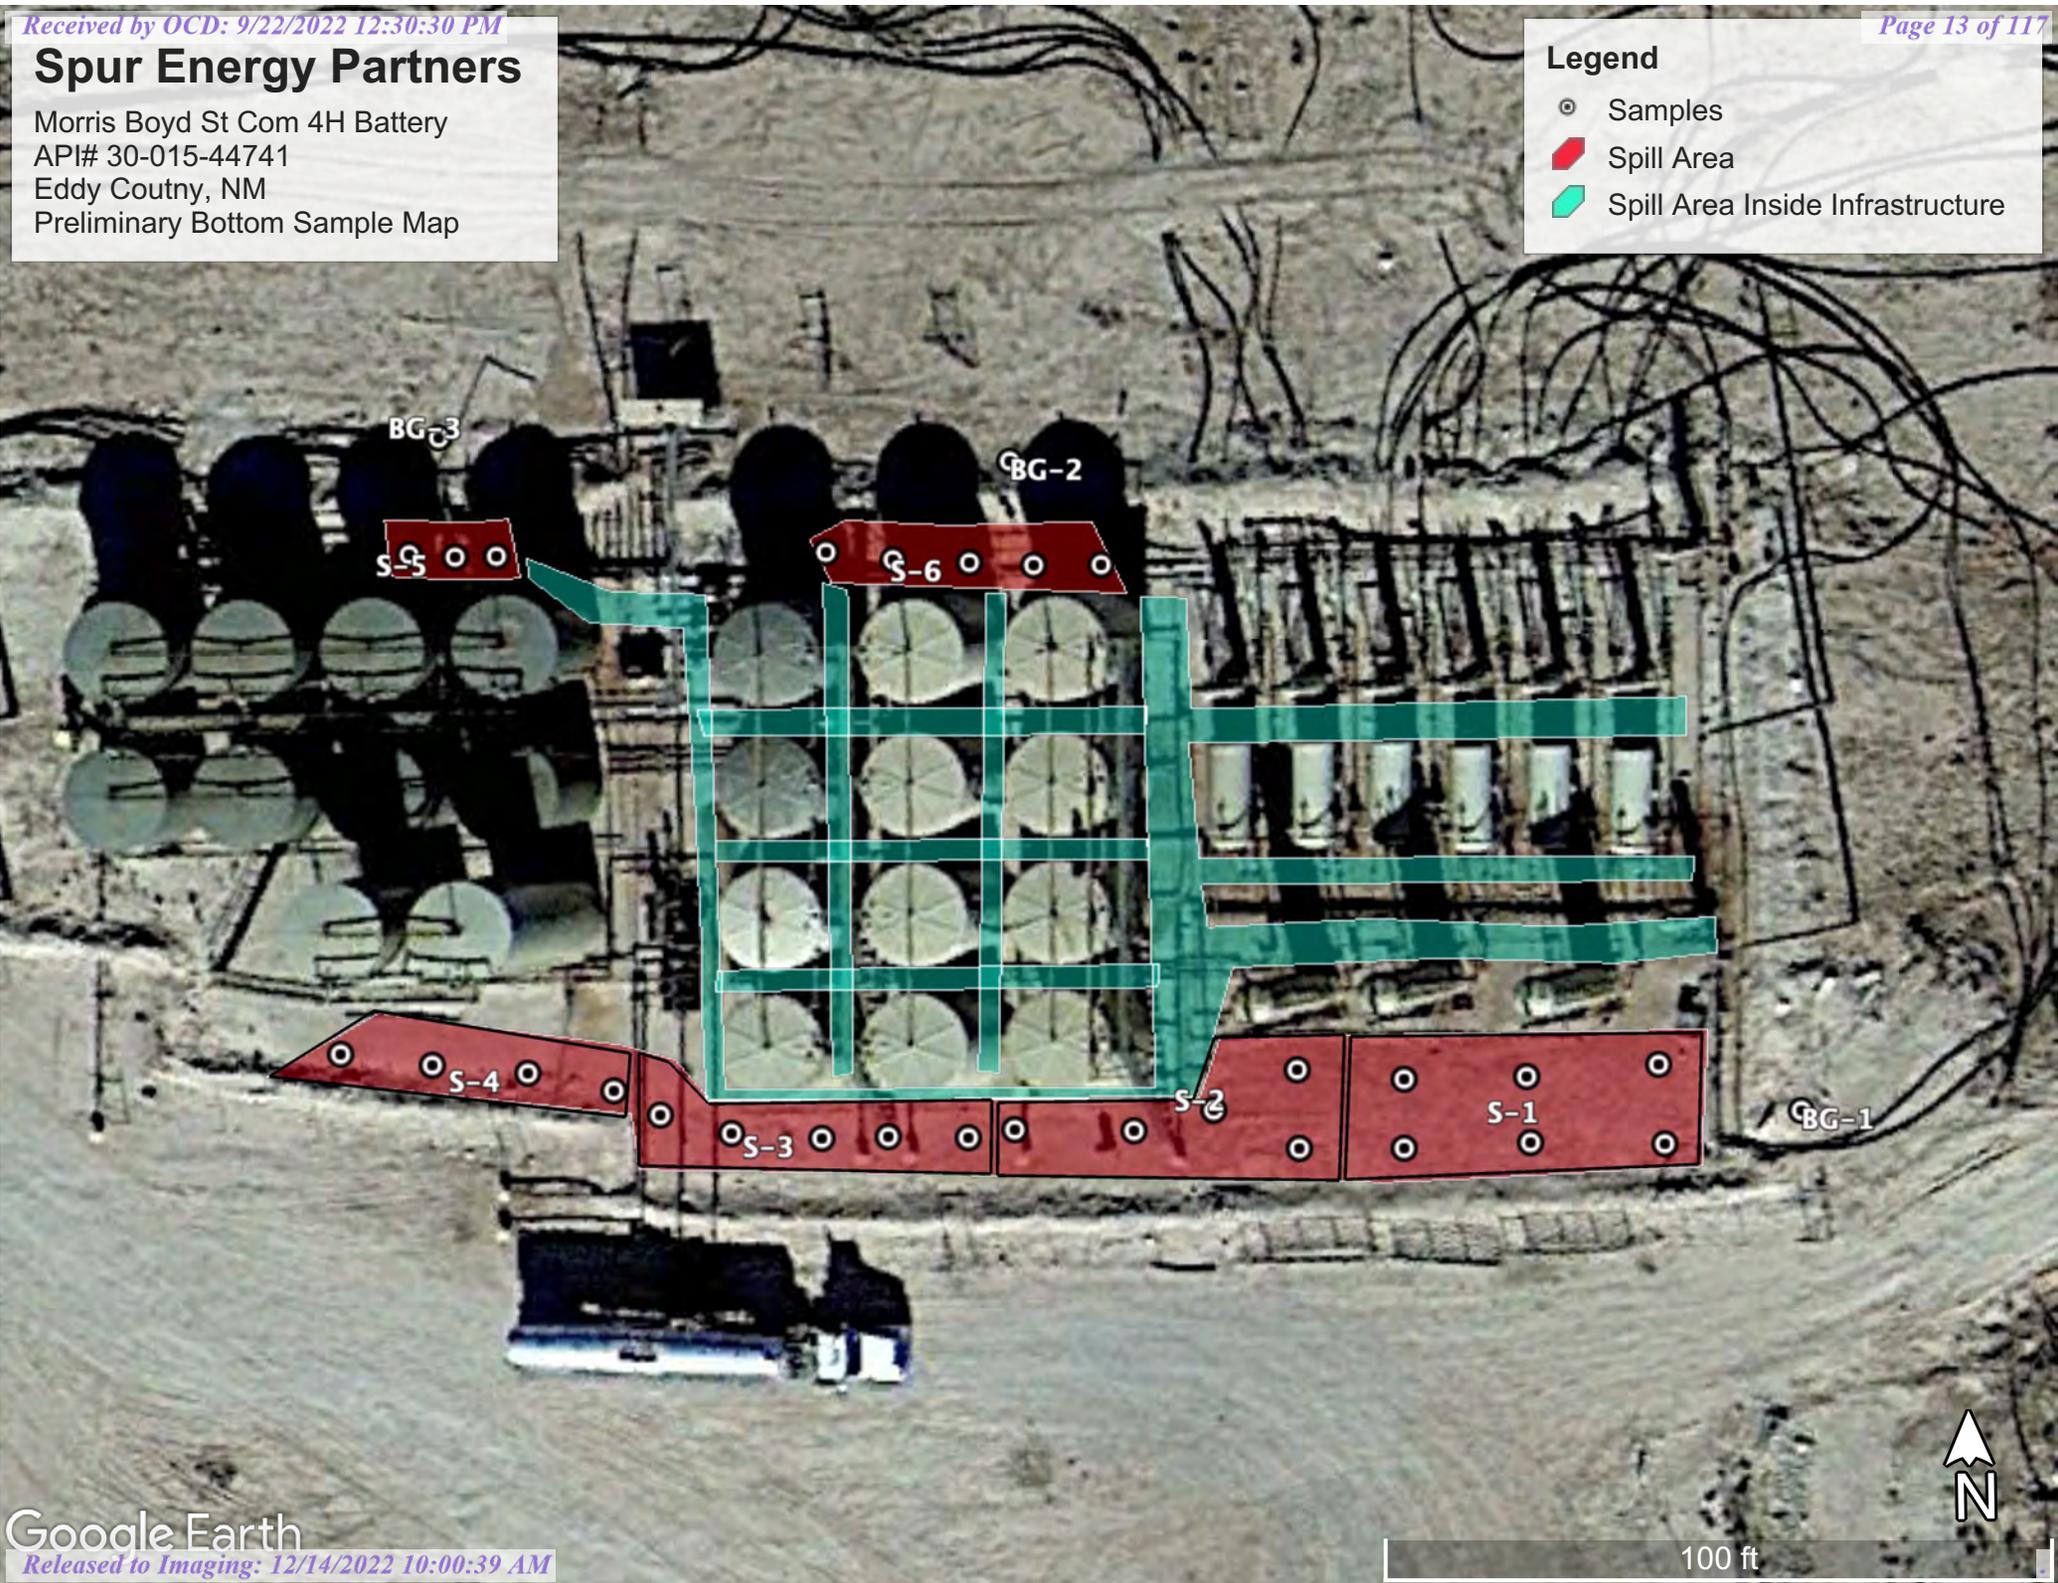
- Samples
- Spill Area
- Spill Area Inside Infrastructure

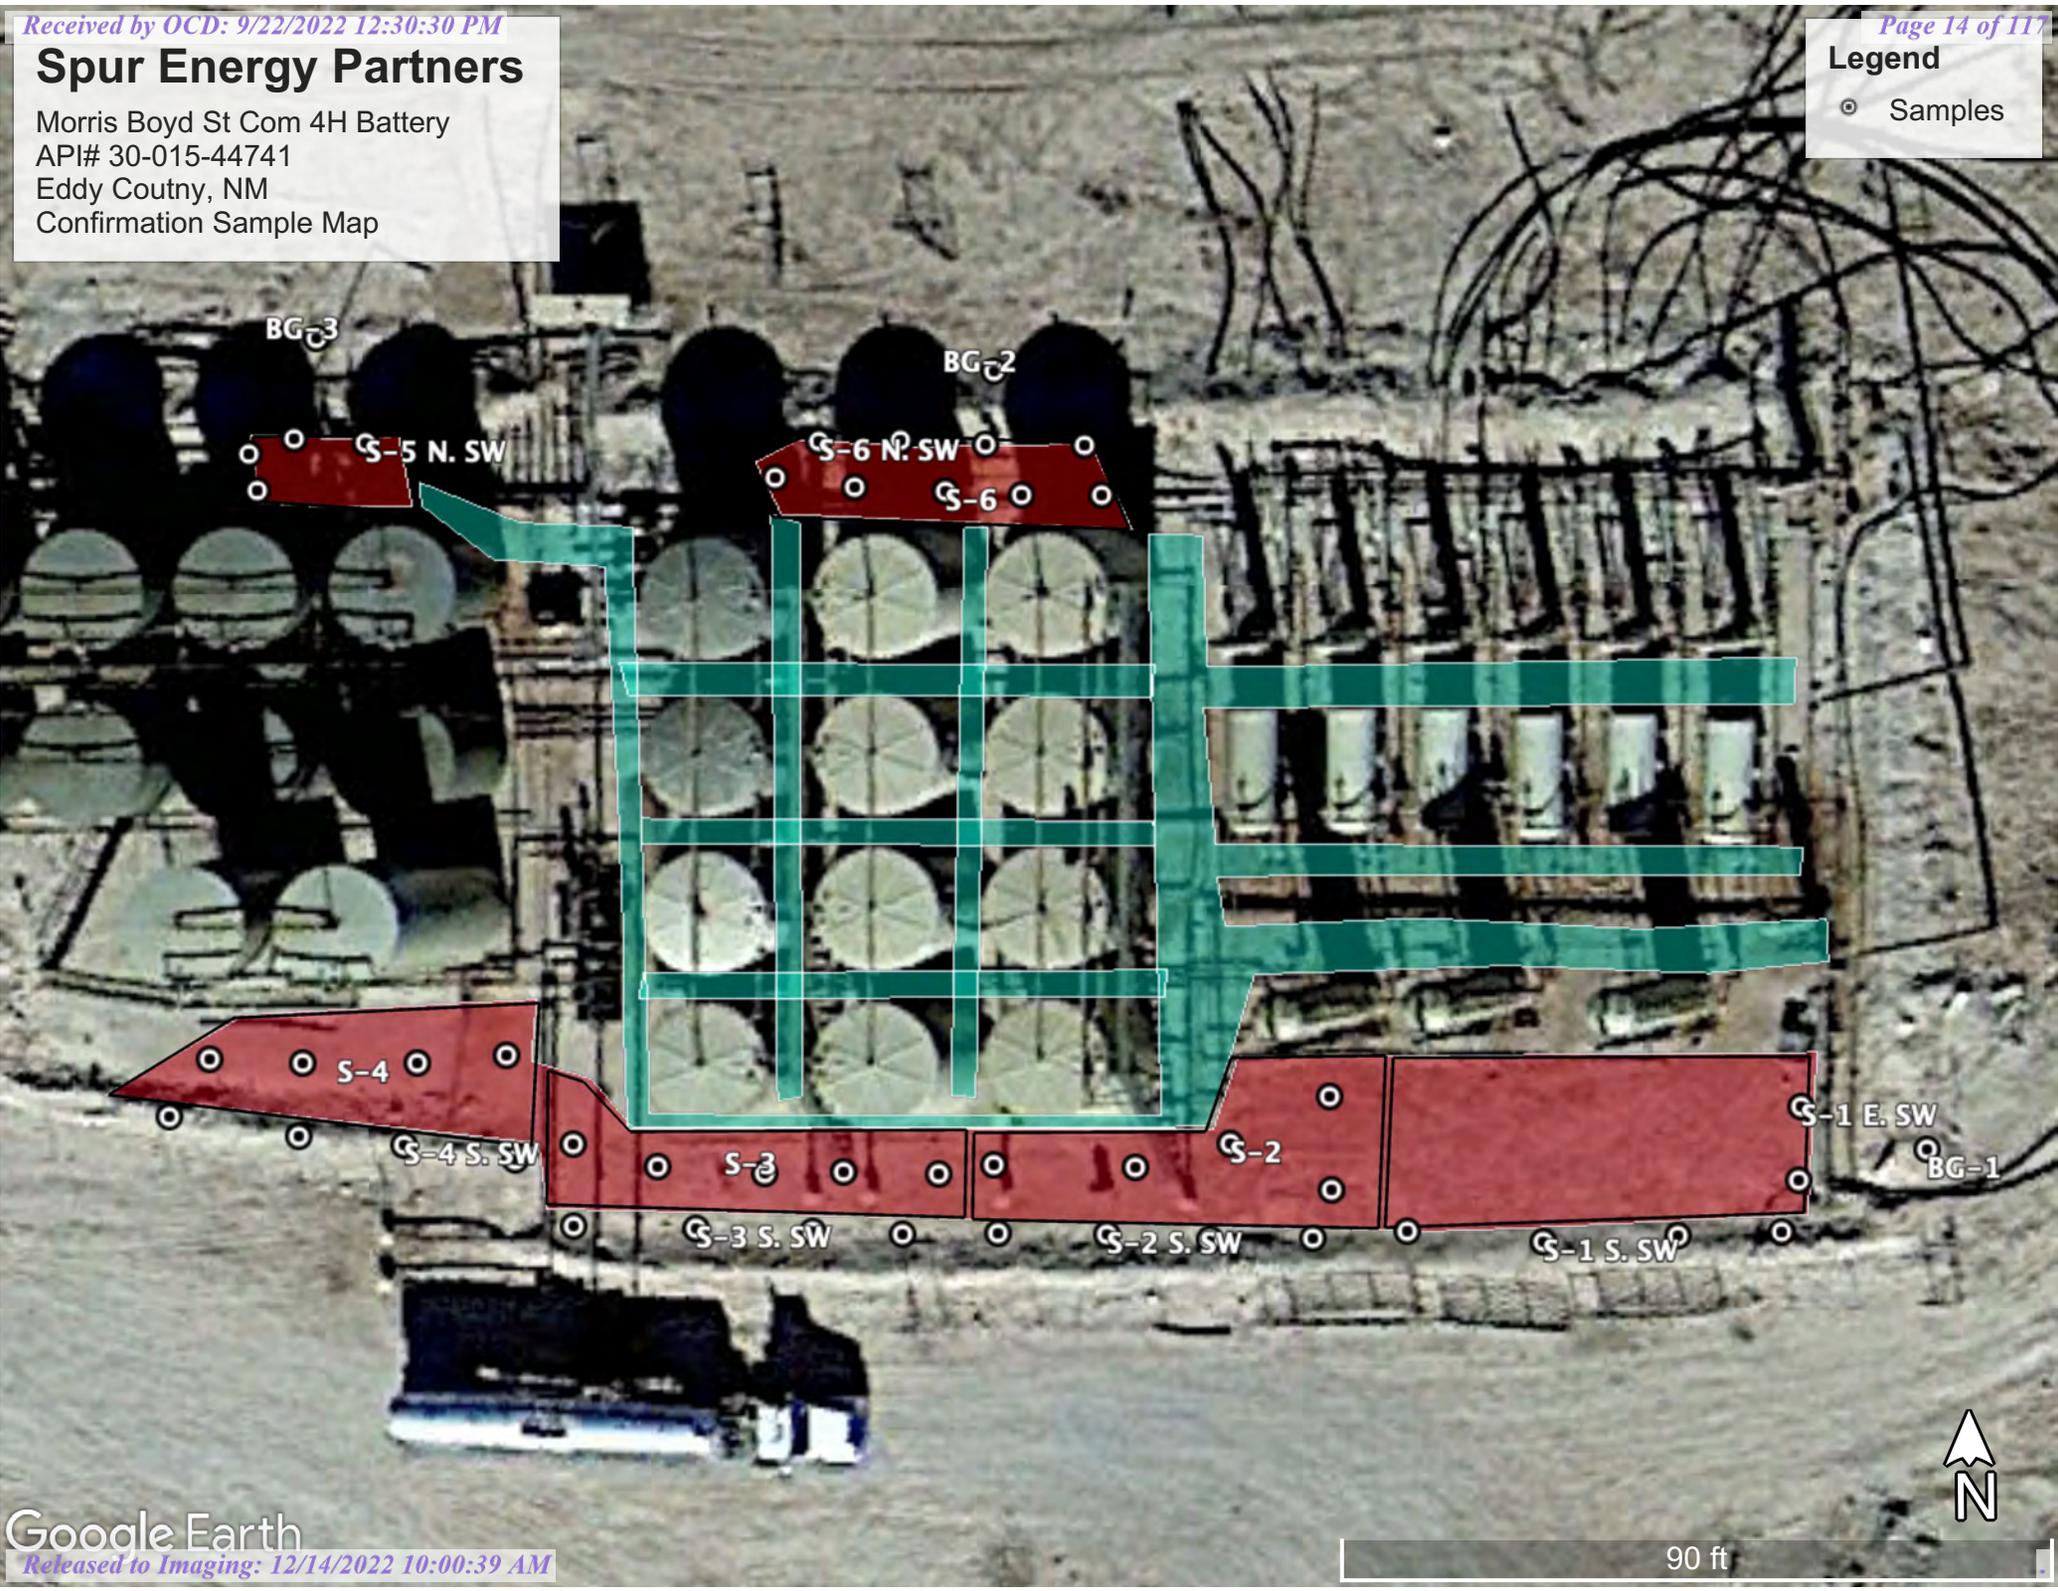
Morris Boyd St Com 4H Battery
API# 30-015-44741
Eddy Coutny, NM
Confirmation Sample Map

○ Samples

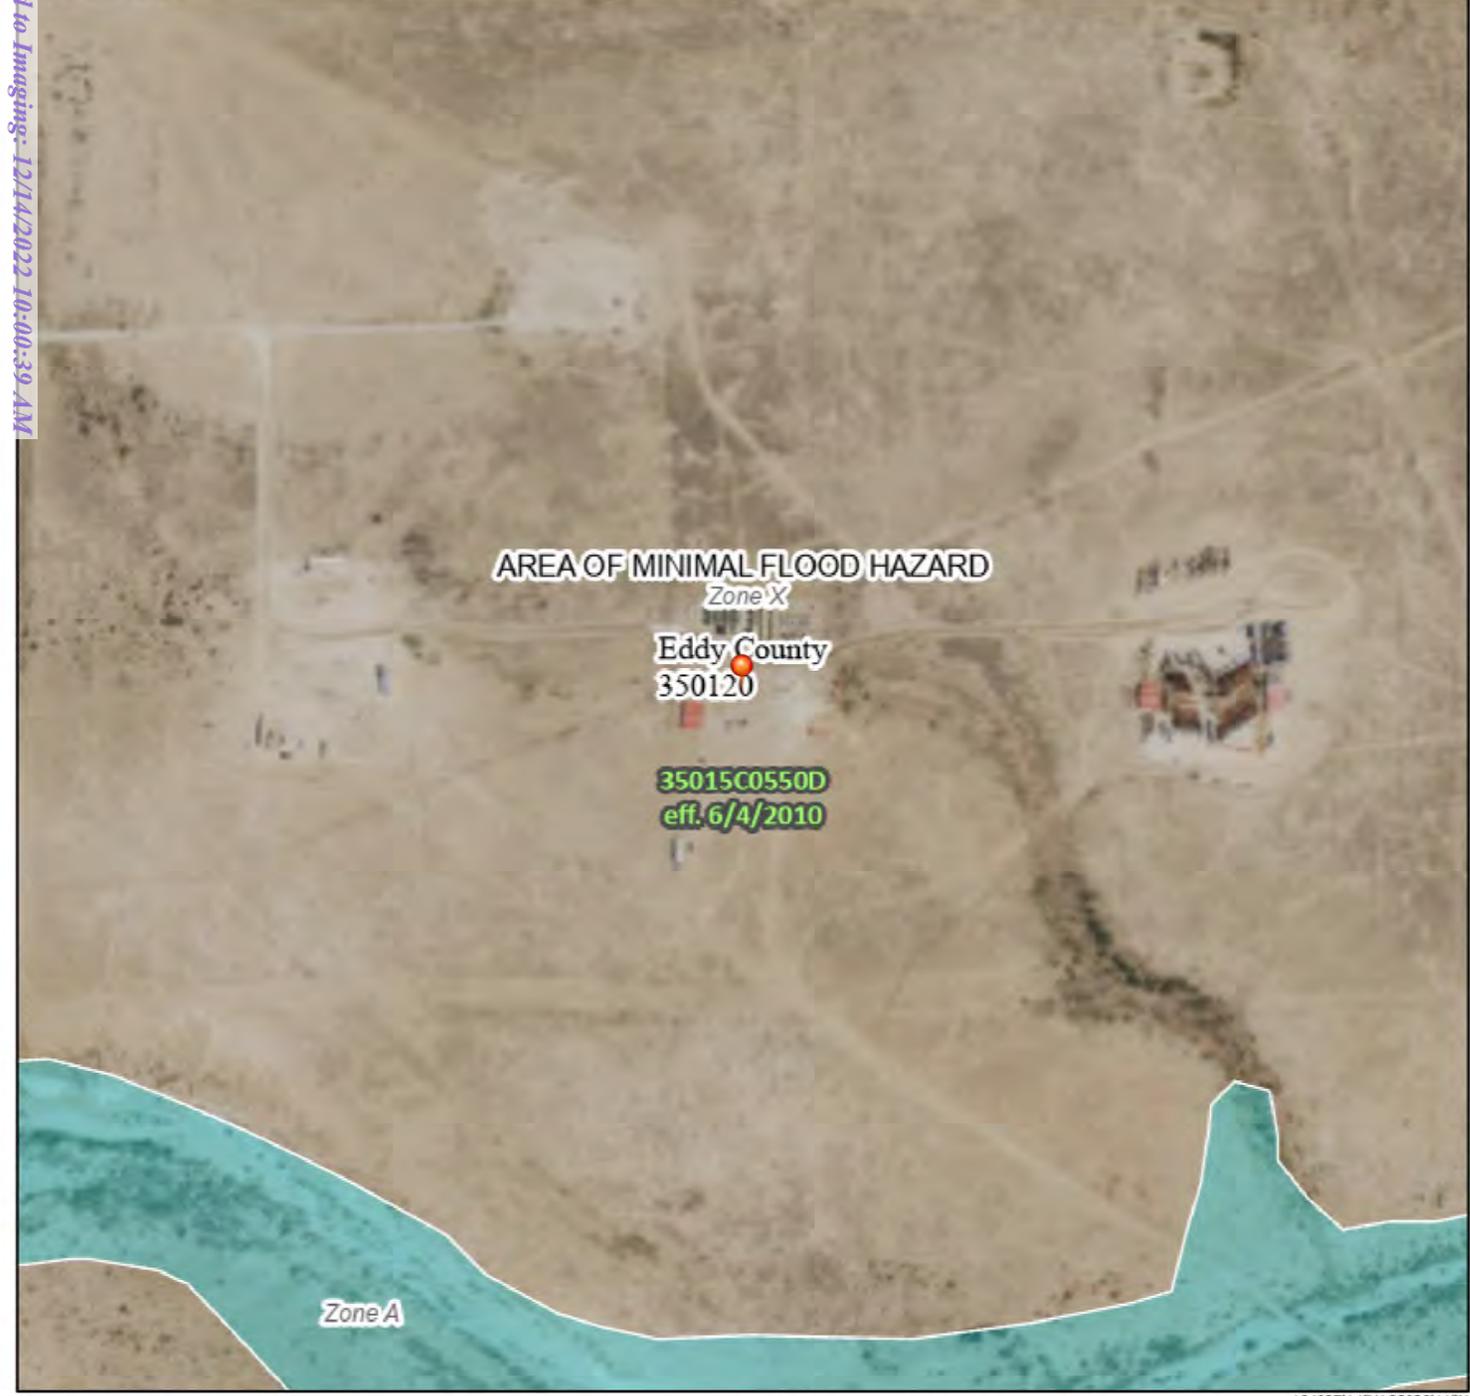
National Flood Hazard Layer FIRMette

The flood hazard information is derived directly from the authoritative NFHL web services provided by FEMA. This map was exported on 5/27/2021 at 8:41 AM and does not reflect changes or amendments subsequent to this date and time. The NFHL and effective information may change or become superseded by new data over time.

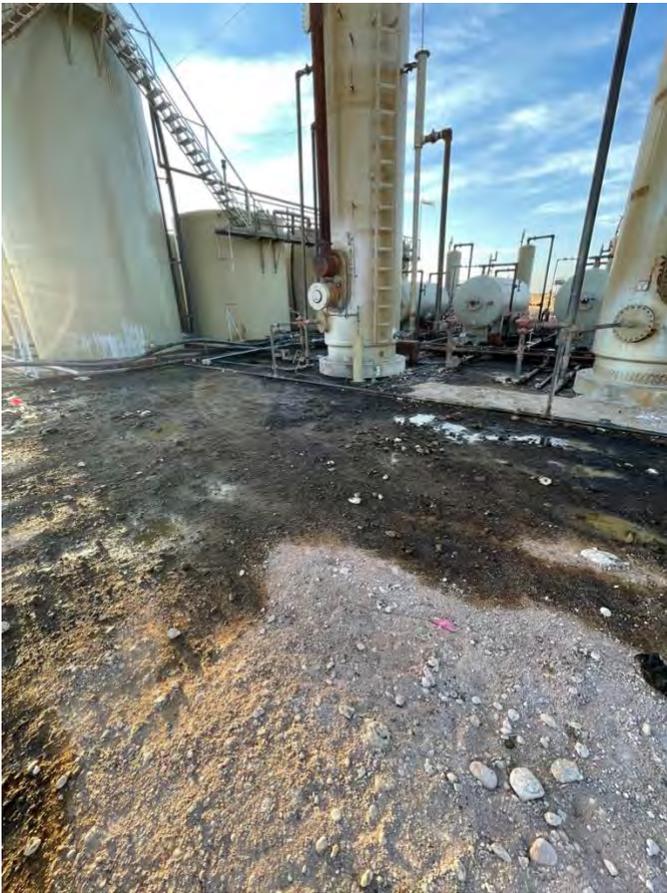
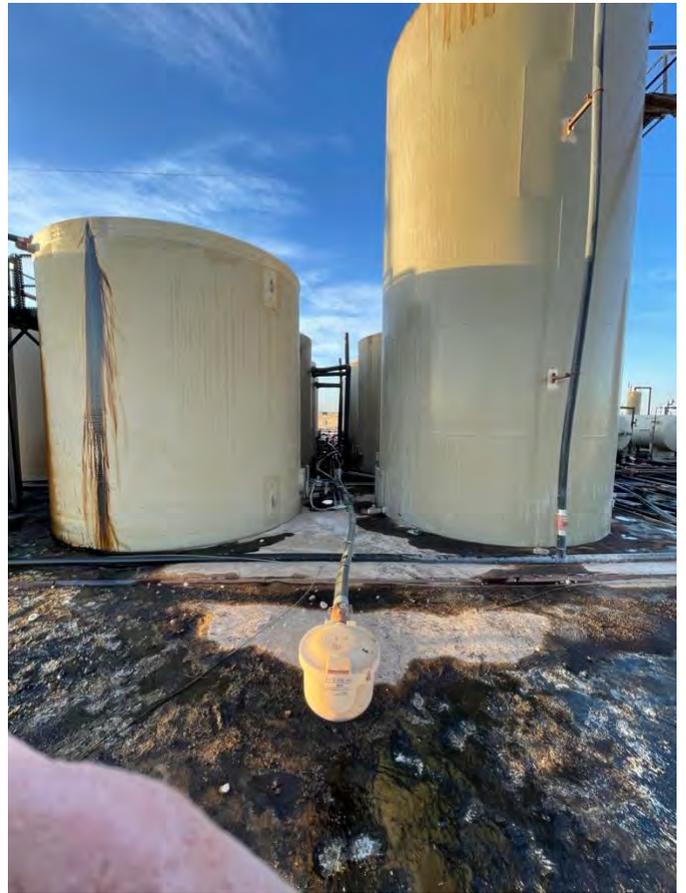
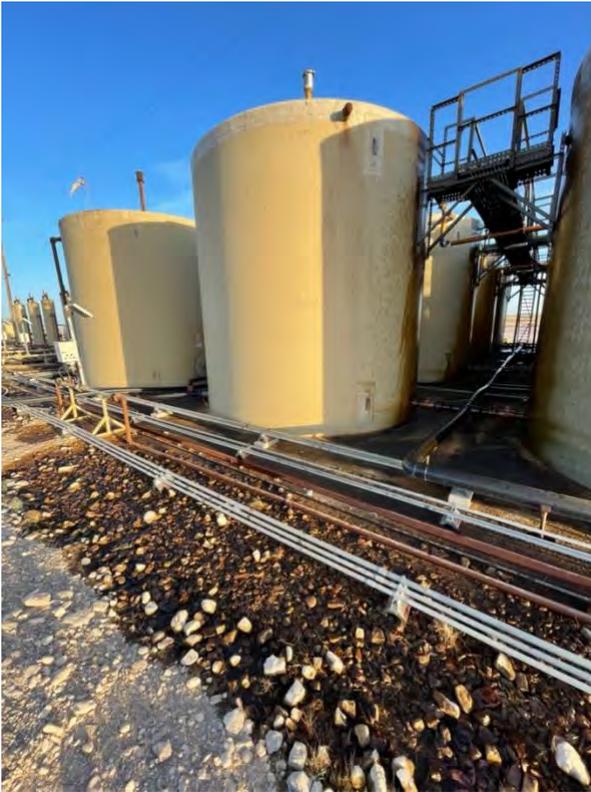
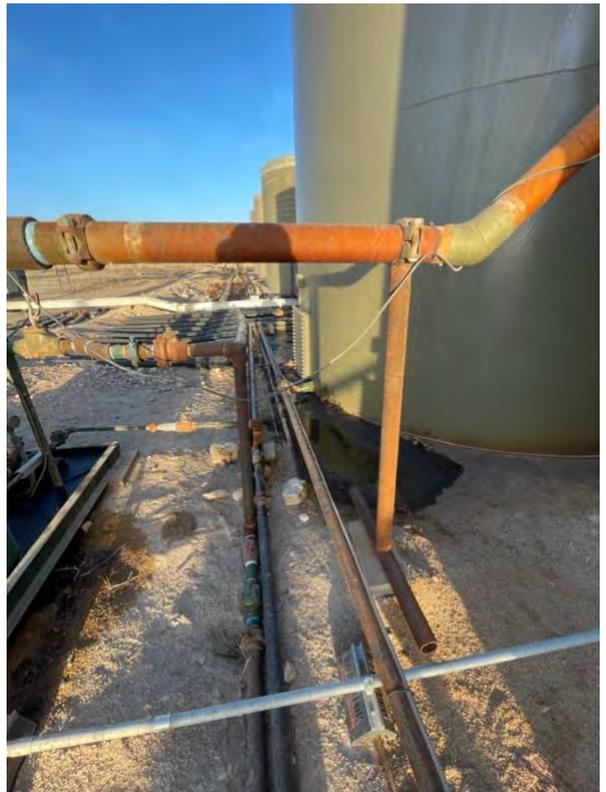
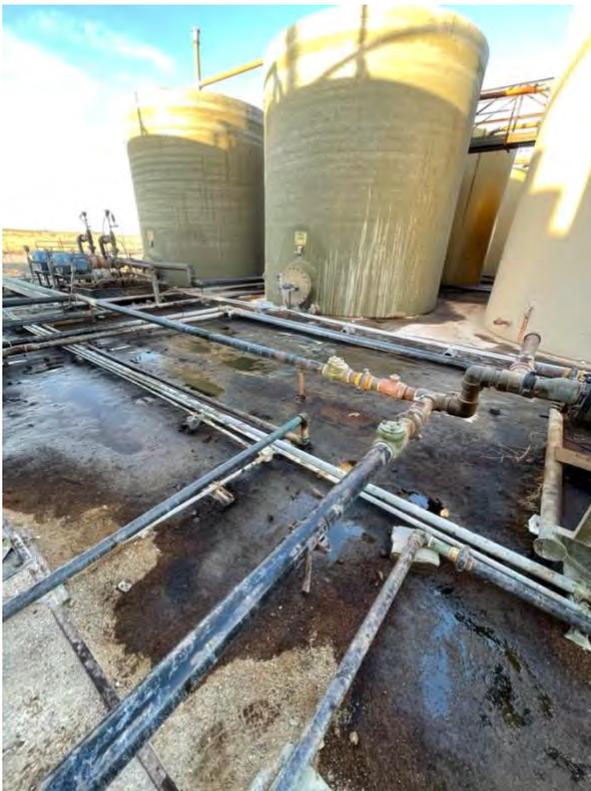
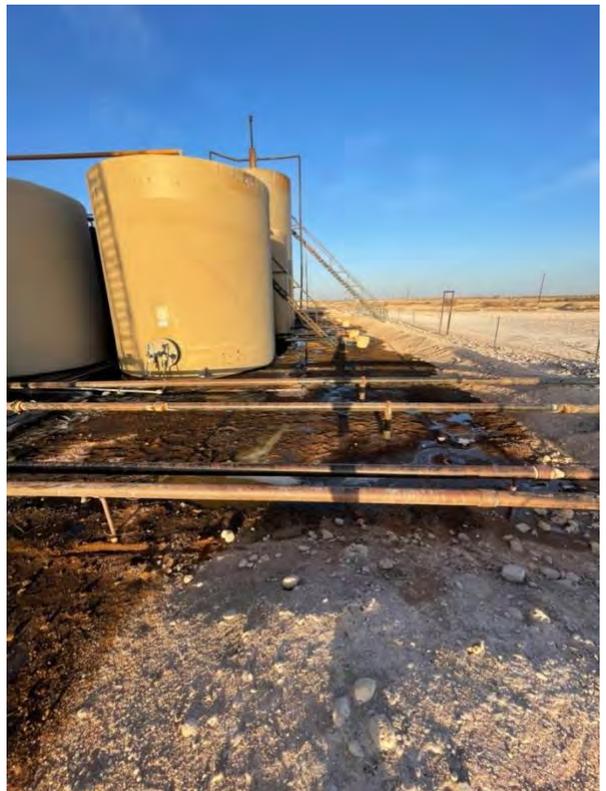
Before Remediation

Release Details			
Type of Release:	Crude Oil	Volume of Release:	104 bbls
		Volume Recovered:	70 bbls
Source of Release:	Oil Tanks	Date of Release:	04/09/22
Was Immediate Notice Given?	Yes	If, Yes, to Whom?	Mike Bratcher, NMOCD
Was a Watercourse Reached?	No	If Yes, Volume Impacting Watercourse:	N/A
Surface Owner:	State	Mineral Owner:	
Communication system failure resulting in high tank levels and no alarm to notify personnel. This resulted in tanks running over. The release stayed inside the earthen berm.

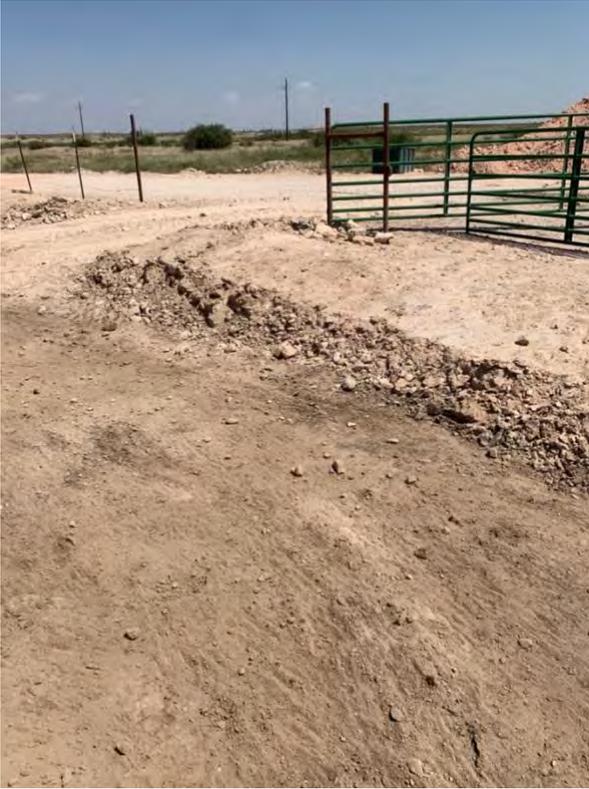
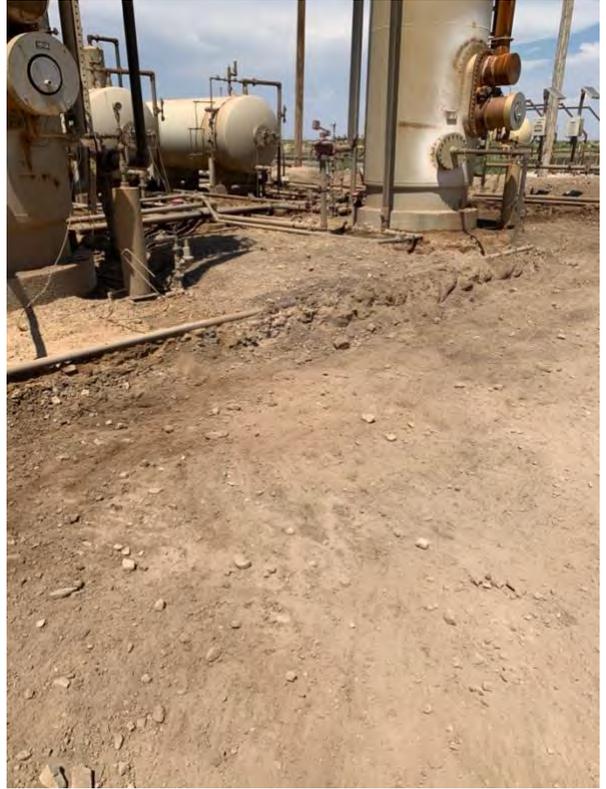
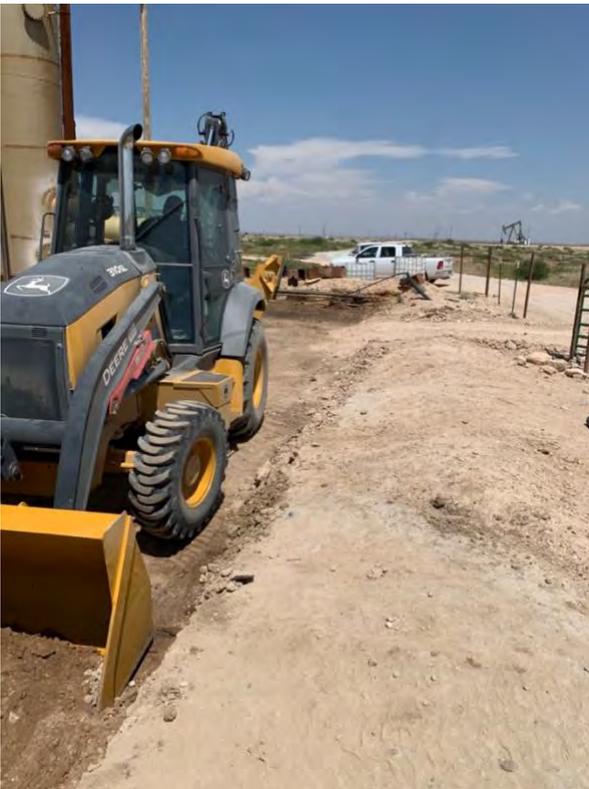
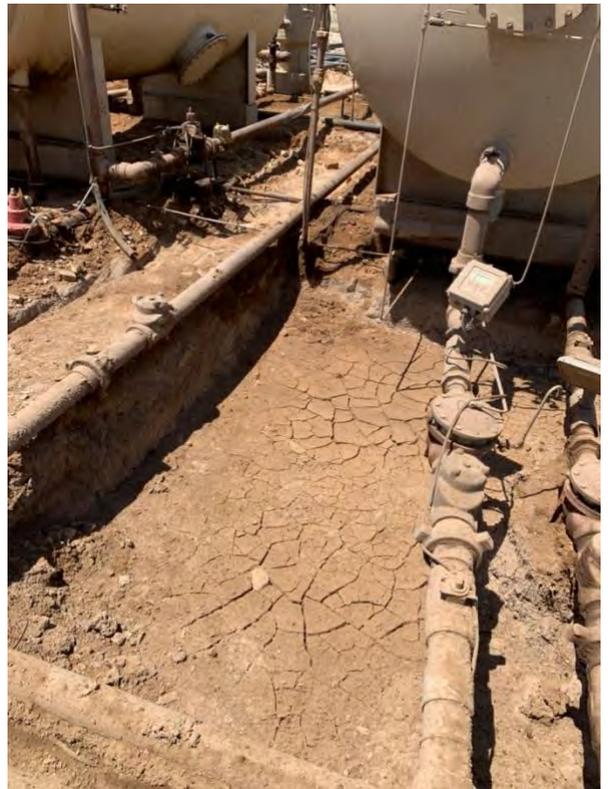
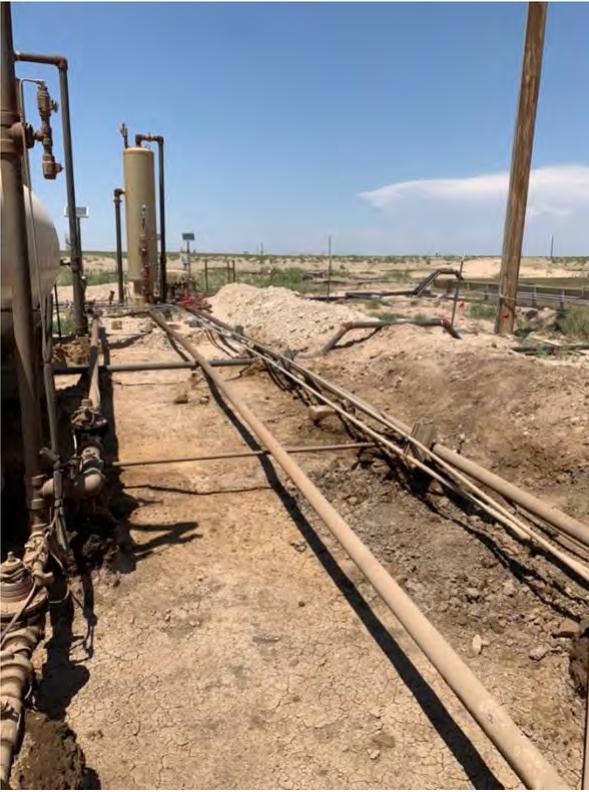
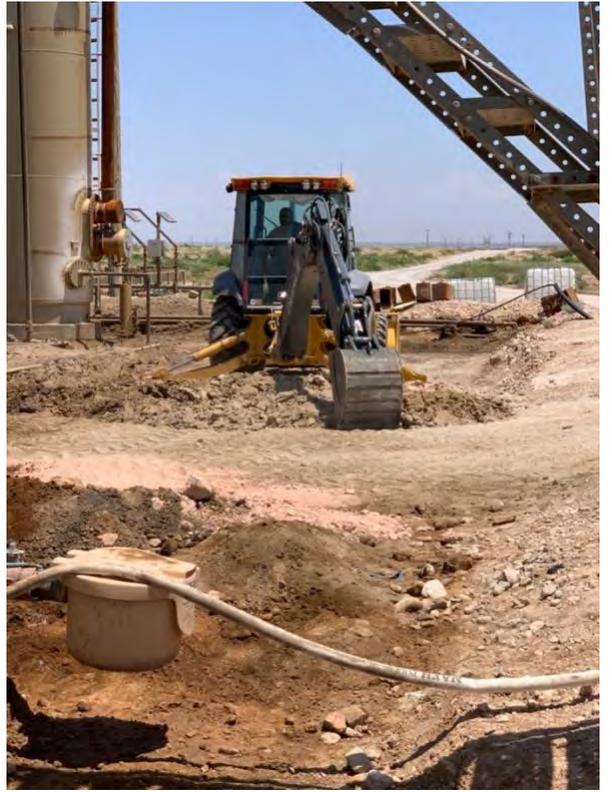
During Remediation

- Utilizing mechanical and hand equipment, we excavated the impacted soils above the NMOCD Closure Criteria in the areas categorized by soil samples S-1, S-3, and S-6 to a depth of 1.5 feet BGS.
- In the area of S-2, we excavated to a depth of 1-foot BGS.
- In the area of S-5, we excavated 6 inches to remove the staining. The initial sampling showed this area to already be below closure criteria. We wanted to stay consistent throughout this project and therefore sampled according to rule 19.25.29.
