Pima Environmental Services, LLC
1601 N. Turner Ste 500
Hobbs, NM 88240
575-964-7740

April 20th, 2021

**Re: Site Assessment and Closure Report
Uncle Sam 13 Federal #001
API No. 30-025-30732
GPS: Latitude 32.751680 Longitude -103.718082
UL "B", Sec. 13, T18S, R32E
Lea County, NM
NMOCD Ref. No. NTO1507838087 (1RP-3569)**

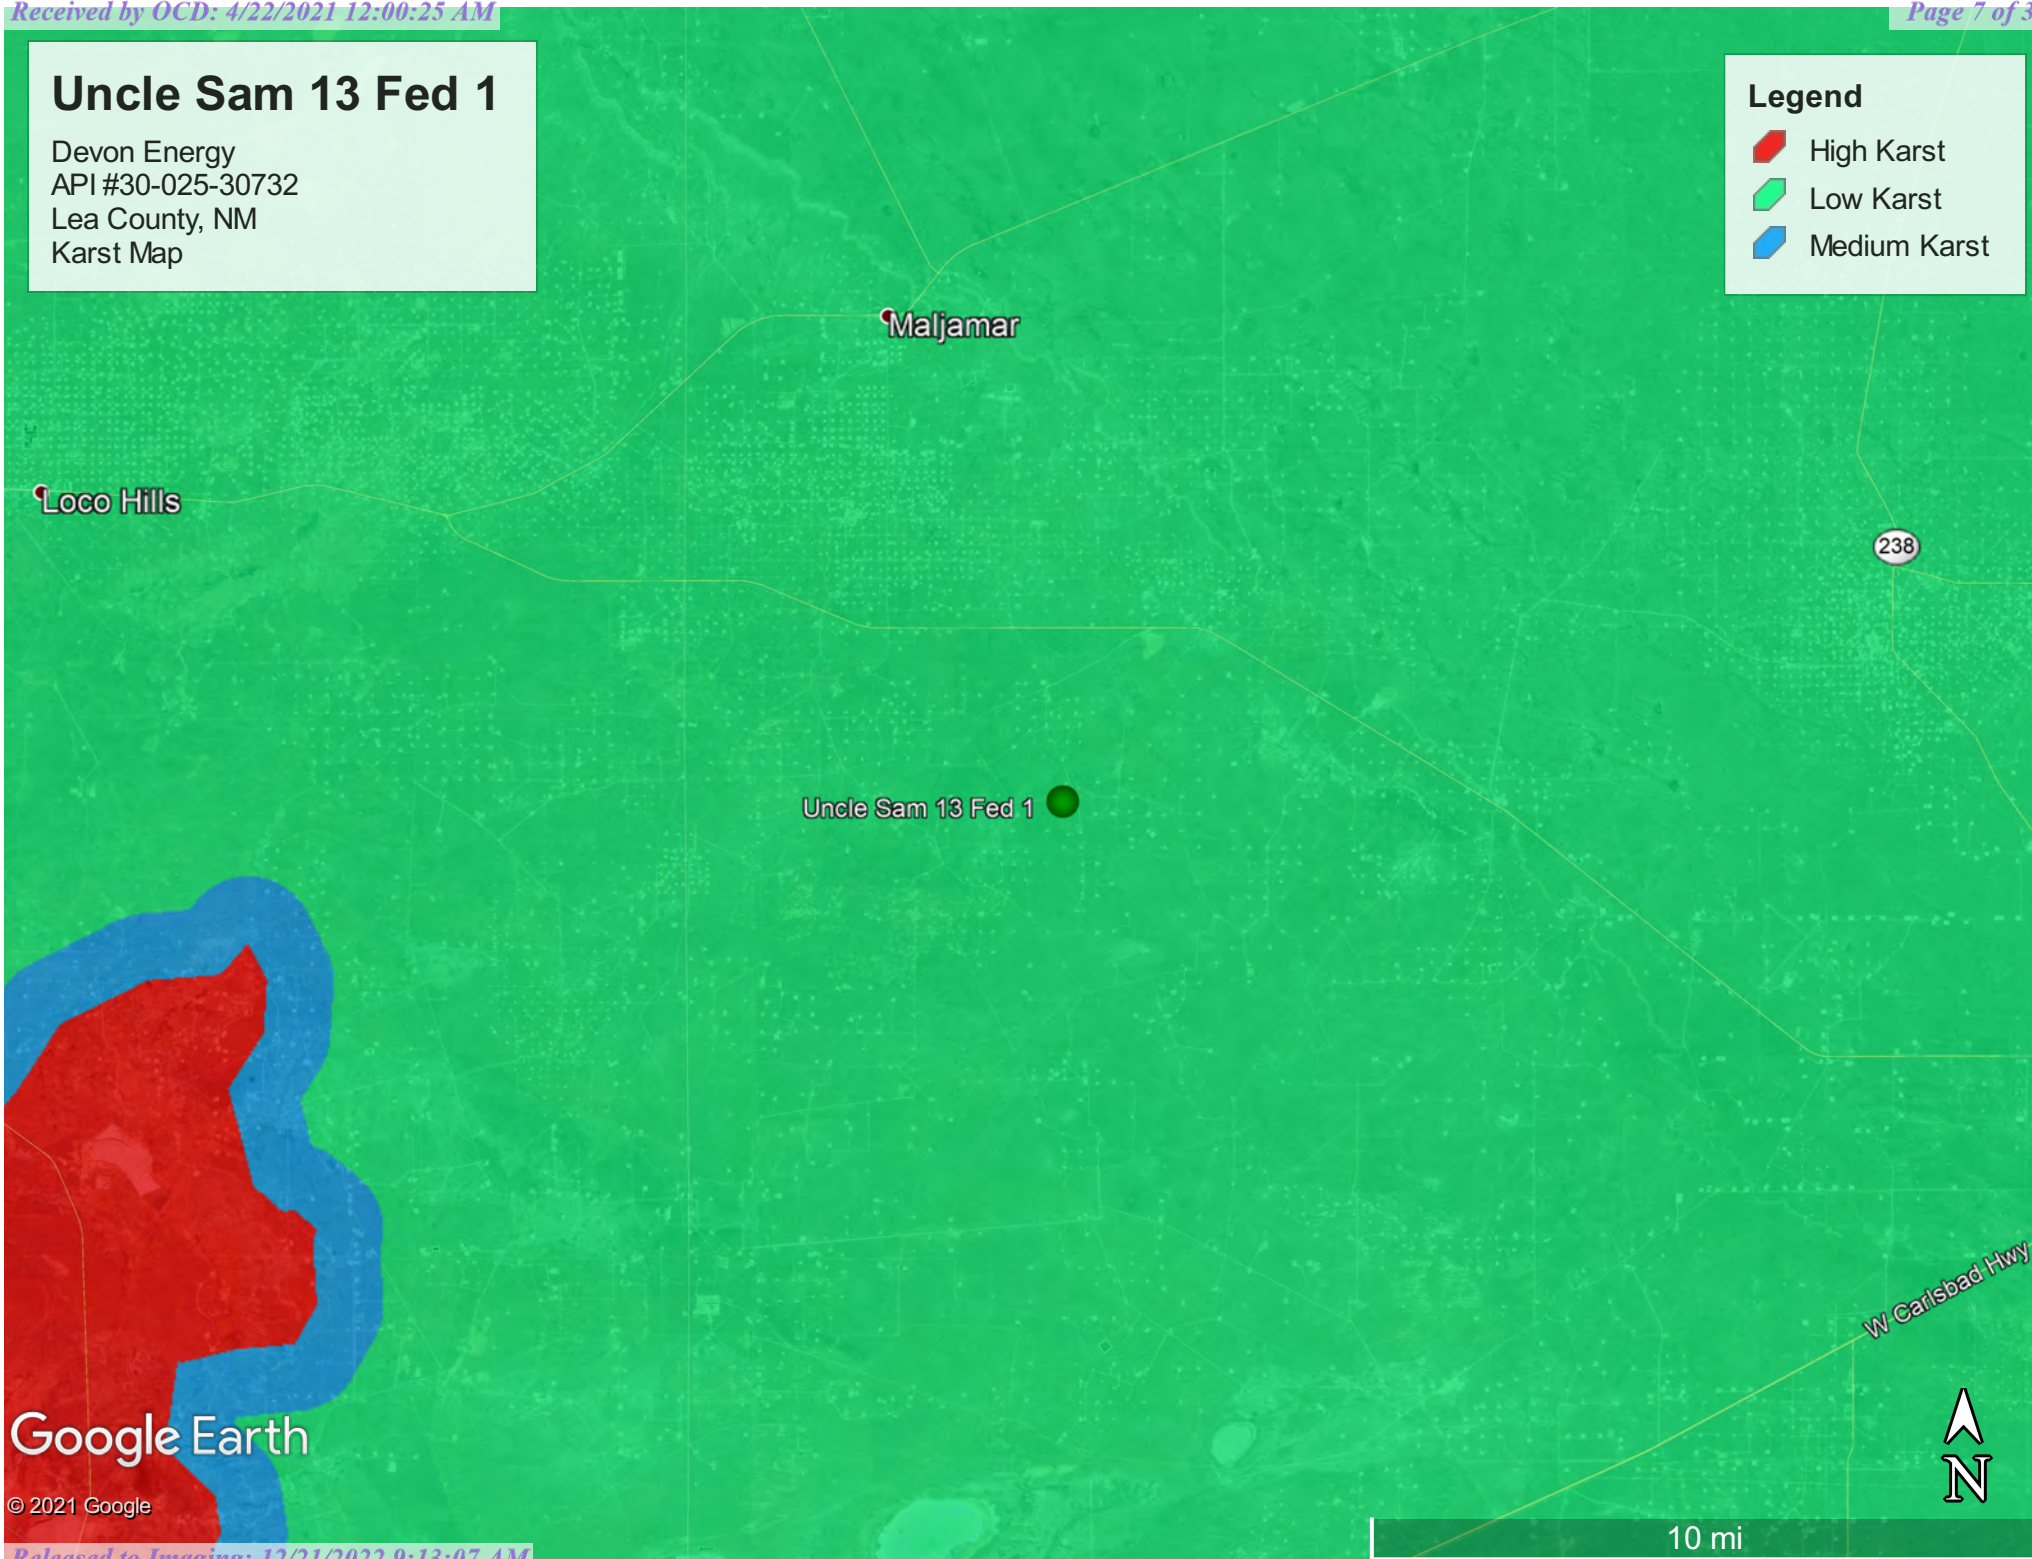
Devon Energy
API #30-025-30732
Lea County, NM
Karst Map

Per the New Mexico Bureau of Geology and Mineral Resources, the geology is in the Quaternary Formation- Eolian deposits (Holocene to middle Pleistocene). Interlayered eolian sands and piedmont-slope deposits along the eastern flank of the Pecos River valley, primarily between Roswell and Carlsbad. Typically capped by thin eolian deposits. The soil in this area is made up of Kermit-Palomas fine sands, 0 to 12 percent slopes according to the United States Department of Agriculture Natural Resources Conservation Service soil survey (Appendix B). The drainage courses in this area are well-drained. There is a low potential for karst geology to be present in the area of the Uncle Sam (Figure 3).

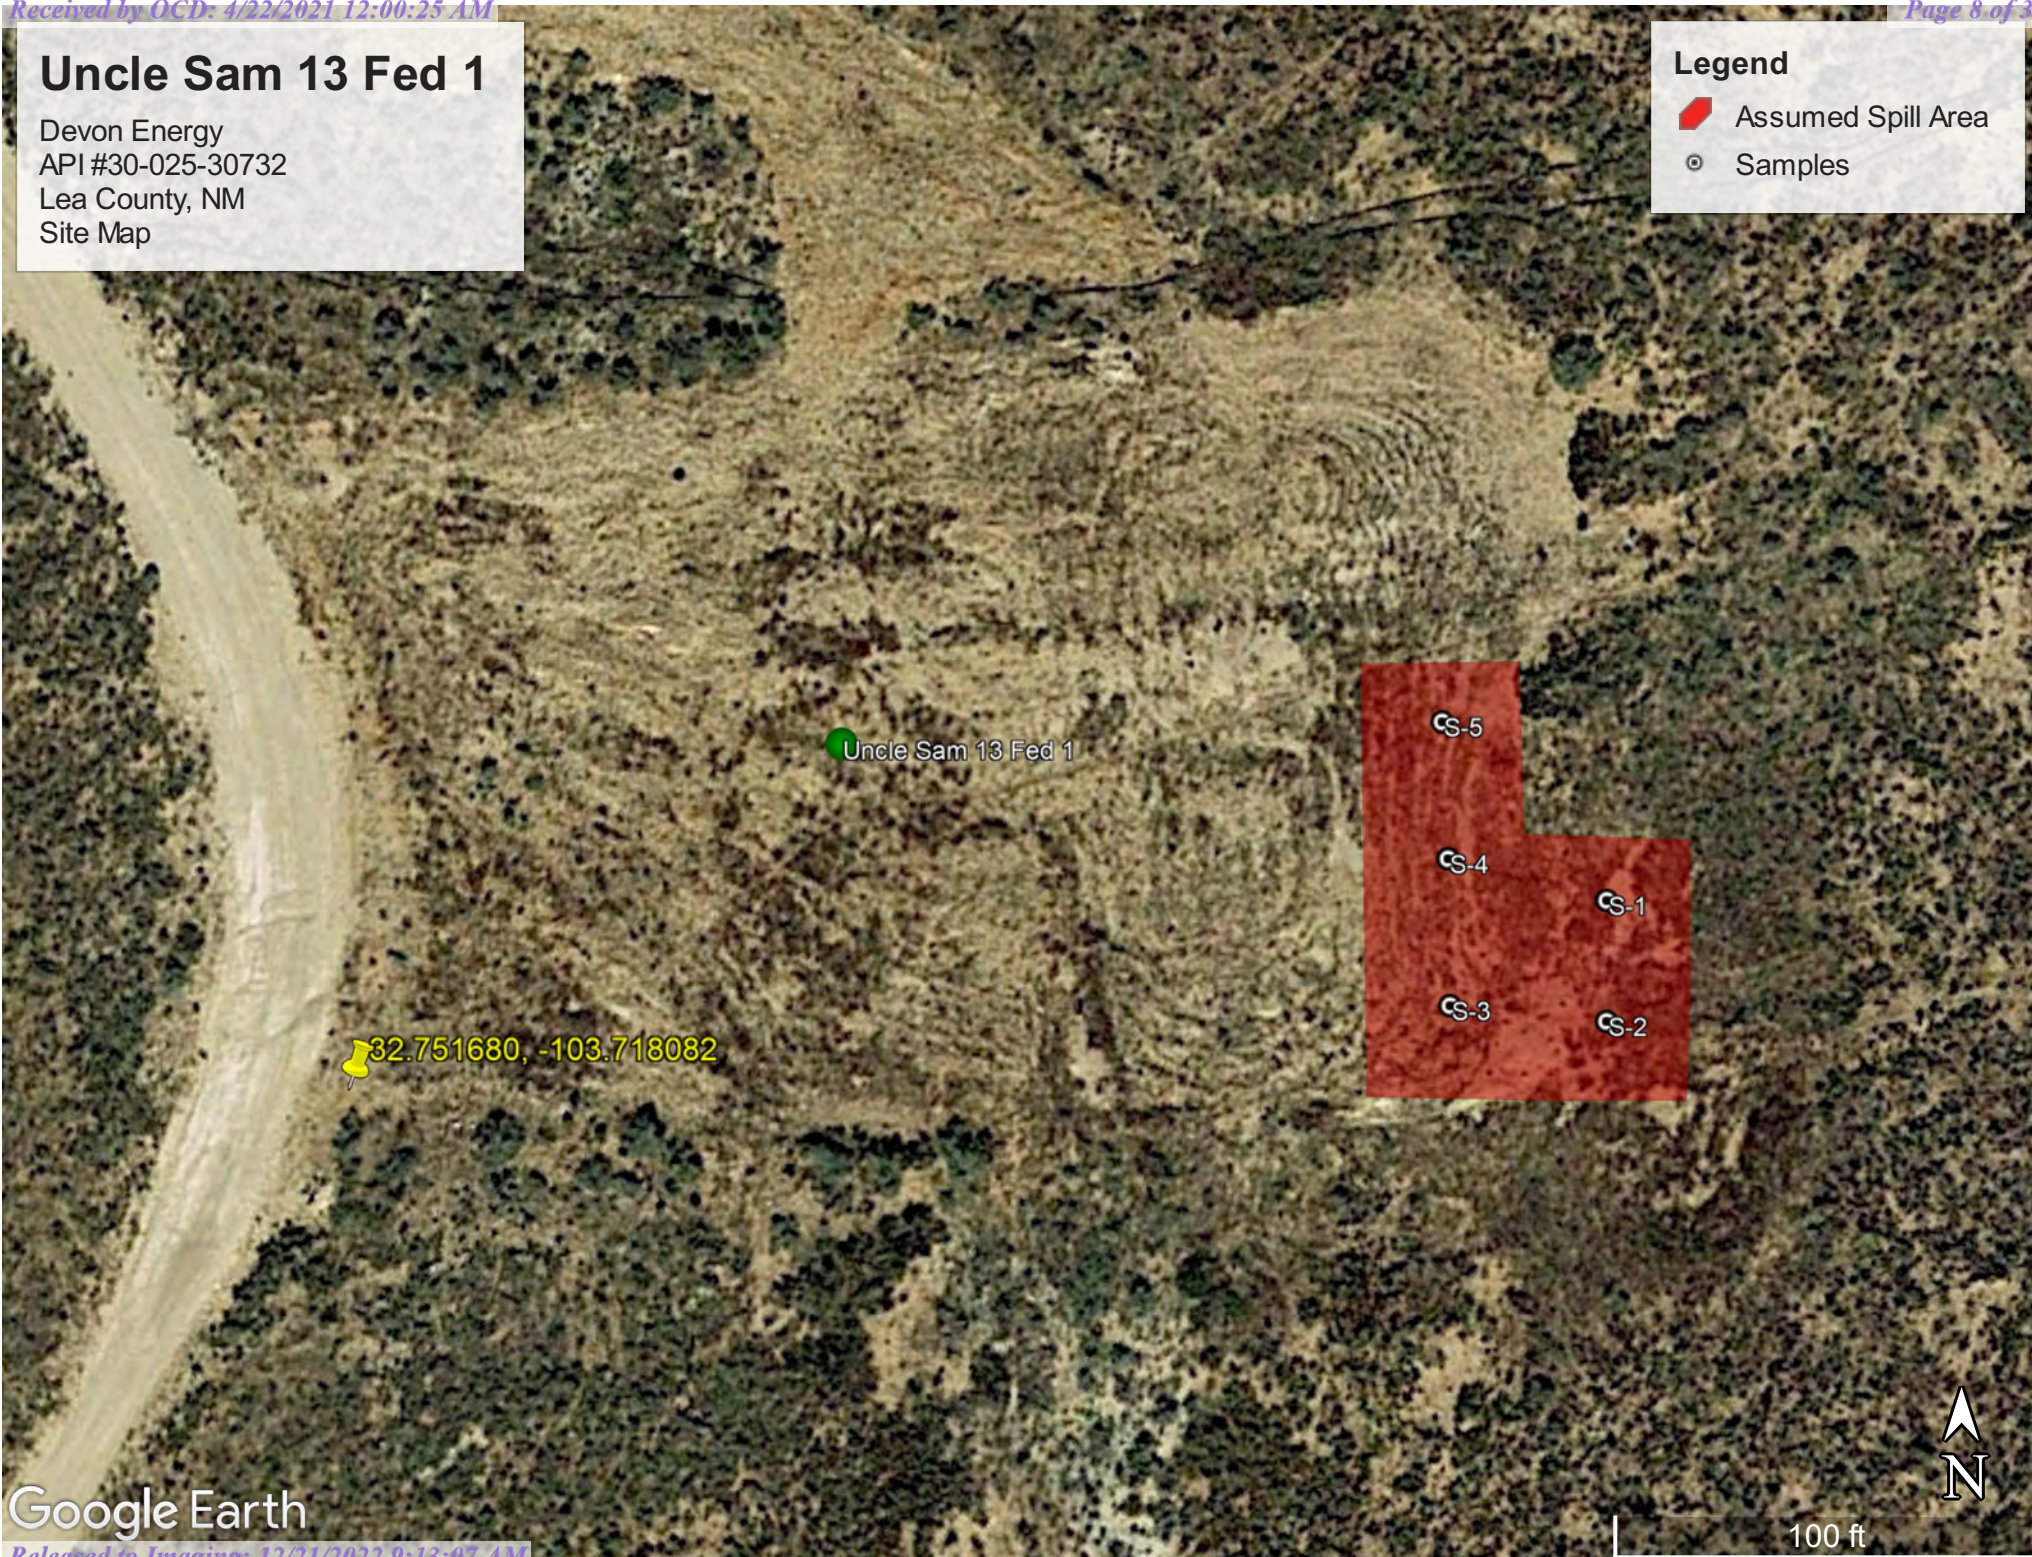
Devon Energy
API #30-025-30732
Lea County, NM
Site Map

On April 14th, 2021, Pima Environmental conducted a site assessment and obtained soil samples. The laboratory results of this sampling event can be found in the following data table.

The sample results were below NMOCD Closure Criteria 19.15.29 NMAC. Based on these findings, no remediation activities were needed at this location.
