HRL
COMPLIANCE
SOLUTIONS

June 5, 2020

Subject: Site Characterization and Closure Report
Cotton Draw Unit 172H (April 2015)
2RP-2966
Eddy County, New Mexico

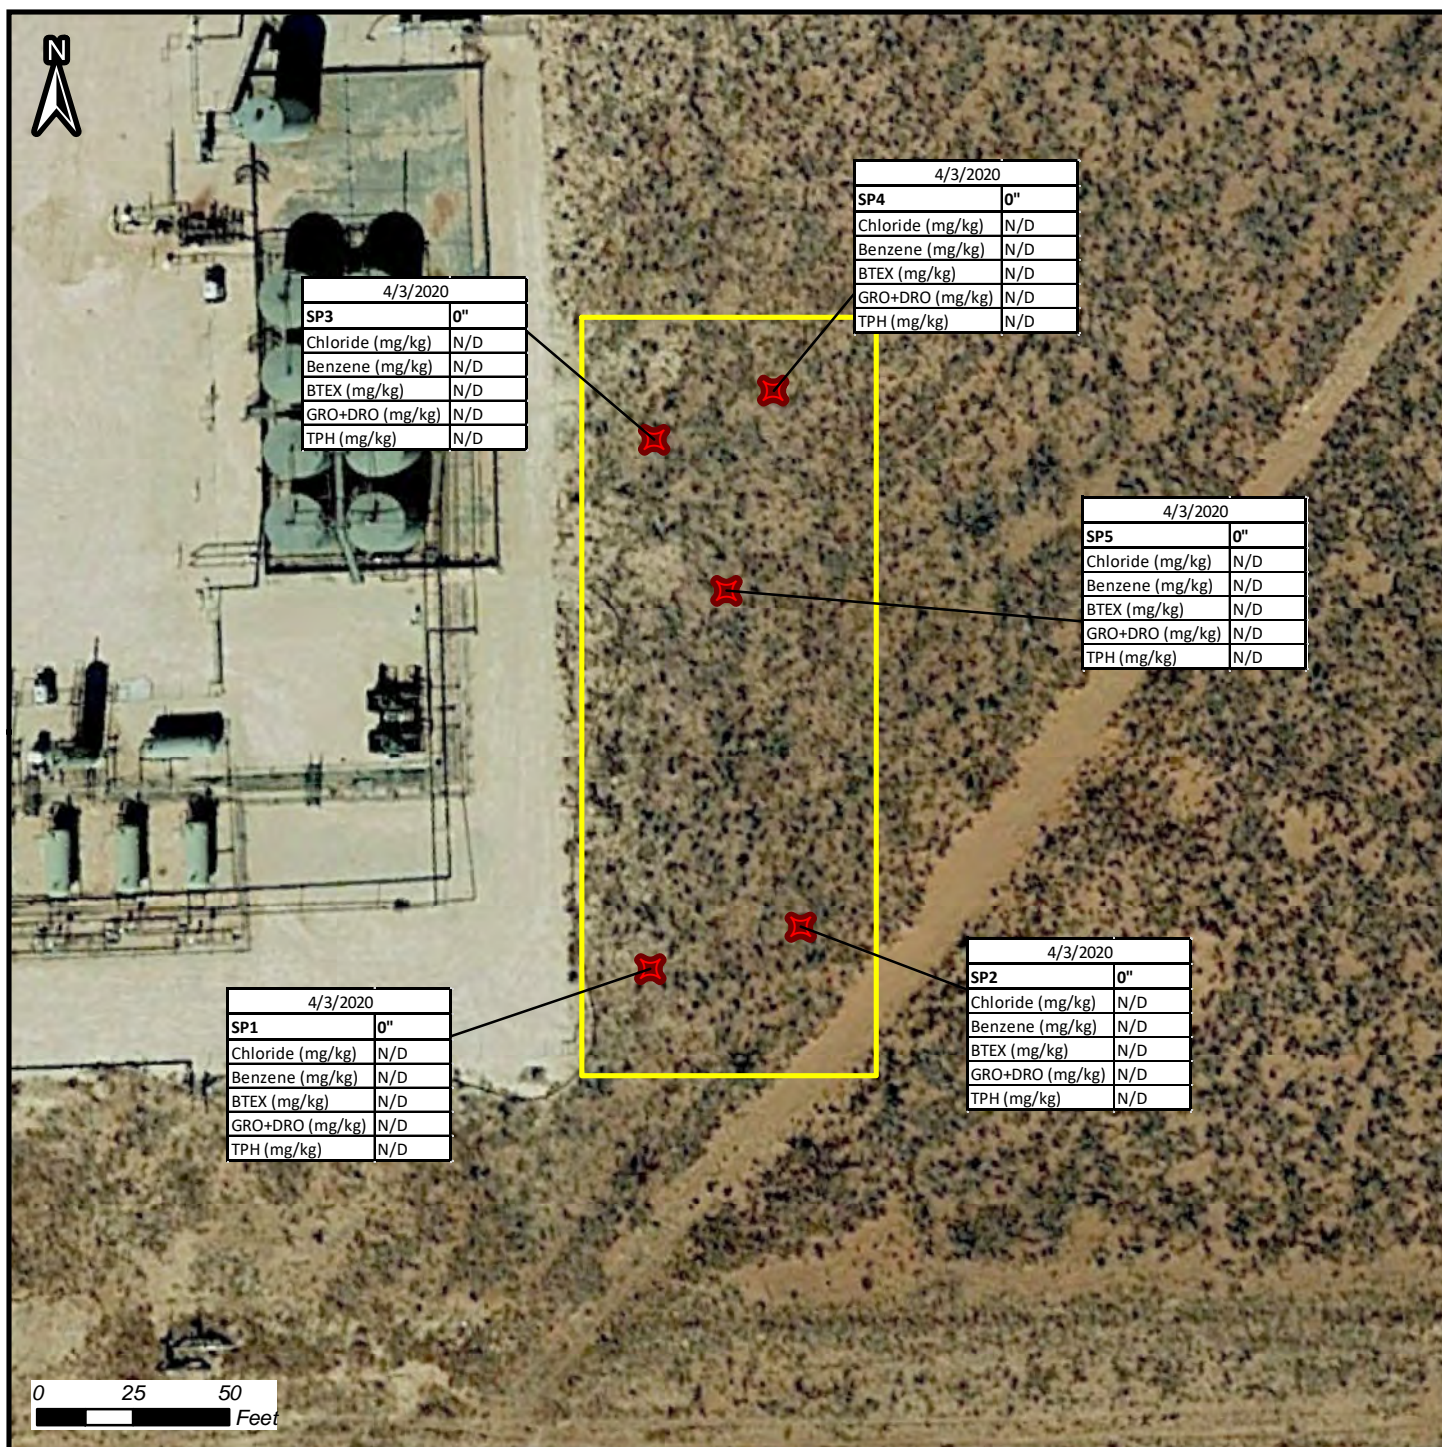
Figure 3: Confirmation Sample Location Map

The area of investigation measures 76 feet by 198 feet and covers an area of approximately 15,162 square feet. There is no impacted area above the applicable standards.

A scaled diagram depicting the potentially impacted area and nearby significant features, such as roads, site infrastructure, location of borings, sample points, monitoring wells (if present) and subsurface features has been prepared (Figure 3). HRL utilized a Trimble GeoXT global positioning system (GPS) unit to collect latitude and longitude data for the sample locations. Based on evaluation of the laboratory results of the soil samples, remediation of the impacted soil is not necessary (Attachment B).

The results of the soil samples were below the applicable closure criteria specified in 19.15.29.12 NMAC. Therefore, no additional remedial action is required; HRL recommends closure of this release.

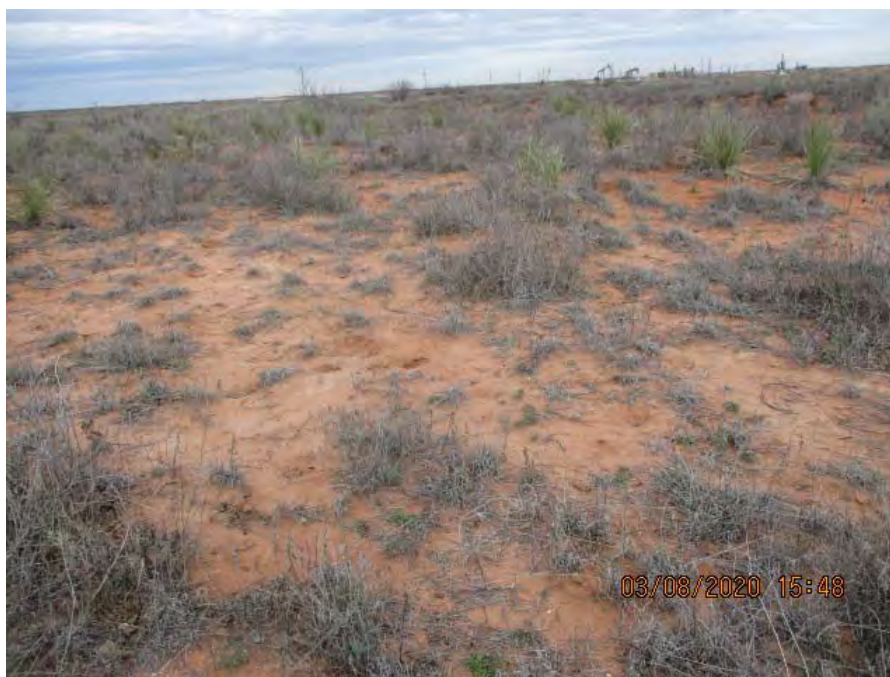
View of the Site

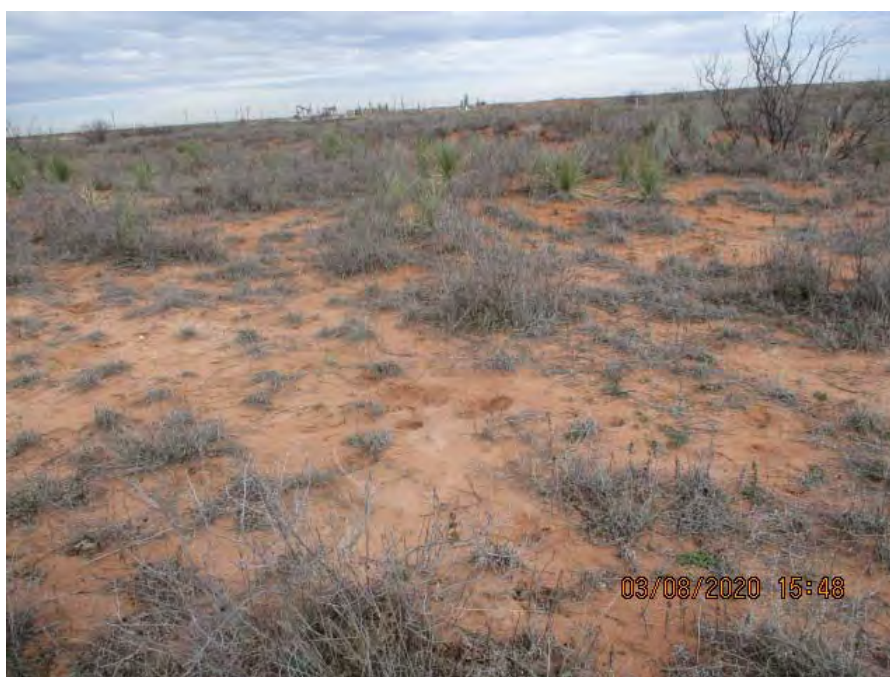
View of the Site
