Re: Site Assessment, Remediation, and Closure Report
Volleyball State #1
API No. 30-005-63887
GPS: Latitude 33.3012657 Longitude -104.3045883
UL "P", Sec. 02, T12S, R26E
Chaves County, NM
NMOCD Ref. No. NAPP2222836453

Pima Environmental Services, LLC (Pima) has been contracted by Armstrong Energy Corporation to perform a spill assessment, remediation activities, and submit this closure report for a crude oil release that occurred at the Volleyball State #001. The initial C-141 was submitted on August 16th, 2022 (Appendix C). This incident was assigned Incident ID NAPP2222836453, by the New Mexico Oil Conservation Division (NMOCD).

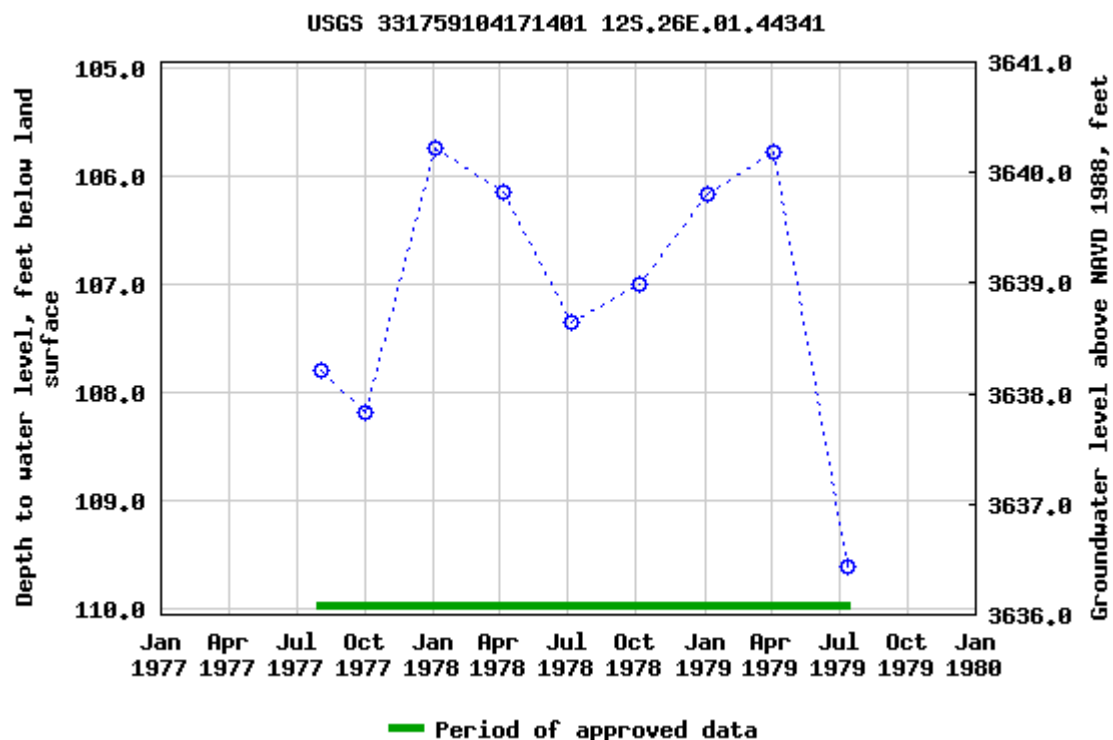
USGS 331759104171401 12S.26E.01.44341

The depth of the well is 310 feet below land surface.

This well is completed in the Artesia Group (313ARTS) local aquifer.

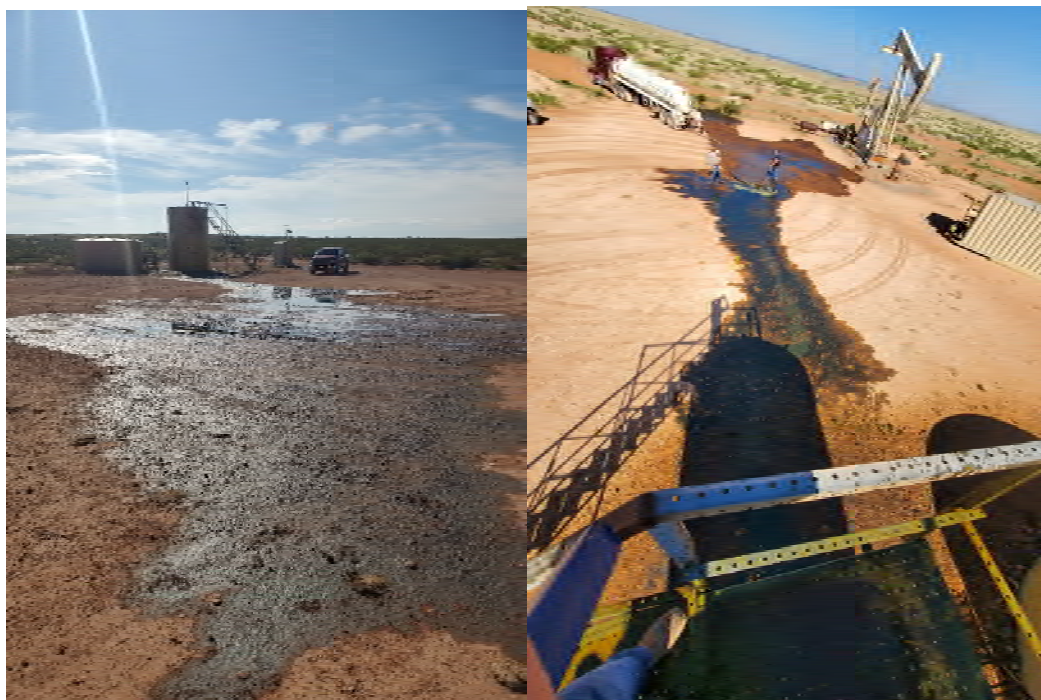
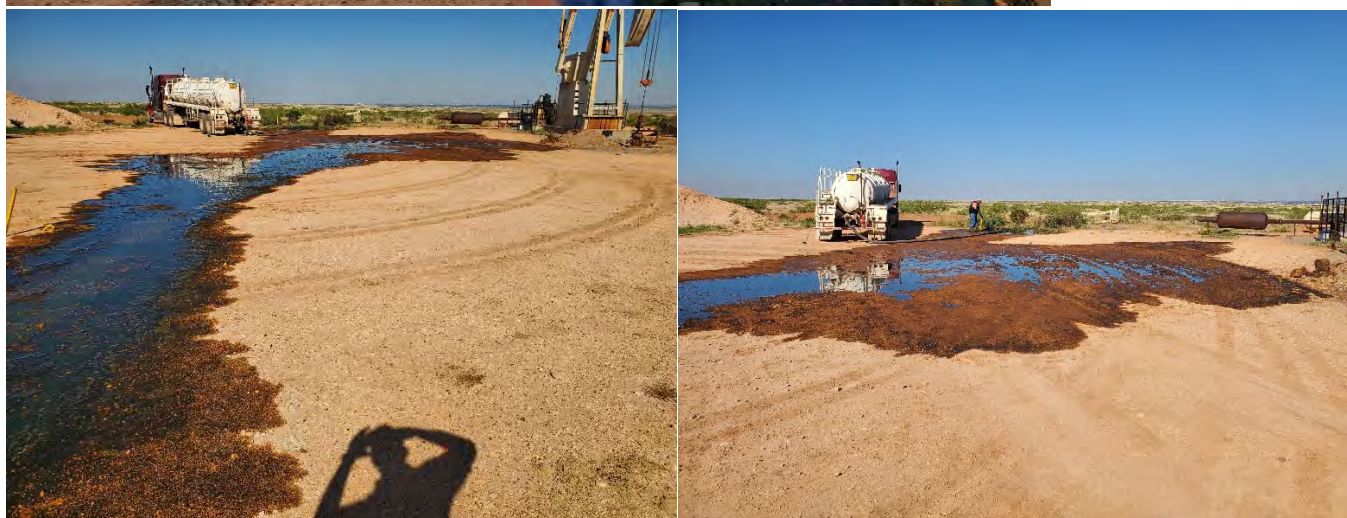
Pre- Excavation

nAPP222836453: On August 16th, 2022, a hung dump valve inside a separator caused an overflow of an oil tank. The affected area measures approximately 2,278 ft² on the surface of the hard pack caliche soil. Approximately 48 barrels of crude oil was released, 25 barrels were recovered, all remained on pad.

On August 16th, 2022, Armstrong Energy Corporation mobilized personnel to the site to assess the area. Armstrong immediately scrapped up the affected area using a backhoe and transported the contaminated material to an NMOCD approved landfill for disposal.

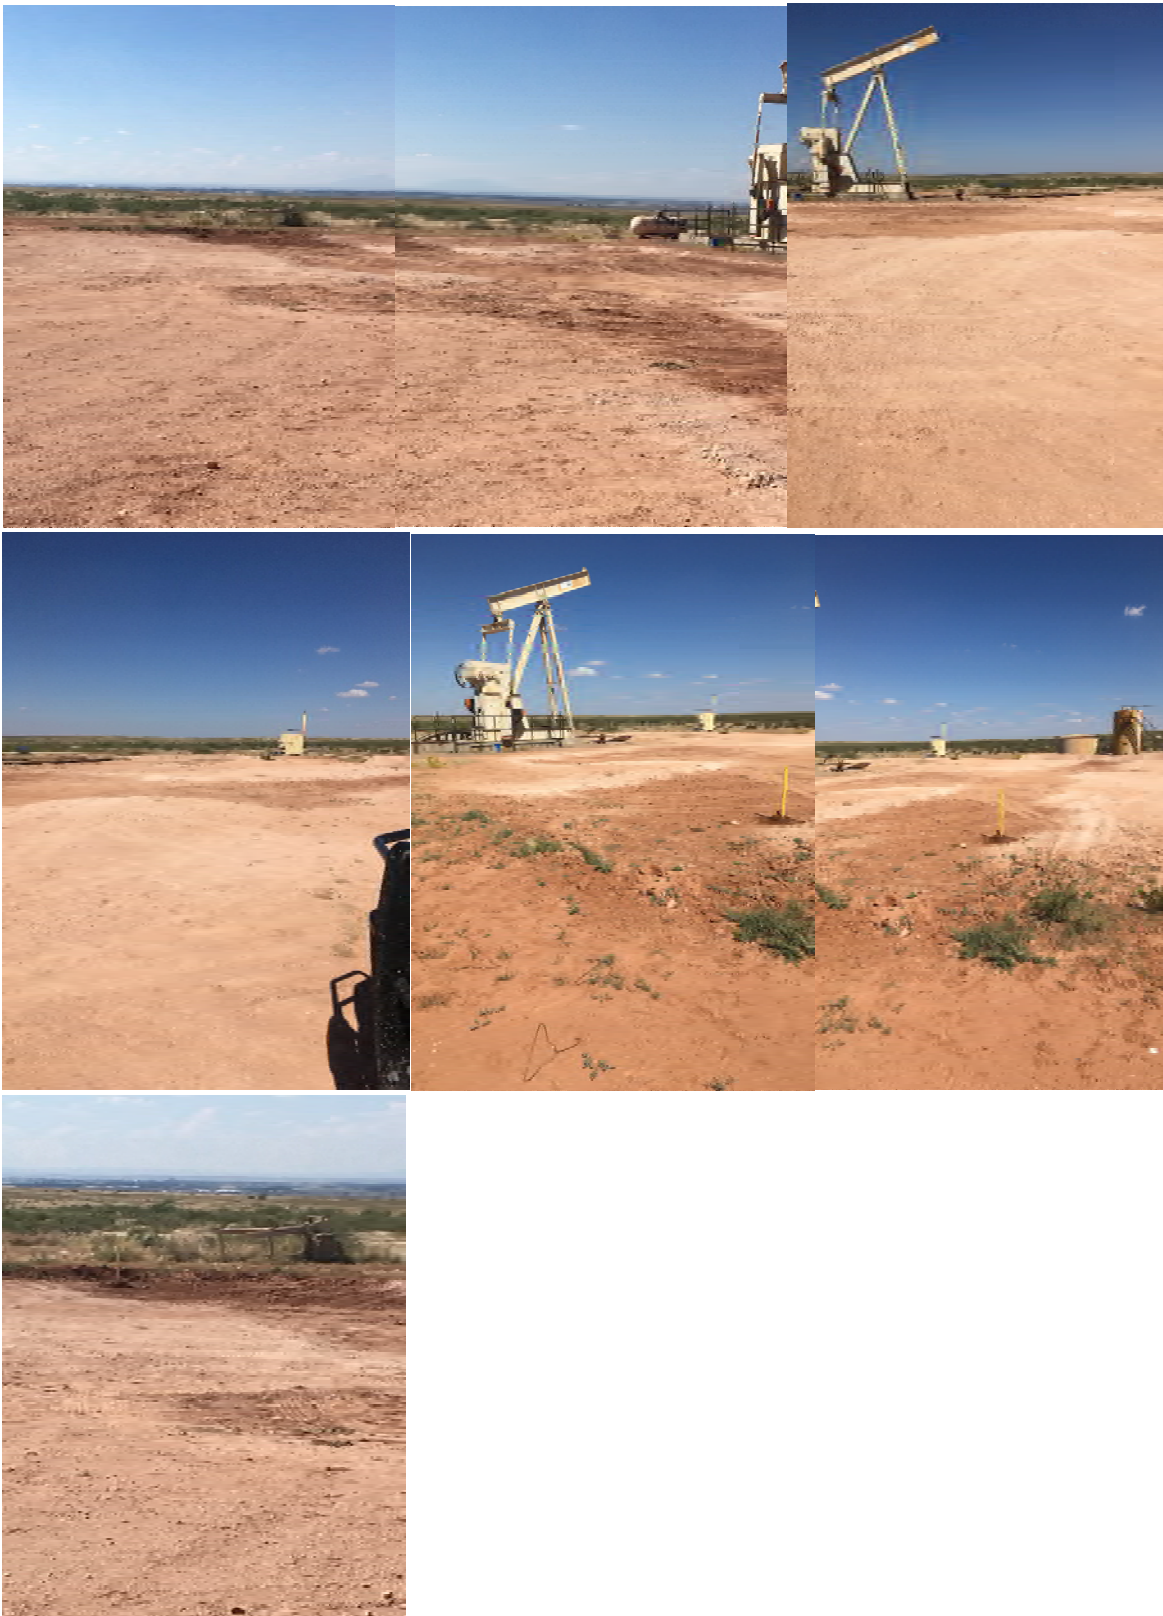
Post-Excavation

On September 10th, 2022, Pima mobilized personnel and equipment to conduct remedial activities. We scraped the area overlapping soil samples (CS1) and (CSW1-CSW4) to a depth of one (1) foot bgs. Photographic documentation can be found in Appendix D.
