September 30, 2022

Vertex Project #: 22E-00716-09

Spill Closure Report: Routh NU #1 Pipeline (Section 14, Township 19 South, Range 24 East)
County: Eddy
Incident Report: nAPP2223138504

2022 Impact Assessment and Closure
September 2022

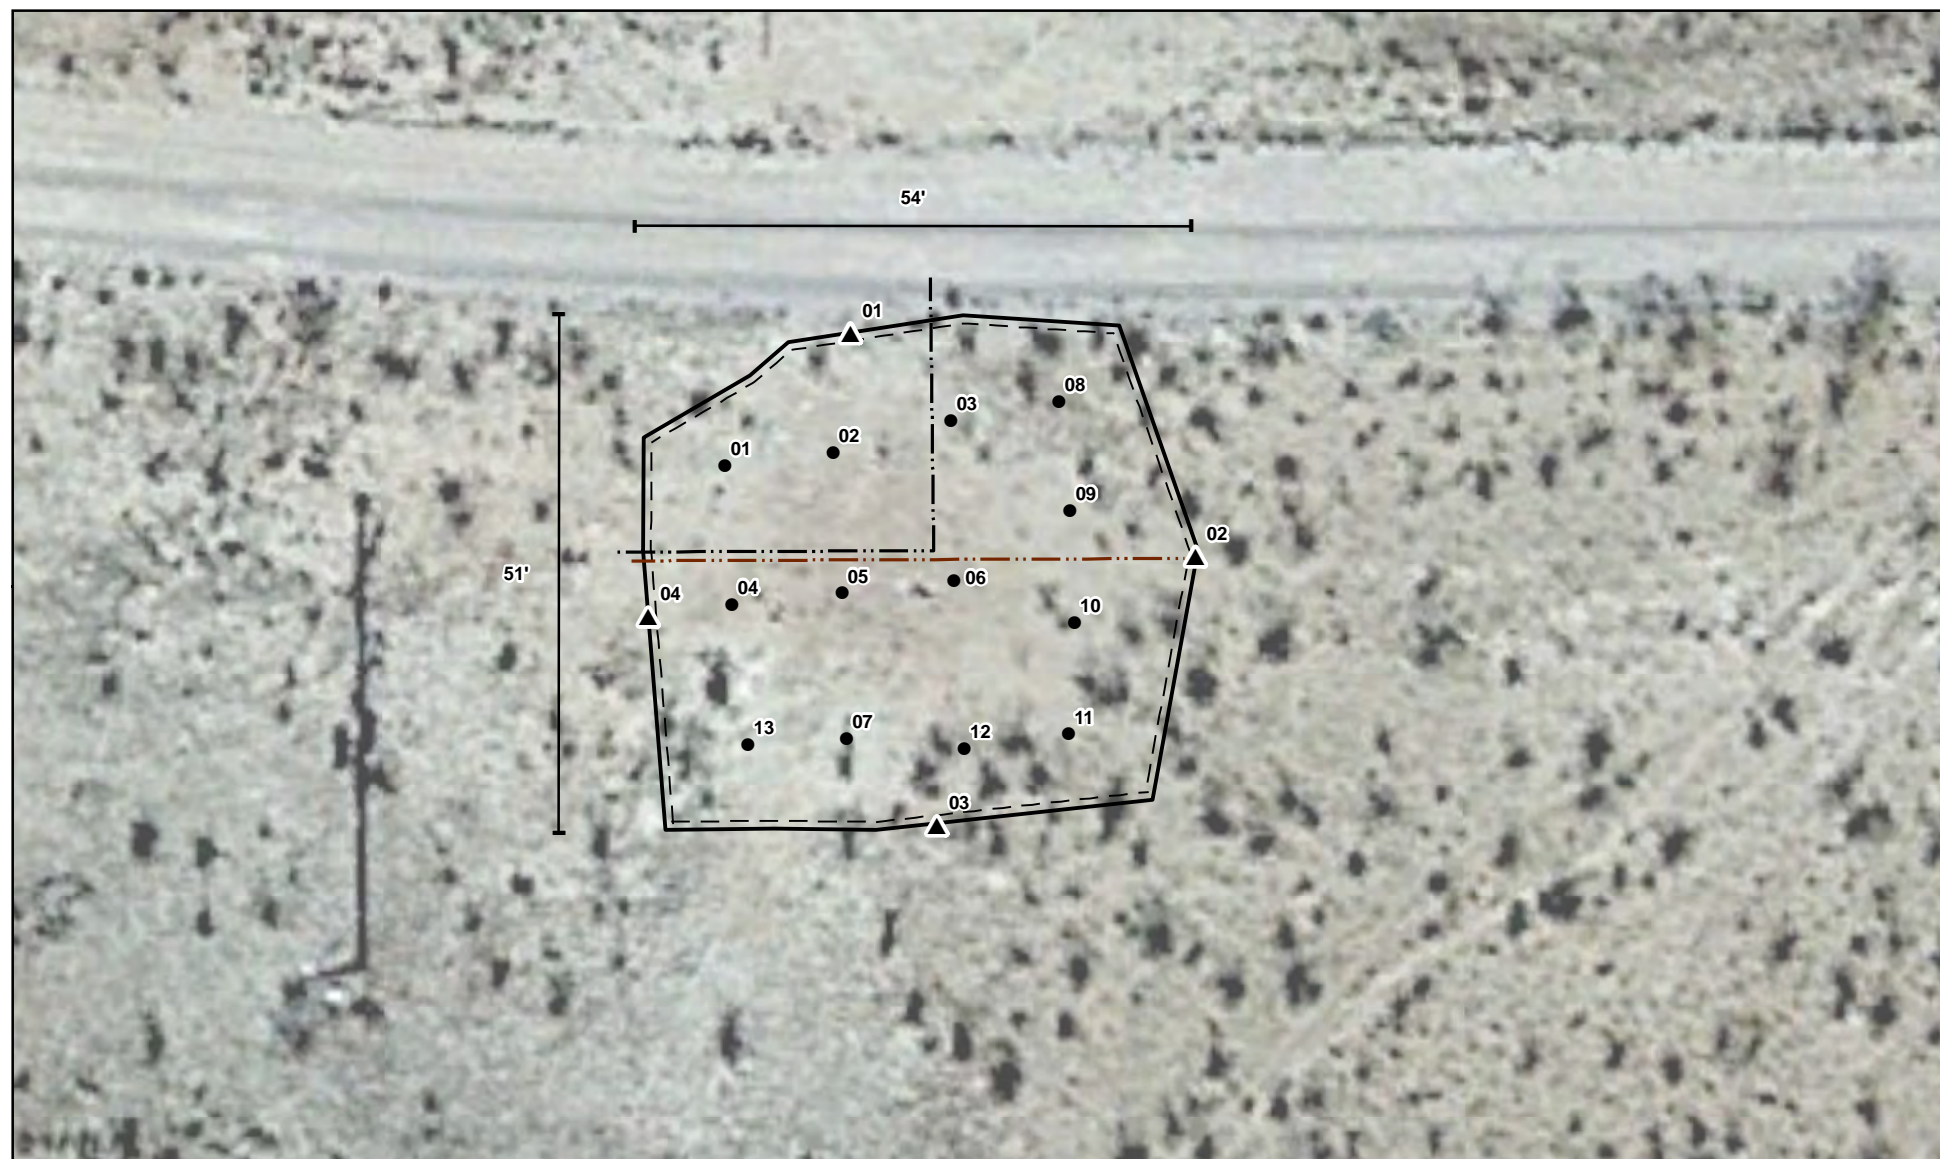
● Base Sample (Prefixed by "BES22-")
 ▲ Wall Sample (Prefixed by "WES22-")
 - - - 3" Pipeline
 - - - 10" Pipeline
 [Excavation Area Icon] 4' Excavation Area (~2,353 sq. ft.)

Remediation efforts began on August 25, 2022, and were completed on September 19, 2022. Vertex personnel supervised the excavation of impacted soils. Field screening was completed on a total of 17 sample points and consisted of analysis using a Photo Ionization Detector (volatile hydrocarbons), Dextsil Petroflag using EPA SW-846 Method 9074 (extractable hydrocarbons) and Titration (chlorides). Field screening results were used to identify areas requiring further remediation from those areas showing concentrations below determined closure criteria levels. Soils were removed to a depth of 4 feet bgs. Impacted soil was transported by a licensed waste hauler and disposed of at an approved waste management facility. Field screening results are presented Table 3, Attachment 2.

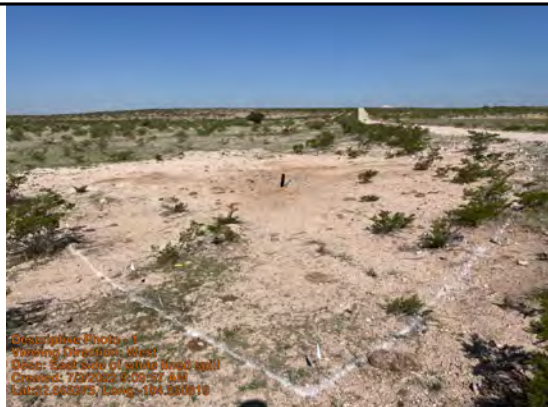
East side of white lined impacted area

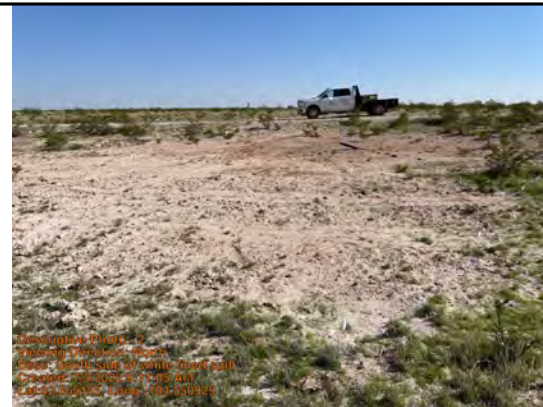
South side of white lined impacted area

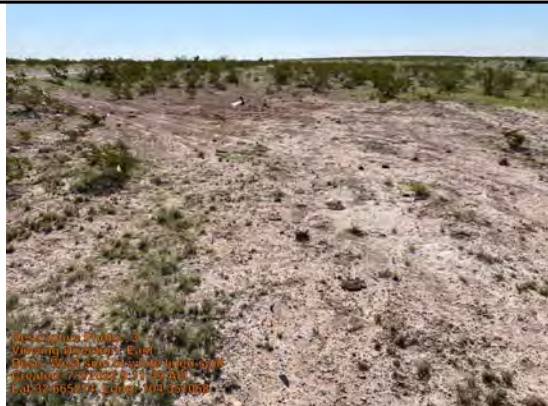
West side of white lined impacted area

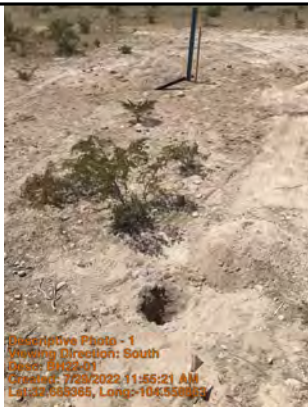
Descriptive Photo - 1
Viewing Direction: South
Desc: BH22-01
Created: 7/29/2022 11:55:21 AM
Lat:32.685285, Long:-104.550915

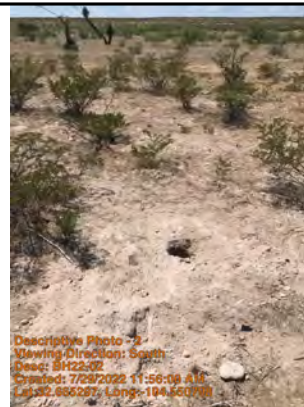
Descriptive Photo - 2
Viewing Direction: South
Desc: BH22-02
Created: 7/29/2022 11:56:09 AM
Lat:32.685287, Long:-104.550916

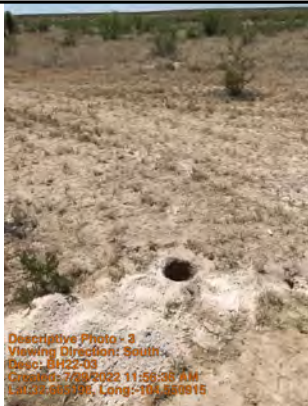
Descriptive Photo - 3
Viewing Direction: South
Desc: BH22-03
Created: 7/29/2022 11:56:38 AM
Lat:32.685285, Long:-104.550915

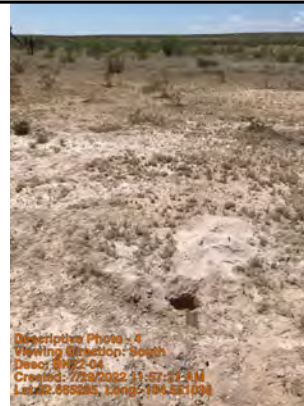
Descriptive Photo - 4
Viewing Direction: South
Desc: BH22-04
Created: 7/29/2022 11:57:11 AM
Lat:32.685285, Long:-104.551004

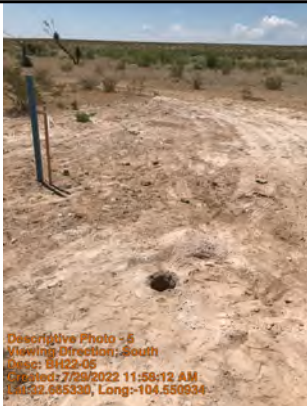
<p>Descriptive Photo - 5 Viewing Direction: South Desc: BH22-05 Created: 7/29/2022 11:58:12 AM Lat: 32.665330, Long: -104.580934</p>

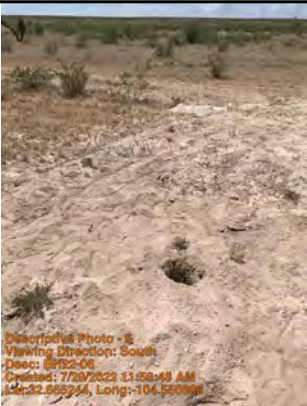
<p>Descriptive Photo - 6 Viewing Direction: South Desc: BH22-06 Created: 7/29/2022 11:58:48 AM Lat: 32.665344, Long: -104.580934</p>
BH22-05	BH22-06

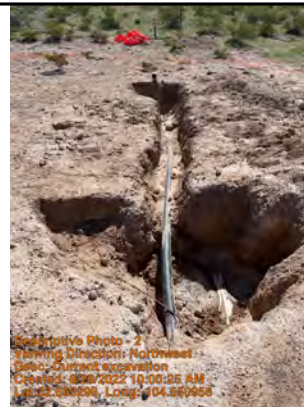
Current excavation

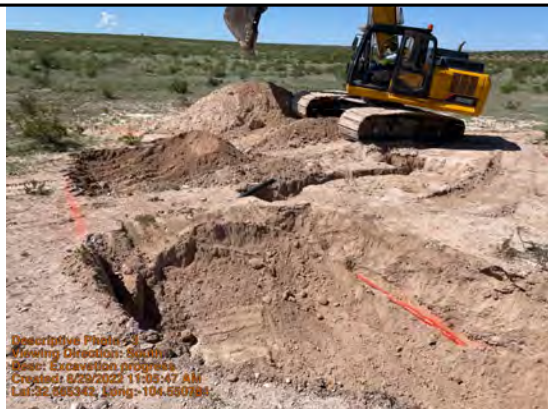
Excavation progress

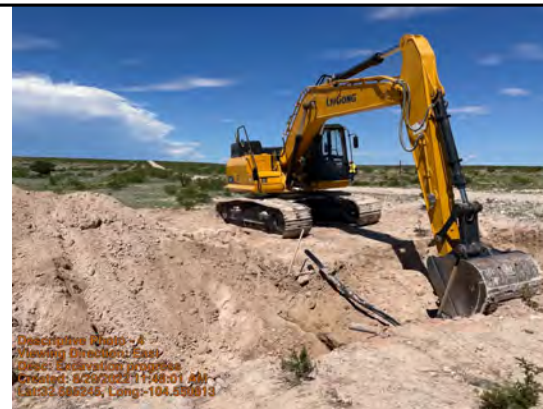
Excavation progress

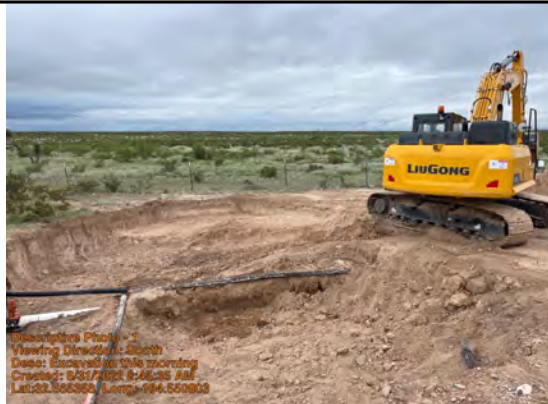
Excavation this morning

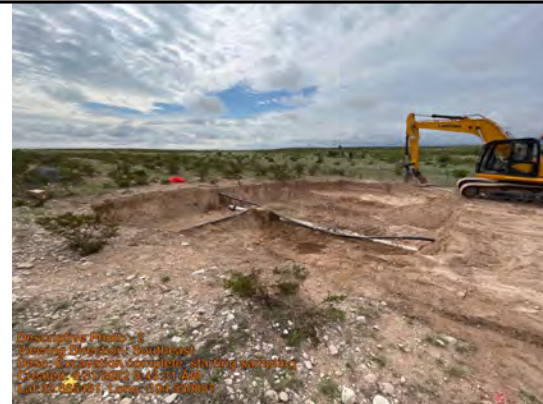
Excavation complete, starting sampling

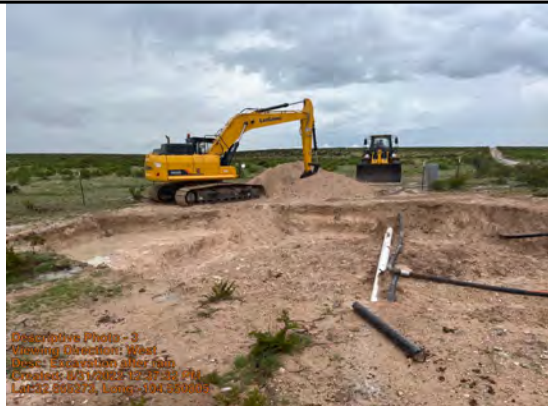
Excavation after rain

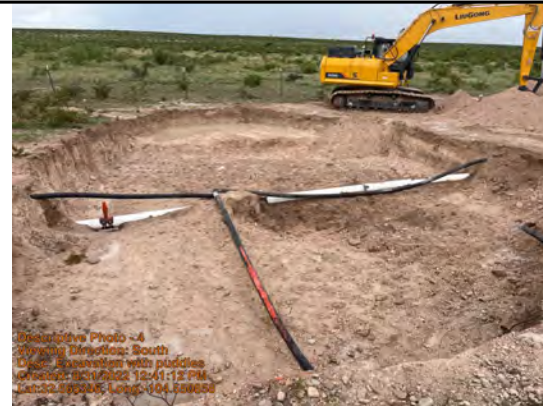
Excavation with puddles

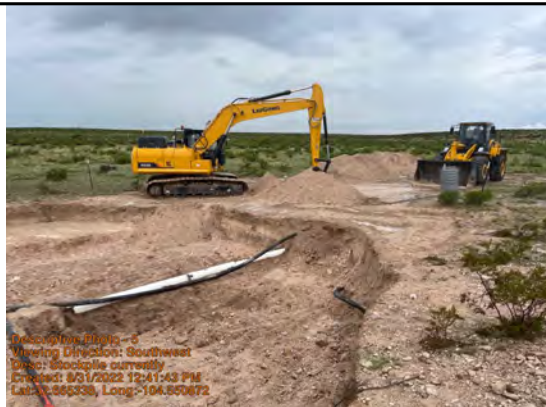
Stockpile currently

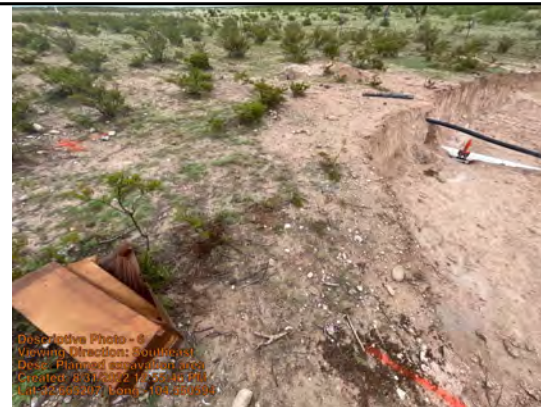
Planned excavation area

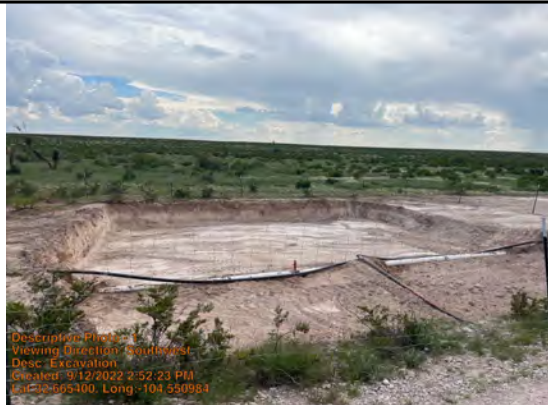
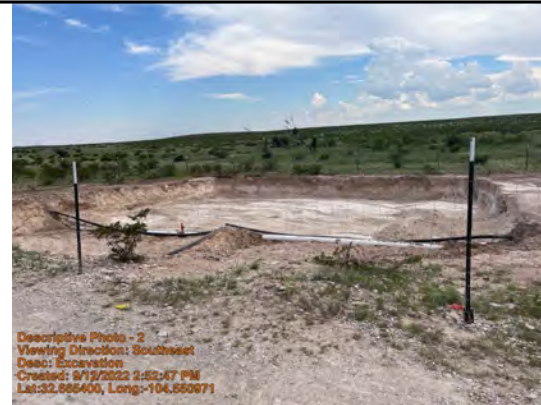
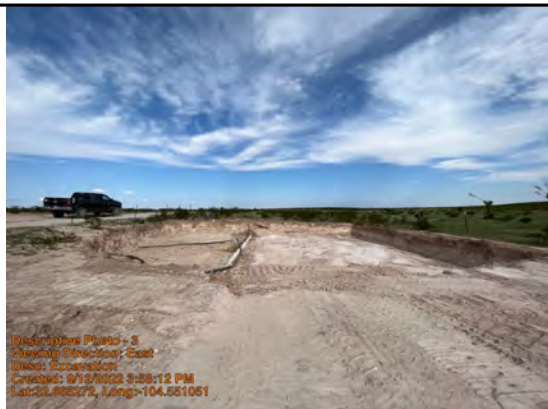
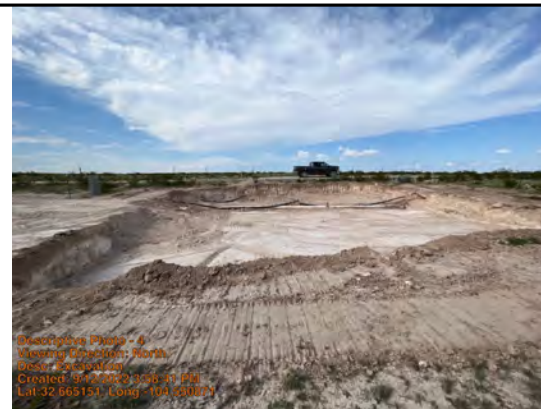
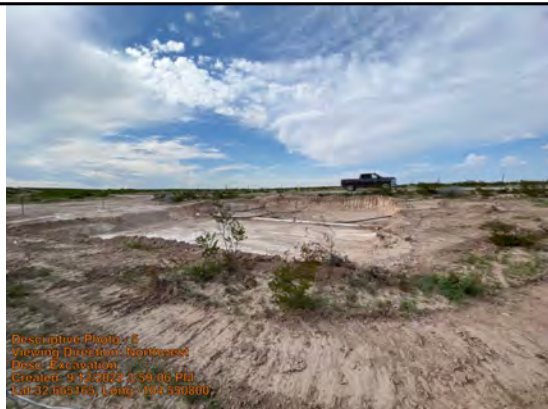
Excavation

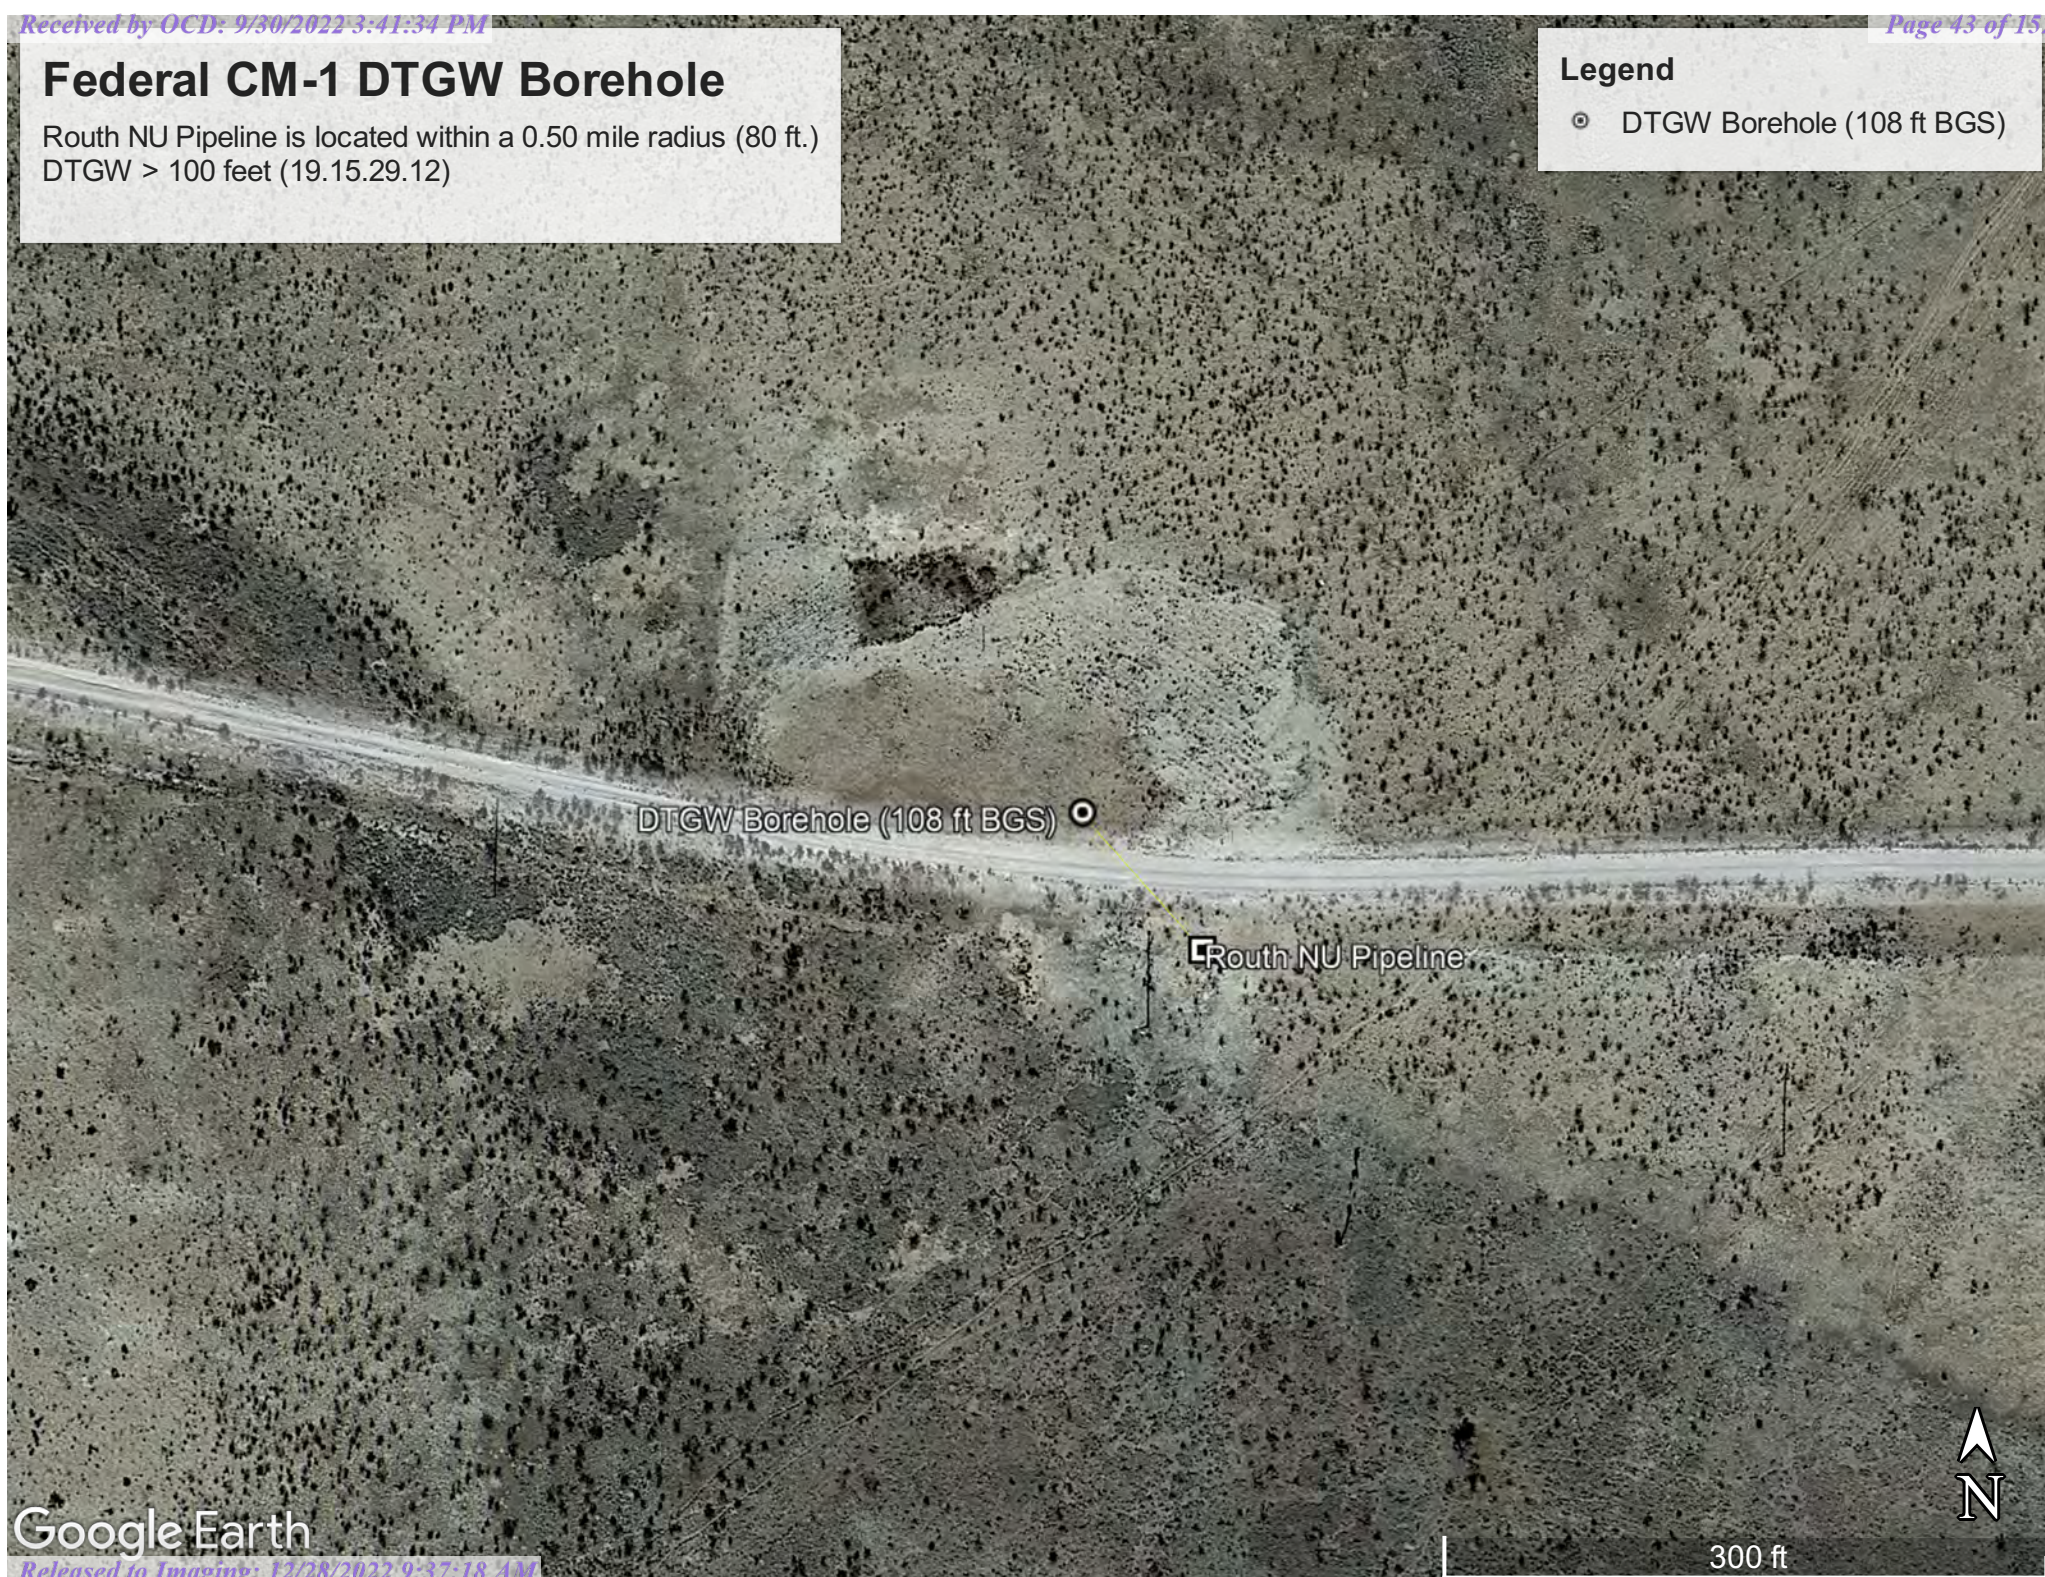
- DTGW Borehole (108 ft BGS)

The depth to groundwater was determined by drilling a borehole permitted by the New Mexico Office of the State Engineer (NMOSE) within a 0.5-mile radius of the site. The borehole was drilled to a depth of 108 feet, was left open as per requirements on the WR-07 Application for Permit to Drill a Well With No Water Right and an interface probe lowered into the bottom of the borehole to investigate if groundwater may have accumulated during the 72 hour waiting period. No water was found present at that time. The borehole was then plugged as per requirements on the WR-08, Well Plugging Plan of Operations. Documentation used in Closure Criteria Determination research is included in Attachment 5.
