**RE: Liner Inspection and Closure Report**  
**Fiji 17 CTB 1**  
**API No. N/A**  
**GPS: Latitude 32.307550 Longitude -103.796265**  
**UL- G, Section 17, Township 23S, Range 31E**  
**NMOCD Reference No NAPP2219927062**

Devon Energy Production Company (Devon) has contracted Pima Environmental Services, LLC (Pima) to perform a liner inspection and prepare this closure report for a produced water release that happened at the Fiji 17 CTB 1 (Fiji). An initial C-141 was submitted on July 28, 2022, and can be found in Appendix B. This incident was assigned Incident ID NAPP2219927062, by the New Mexico Oil Conservation Division (NMOCD).

**Liner Inspection Form**

Site: Fiji 17 CTB 1

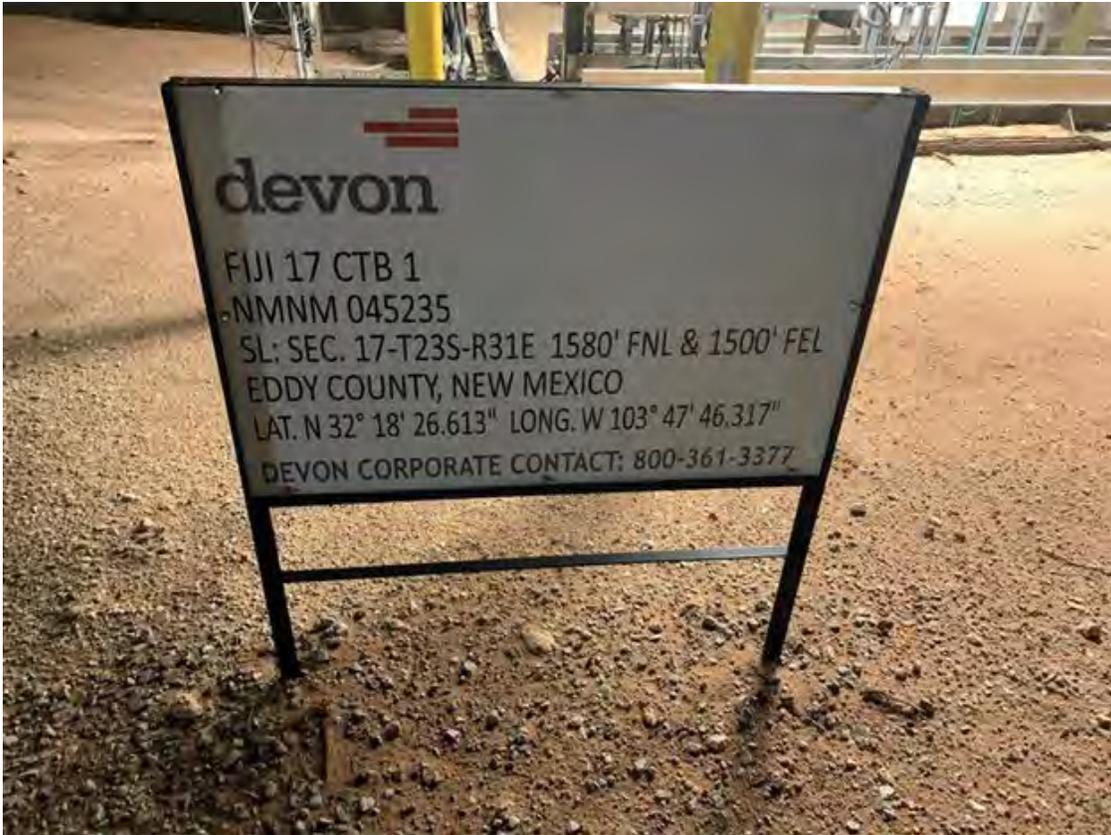
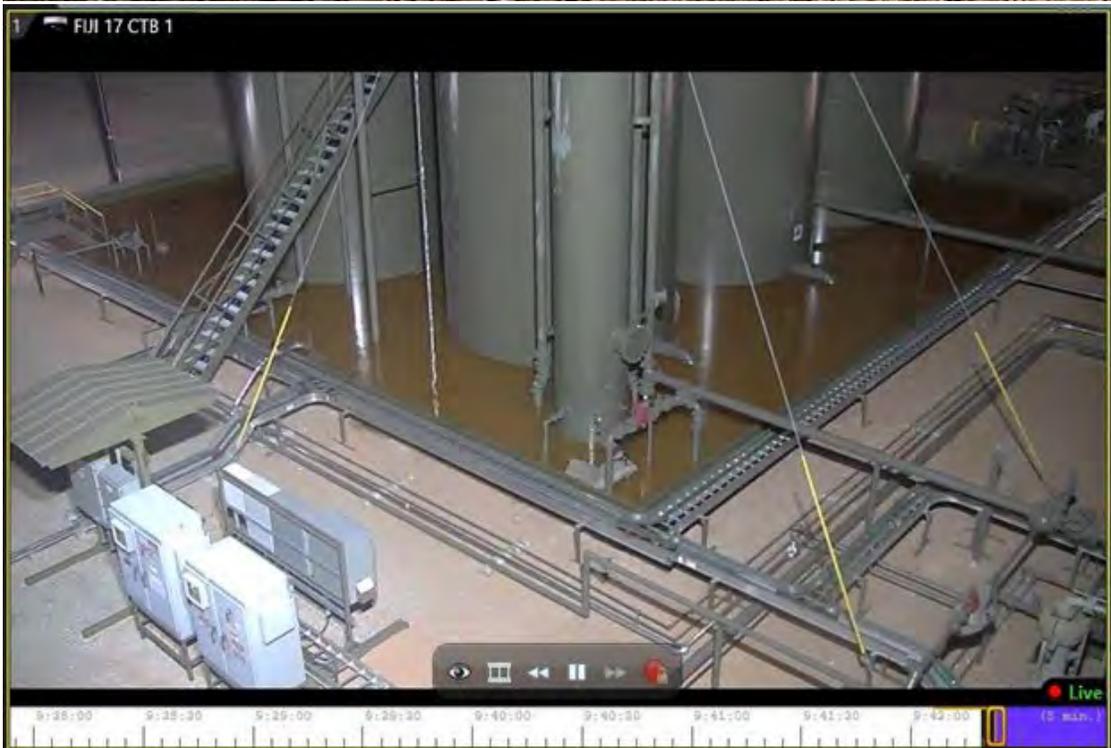
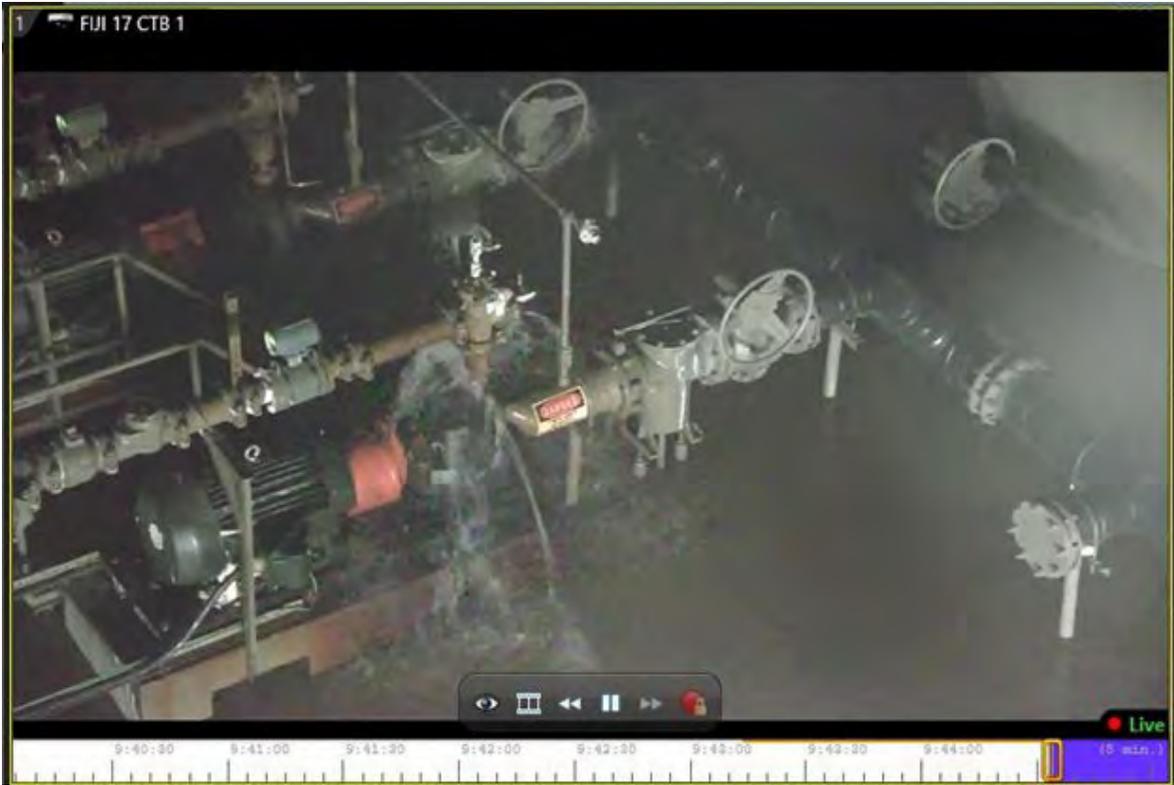
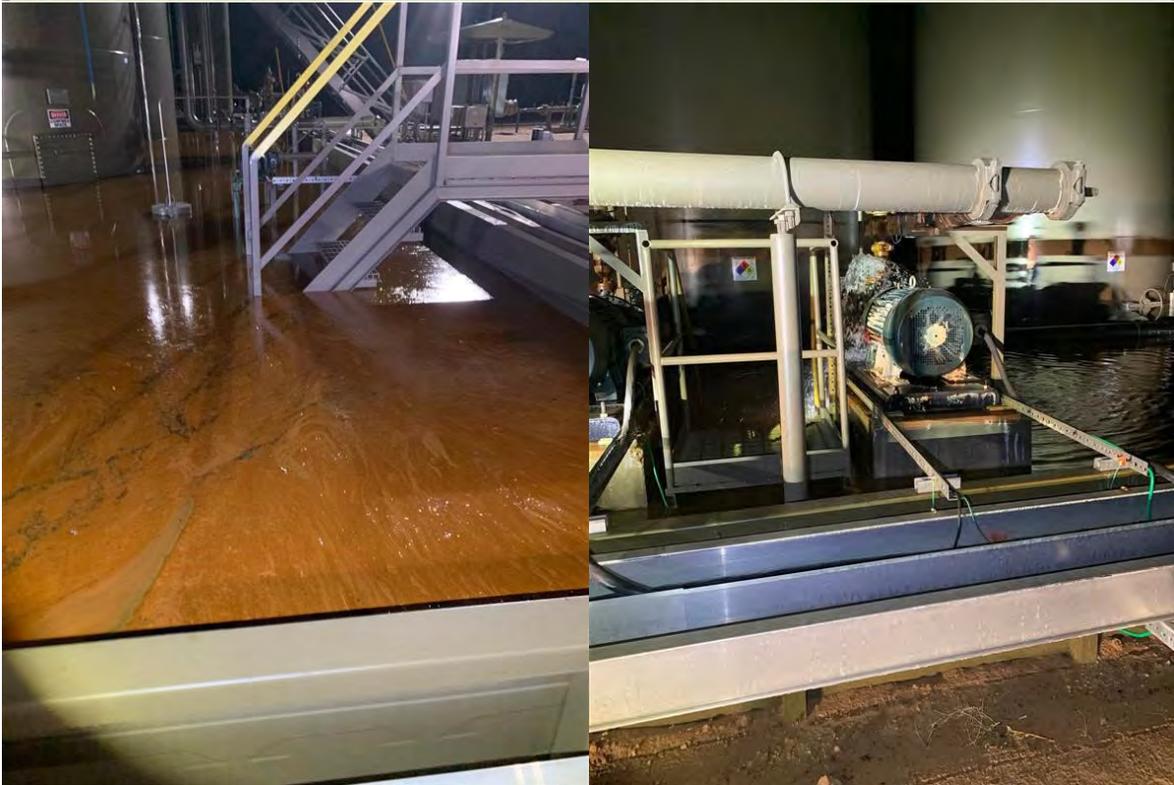
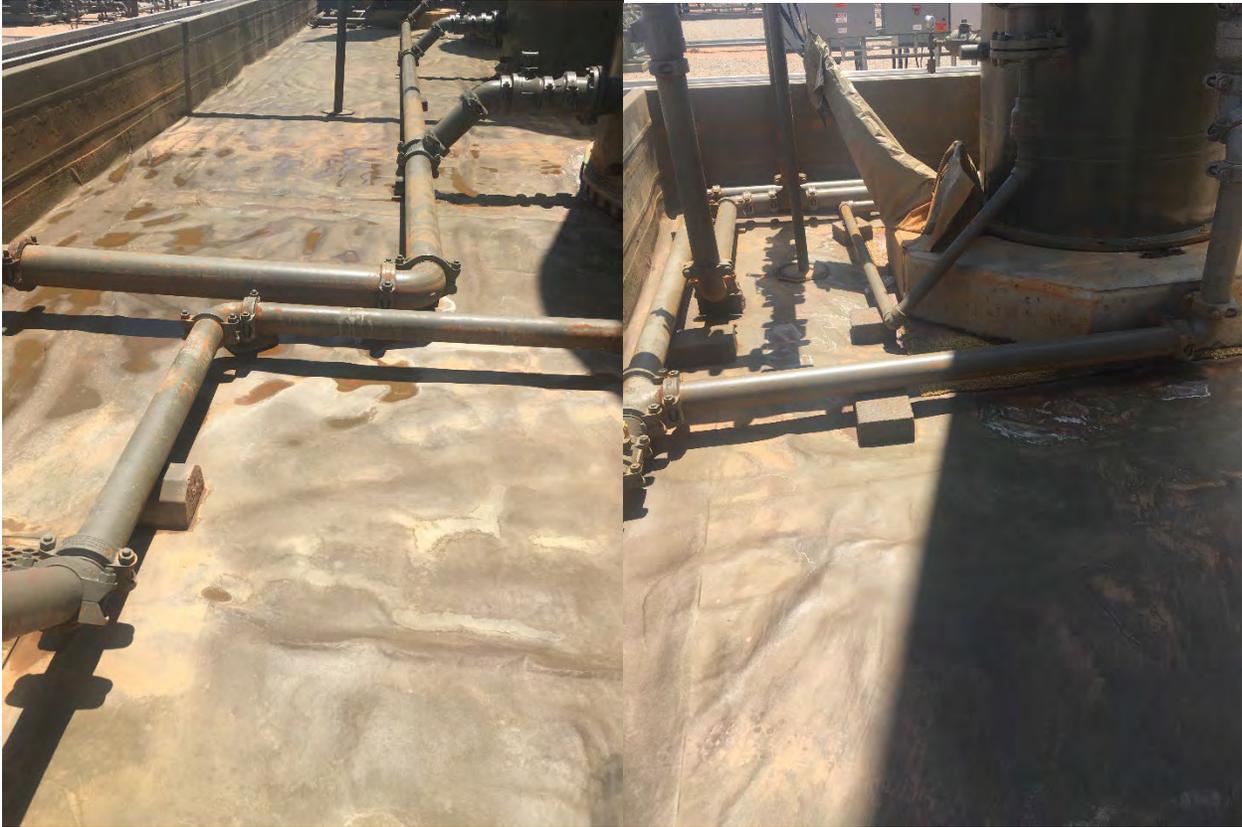
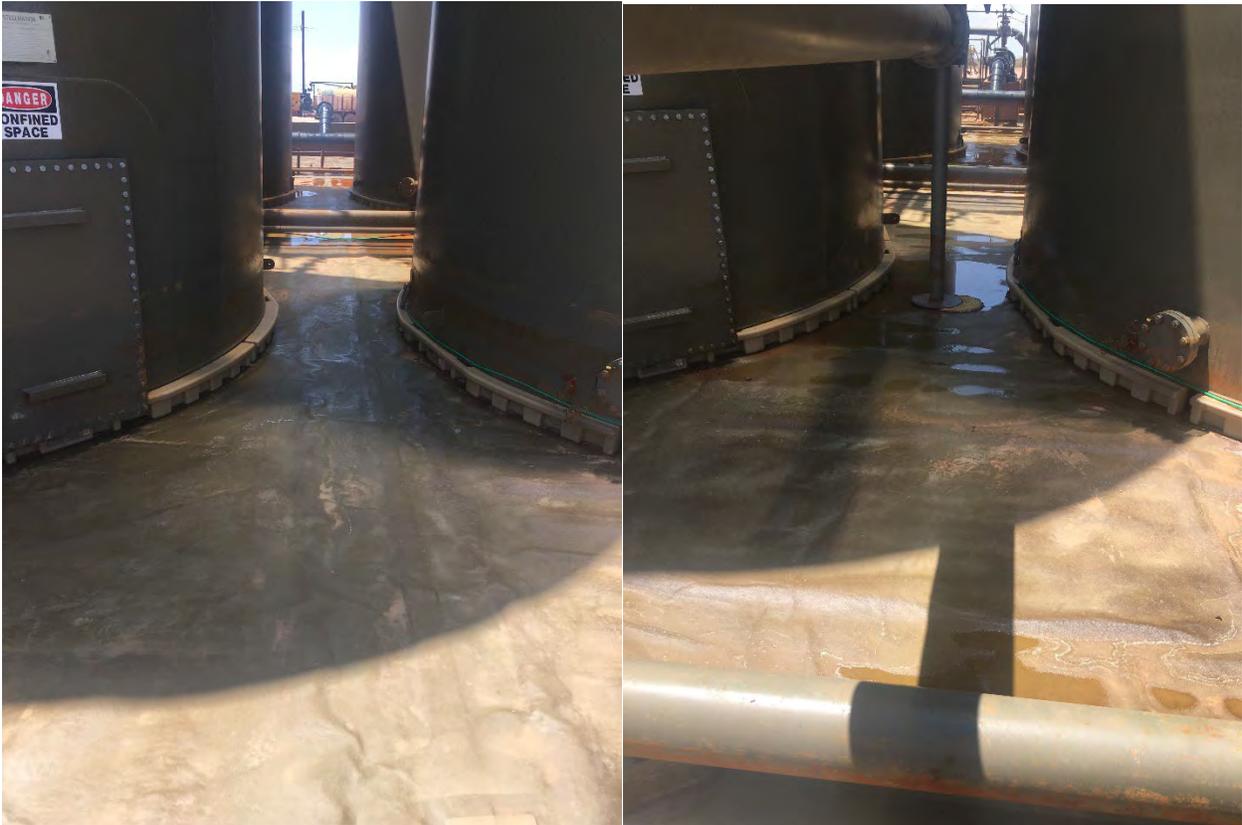
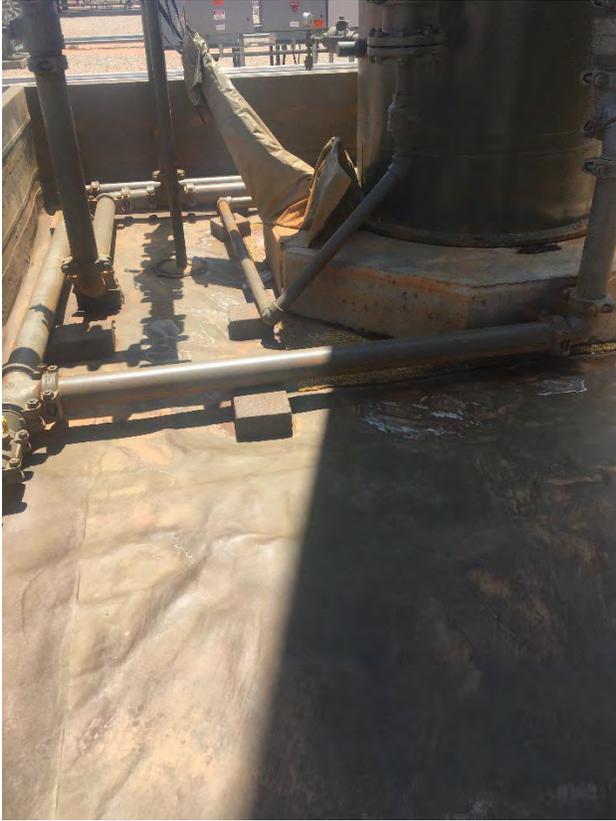
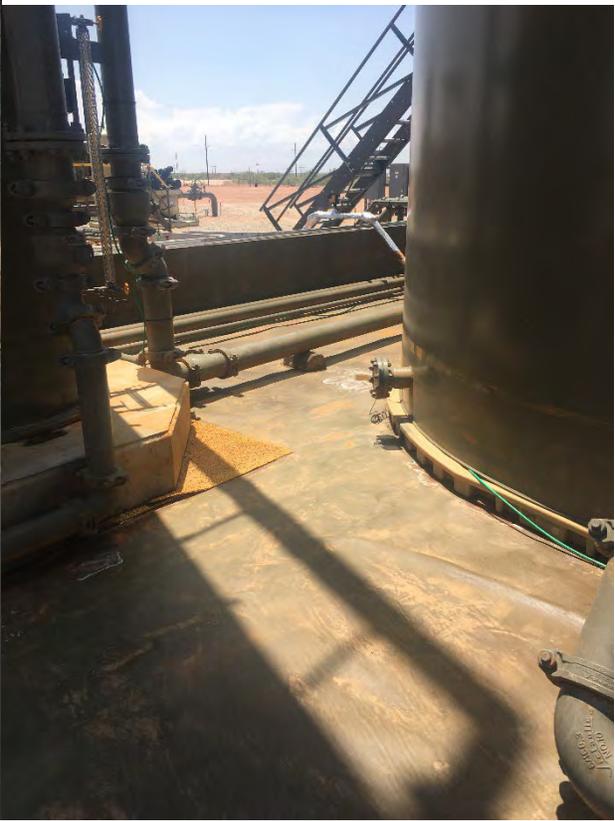
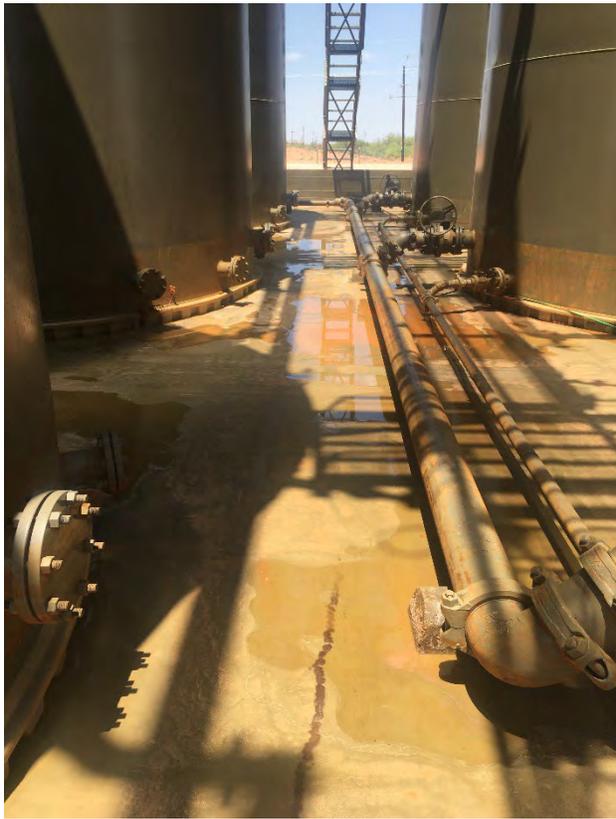
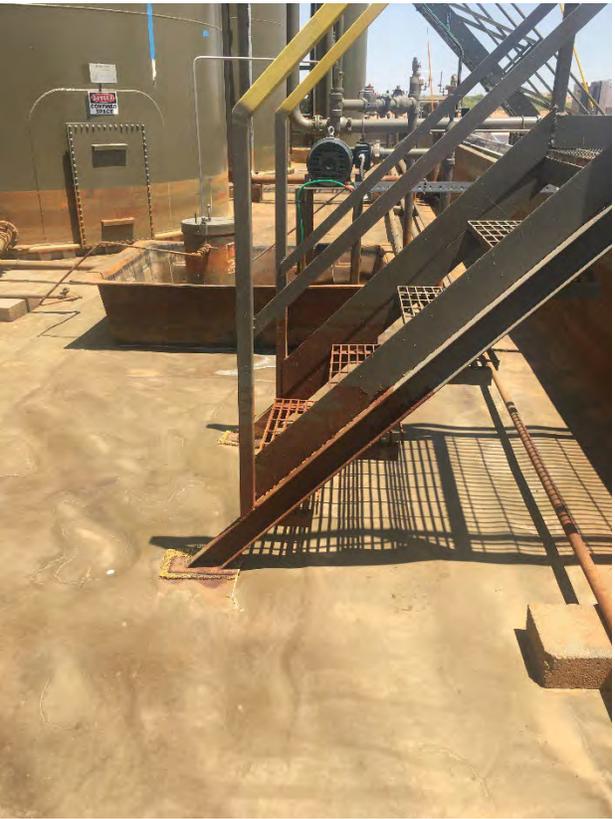
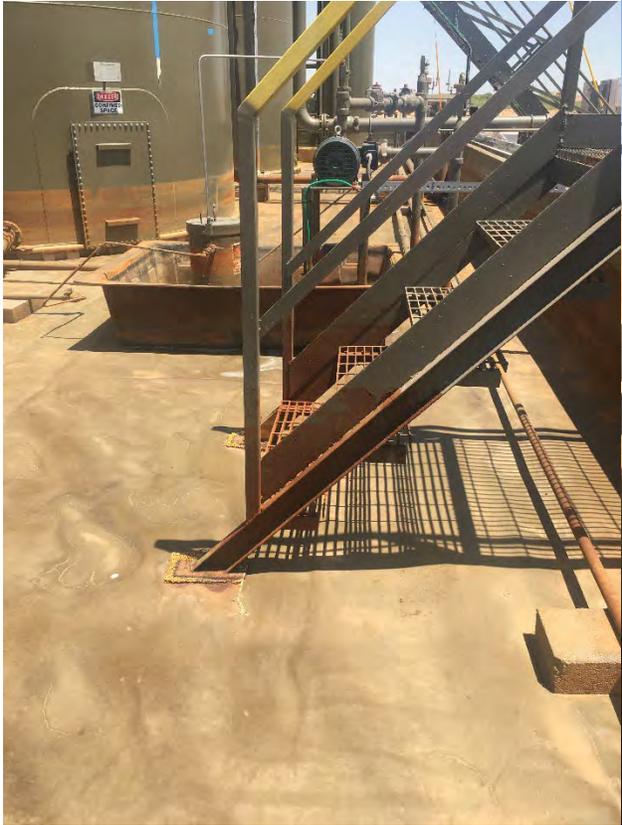
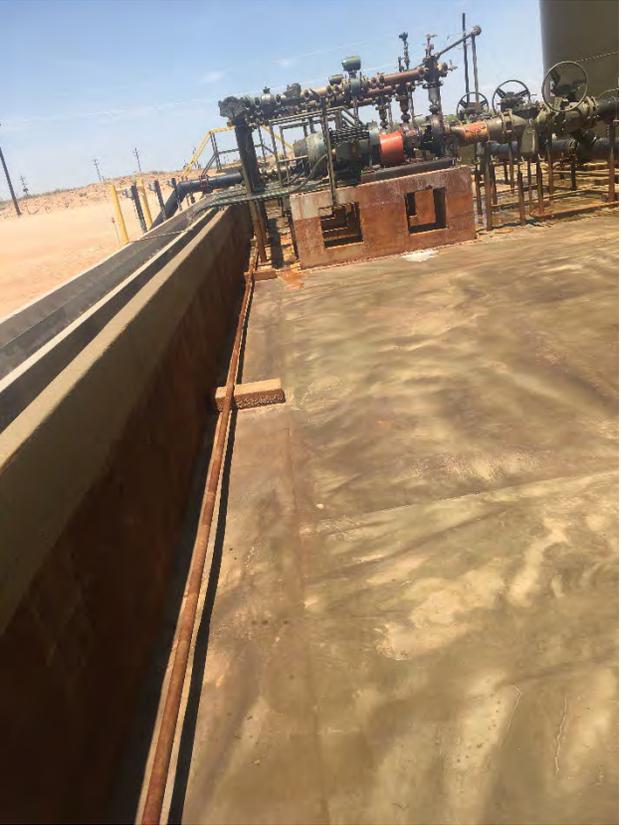
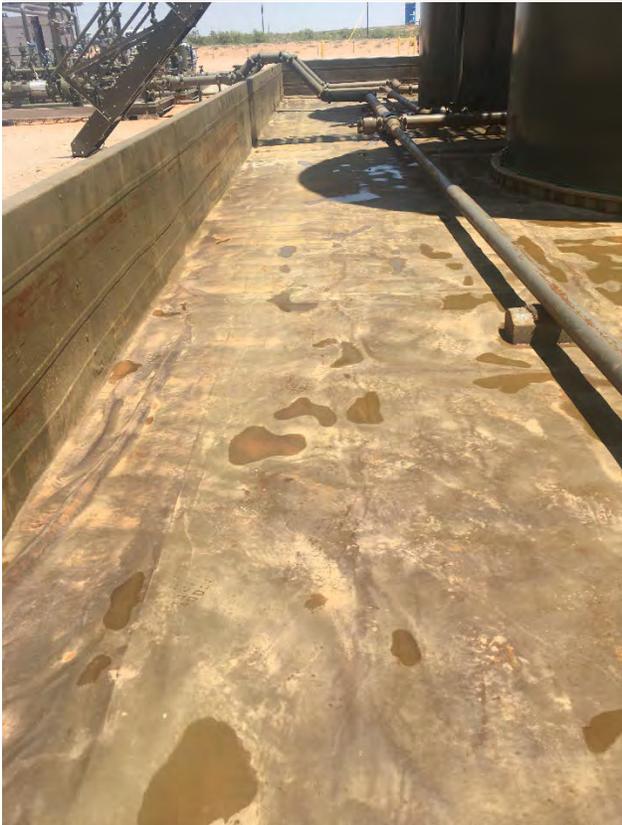
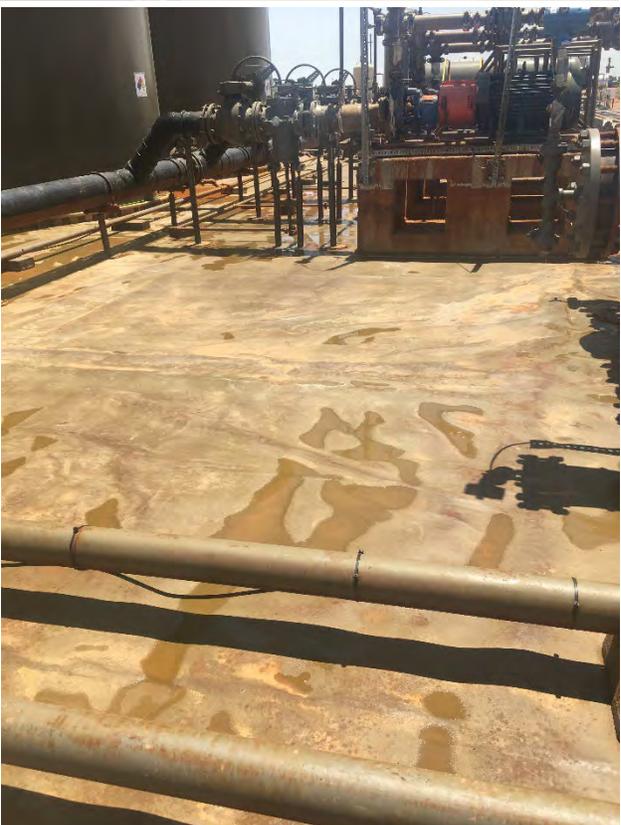
Photographic Documentation

On August 7, 2022, after sending the 48-hour notification via email, Pima Environmental conducted a liner inspection at this location. We concluded that this liner and containment maintained its integrity and was able to retain the fluids. The liner inspection form and photographic documentation can be found in Appendix C.

Visualization	Yes	No	Comments
Is there a tear in the liner?		X	
Are there holes in the liner?		X	
Is the liner retaining any fluids?	X		Water & soap from pressure washer cleaning crew
Does the liner have integrity to contain a leak?	X
