Closure Report

State CO SWD System

2RP-2479

nAB1425342247

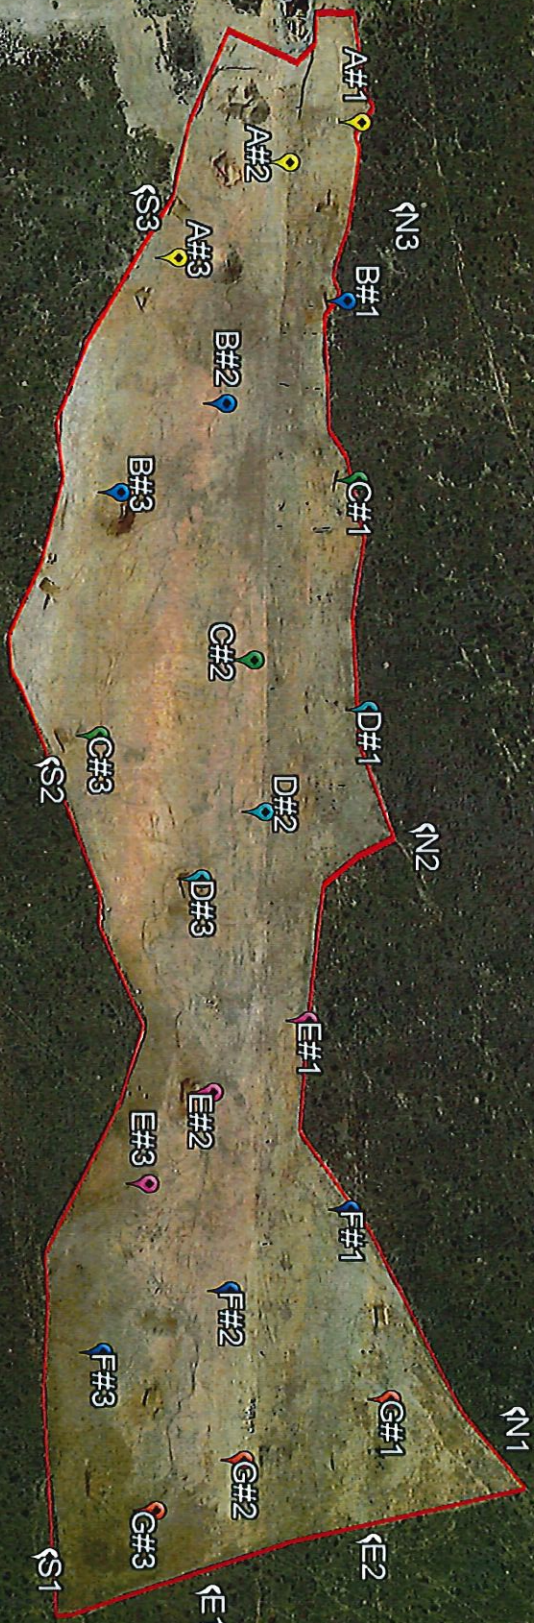
Figure 1

Scaled Site Map and Sampling Diagram

State CO SWD System

(Foster FF)

Final delineation sampling was conducted on 12/23/2015 (see Figure 1). When all work was completed, a C-141 Final Report, was submitted to the NMOCD for closure of the site. The area was reseeded per the surface owners preferred seed mixture.

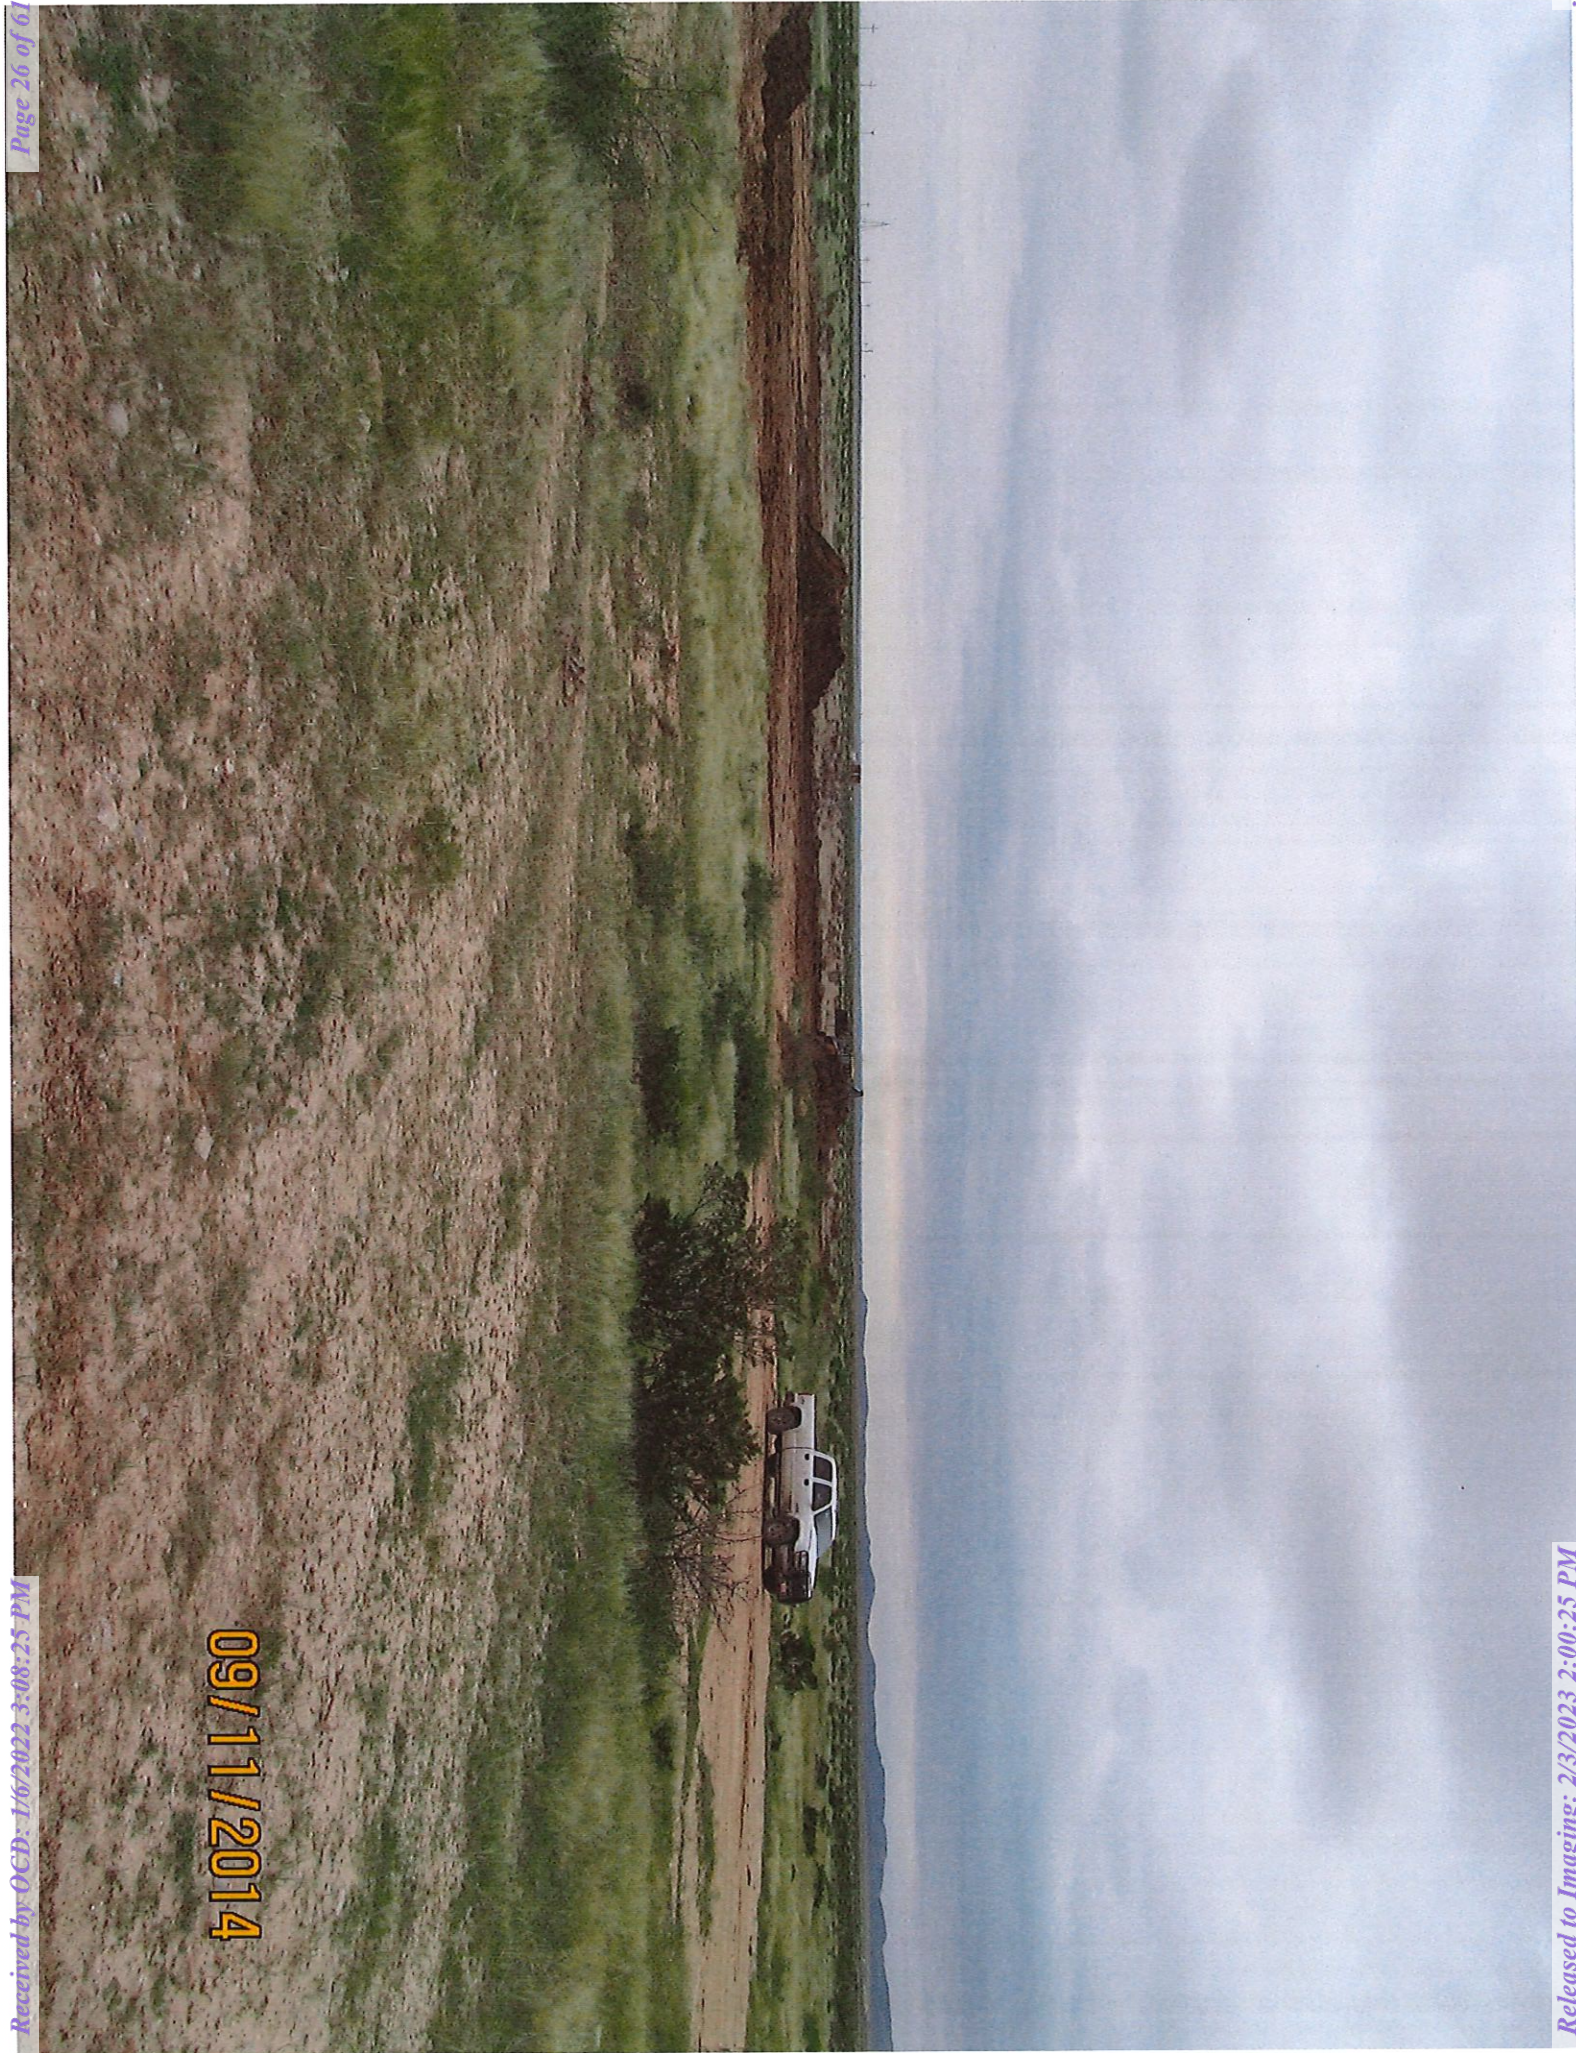
FOSTER "FF" BATTERY

NWSW

Sec.1 - T20S - R24E

09/11/2014

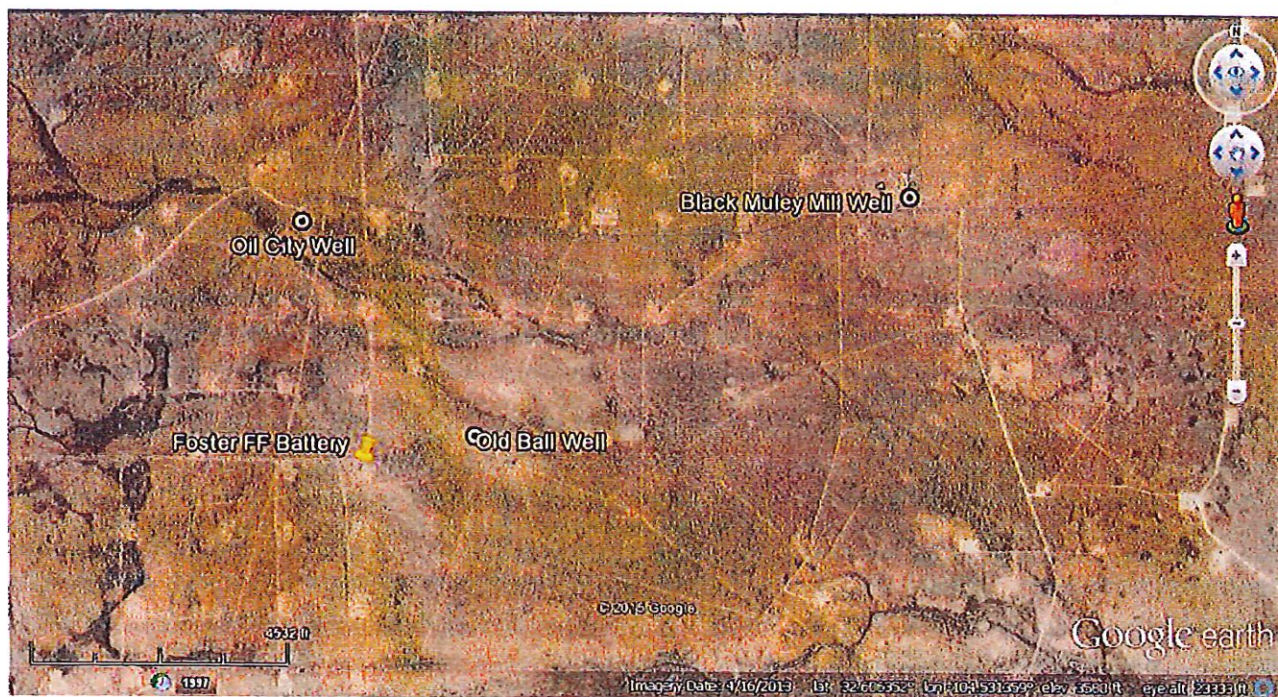
Water Well Locations, Vicinity of Foster FF Battery, Eddy County, New Mexico

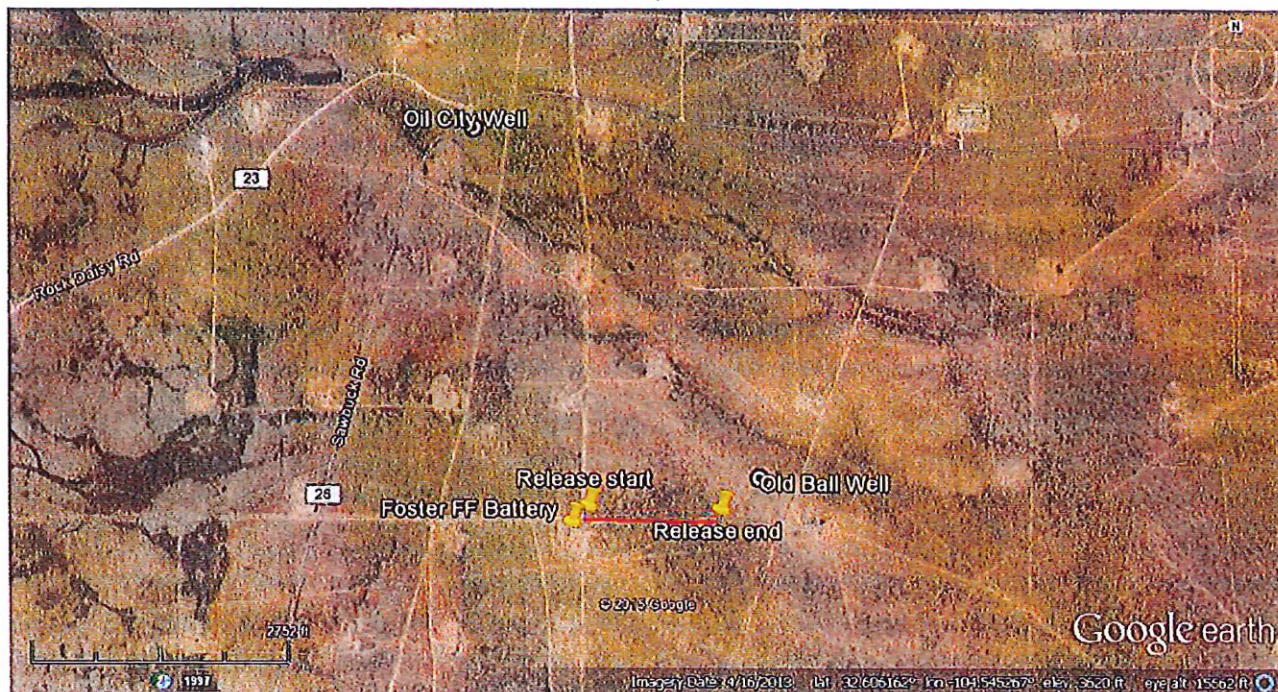
Water Wells in Proximity to Foster FF Battery Release Location

We then traveled to the release point and GPS measurements were taken at that location and eastward to the farthest distance from the release point, a distance of about 1,450 feet.

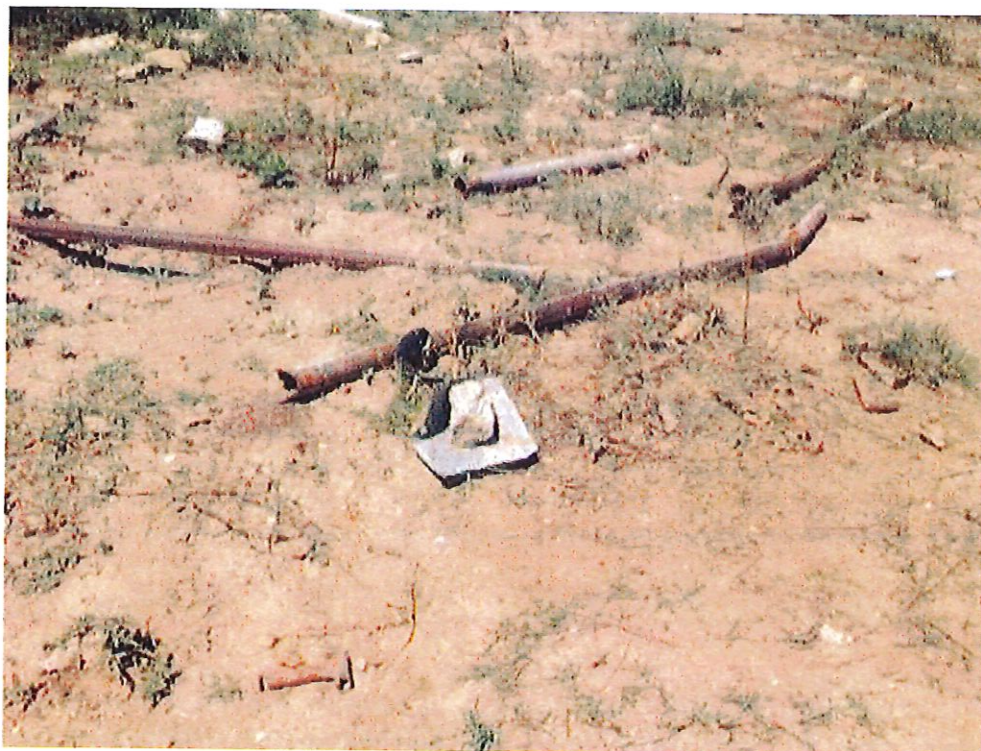
"Oil City" Water Well July 13, 2015

Well location under sheet metal piece

I met Mr. Robert Asher of Yates and we arrived at the location of the Oil City well about 11:00 a.m. State Engineer information had the depth of the well at 300 feet but no other information was available from their online data base. Upon arrival we noted the well casing was at ground level with a rock over a piece of sheet metal. There was no protection from runoff in the event of a heavy rainfall. We inserted a water level probe and found water at 54.61 feet below ground surface. We measured the depth of the well and found it plugged at 56.2 feet. The bottom was relatively solid and no mud was observed on the probe. The 1.6 feet of water in the well is most certainly surface drainage from recent very heavy rainfall in the area.

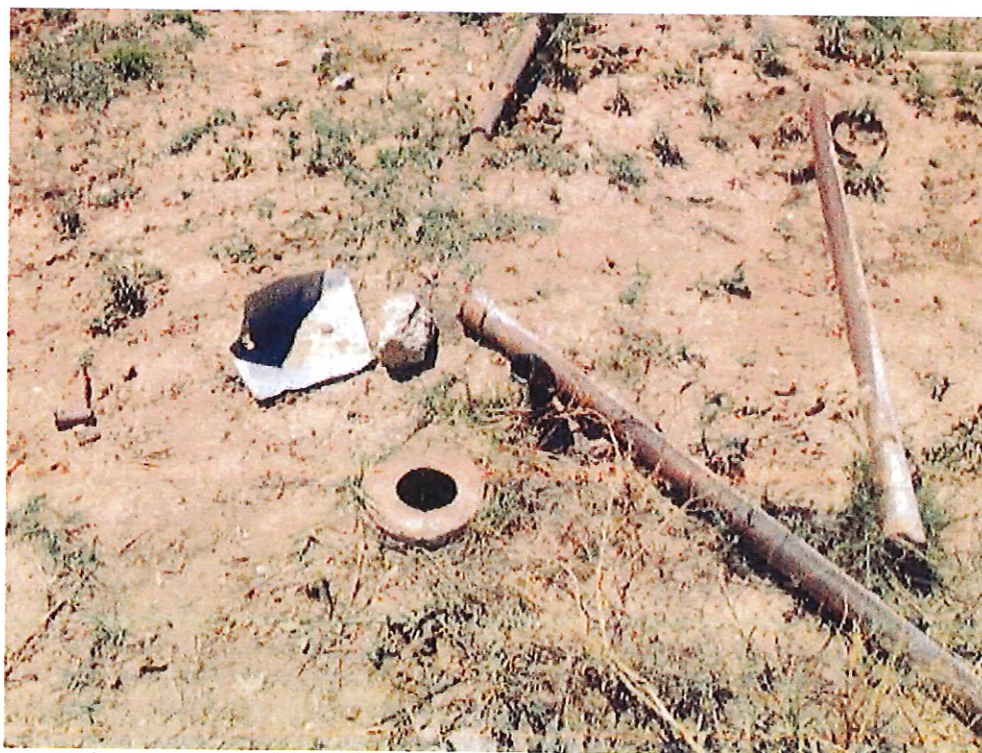
Top of open well at ground surface

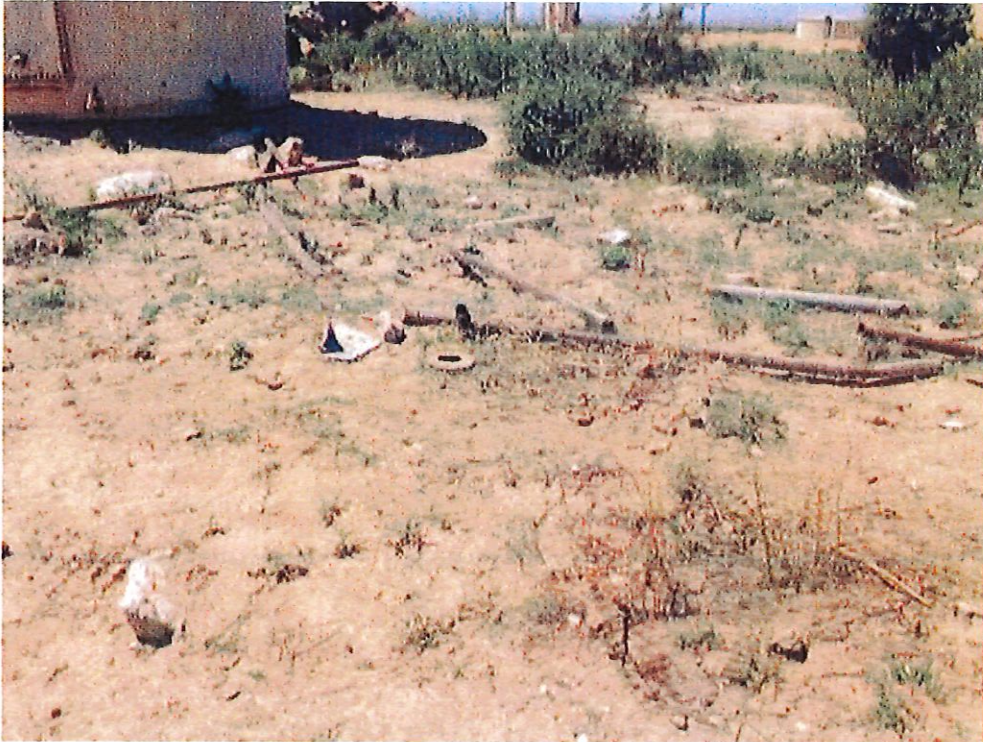
Open well. Water tank in left background receives water from another source
