SUBJECT: Remediation Closure Report for the Burton Flat Deep Unit 38 Release (2RP-3411), Eddy County, New Mexico

On behalf of Devon Energy Production Company (Devon), Souder, Miller & Associates (SMA) has prepared this Remediation Closure Report that describes the remediation of a release of liquids related to oil and gas production activities at the Burton Flat Deep Unit 38 site. The site is in Unit P, Section 02, Township 21S, Range 27E, Eddy County, New Mexico, on Federal land. Figure 1 illustrates the vicinity and site location on an USGS 7.5 minute quadrangle map.

Figure 1: Vicinity and Well Head Protection Map  
Figure 2: Surface Water Radius Map  
Figure 3: Site and Initial Sample Location Map  
Figure 3A: Site and Confirmation Sample Location Map

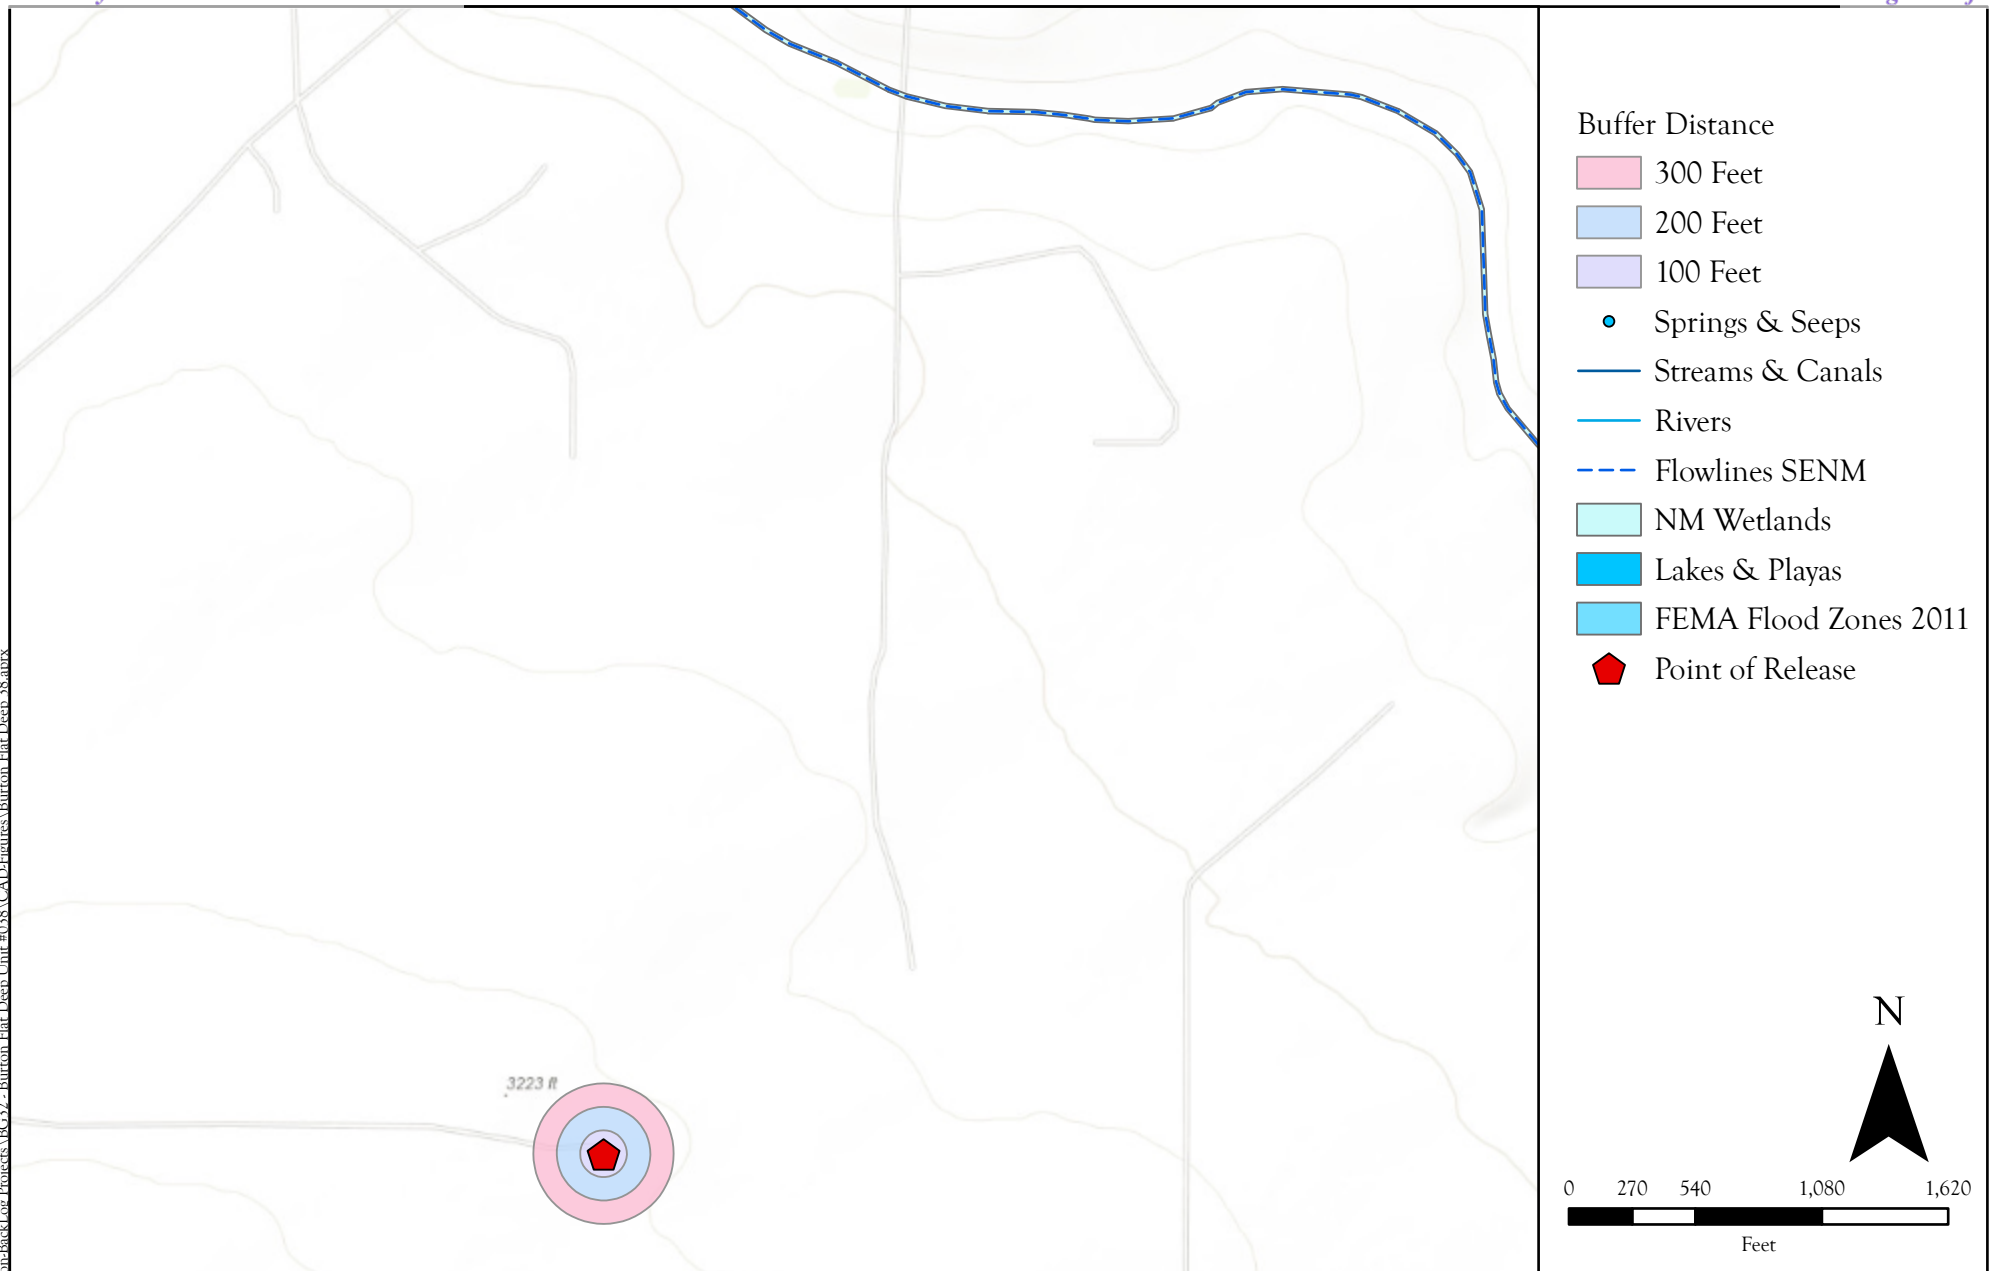
Table 2 demonstrates the Closure Criteria applicable to this location. Figure 2 illustrates the site with 200 and 300-foot radii to indicate that it does lie within a sensitive area as described in 19.15.29.12.C(4) NMAC.

Surface Water Protection Map  
 Burton Flats Deep Unit #38- Devon Energy  
 32.5030666, -104.1527476 Lea County, New Mexico

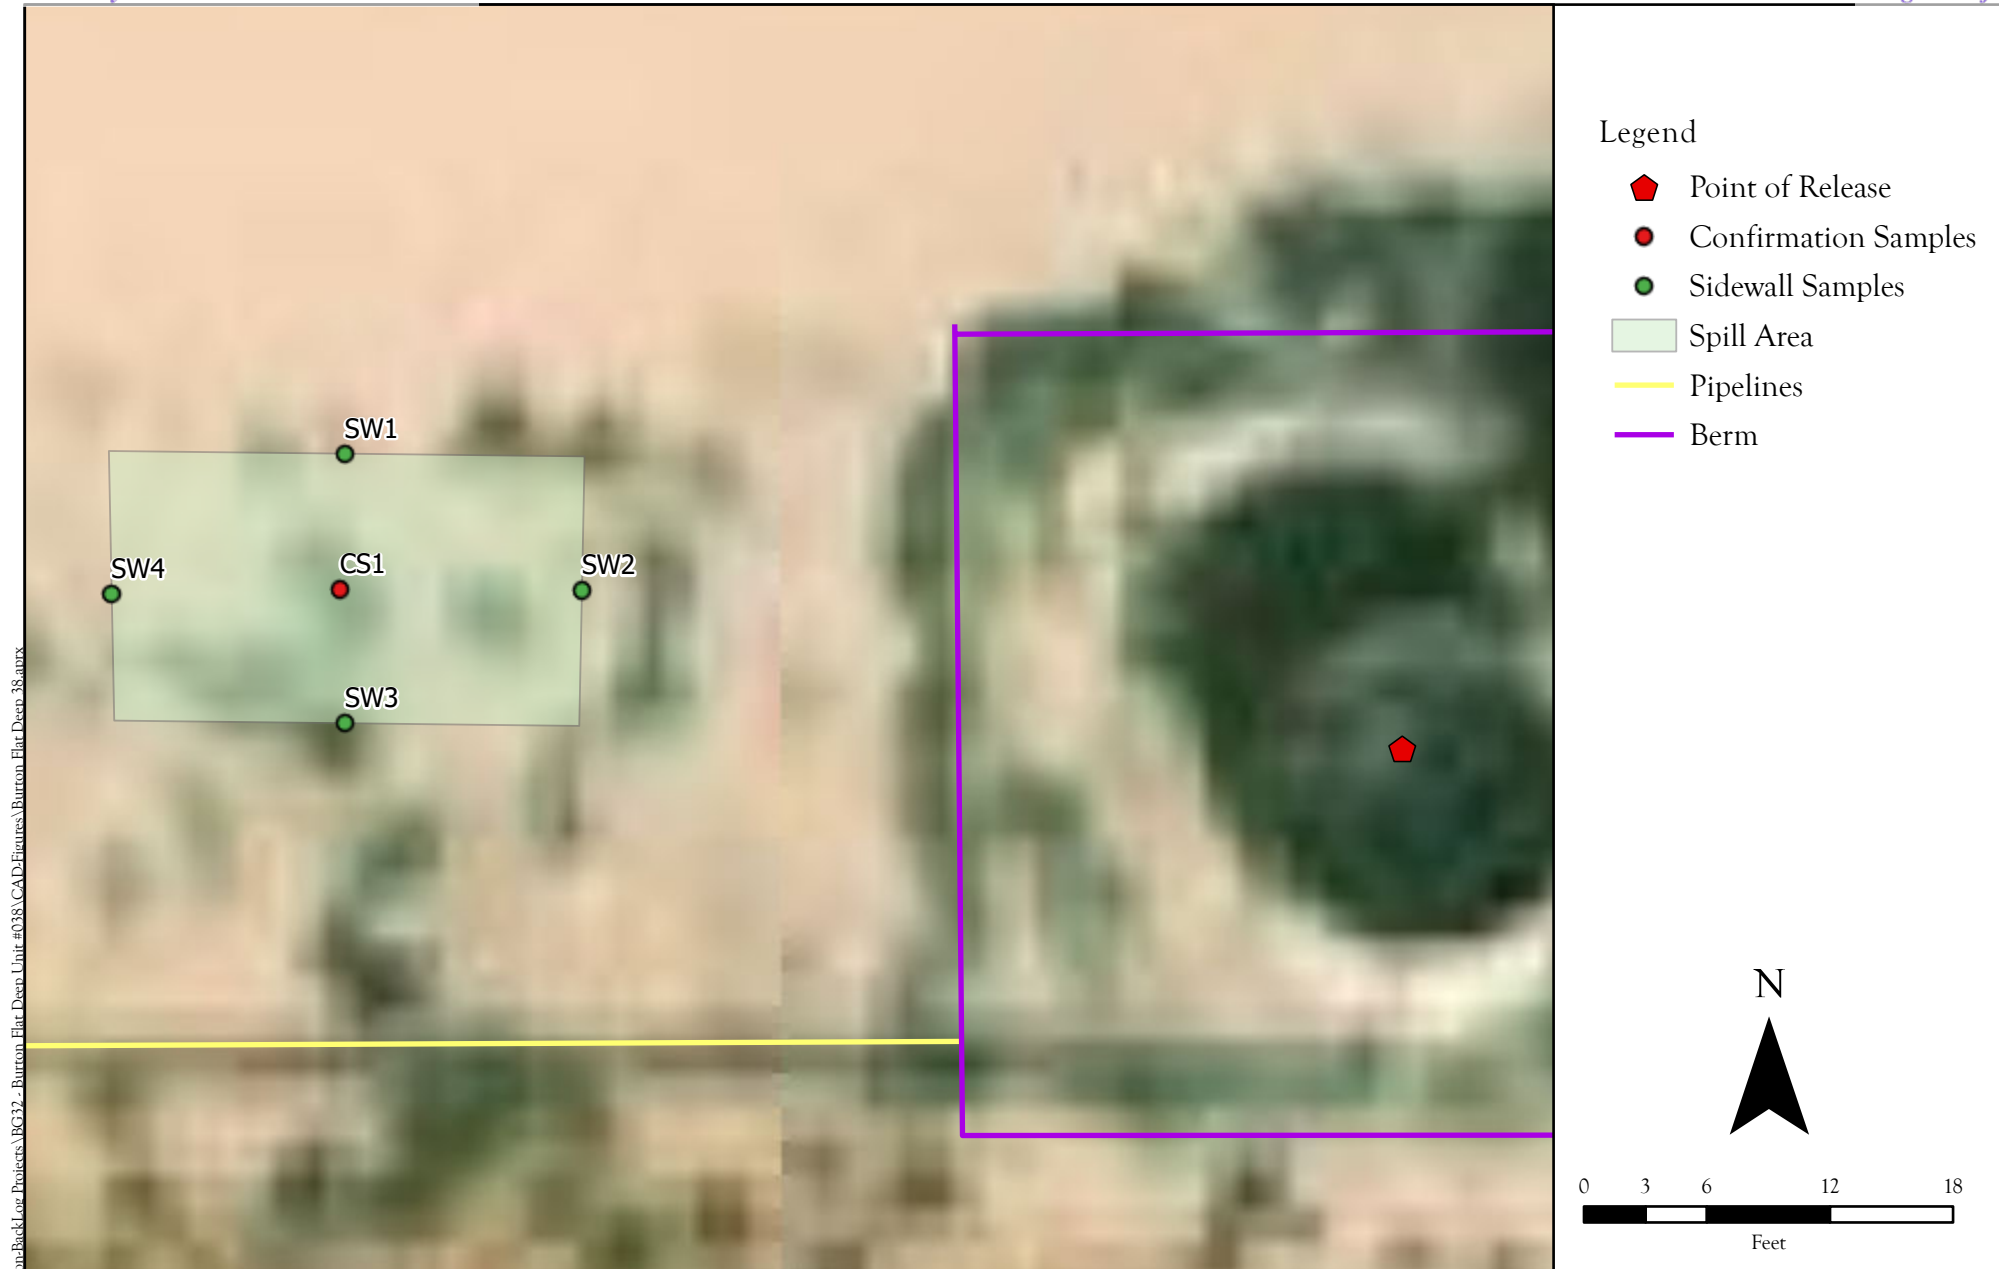
Figure 3A

On September 17, 2020, SMA conducted confirmation samples collected from the walls and base of the excavation, which measured approximately 13 by 20 feet by one-foot depth (260 square feet). On September 30, 2020 SMA returned to the site to extend the eastern side (SW2) two (2) feet to the east until NMOCD Criteria would be met.

Confirmation samples were comprised of five-point composites of the base (CS1) and walls (SW1-SW4).

Site and Confirmation Sample Location Map  
 Burton Flat Deep Unit #38- Devon Energy  
 32.5030666, -104.1527476 Eddy County, New Mexico

As demonstrated in Table 3, all closure samples meet the Closure Criteria. The site has been remediated to meet the standards of Table I of 19.15.29.12 NMAC.

Contaminated soils were removed and replaced with clean backfill material to return the surface to previous contours. The contaminated soil was transported and disposed of at Northern Delaware Basin Landfill near Jal, NM, an NMOCD-permitted disposal facility.
