Re: Site Assessment, Remediation, and Closure Report
Gilmore 24 #001
API No. 30-025-34141
GPS: Latitude 32.909729 Longitude -103.3012466
UL "H", Sec. 24, T16S, R36E
Lea County, NM
NMOCD Ref. No. NPAC0801452097

Pima Environmental Services, LLC (Pima) has been contracted by Armstrong Energy Corporation to perform a spill assessment, remediation activities, and submit this closure report for a crude oil release that occurred at the Gilmore 24 #001. The initial C-141 was submitted on September 8th, 2022 (Appendix C). This incident was assigned Incident ID NPAC0801452097, by the New Mexico Oil Conservation Division (NMOCD).

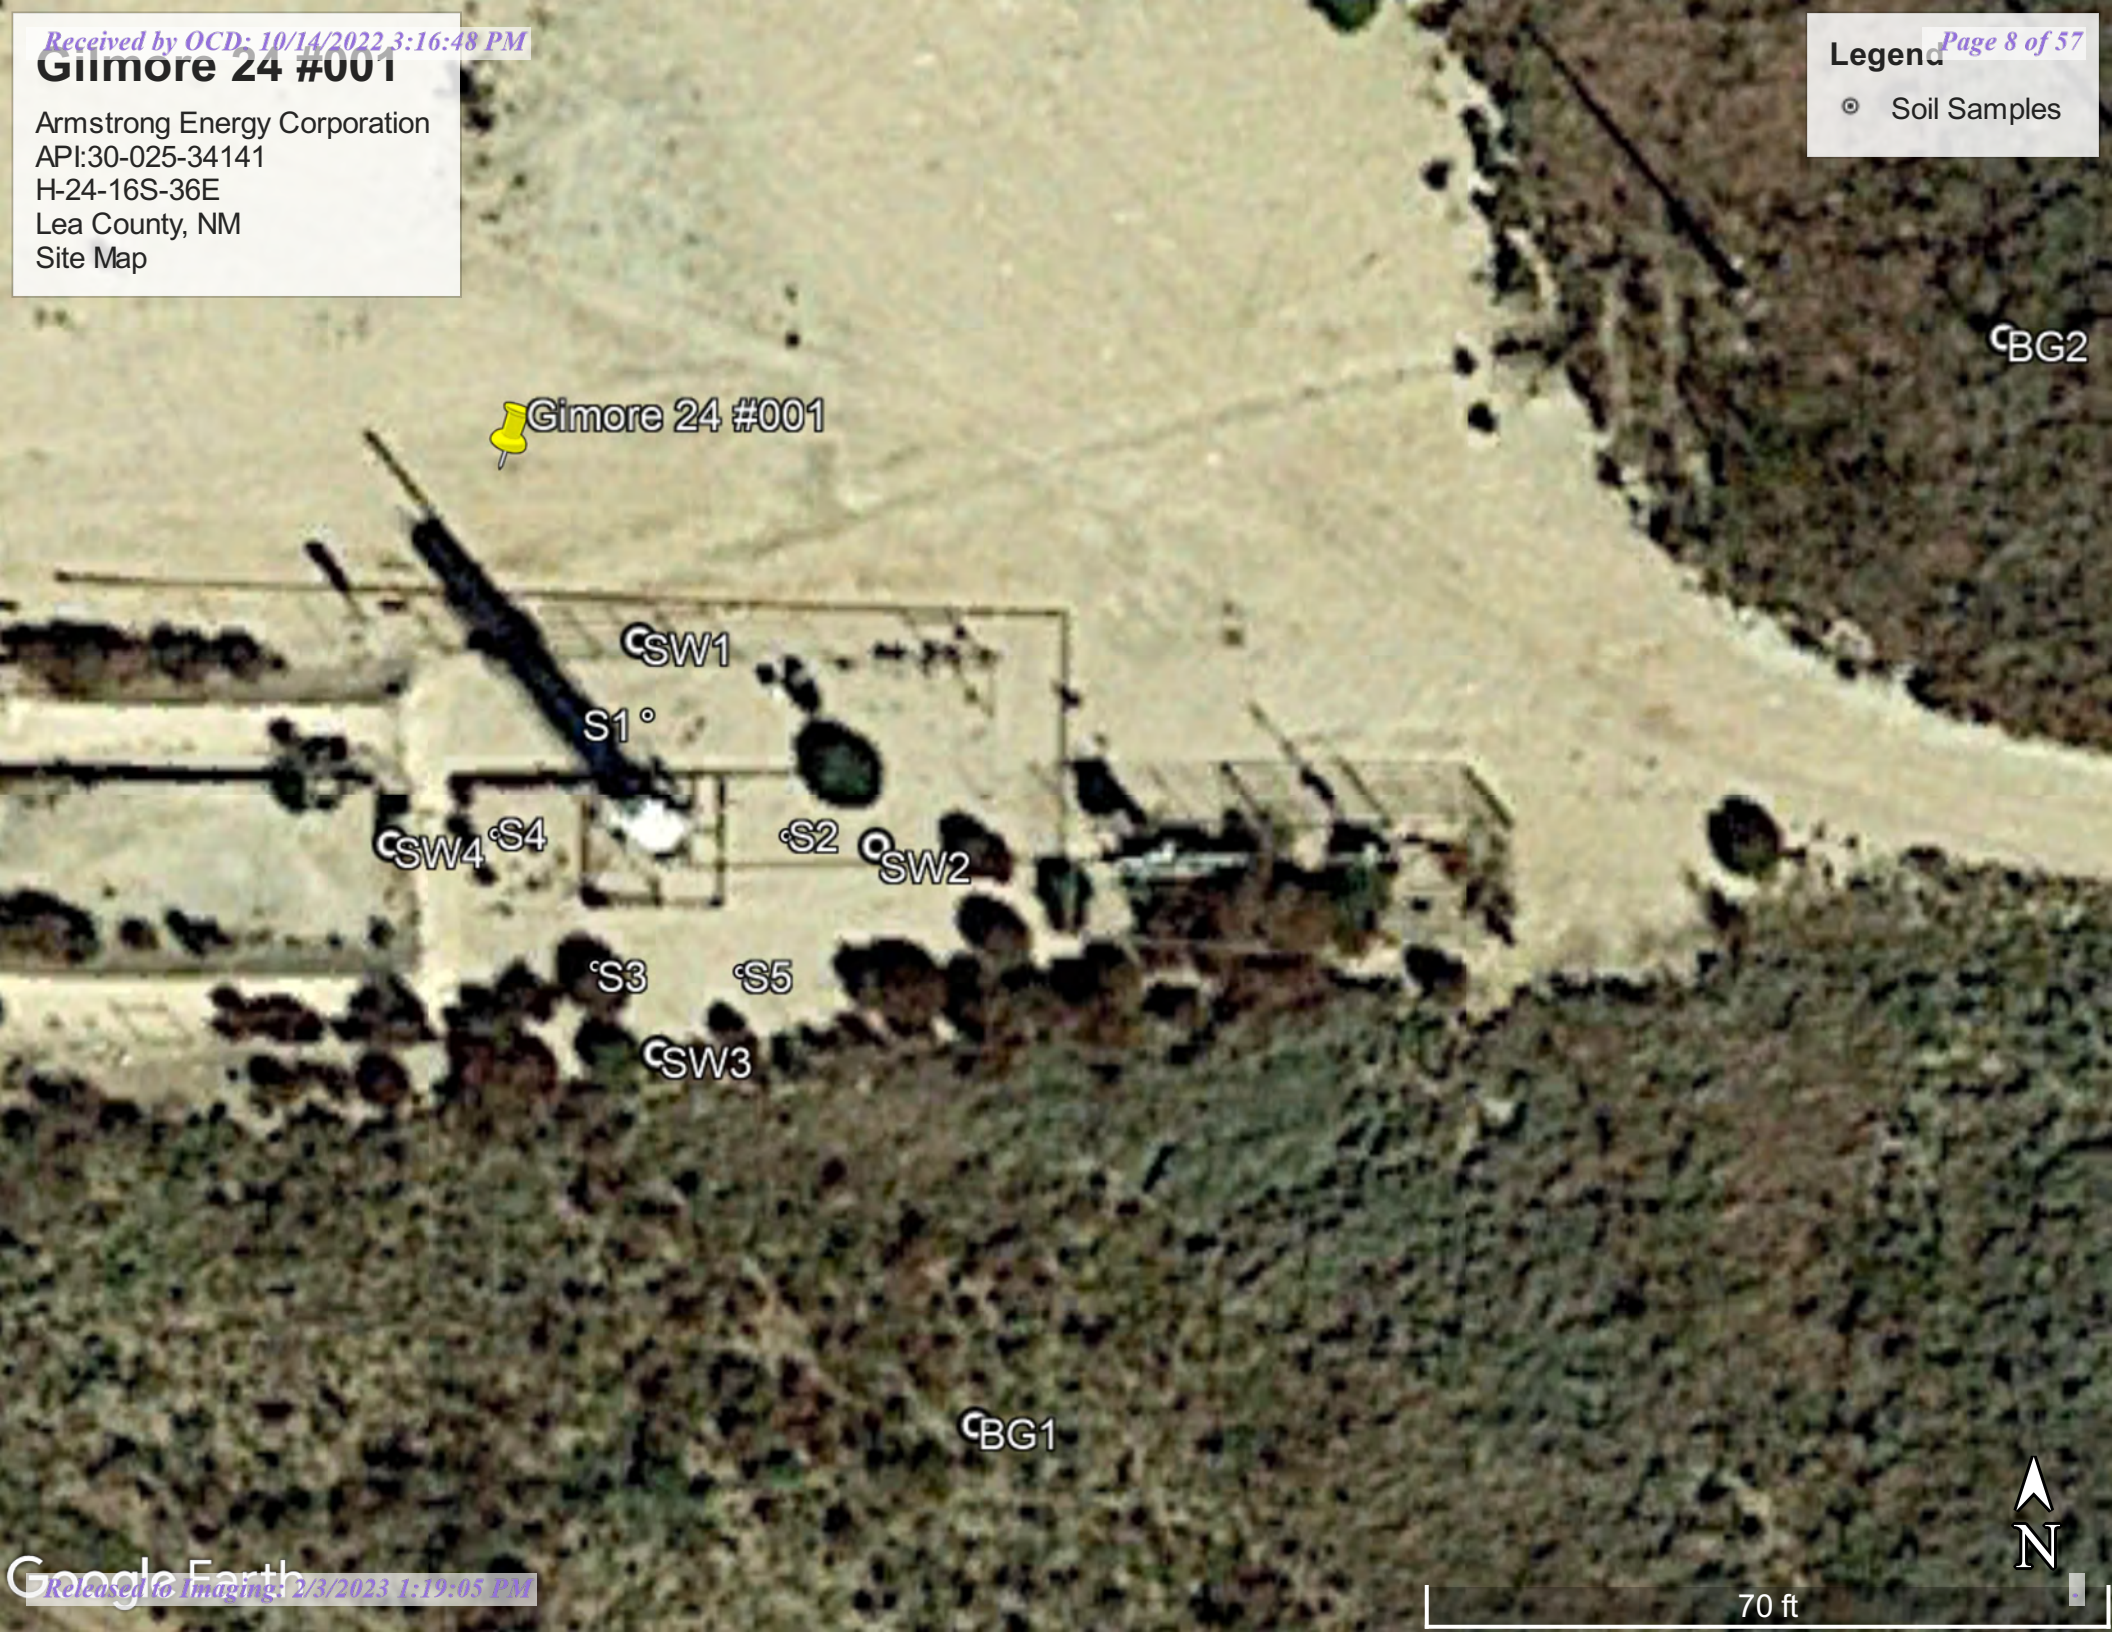
Armstrong Energy Corporation
API:30-025-34141
H-24-16S-36E
Lea County, NM
Site Map

On September 19th, 2022, Pima Environmental Services mobilized personnel to the site to conduct delineation activities. Pima sampled the area between the point of release and the separators. Laboratory results of this sampling event can be found in the following data table.

9-19-22 Soil Sample Results

Due to analytical levels falling below NMOCD closure criteria, no further immediate action is required. Pima Environmental will address any superficial staining surrounding the production equipment.
