**Re: Closure Request  
Rojo 26 Oil Dump Valve Failure  
Incident Number nAPP2224256412  
Lea County, New Mexico**

BTA Oil Producers, LLC  
Closure Request  
Rojo 26 Oil Dump Valve Failure

BTA Oil Producers, LLC  
Rojo 26 Oil Dump Valve  
Incident Number nAPP2224256412  
Unit Letter O, Sec 22, T25S, R33E  
Lea County, New Mexico

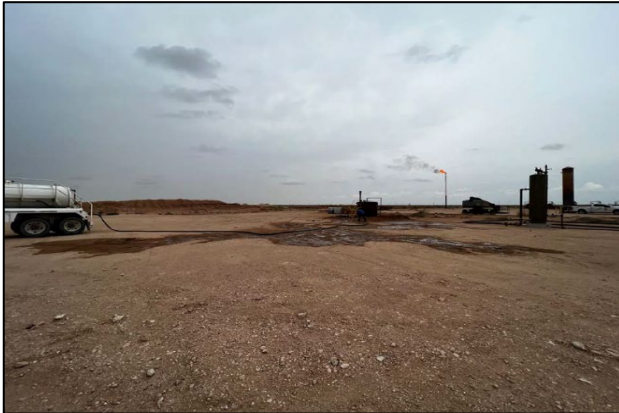
Photograph: 1                      Date: 8/16/2022  
Description: Soil staining observed during fluid recovery.  
View: Northeast

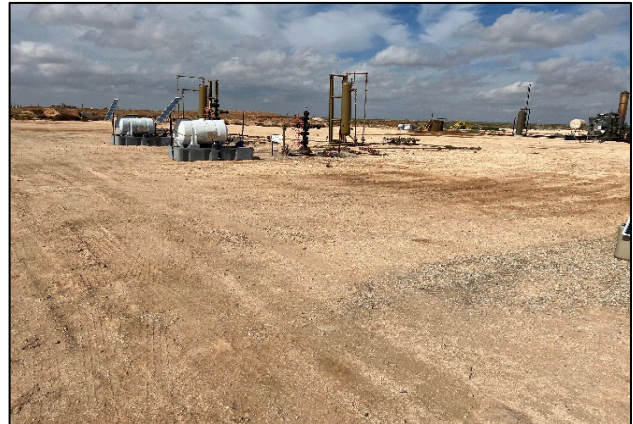
Photograph: 2                      Date: 11/8/2022  
Description: View of release during Site assessment.  
View: North

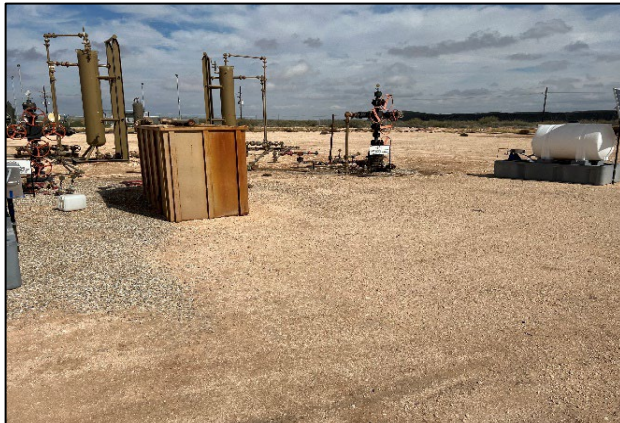
Photograph: 3                      Date: 11/8/2022  
Description: View of release during Site assessment.  
View: Southeast

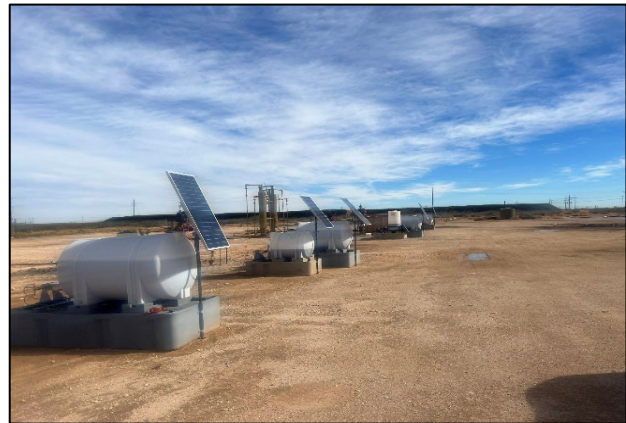
Photograph: 4                      Date: 11/28/2022  
Description: View during delineation activities  
View: East
