**Re: Liner Inspection and Closure Request
ConocoPhillips (Heritage Concho)
Gadwall 35 #1H Tank Battery Release
Unit Letter A, Section 35, Township 24 South, Range 32 East
Lea County, New Mexico
Incident ID# NAPP2302439496**

Liner Inspection and Closure Report
February 16, 2023

**GADWALL 35 #1H TANK BATTERY RELEASE
TOPOGRAPHIC MAP**

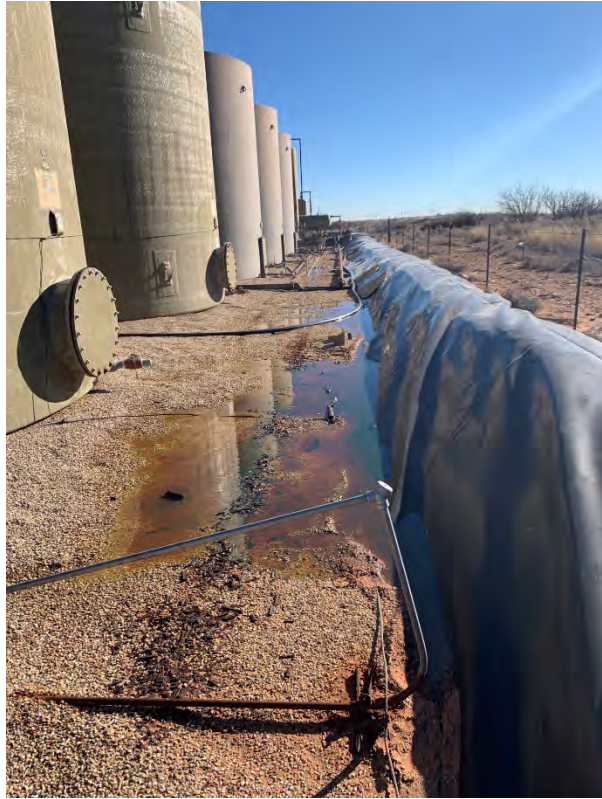
TETRA TECH, INC. PROJECT NO. 212C-MD-02986	DESCRIPTION	View east. Released fluids in southern portion of lined secondary containment.	1
	SITE NAME	Gadwall 35 #1H Tank Battery Release	1/13/2023

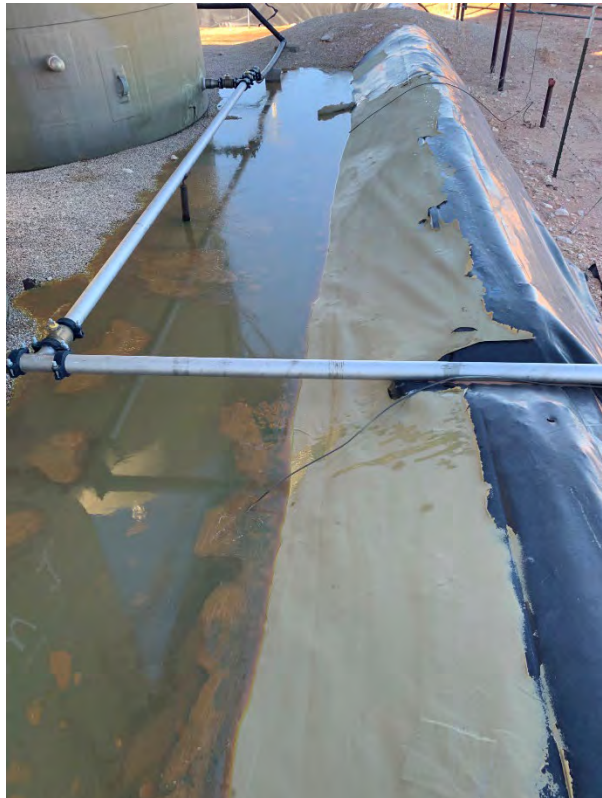
TETRA TECH, INC. PROJECT NO. 212C-MD-02986	DESCRIPTION	View west. Released fluids in northern portion of lined secondary containment.	2
	SITE NAME	Gadwall 35 #1H Tank Battery Release	1/13/2023

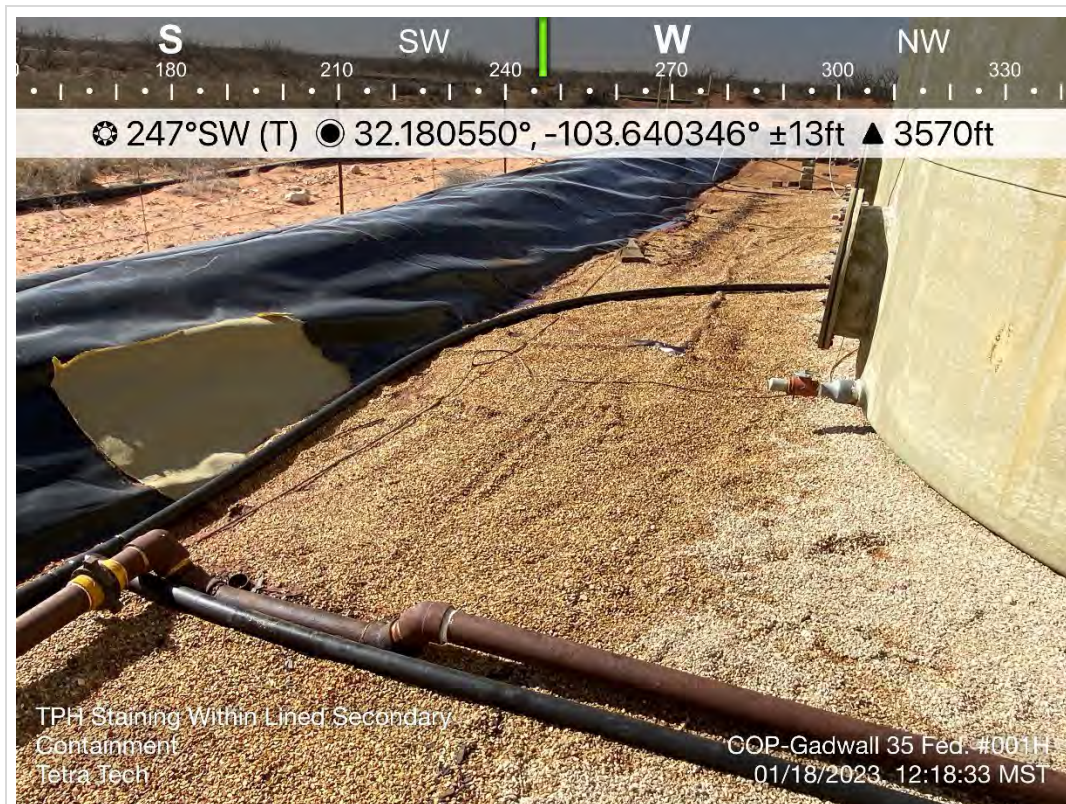
TETRA TECH, INC. PROJECT NO. 212C-MD-02986	DESCRIPTION	View south-southwest. Staining within northwestern portion of lined secondary containment.	3
	SITE NAME	Gadwall 35 #1H Tank Battery Release	1/18/2023

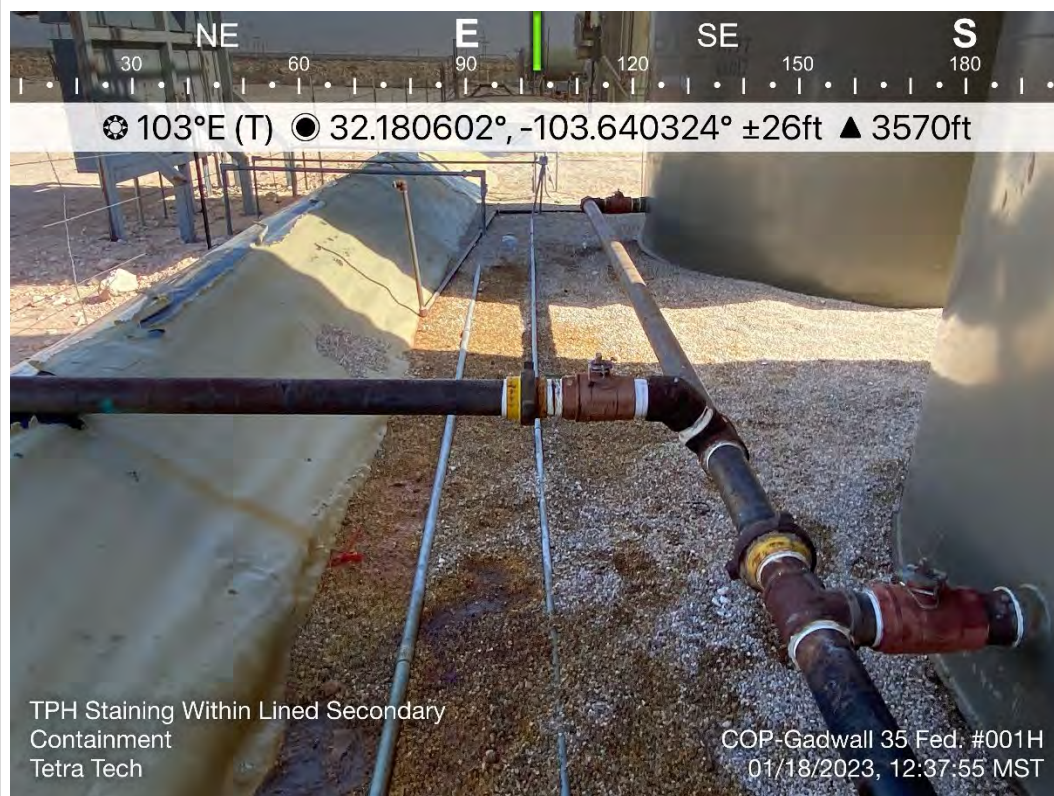
TETRA TECH, INC. PROJECT NO. 212C-MD-02986	DESCRIPTION	View east. Staining within northern portion of lined secondary containment.	4
	SITE NAME	Gadwall 35 #1H Tank Battery Release	1/18/2023

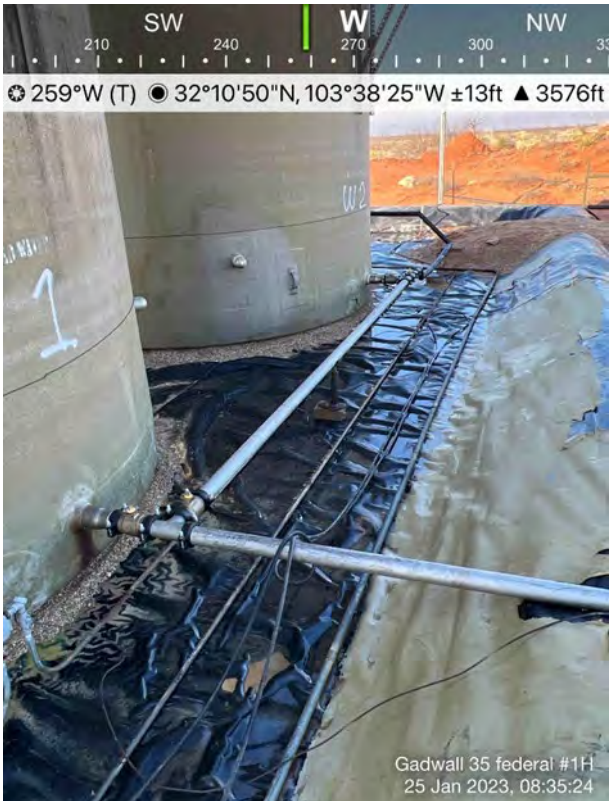
TETRA TECH, INC. PROJECT NO. 212C-MD-02986	DESCRIPTION	View west. Northwestern portion of lined secondary containment following removal of stained material.	5
	SITE NAME	Gadwall 35 #1H Tank Battery Release	1/25/2023

On January 25, 2023, COP Operations personnel were at the Site to complete the removal of potentially impacted base course/gravel material within the secondary containment. The base course material that was saturated or visibly stained was removed and properly disposed of at an approved facility.

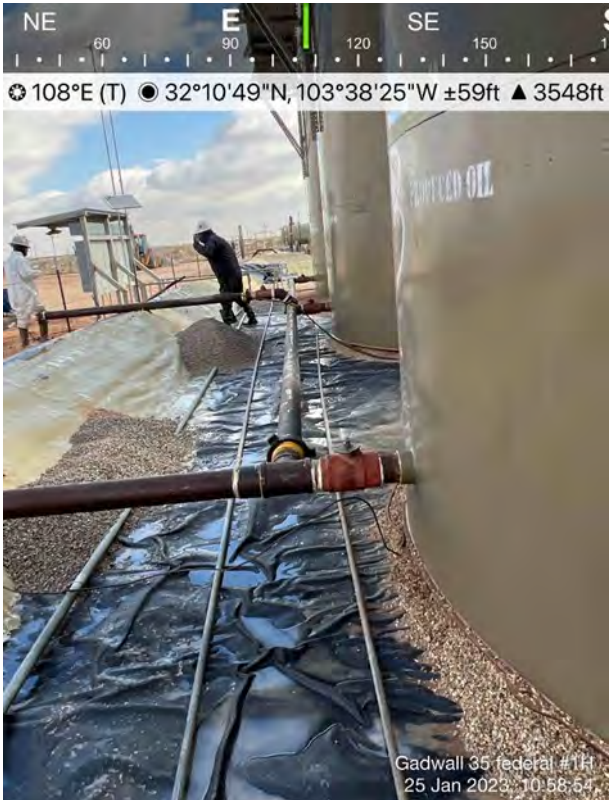
TETRA TECH, INC. PROJECT NO. 212C-MD-02986	DESCRIPTION	View east. Northern portion of lined secondary containment following removal of stained material.	6
	SITE NAME	Gadwall 35 #1H Tank Battery Release	1/25/2023

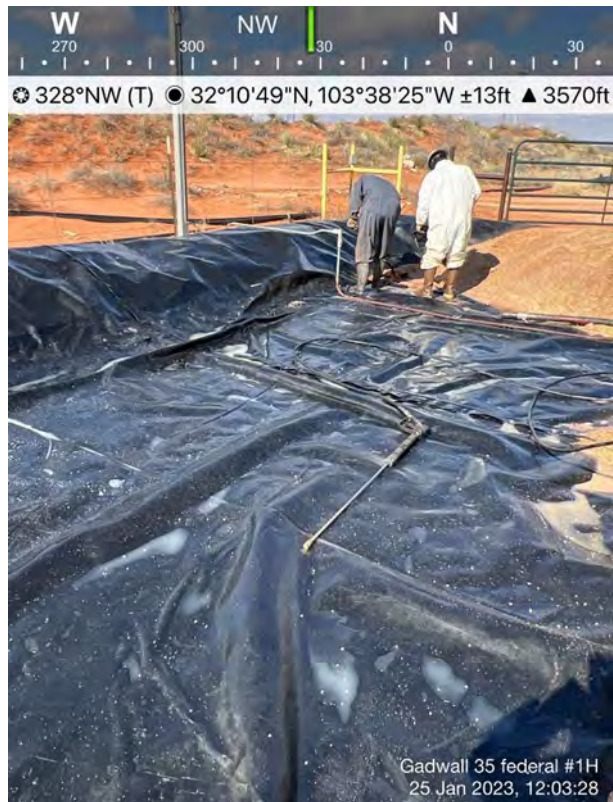
TETRA TECH, INC. PROJECT NO. 212C-MD-02986	DESCRIPTION	View northwest. Northwestern portion of lined secondary containment following removal of stained material.	7
	SITE NAME	Gadwall 35 #1H Tank Battery Release	1/25/2023

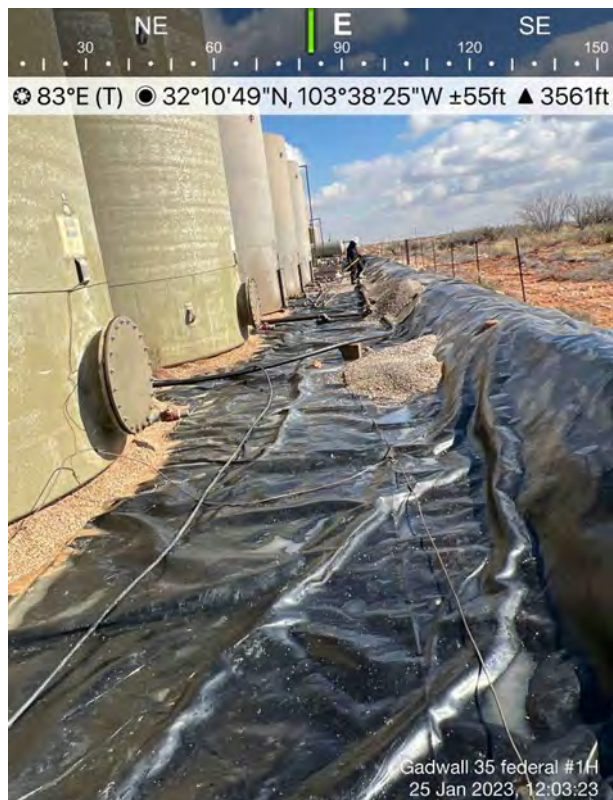
TETRA TECH, INC. PROJECT NO. 212C-MD-02986	DESCRIPTION	View east. Southern portion of lined secondary containment following removal of stained material.	8
	SITE NAME	Gadwall 35 #1H Tank Battery Release	1/25/2023

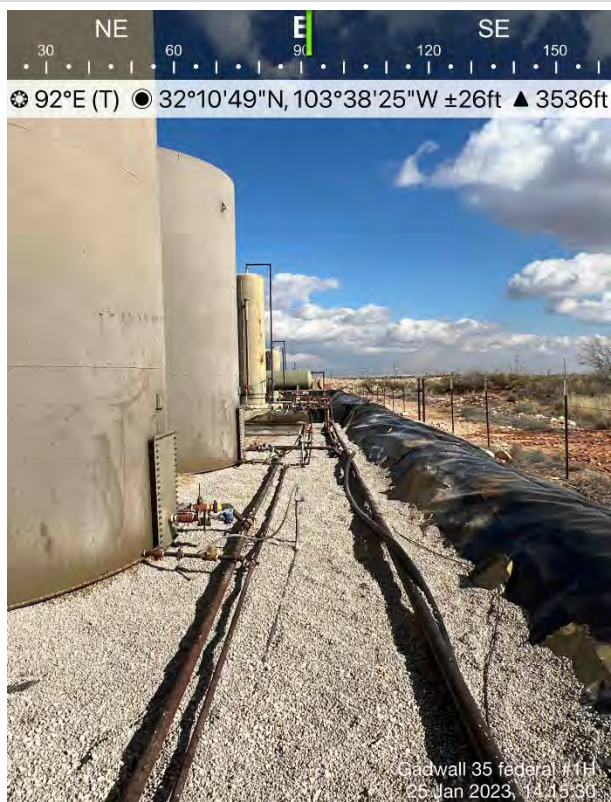
TETRA TECH, INC. PROJECT NO. 212C-MD-02986	DESCRIPTION	View east. Southern portion of lined secondary containment following placement of base course material.	9
	SITE NAME	Gadwall 35 #1H Tank Battery Release	1/25/2023

As a result of a miscommunication between Tetra Tech and COP Operations personnel, clean base course material was placed and graded inside the tank battery secondary containment before the liner inspection could be officially completed by Tetra Tech. Photographic documentation of the January 2023 remedial activities is included in Appendix C

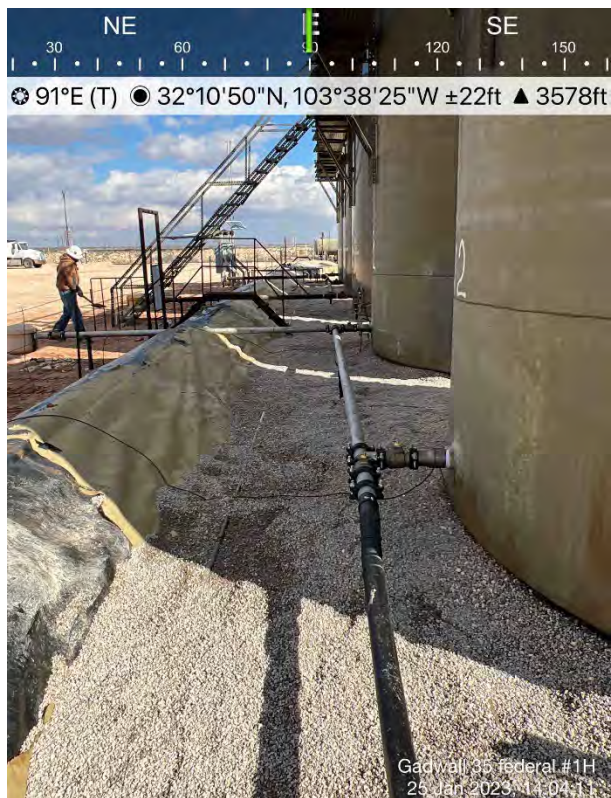
TETRA TECH, INC. PROJECT NO. 212C-MD-02986	DESCRIPTION	View east. Northern portion of lined secondary containment following placement of base course material.	10
	SITE NAME	Gadwall 35 #1H Tank Battery Release	1/25/2023

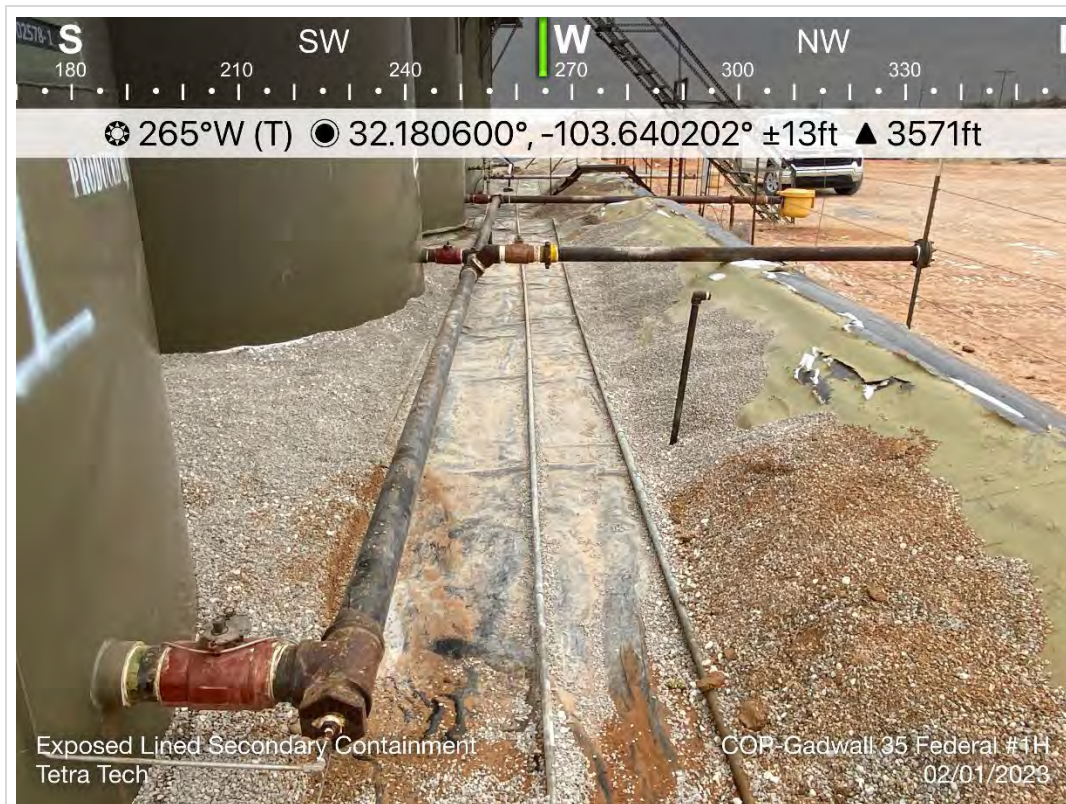
Thus, on February 1, 2022, Tetra Tech personnel performed an inspection of the liner within the secondary containment of the Gadwall 35 #1H Tank Battery. Due to the liner being covered with clean material resulting from the previously mentioned January 25 activities, base course material was removed by hand in order to expose the polyethylene liner. The clean base course/gravel material was carefully extracted from the area surrounding Tank #3 and the surrounding vicinity. The liner was observed to underlie the tank battery secondary containment area. The liner was intact, with no visible rips or tears and encompassed by a 2-foot-tall earthen berm. The liner extended up and over the earthen berm and was anchored on the exterior side. Photographic documentation of the liner inspection is included in Appendix C.

TETRA TECH, INC. PROJECT NO. 212C-MD-02986	DESCRIPTION	View east. Exposed liner in the northern portion of the lined secondary containment.	11
	SITE NAME	Gadwall 35 #1H Tank Battery Release	9/8/2022

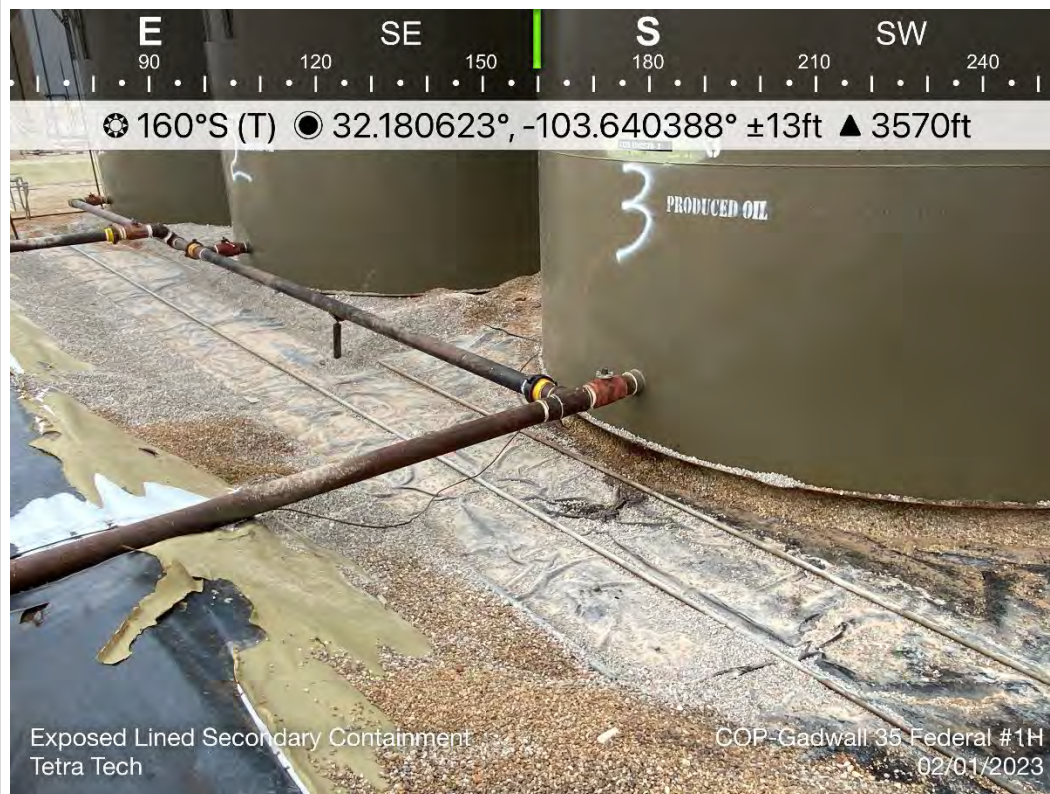
TETRA TECH, INC. PROJECT NO. 212C-MD-02986	DESCRIPTION	View south-southeast. Exposed liner near the release source in the northern portion of the lined secondary containment.	12
	SITE NAME	Gadwall 35 #1H Tank Battery Release	9/8/2022

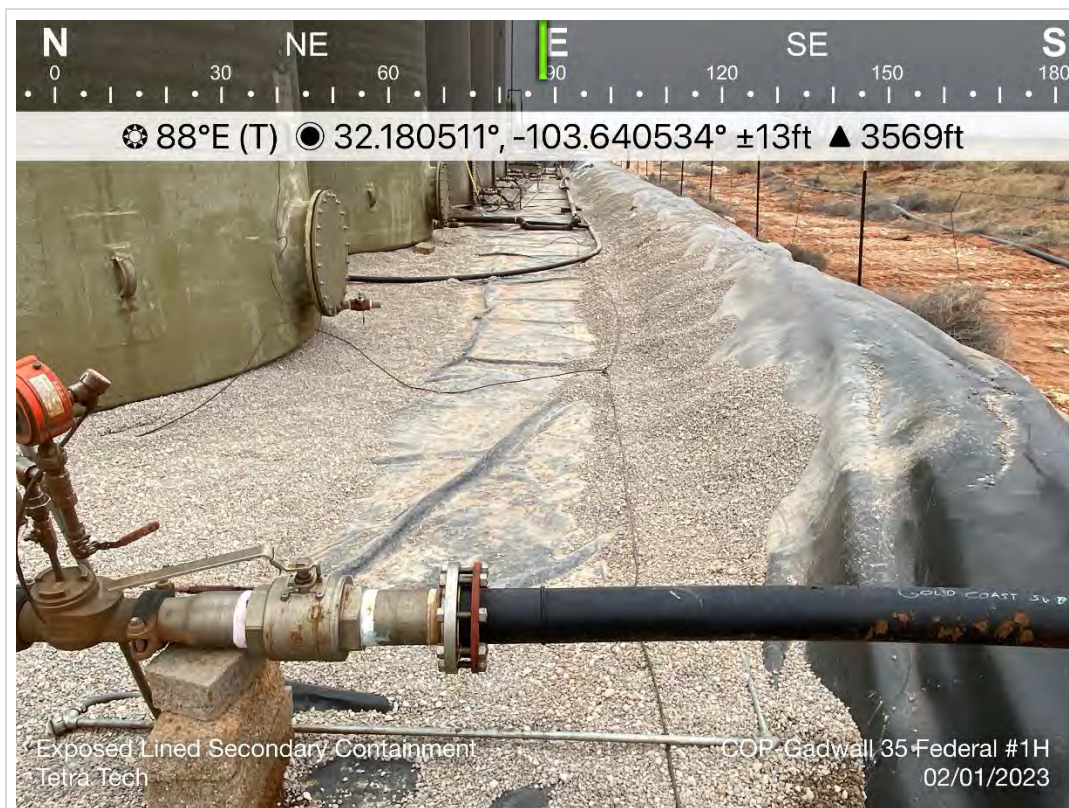
TETRA TECH, INC. PROJECT NO. 212C-MD-02986	DESCRIPTION	View east. Exposed liner in the northern portion of the lined secondary containment.	13
	SITE NAME	Gadwall 35 #1H Tank Battery Release	9/8/2022

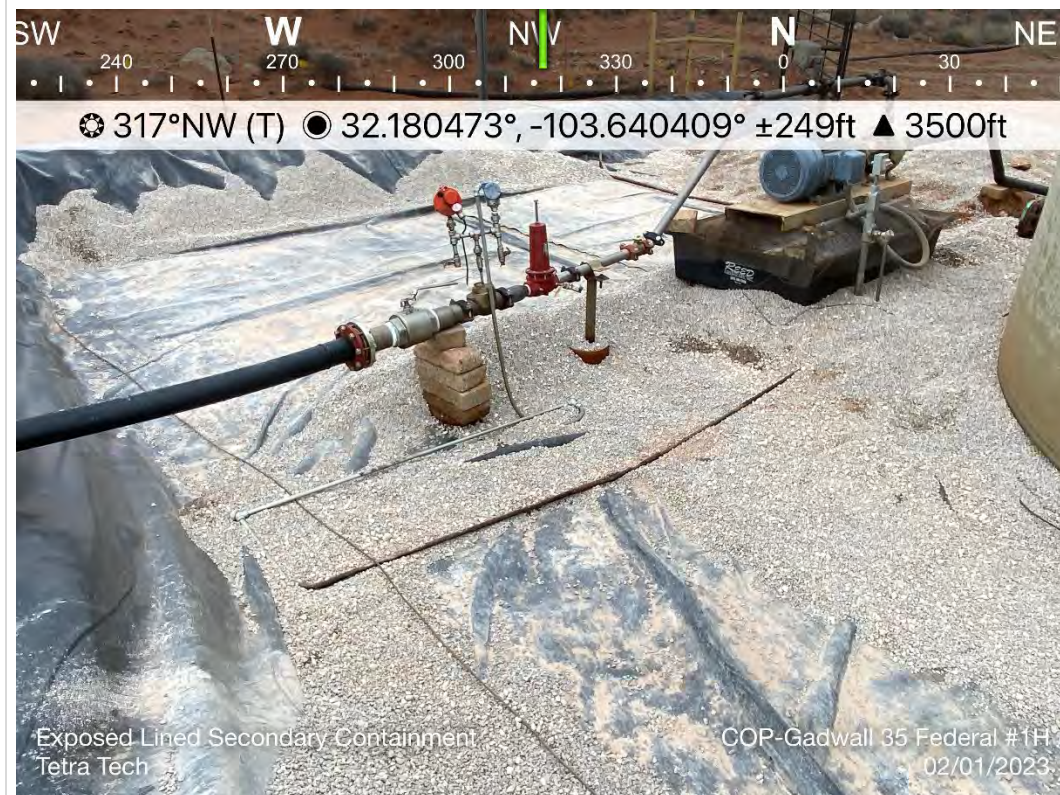
TETRA TECH, INC. PROJECT NO. 212C-MD-02986	DESCRIPTION	View northwest. Exposed liner in the western portion of the lined secondary containment.	14
	SITE NAME	Gadwall 35 #1H Tank Battery Release	9/8/2022
