RE: Closure Request
Poker Lake Unit CVX JV RR #003H/Poker Lake Unit Ross Ranch 19 Battery
Remediation Permit Number 2RP-4706
Eddy County, New Mexico

LT Environmental, Inc. (LTE), on behalf of XTO Energy, Inc. (XTO), presents the following letter report detailing excavation of impacted soil and confirmation soil sampling activities at the Poker Lake Unit CVX JV RR #003H/Poker Lake Unit Ross Ranch 19 Battery (Site) located in Unit P, Section 19, Township 25 South, Range 30 East, in Eddy County, New Mexico (Figure 1).

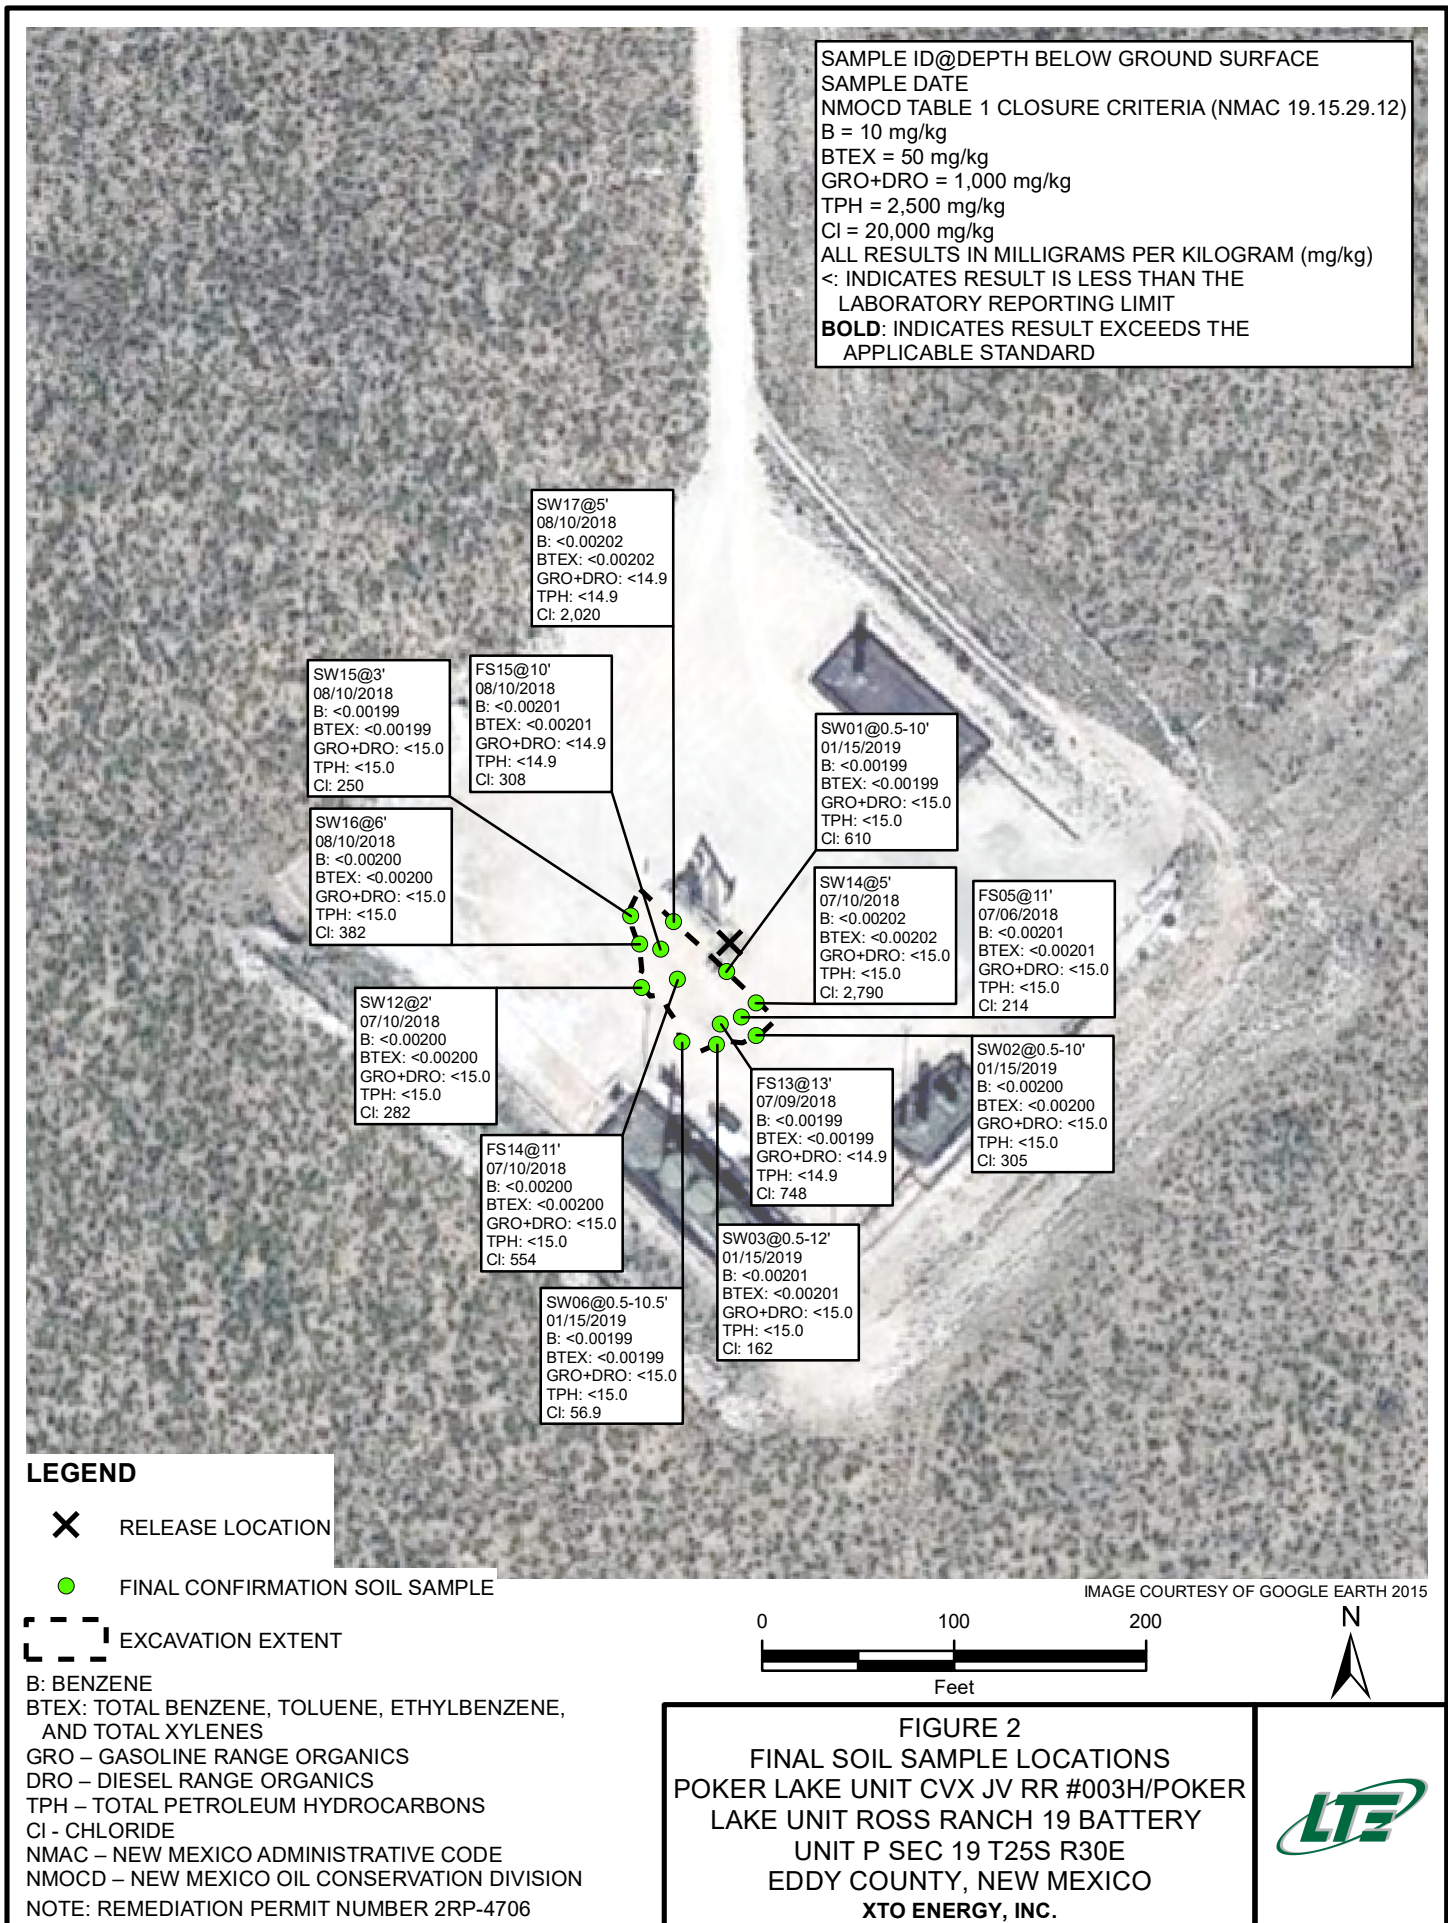
The excavation measured approximately 3,000 square feet in area with a depth of 10 feet to 13 feet bgs. The horizontal extent of the excavation is illustrated on Figure 2. Approximately 1,660 cubic yards of impacted soil were removed from the excavation. The impacted soil was transported and properly disposed of at the Lea Land Landfill Facility in Hobbs, New Mexico, and the R30 Red Bluff Landfill Facility in Orla, Texas.

the NMOCD Table 1 closure criteria and no further excavation was required. Laboratory analytical results are presented on Figure 2 and summarized in Table 1, and the complete laboratory analytical reports are included as Attachment 2.

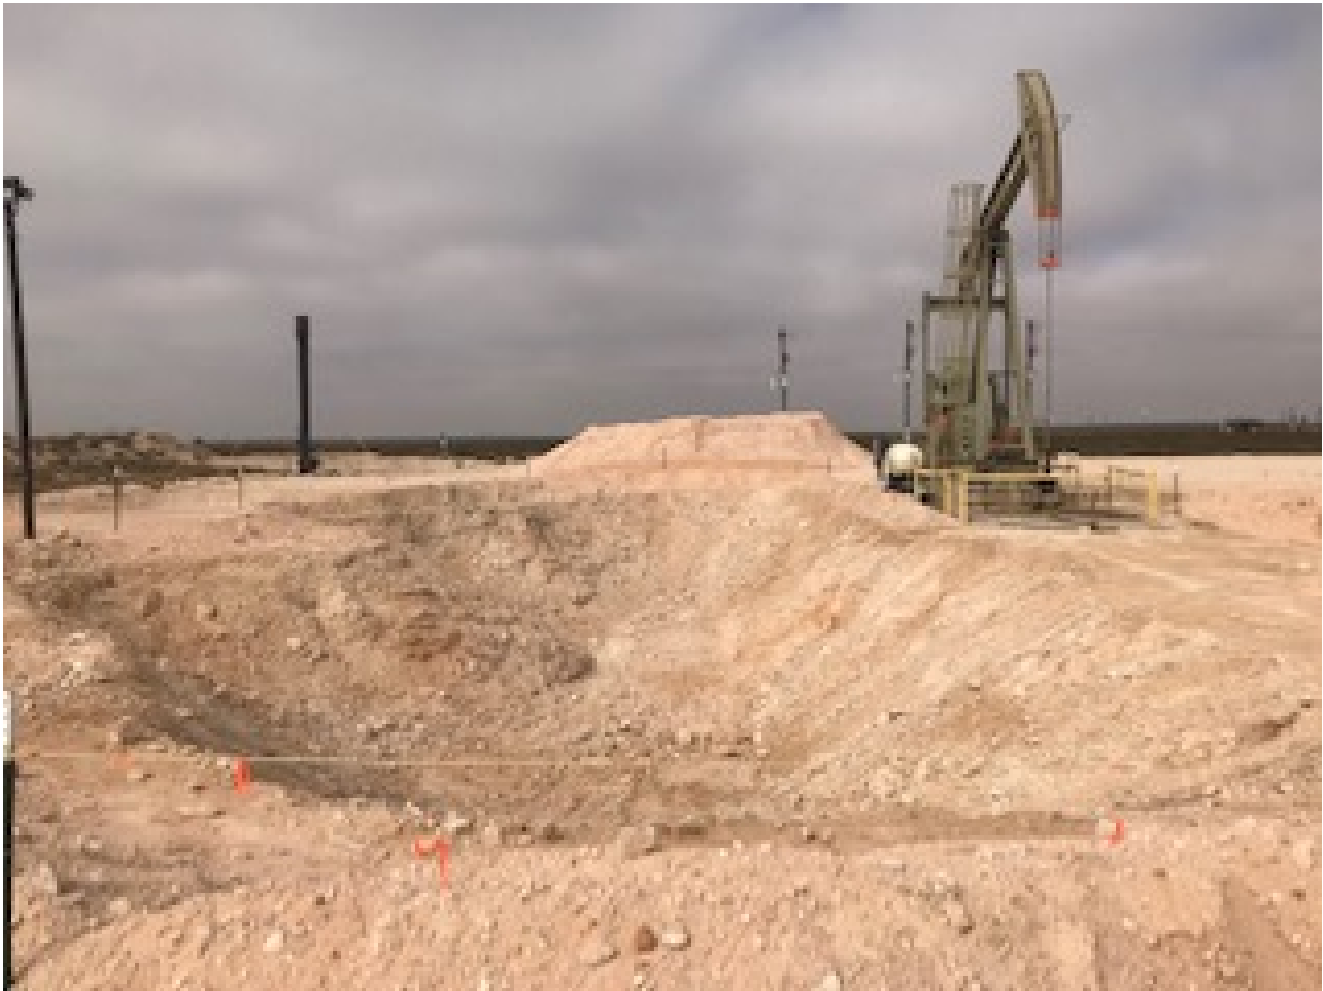
Northwest facing view of the excavation.

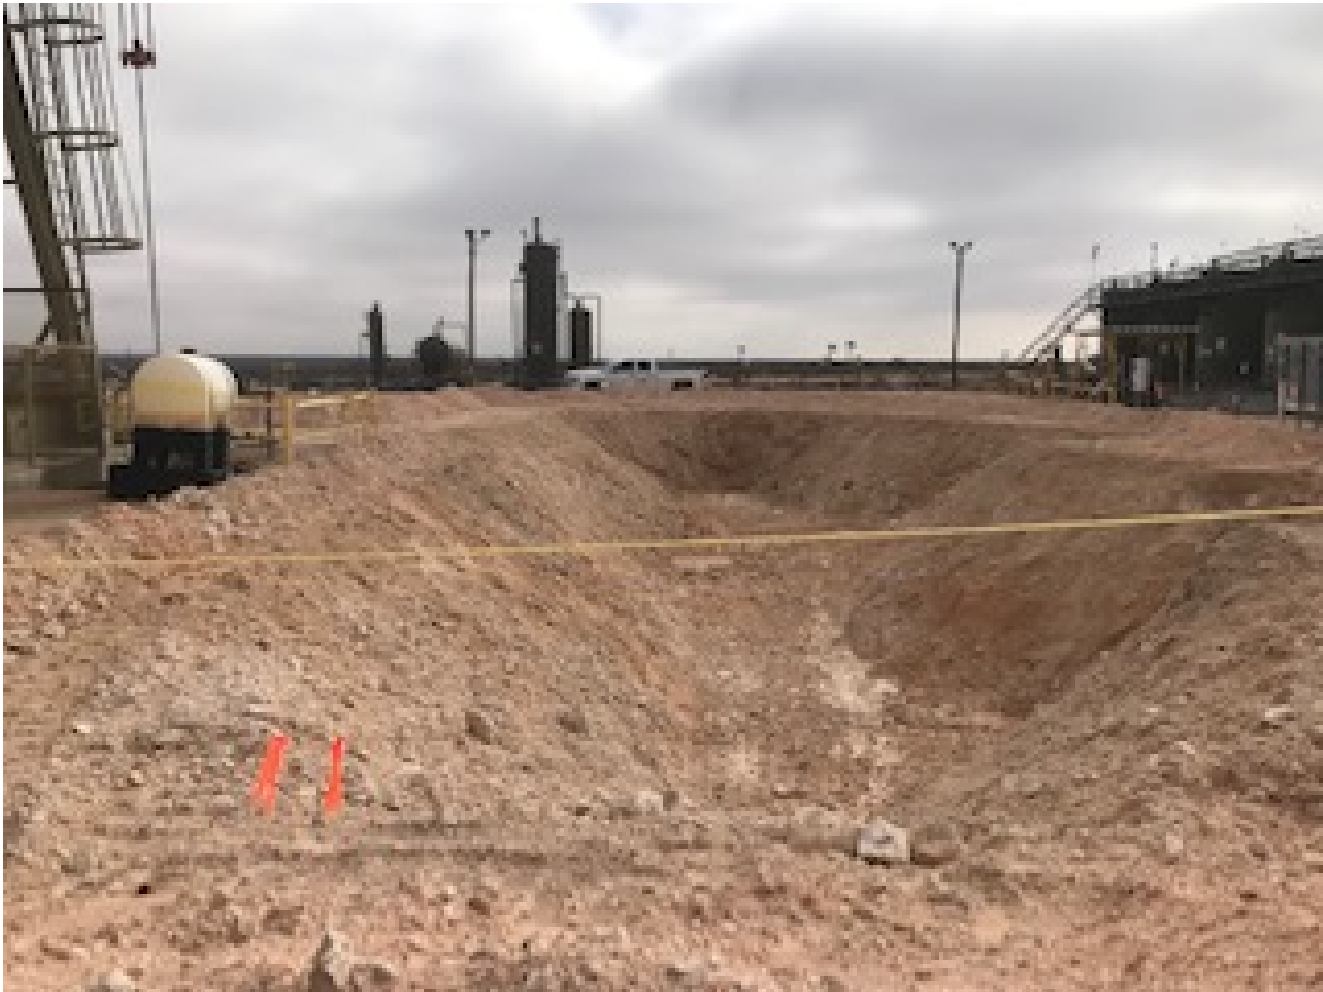
Southeast facing view of the excavation.

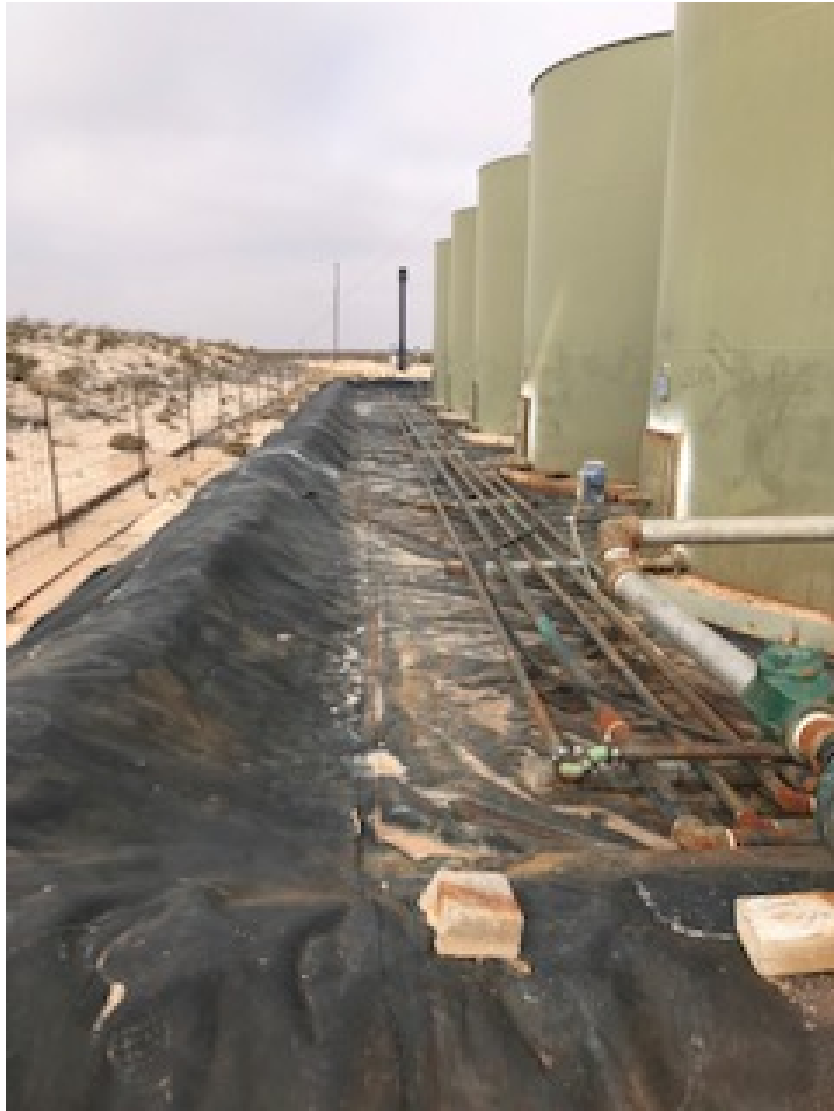
View of the lined tank battery containment.

During April 2018, LTE personnel inspected the Site to evaluate and document the release areas. Excavation was scheduled for the stuffing box release area near the well head. No further remediation was required for the produced water tank release in the lined containment; the released fluid was recovered, and the liner was intact.
