**RE: Closure Report
ConocoPhillips
Heritage Concho
Y Energy State Com #001H Tank Release
Unit Letter L, Section 32, Township 18 South, Range 30 East
Eddy County, New Mexico
Incident ID: nMLB1122348831
2RP-831**

**Y ENERGY COM #001H RELEASE
REMEDATION EXTENT AND CONFIRMATION SAMPLE LOCATIONS**

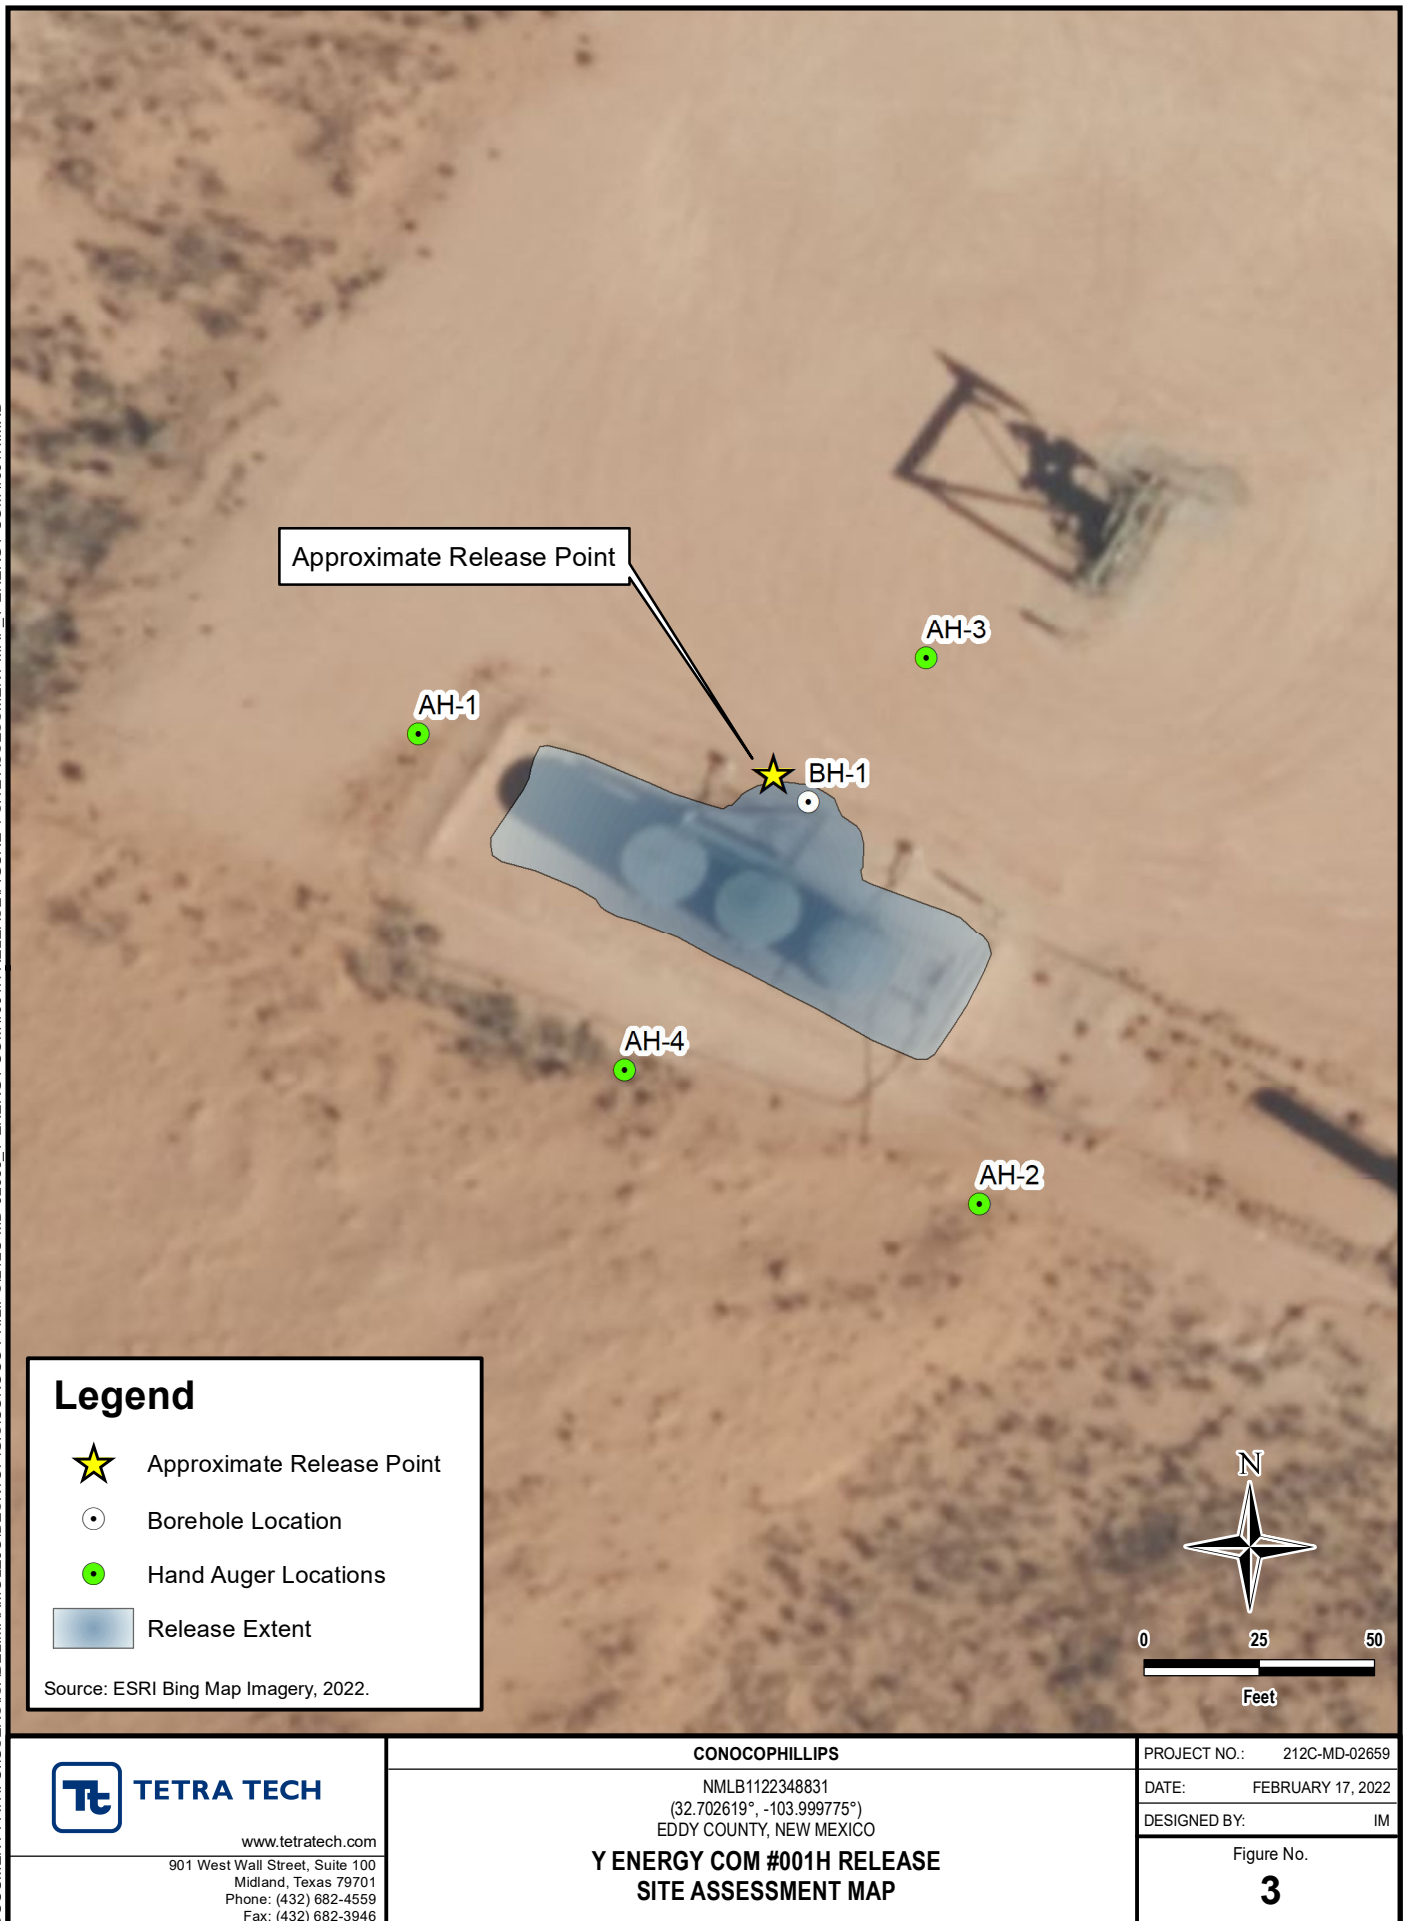
On January 24, 2022, Tetra Tech personnel were on site to assess the release footprint. Four (4) soil borings were complete with hand auger (AH-1 through AH-4) to depths of 2 feet bgs to complete horizontal delineation of the release extent. Tetra Tech returned to the site on February 9, to drill one (1) soil boring (BH-1) using an air rotary drilling rig immediately adjacent to the berm wall to a depth of 10 feet bgs to complete vertical delineation of the release extent. Sampling was not conducted in the area within the berm walls because this area was inaccessible for the drilling rig. Boring locations are presented in Figure 3.

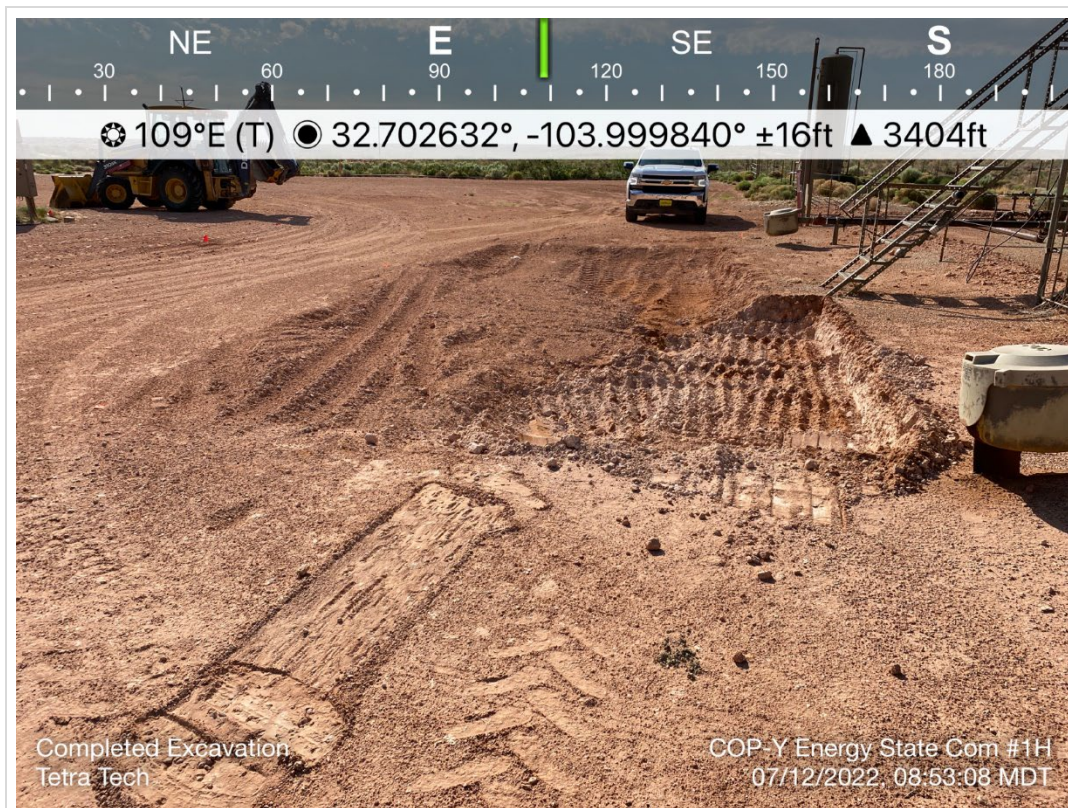
TETRA TECH, INC. PROJECT NO. 212C-MD-02739	DESCRIPTION	View east of the excavation area.	1
	SITE NAME	ConocoPhillips Y Energy State Com #001H Tank Release.	7/12/2022

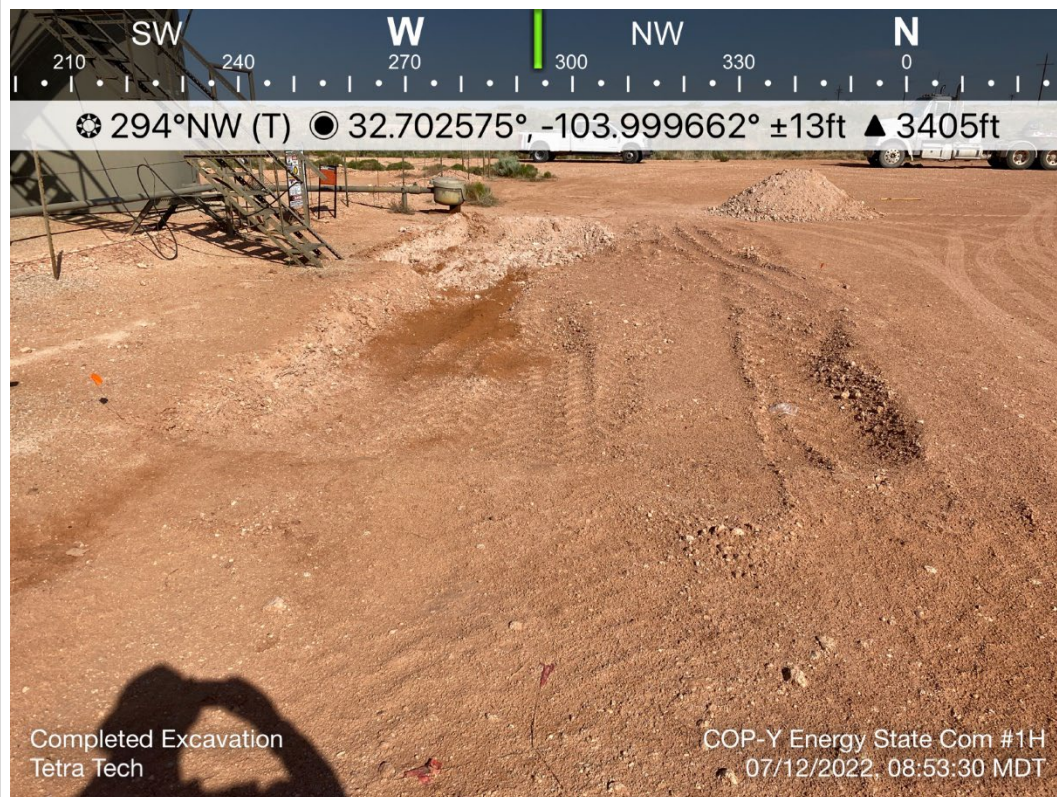
TETRA TECH, INC. PROJECT NO. 212C-MD-02739	DESCRIPTION	View west of the excavation area	2
	SITE NAME	ConocoPhillips Y Energy State Com #001H Tank Release.	7/12/2022

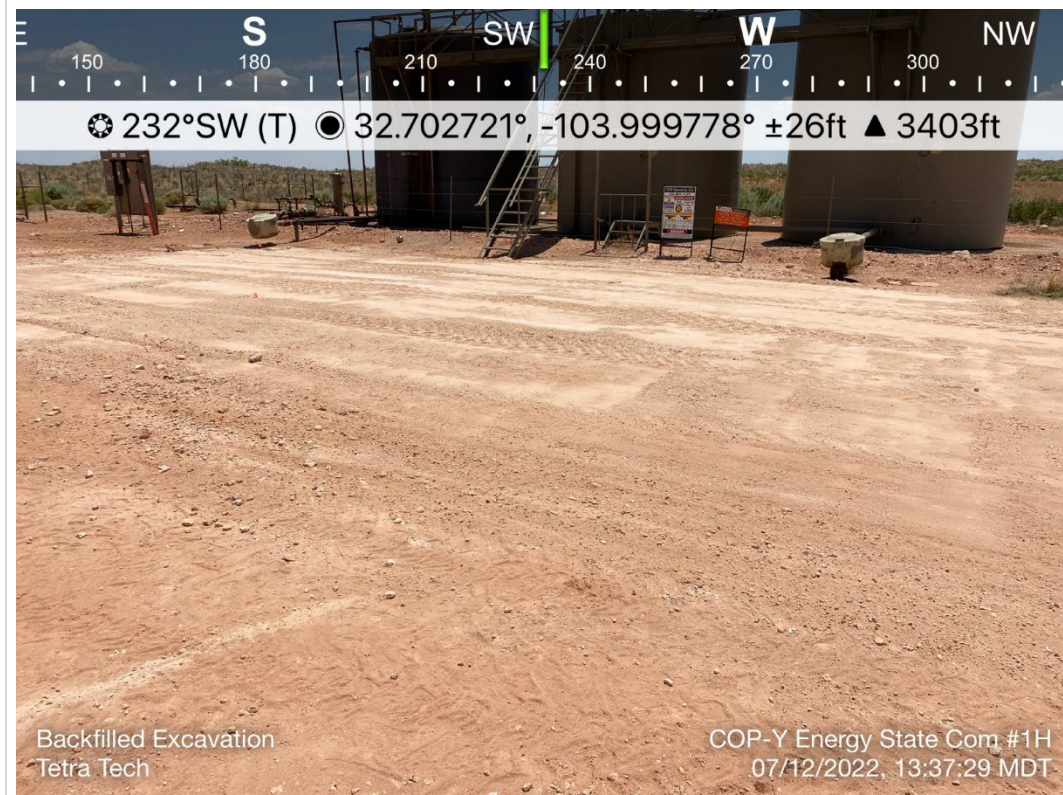
TETRA TECH, INC. PROJECT NO. 212C-MD-02739	DESCRIPTION	View southwest of the backfilled excavation.	4
	SITE NAME	ConocoPhillips Y Energy State Com #001H Tank Release.	7/12/2022
