Devon Energy Production Company
Remuda Basin SWD 1

Closure Report
UL D, Section 20, T23S, R30E
Eddy County, New Mexico

NAB1616740309
NRM2014561795

July 22, 2021
Revised March 13, 2023

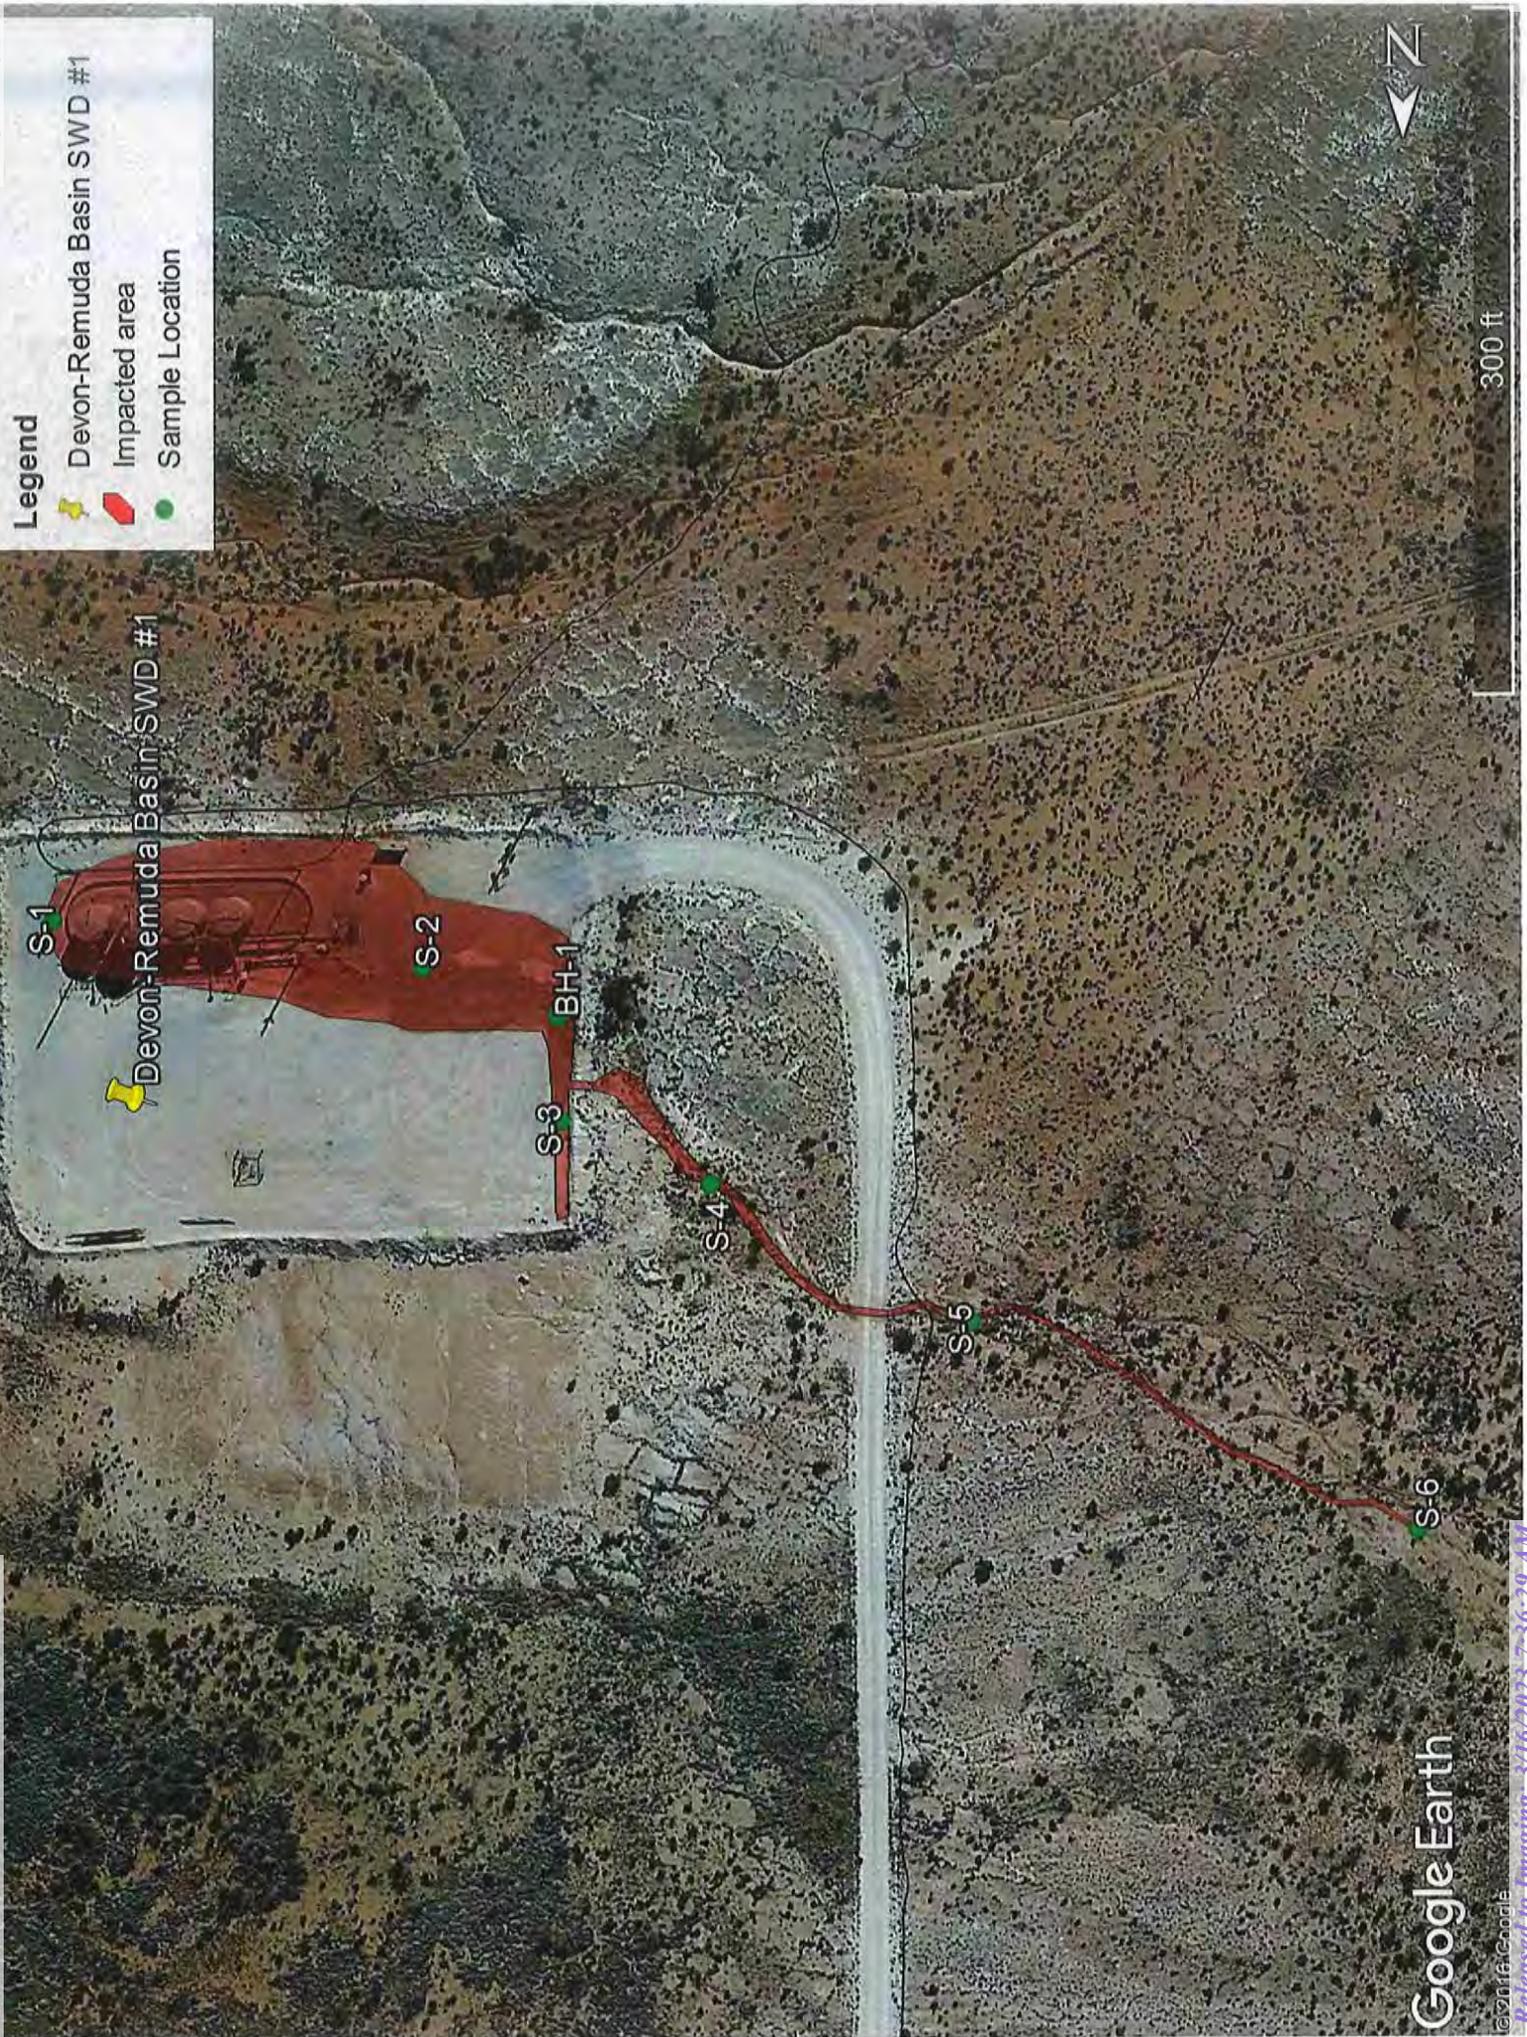
SITE PLAN

On June 12, 2016, the injection pump at this site failed resulting in a tank overflow and the release of approximately 500bbls of produced water. The produced water flowed across the location, breached the berm on the west side of the location, and flowed down gradient into the pasture for approximately 408-feet as shown on the attached site plan.

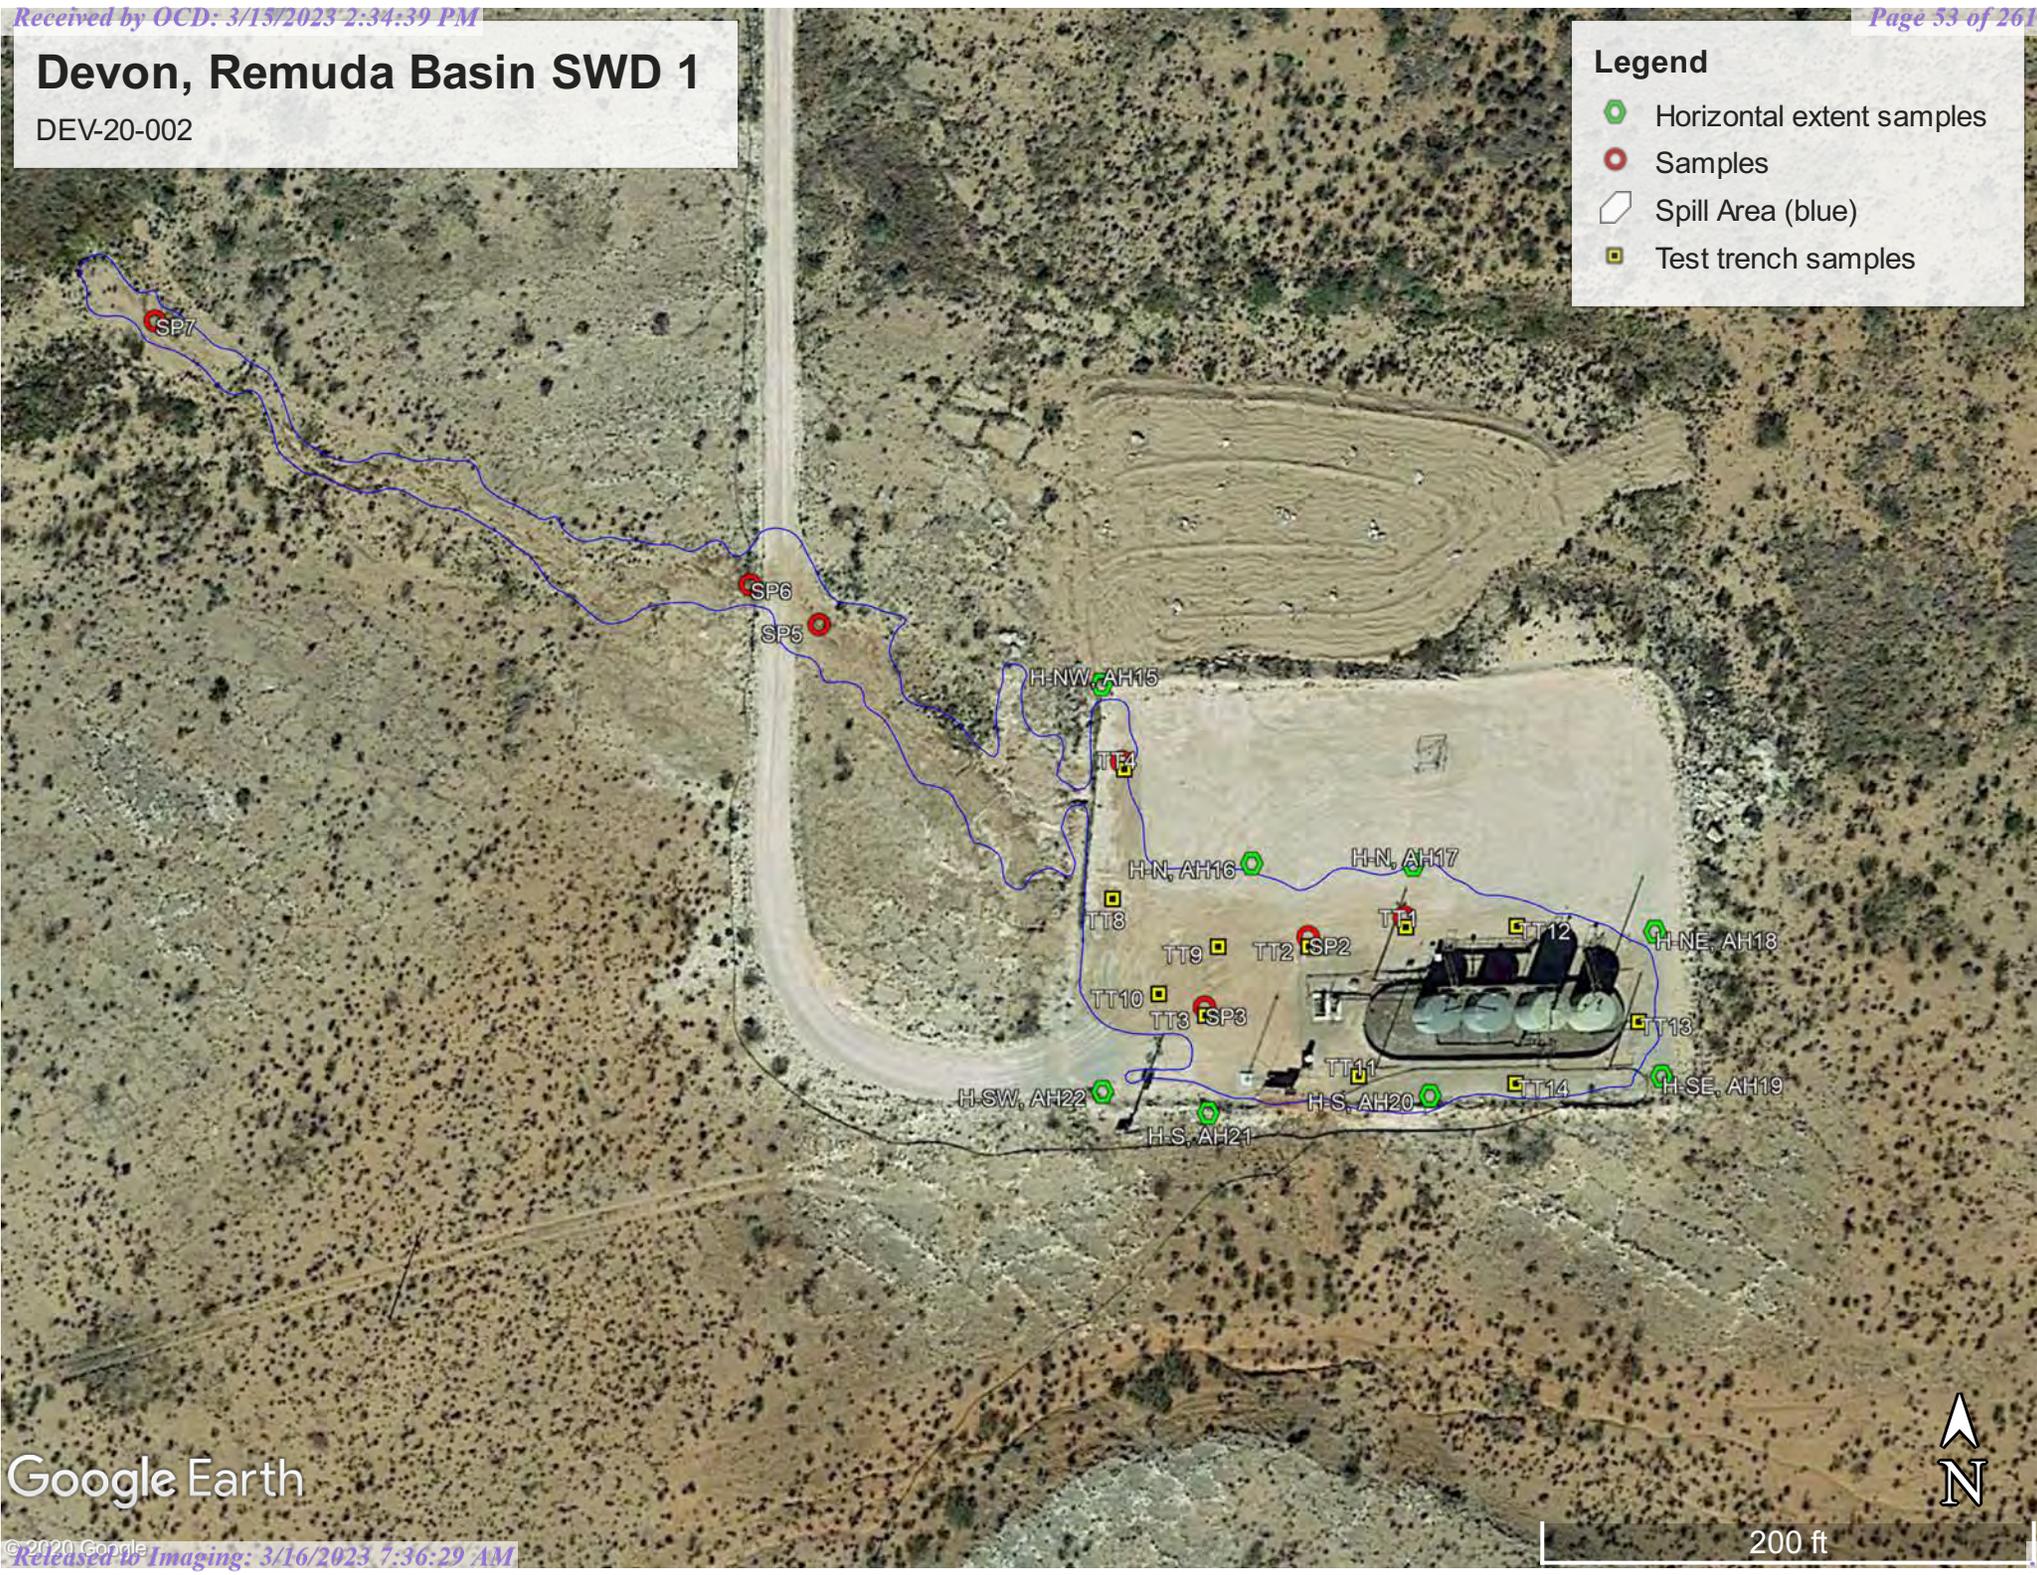
- Horizontal extent samples
- Samples
- Spill Area (blue)
- Test trench samples

The areas impacted off the location, S-4, 5, and 6 should be stripped of all impacted material down to rock. I suggest pressure washing all loose material from the site, recovering the fluids at a catchment, or multiple catchments as you progress toward the tail-end of the spill events.

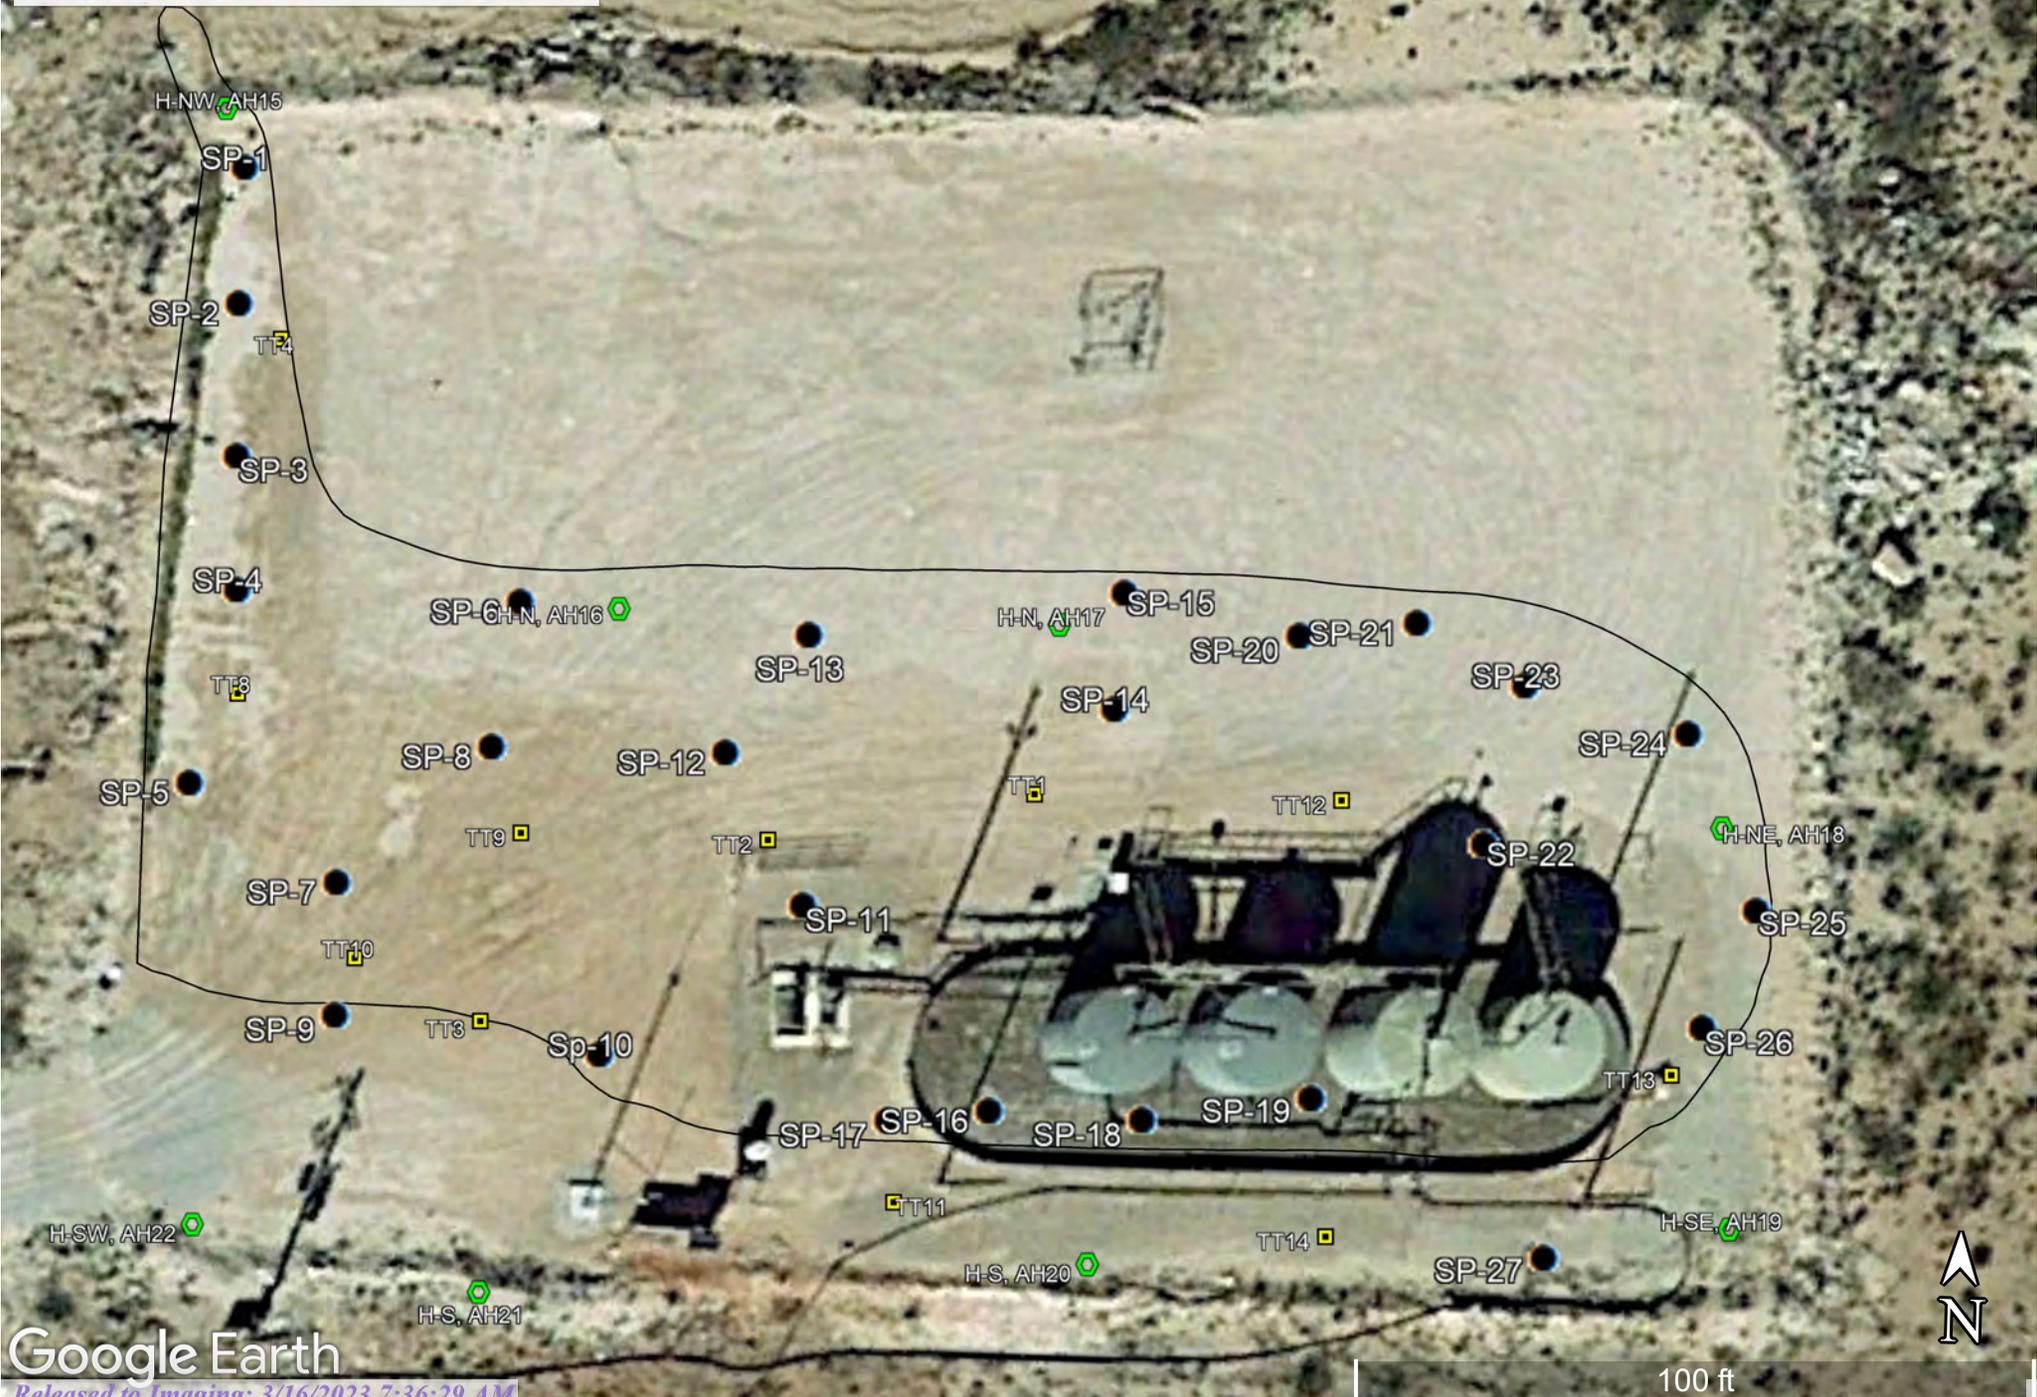
CS SP 1-27

Confirmation Sampling

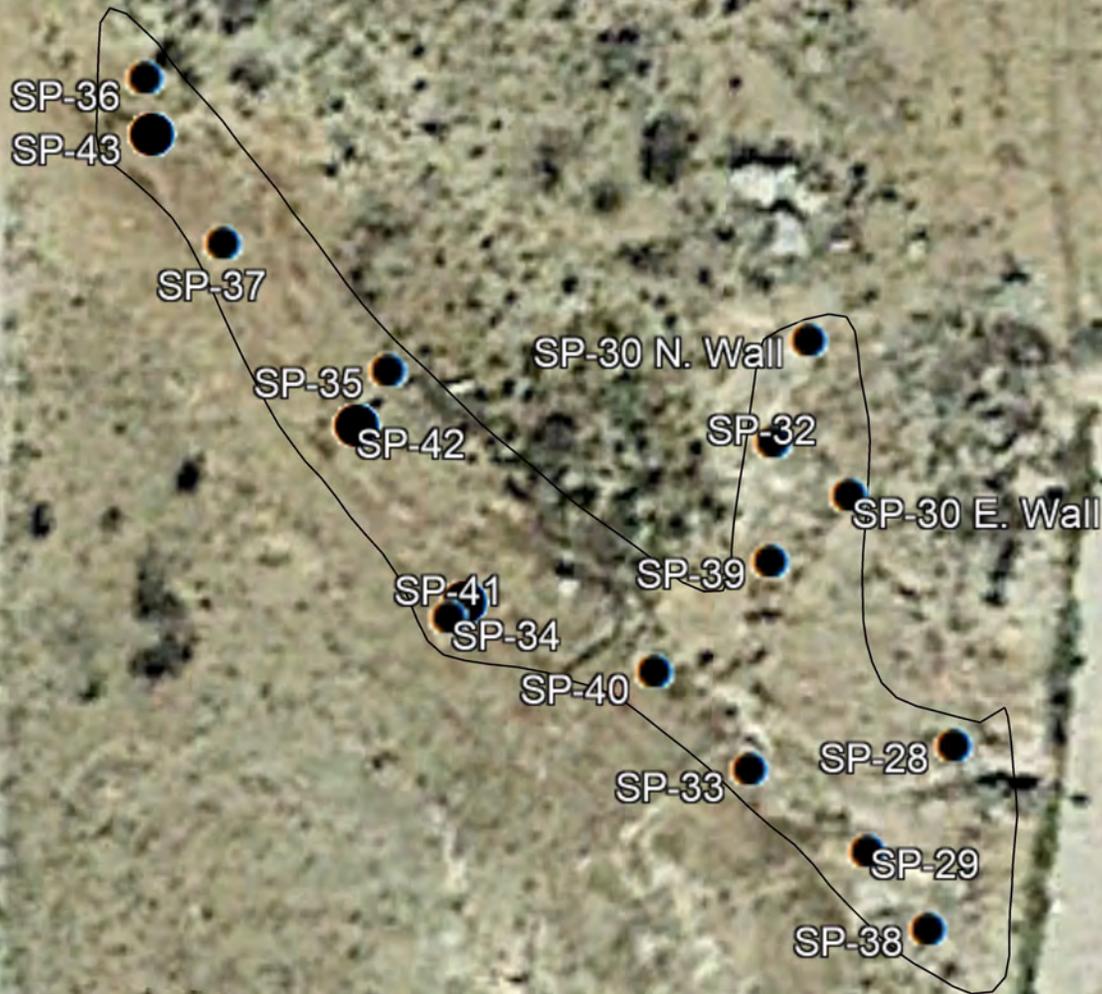
CS SP 28-43

Confirmation Sampling

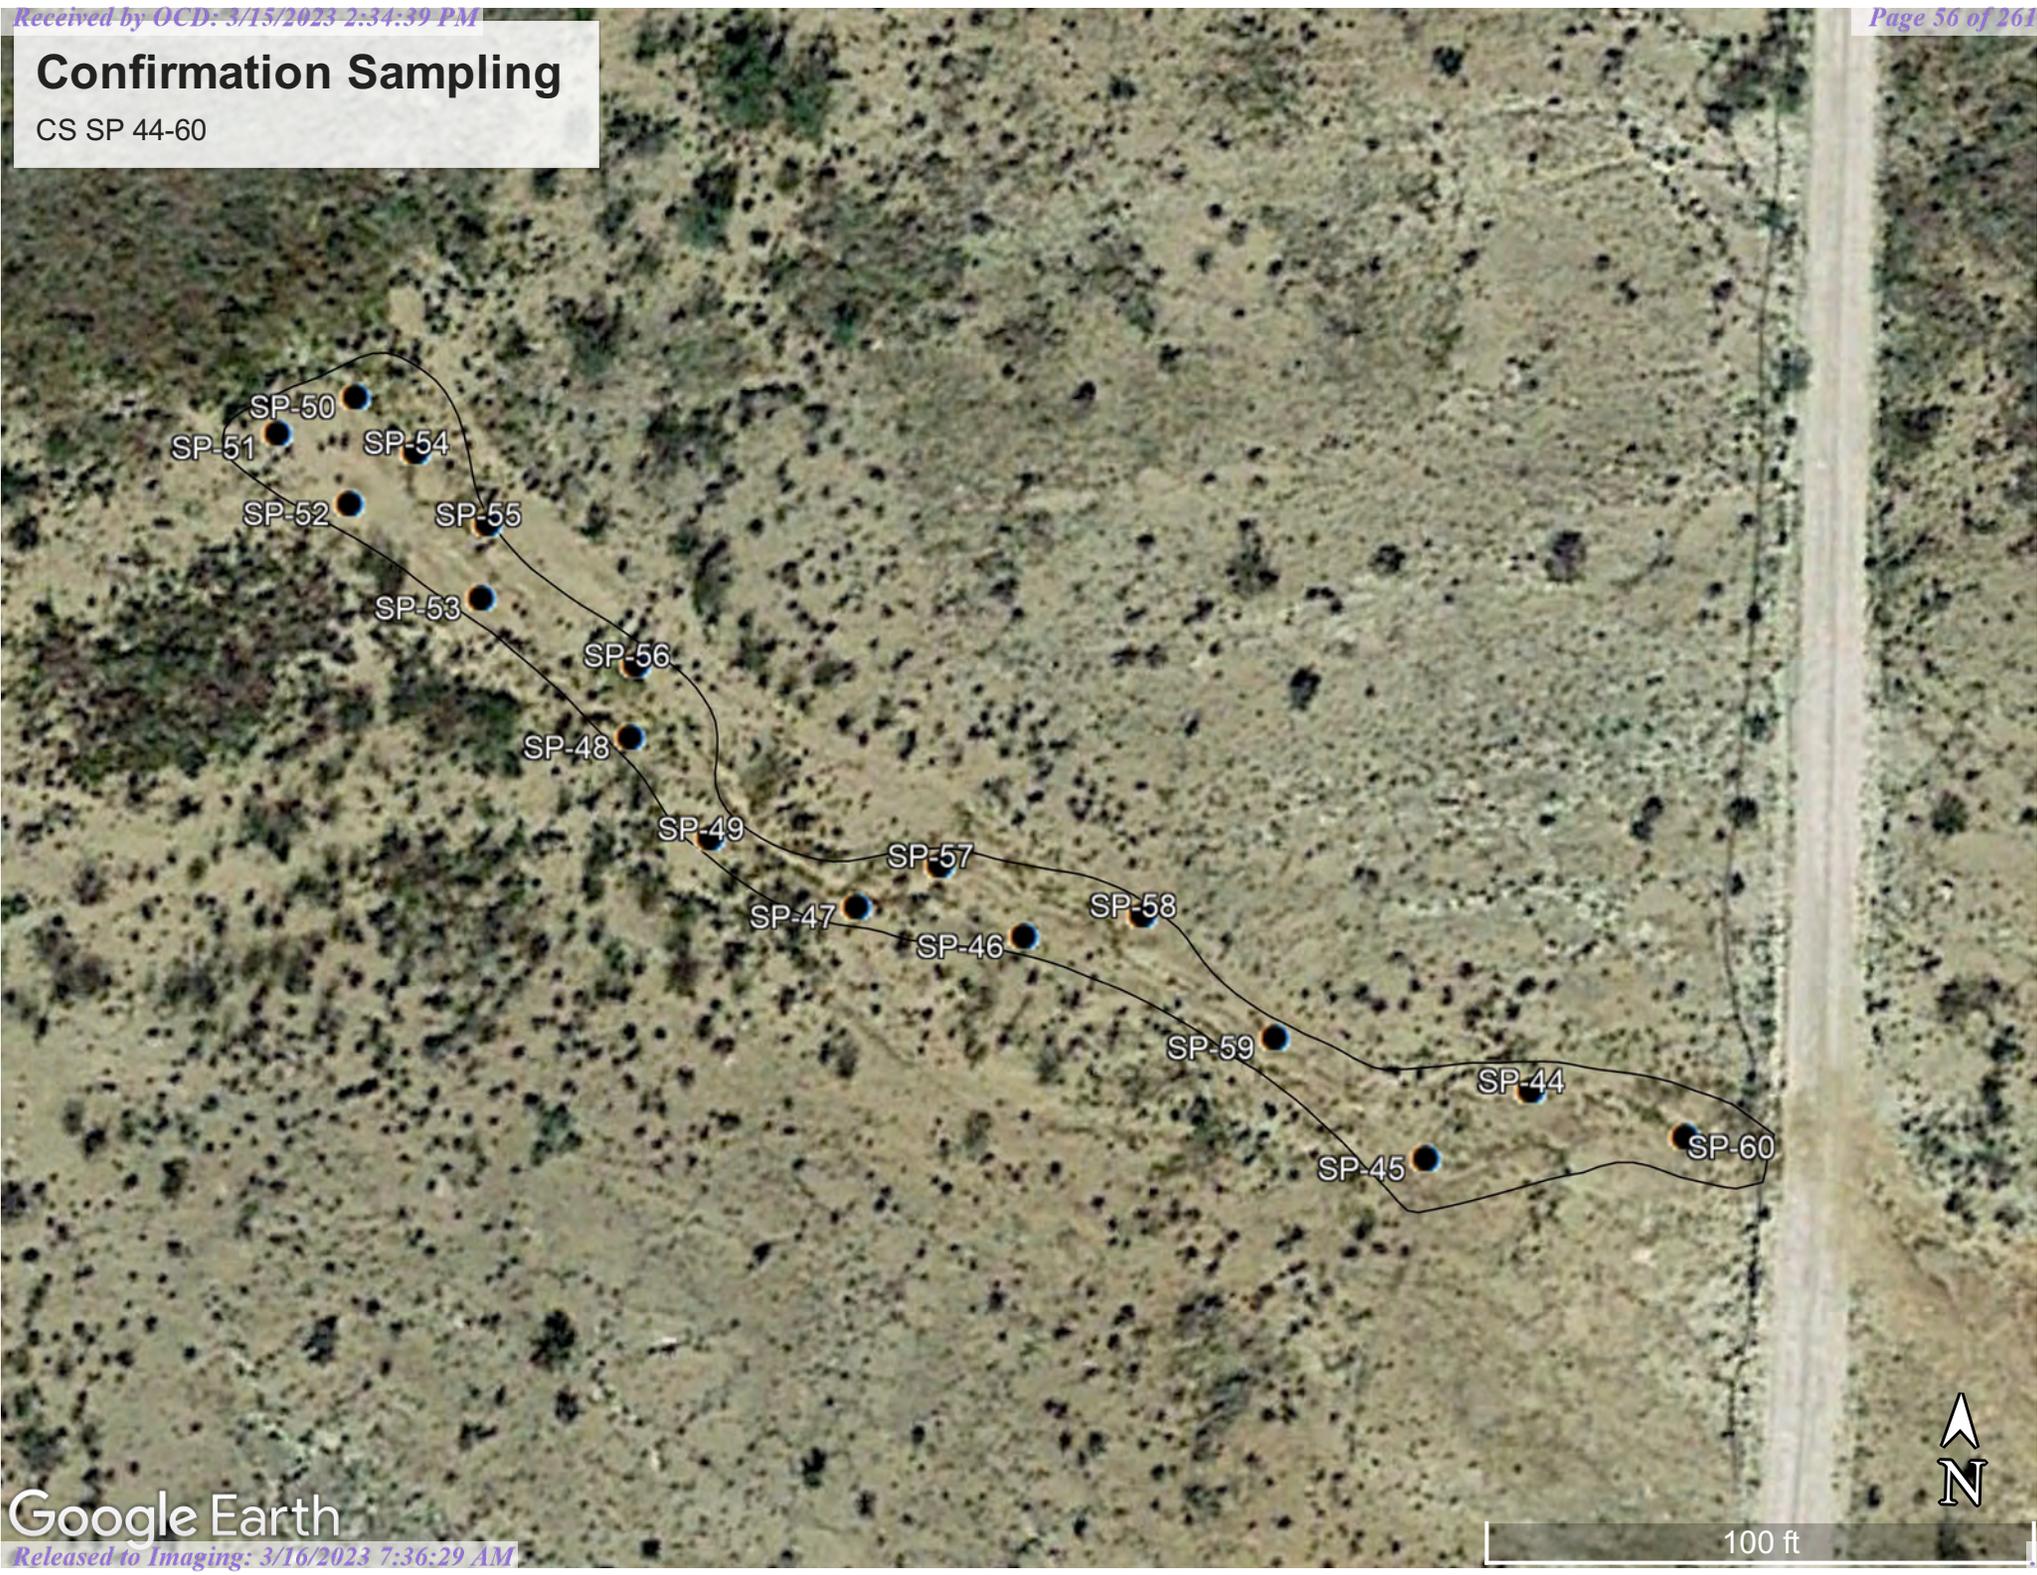
CS SP 44-60

Confirmation Sampling

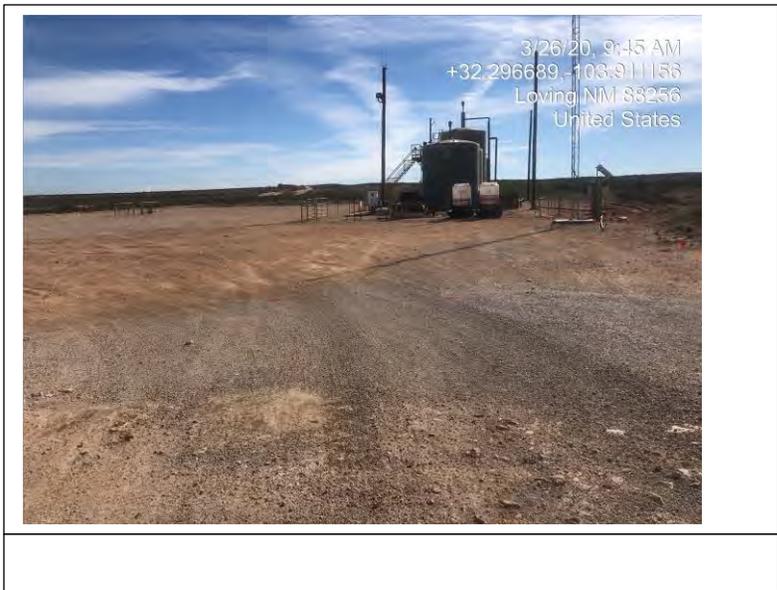
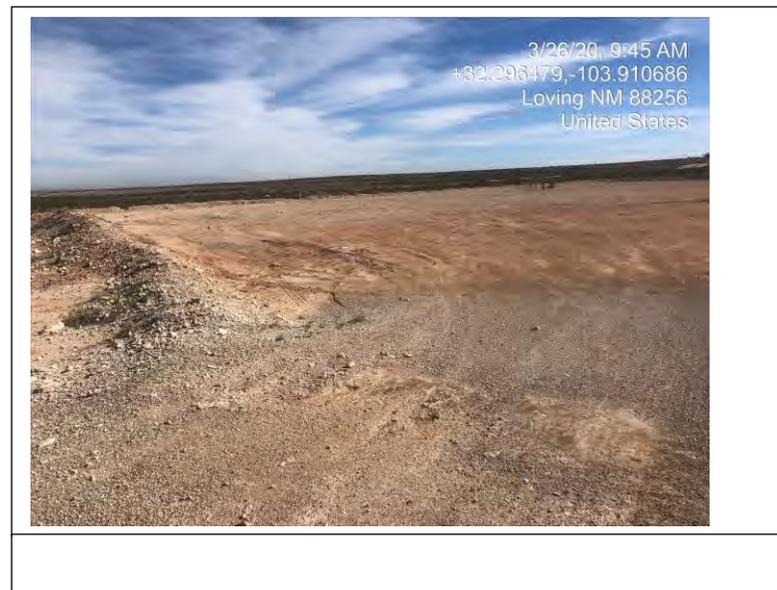
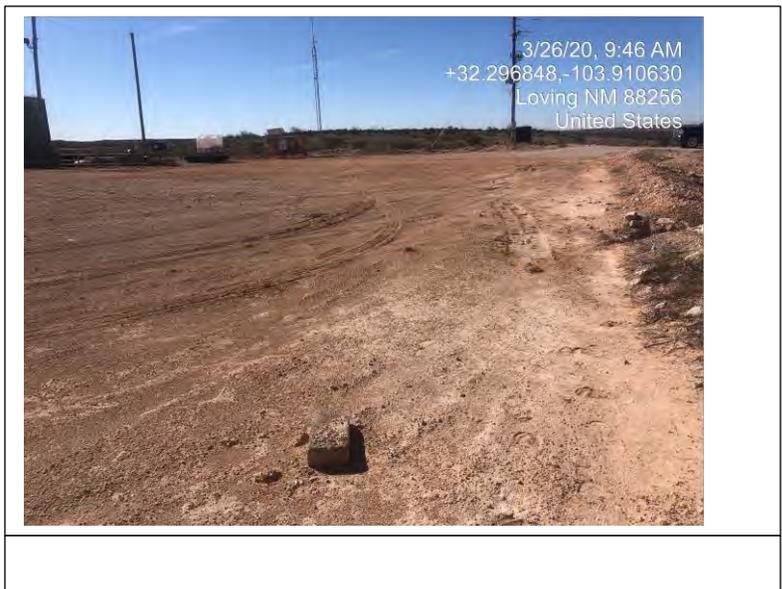
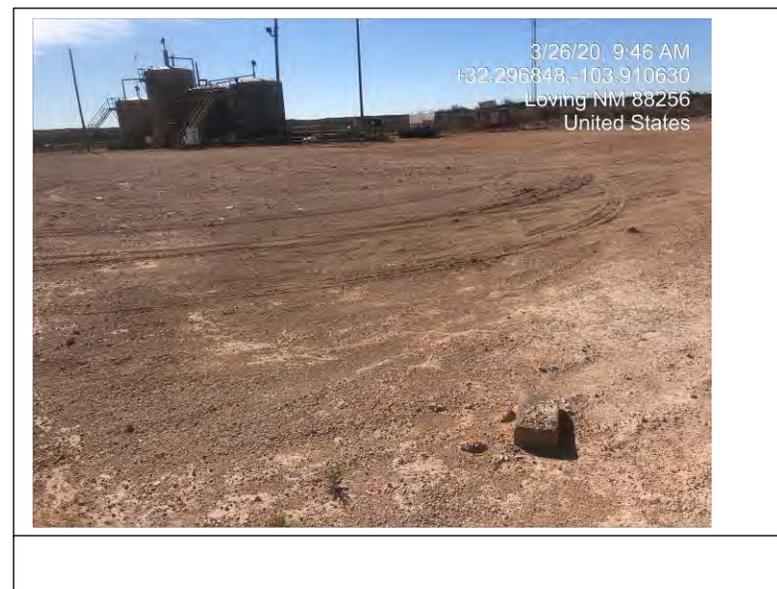
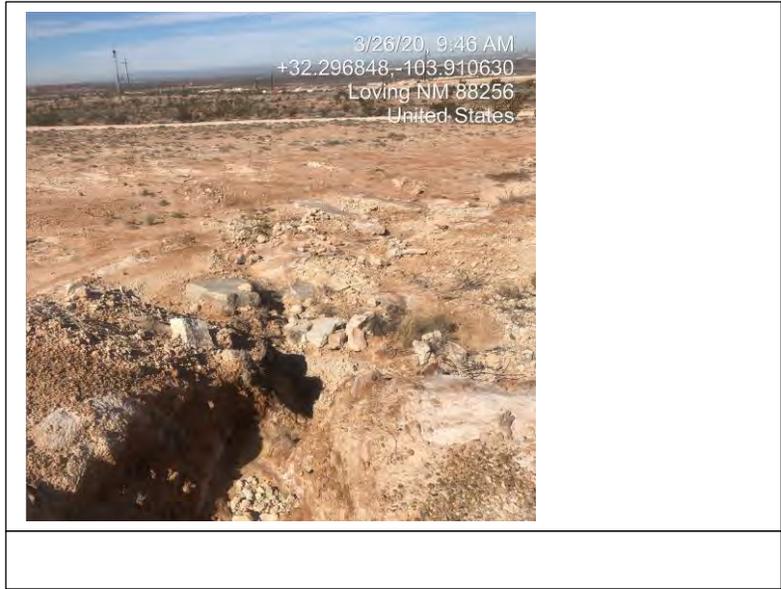
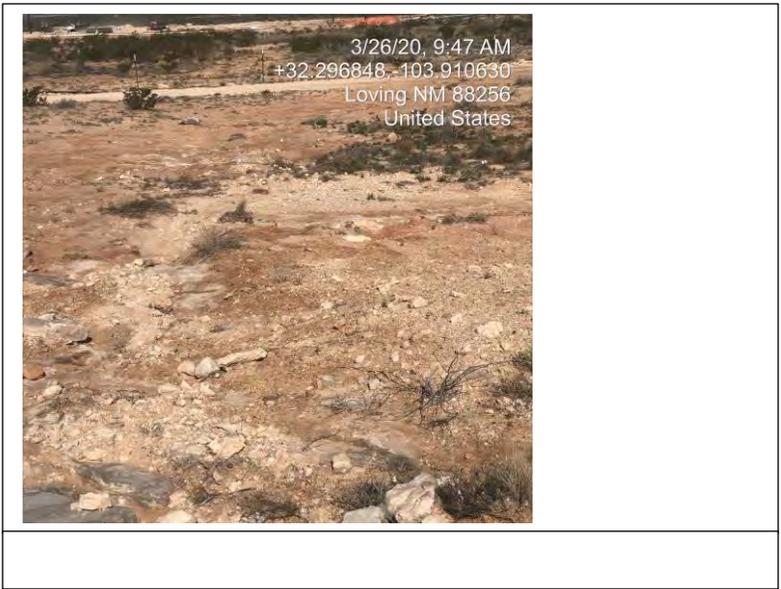
Figure 2: Photos of release and remediation

Devon Energy
Remuda Basin SWD 1 Excavation & Remediation
