Remediation Summary and Closure Request

Bulldog 12"

Lea County, New Mexico

NMOCD Incident # nAPP2302331665

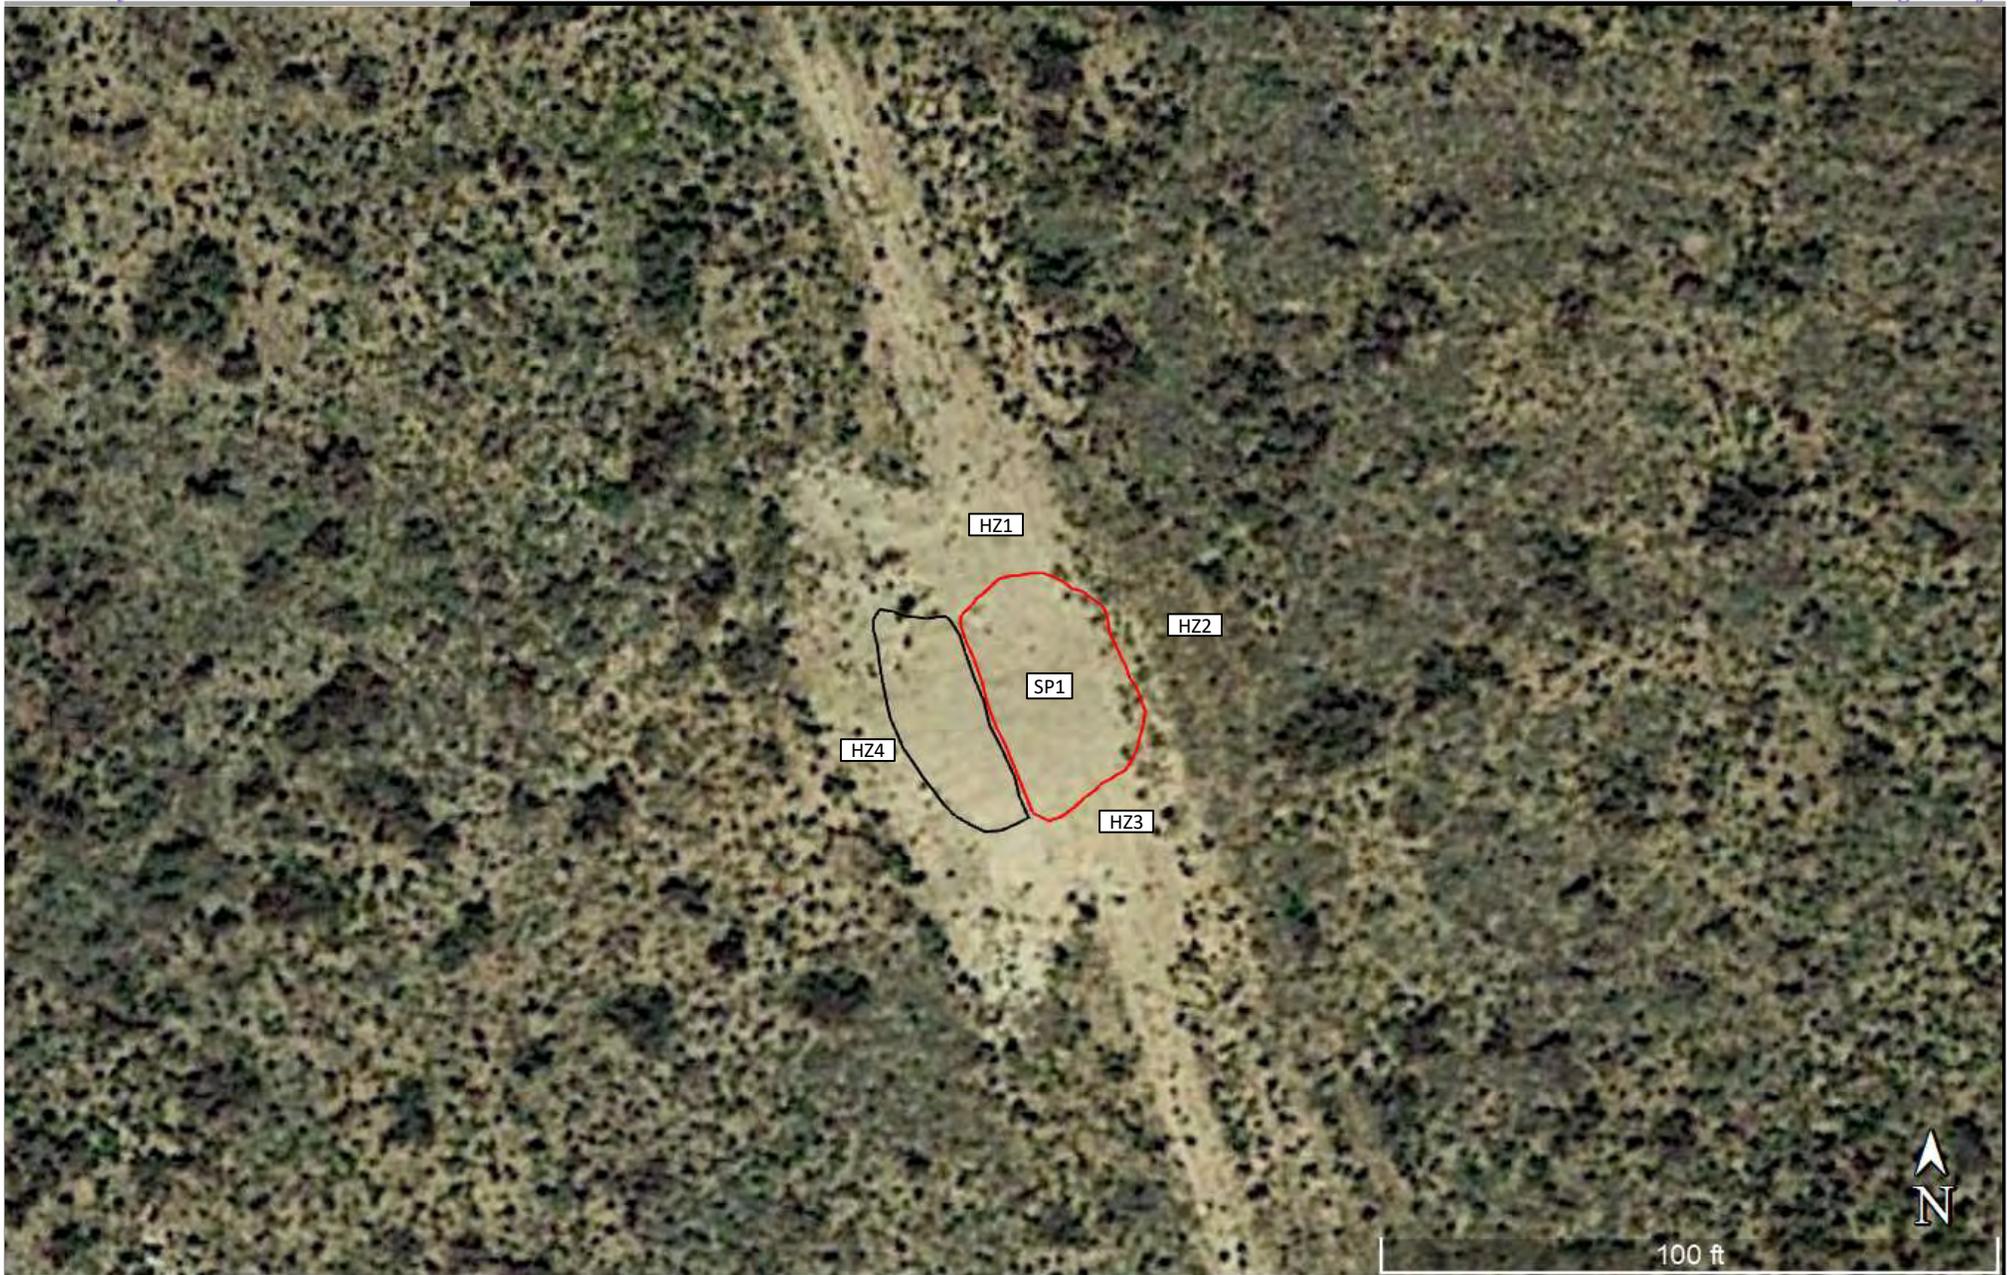
Figure 4

Delineation Sample Map
Frontier Field Services, LLC
Bulldog 12"
GPS: 32.748594, -103.757483
Lea County

Based on field observations and field test data noted above and provided in Attachment V, ten representative soil samples, two from each sample location, were selected for laboratory analysis. Delineation soil samples SP1, and HZ1 through HZ4, were submitted to the laboratory for analysis of BTEX, TPH, and chloride. Laboratory analytical results indicated contaminant concentrations were below the NMOCD Closure Criteria in each of the submitted samples, with the exception of SP1 at Surface, which exhibited TPH concentrations in excess of NMOCD Closure Criteria.

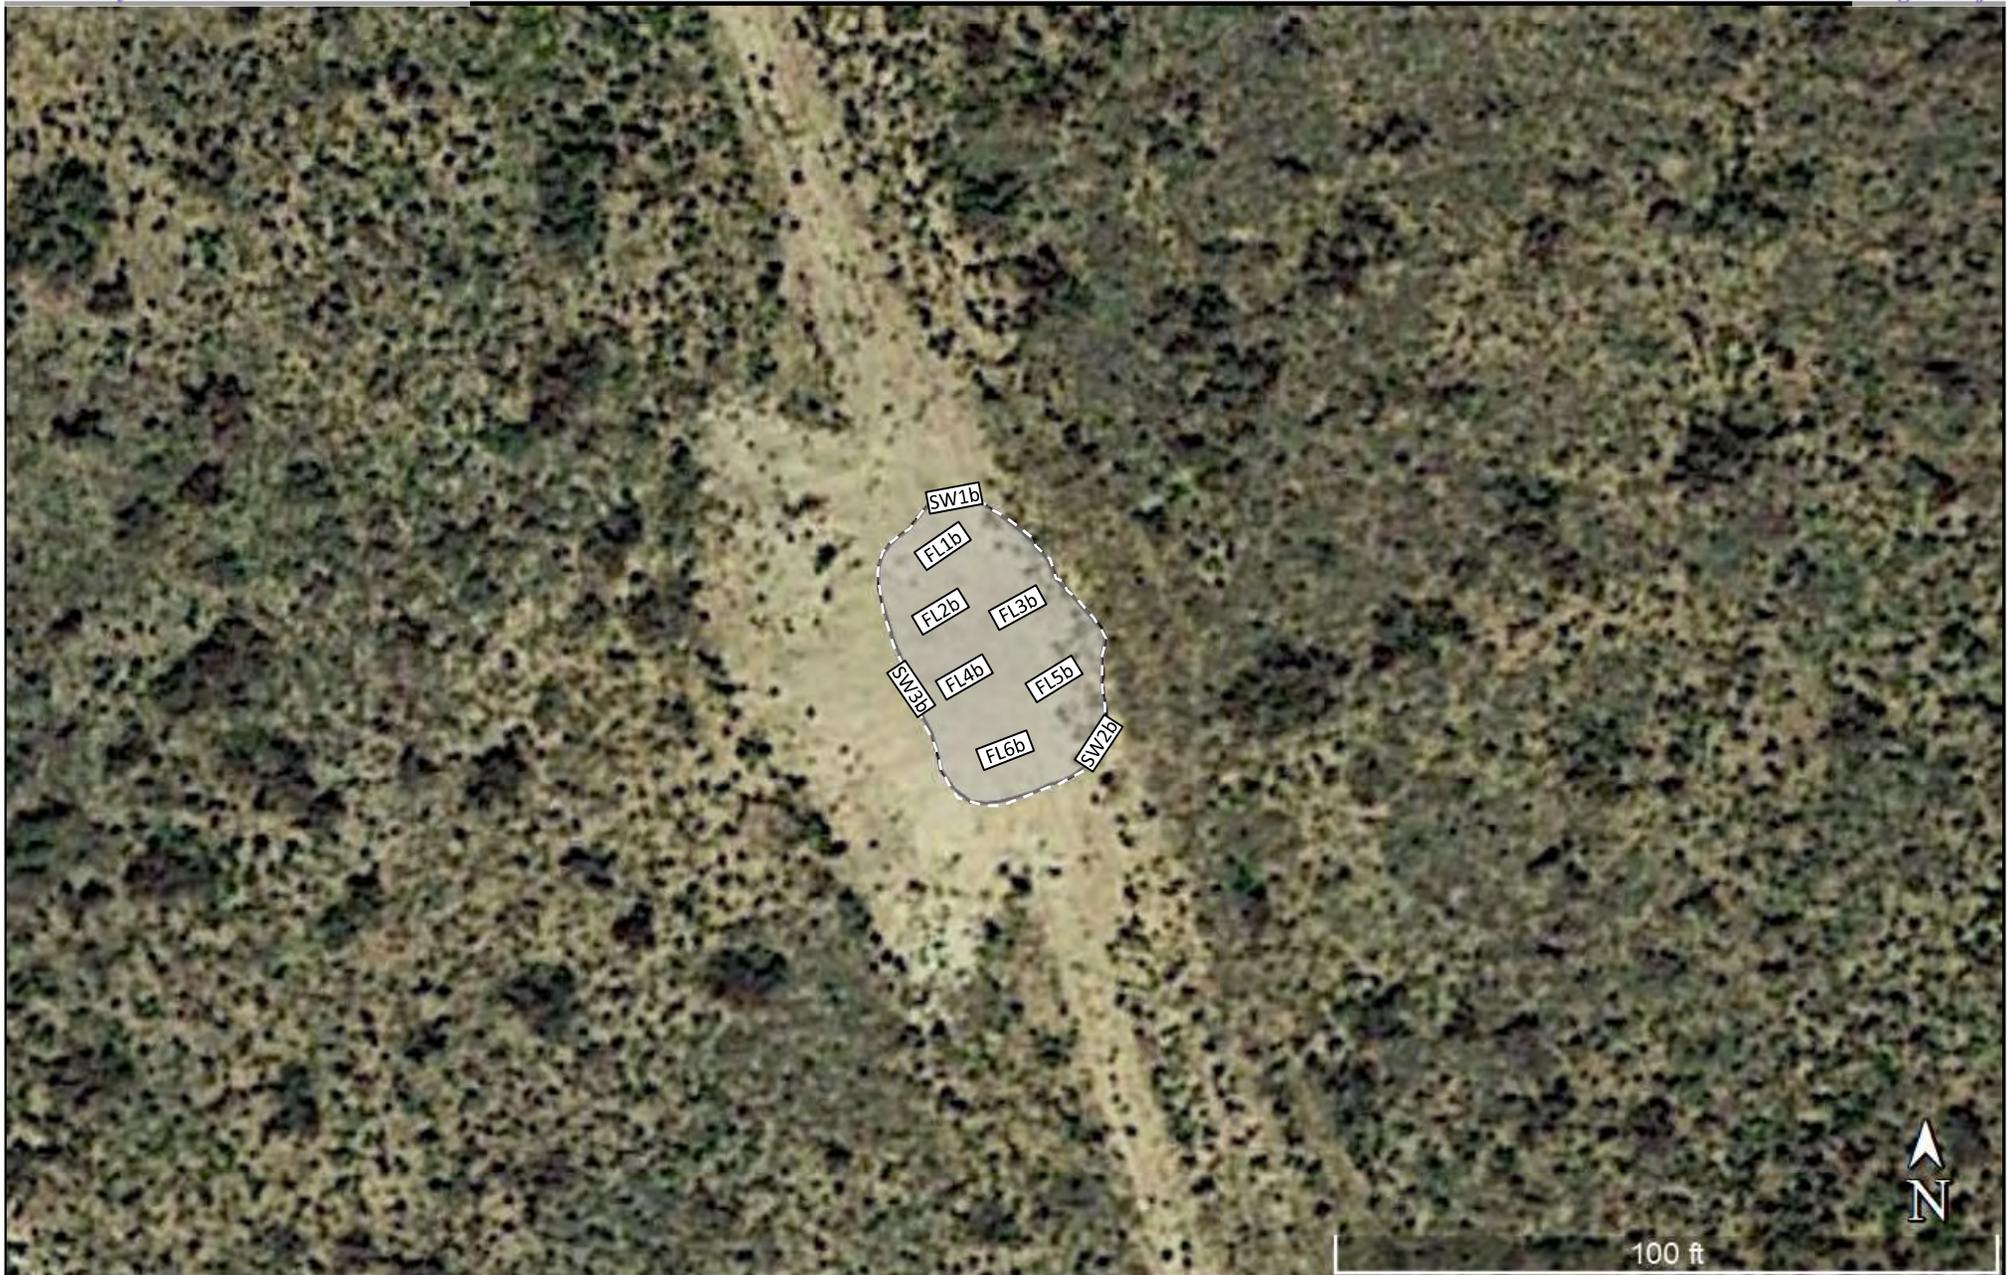
Figure 5

Excavation Sample Map
Frontier Field Services, LLC
Bulldog 12"
GPS: 32.748594, -103.757483
Lea County
