Release Notification and Corrective Action

Name of Company	Oxy Permian Ltd.	Contact	Wade Dittrich
Address	PO Box 4294; Houston, TX 77210	Telephone No.	(575) 390-2828
Facility Name	Pluma 29 State #001 Battery	Facility Type	Battery
Surface Owner	State	Mineral Owner	API No. 30-025-34517

Closure Report

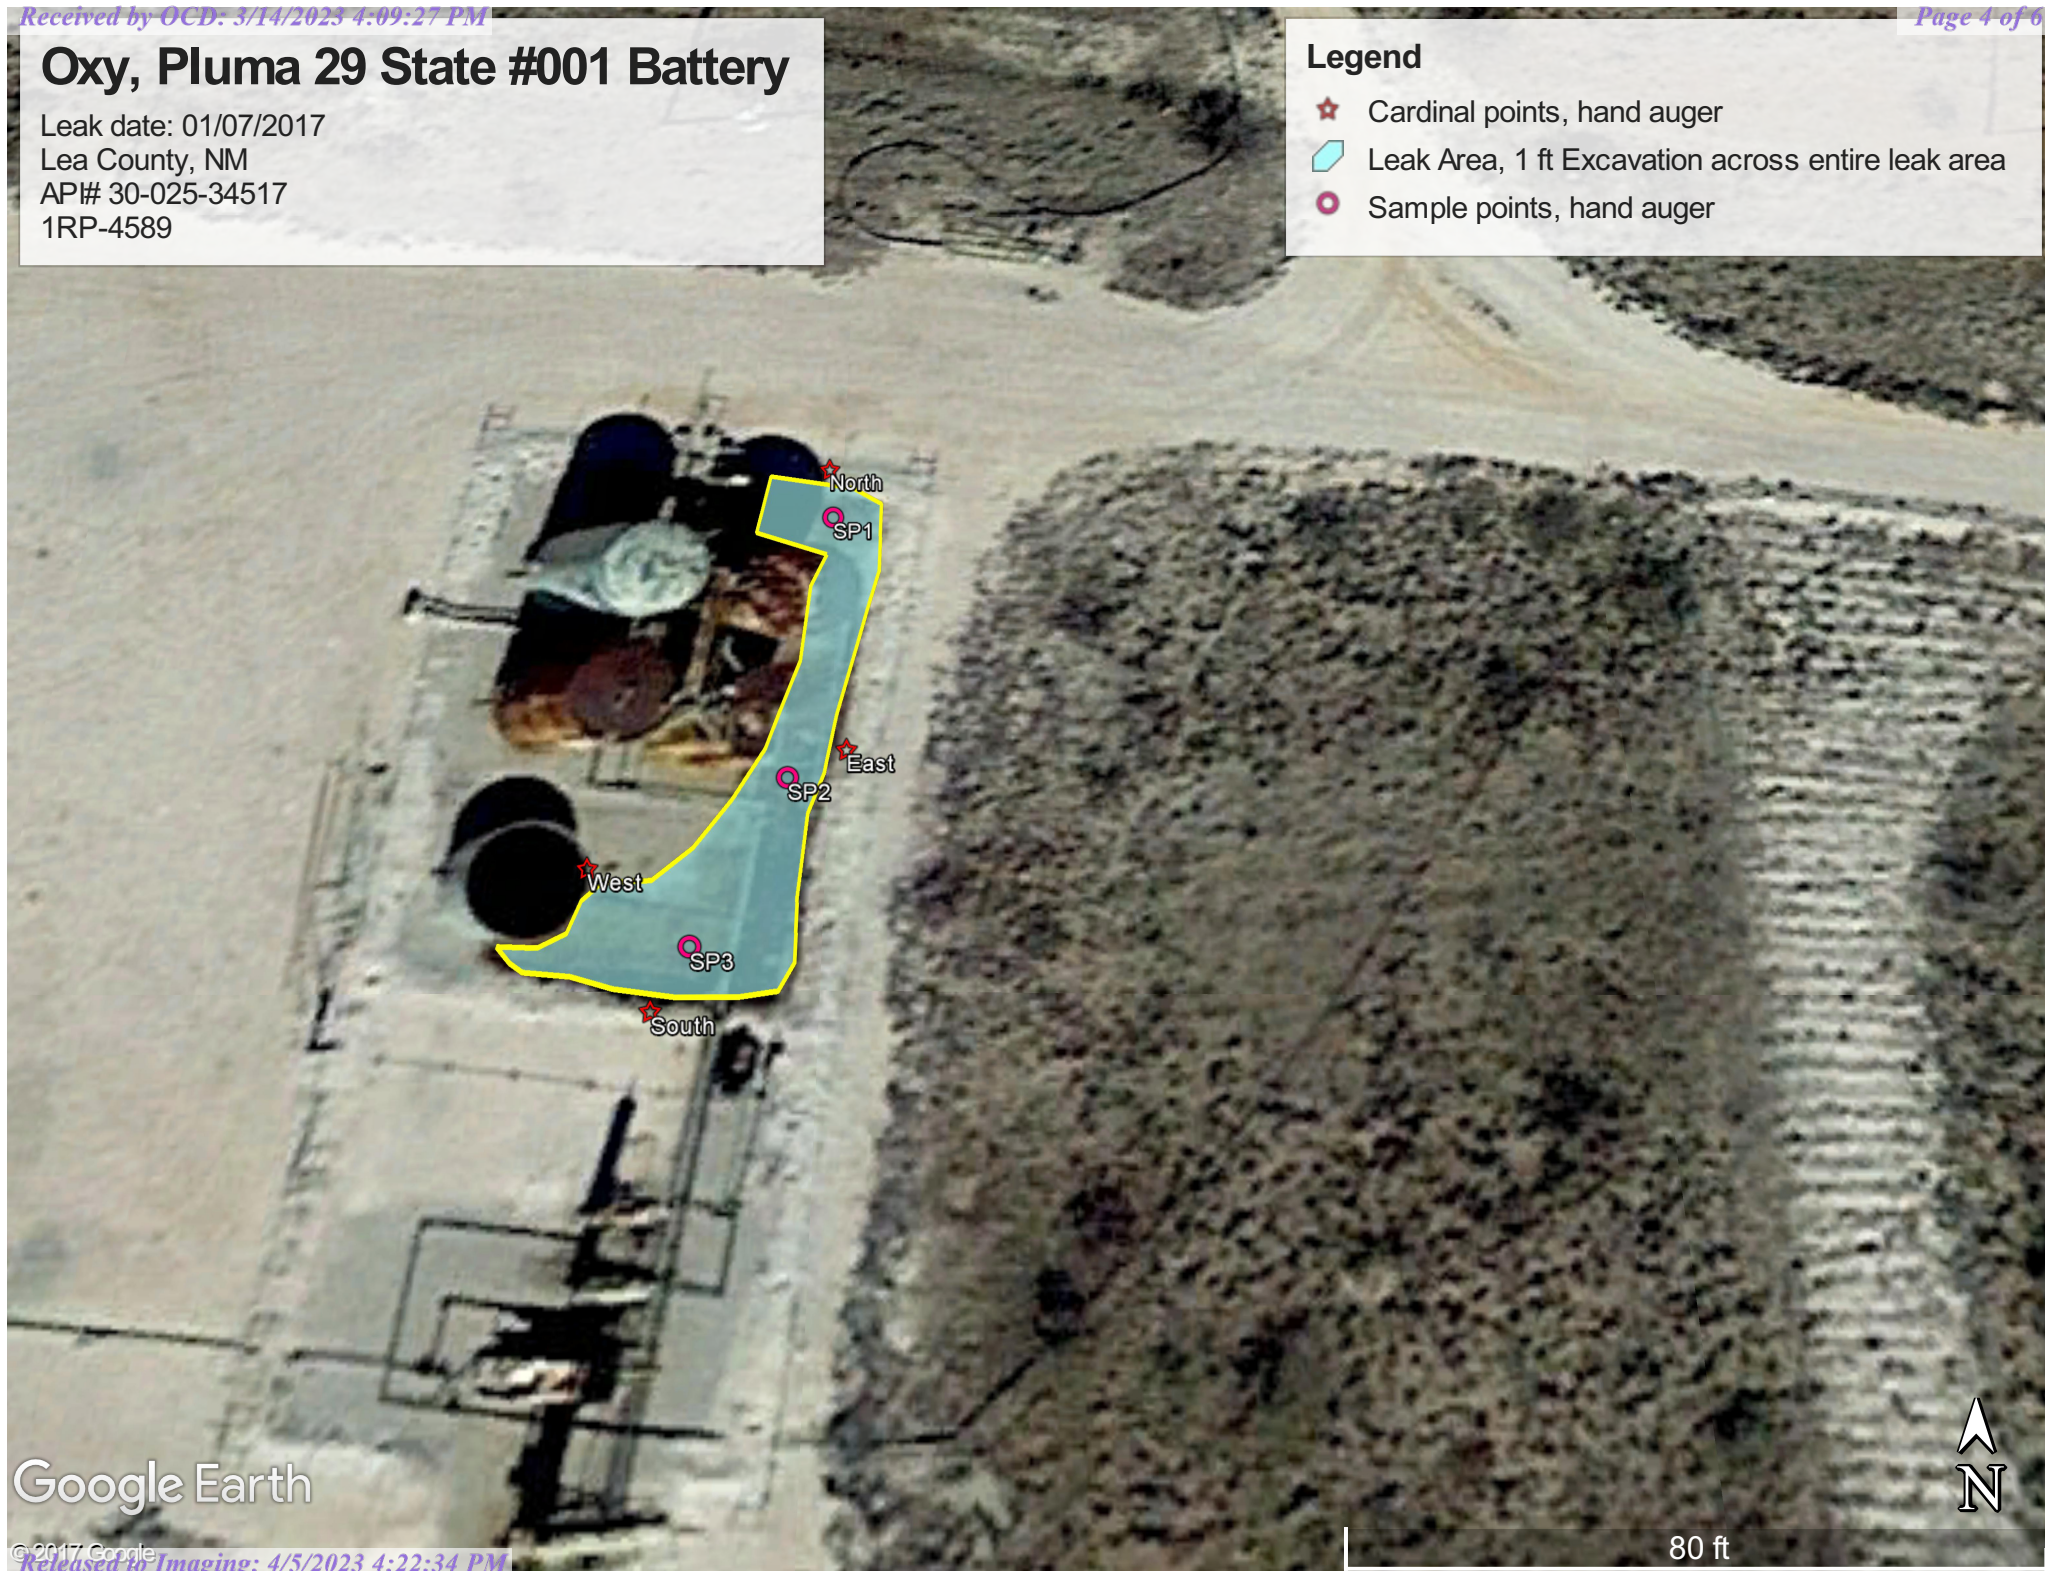
Leak date: 01/07/2017
Lea County, NM
API# 30-025-34517
1RP-4589

- ☆ Cardinal points, hand auger
- Leak Area, 1 ft Excavation across entire leak area
- Sample points, hand auger

The affected area is approximately 70' x 40' on location inside the berm. Remediation was completed in accordance with the remediation plan approved by Olivia Yu of NMOCD via email on 07/31/2017 and approved by Amber Groves of NMSLO via email on 08/02/2017.
