# Closure Report

Site Name:	Bravo Dome Leg 5 4RP-12
Company:	Oxy USA Inc.
Legal Description:	U/L G, Section 3, T18S, R34E
County:	Union County, NM
GPS Coordinates:	N 35.82557 W-103.30850

Date of Release:	2/15/17
Type of Release:	Produced water
Source of Release:	Internal corrosion leak of 8" steel pipeline
Volume of Release:	7 bbls
Volume Recovered:	0 bbls

## Oxy, Bravo Dome Leg 5

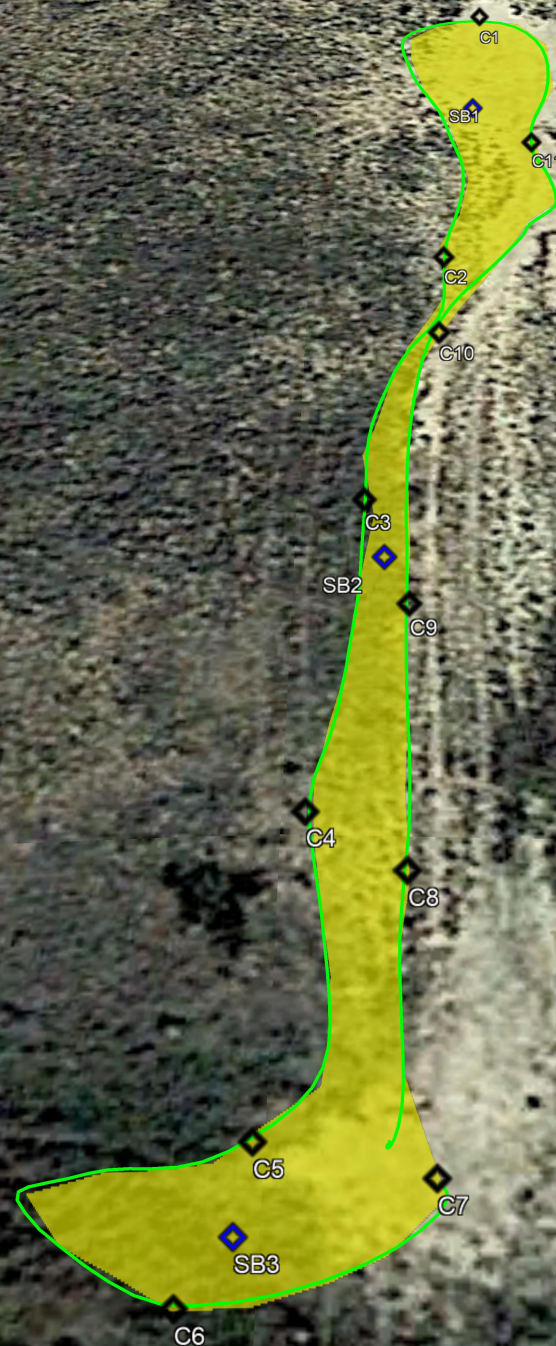
Leak date: 2/15/17  
Union County, NM  
AP# 30-059-20241  
4RP-12

4 ft Excavation with a liner
-

Confirmation sample points
-

Drilling, soil borings
-

Spill area

Remediation Parameters:	Excavated the entire leak to a depth of 4 feet and placed an impermeable liner in the excavation. Confirmation sidewall samples were obtained to confirm a chloride concentration of less than 600 ppm. The site was then backfilled with clean soil.	
Remediation Activities:	5/9/19 to 5/17/19	
Plan Sent to OCD:	11/7/18	Email from Cliff Brunson to Randolph Bayliss
OCD Approval of Plan:	11/8/18	Email from Randolph Bayliss to Cliff Brunson
Plan Sent to BLM:	n/a	n/a
BLM Approval of Plan:	n/a	n/a

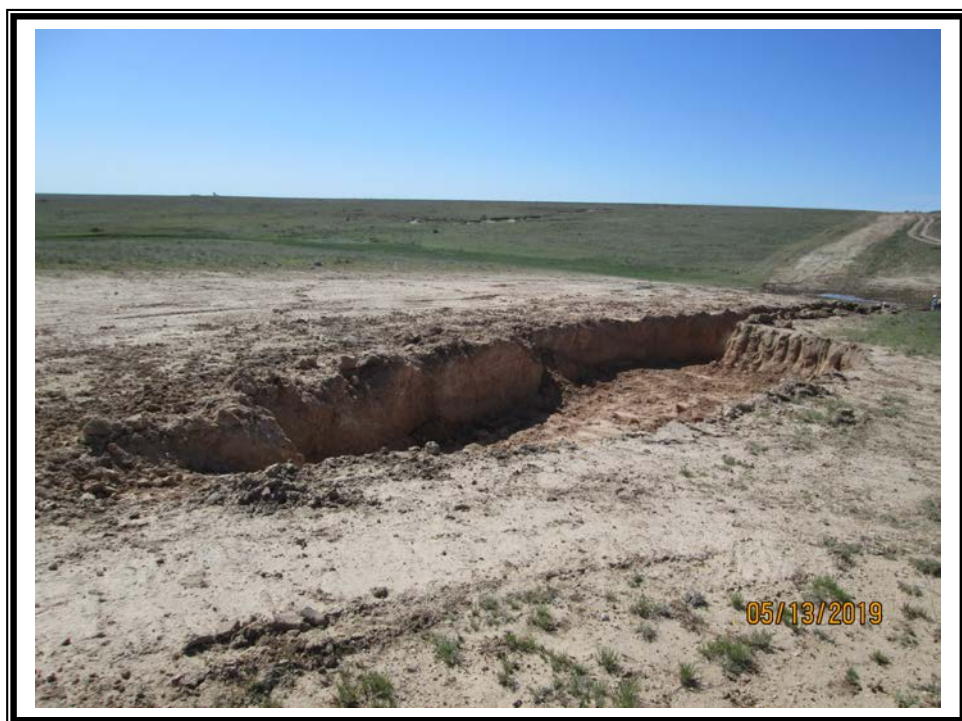
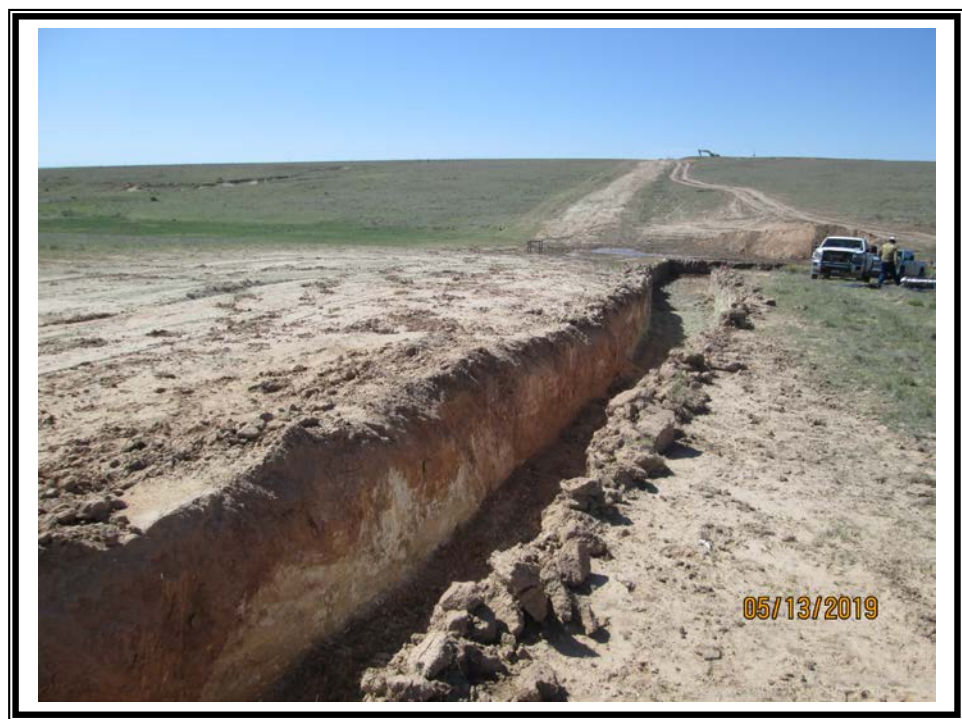
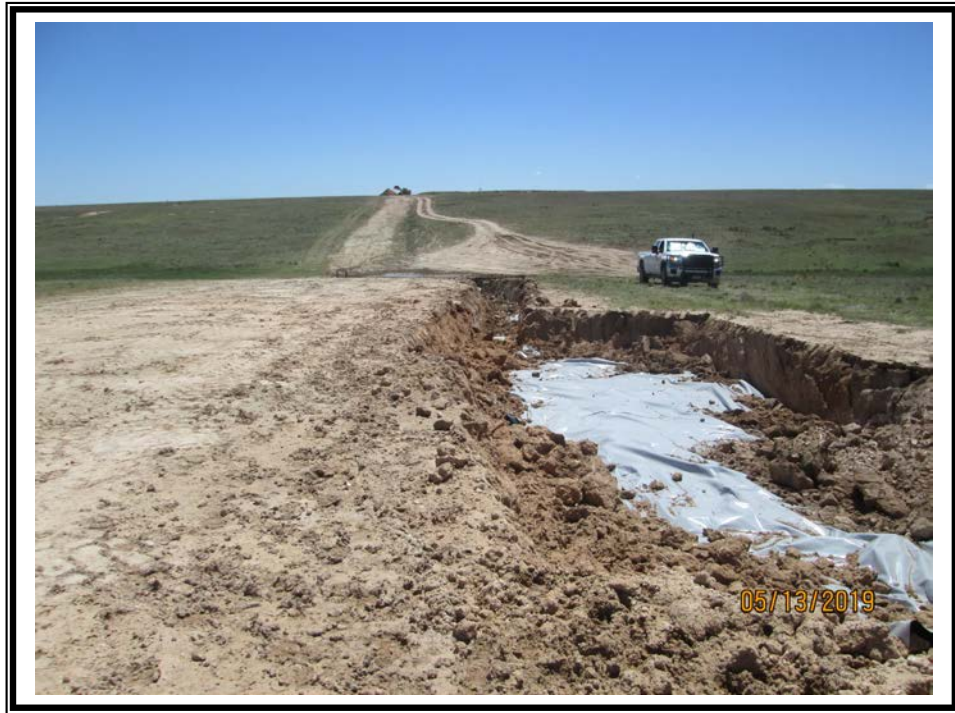
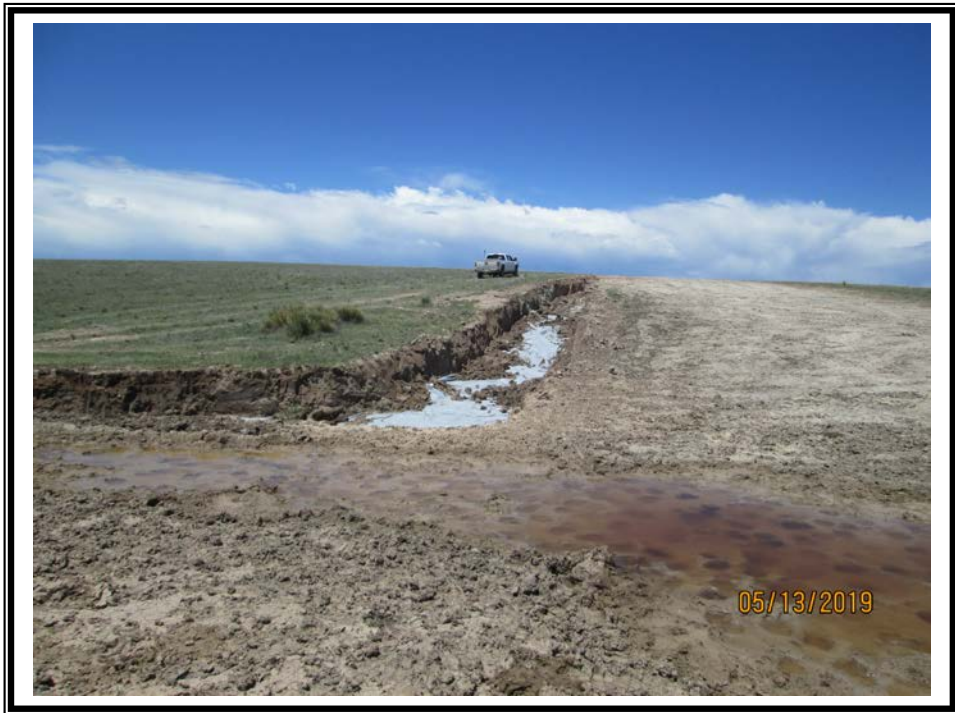
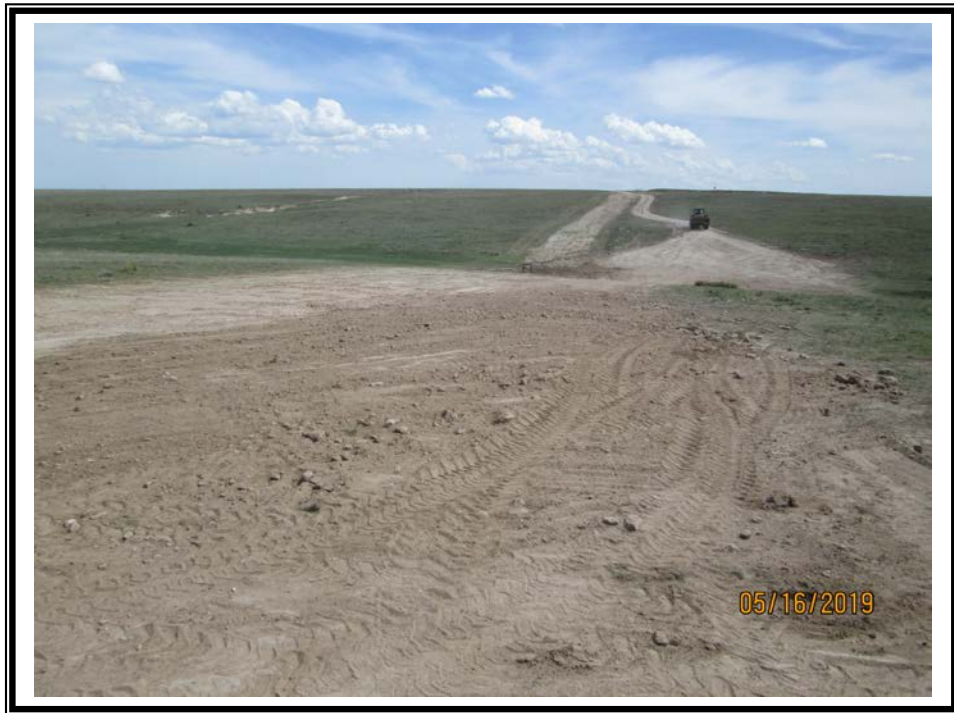
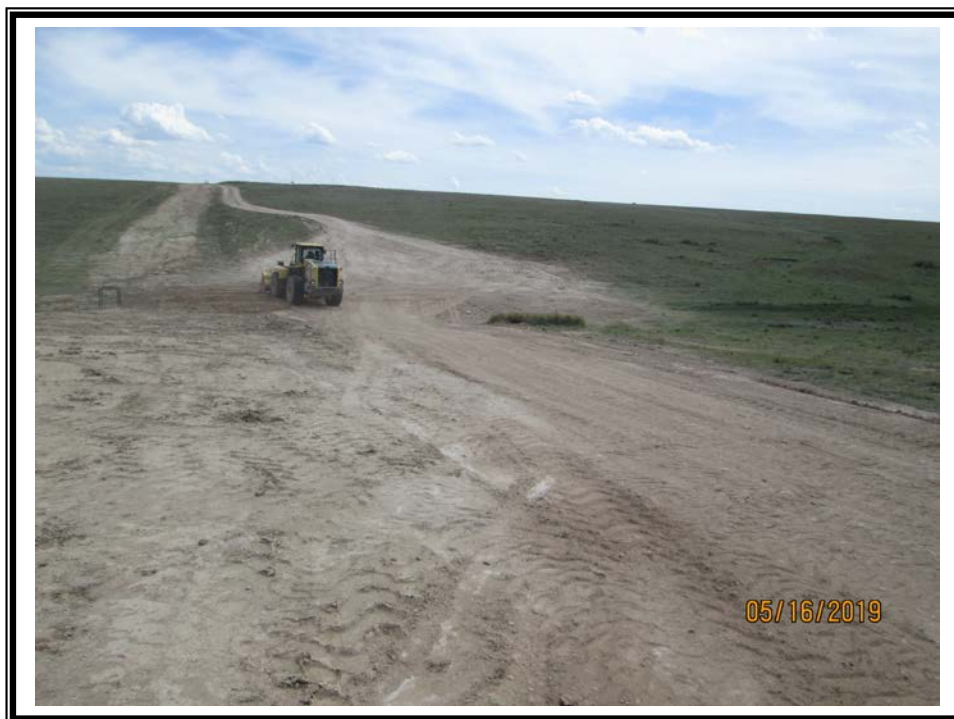
Initial C-141	Provided in the delineation workplan
C-141, page 6	Signed and included
Site Diagram	November 2018
Pictures	Remediation pictures prior to and after backfill
