November 30, 2022

Vertex Project #: 22E-03903

Spill Closure Report: Hudson 11 Federal #002
Section 11, Township 18 South, Range 31 East
API: 30-015-25740
County: Eddy
Incident Report: nAPP2231370856

2022 Spill Assessment and Remediation
November 2022

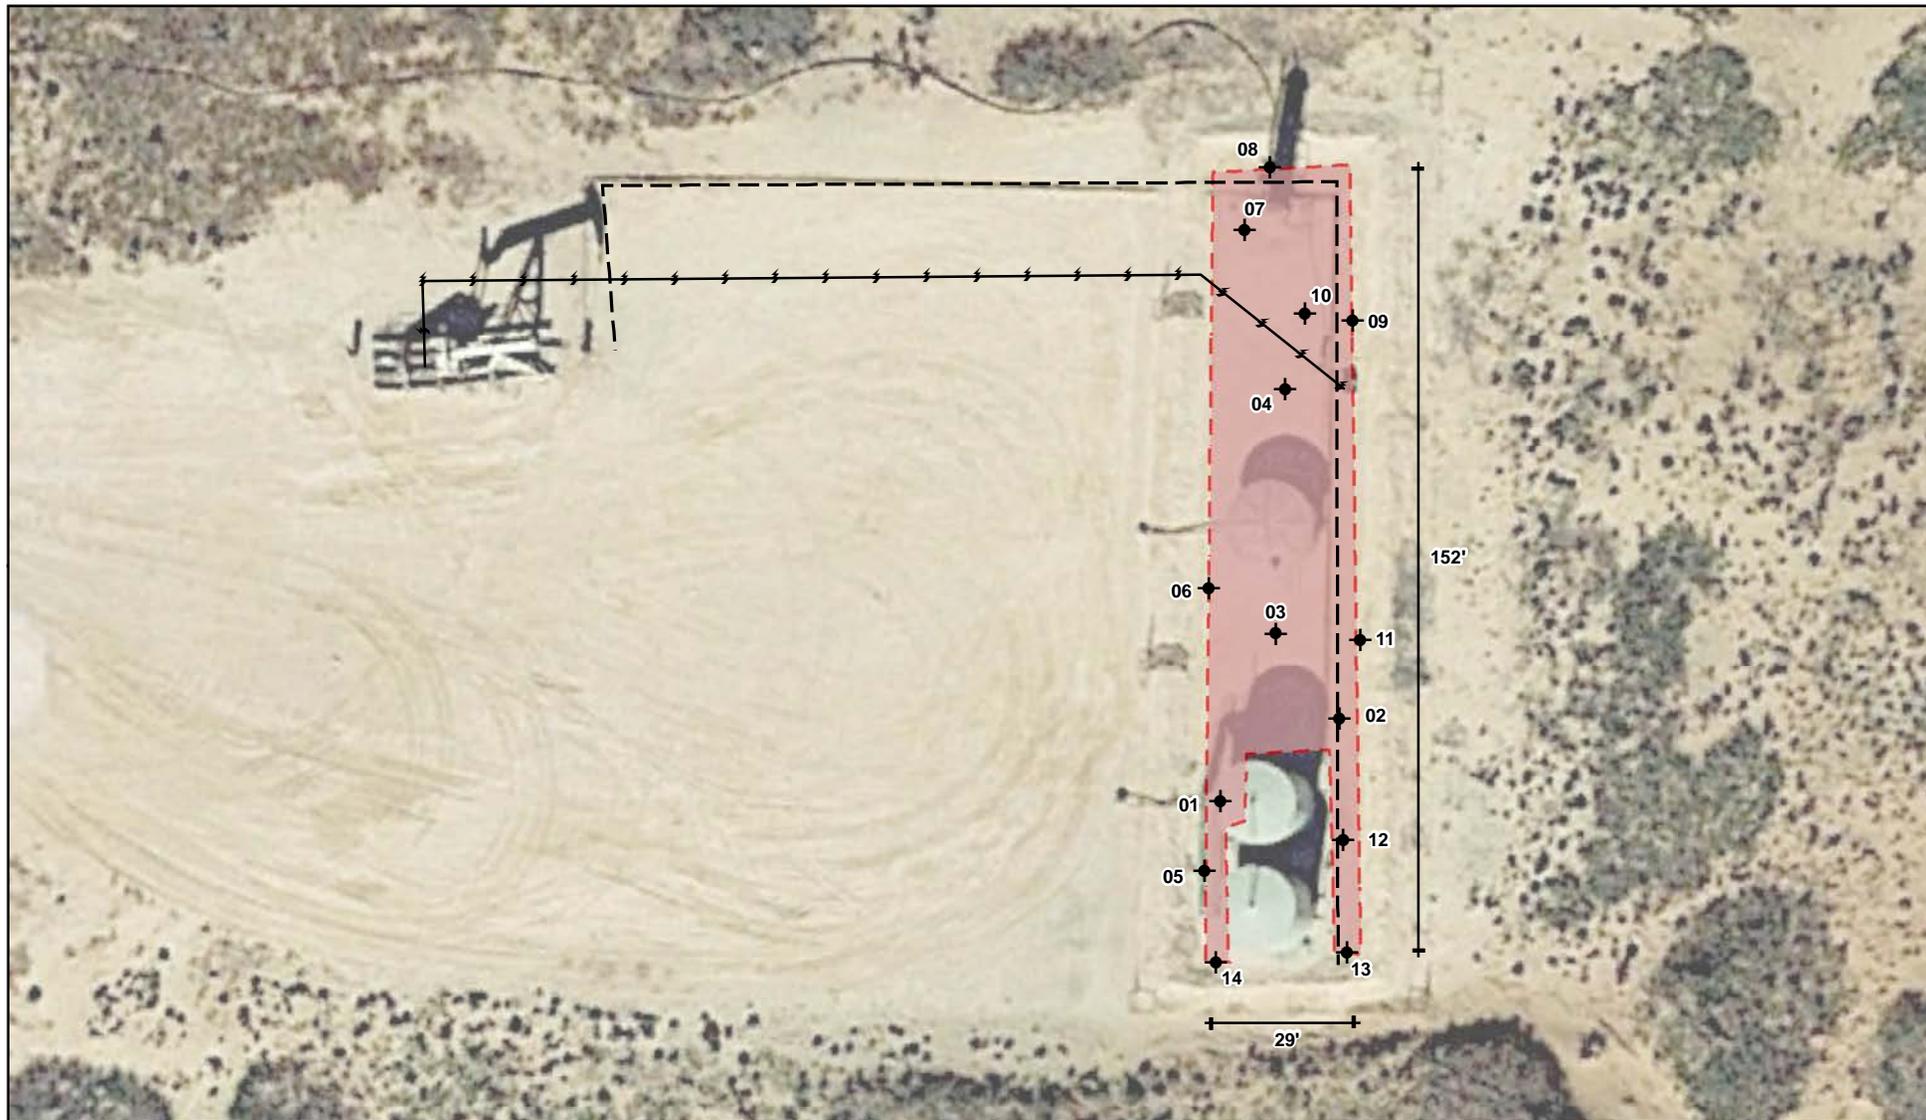
- ◆ Testpit (Prefixed by "TP22-")
- Aboveground Pipeline
- ⚡ Electrical Line
- Approximate Release Area (~3,271 sq. ft.)

The site is located approximately 9.34 miles southeast of Loco Hills, New Mexico (Google Inc., 2022). The legal location for the site is Section 11, Township 18 South and Range 31 East in Eddy County, New Mexico. The spill area is located on Bureau of Land Management (BLM) property. An aerial photograph and site schematic are included on Figure 1 (Attachment 1).

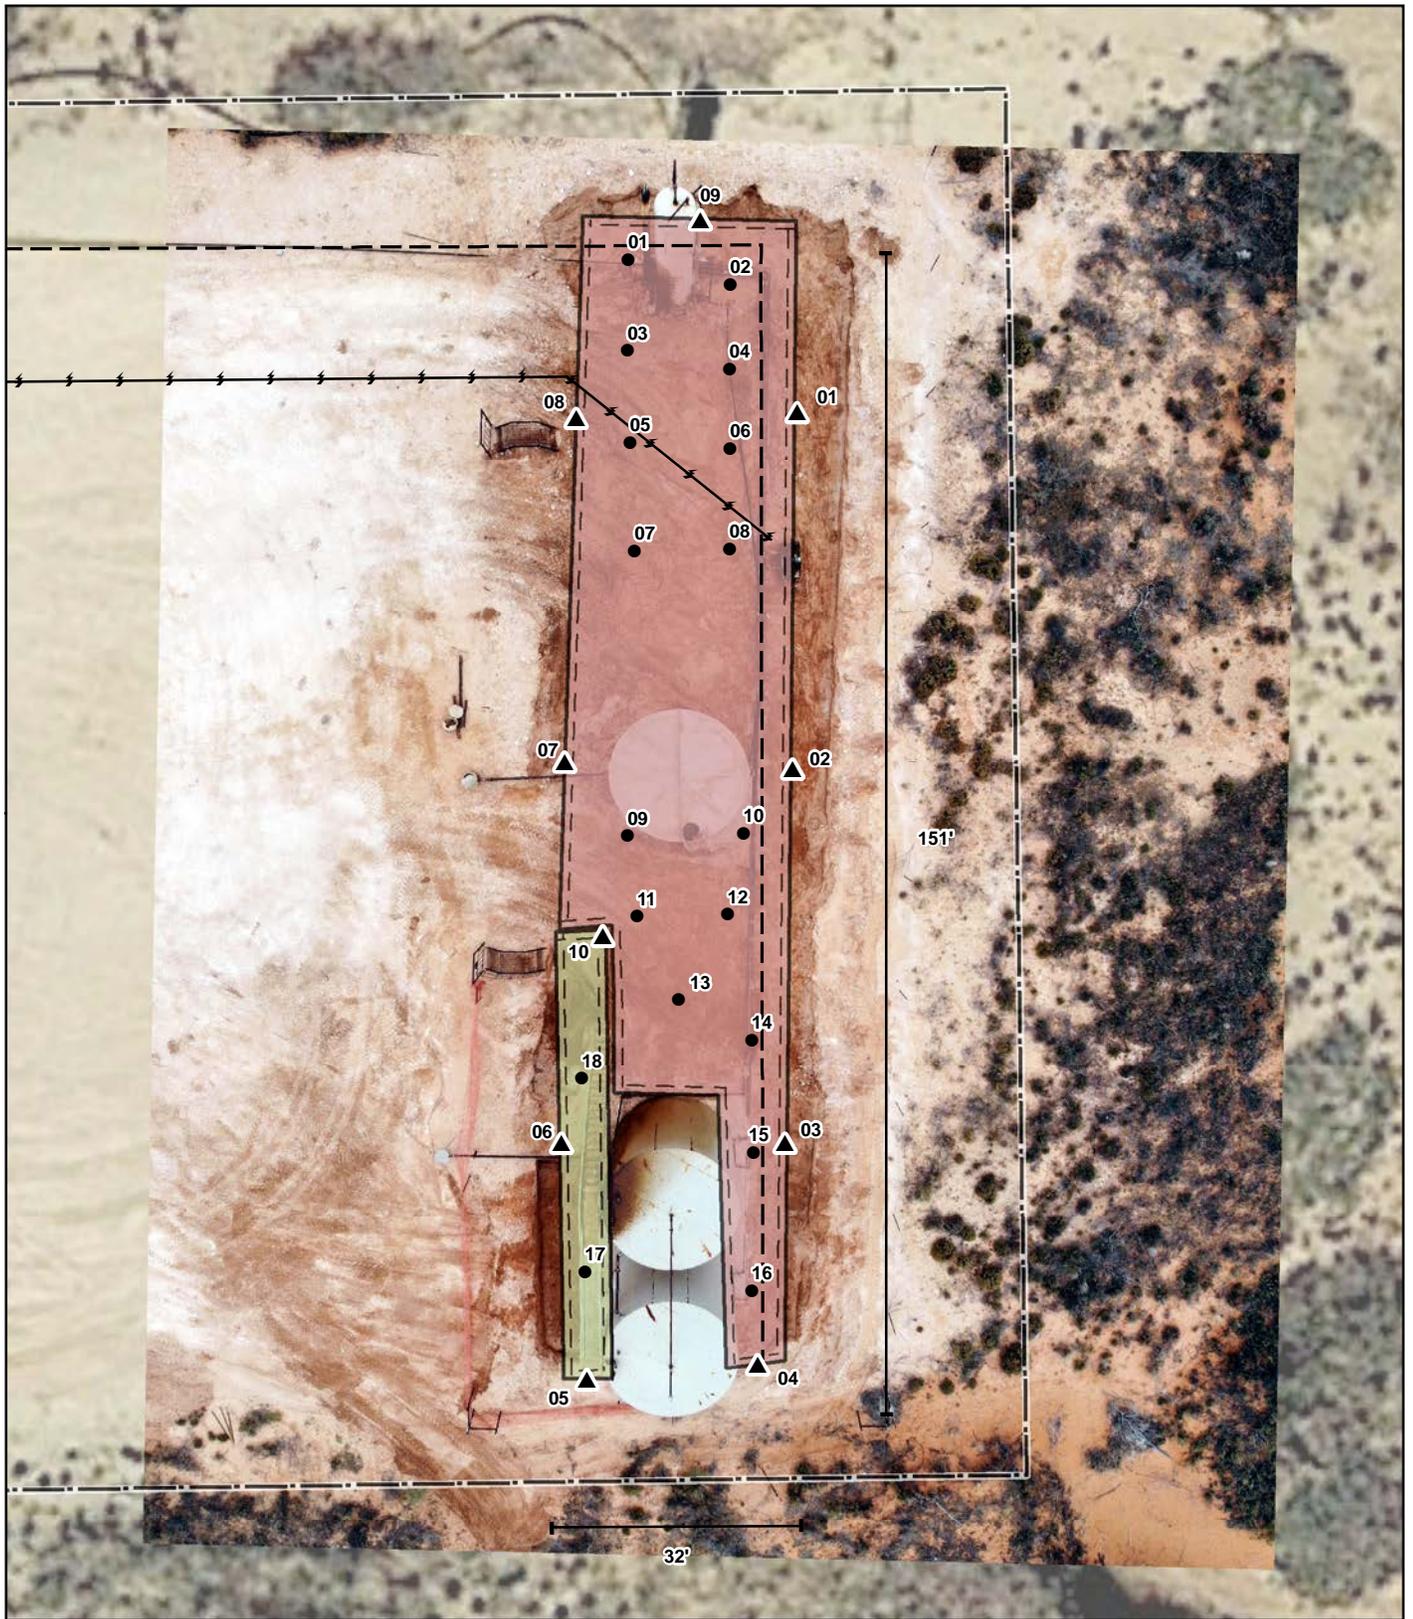
- Base Sample (Prefixed by "WS22-") - - - Aboveground Pipeline [] Approximate Lease Boundary [] Excavation to 3' (~376 sq. ft.)
- ▲ Wall Sample (Prefixed by "BS22-") ⚡ Electrical Line [] Excavation to 1.5' (~3,288 sq. ft.)

Remediation efforts began on November 14, 2022 and were completed on November 22, 2022. Vertex personnel supervised the excavation of impacted soils. Field screening was completed on multiple sample points and consisted of analysis using a photo ionization detector (volatile hydrocarbons), Dextsil Petroflag using EPA SW-846 Method 9074 (extractable hydrocarbons) and electroconductivity meter (chlorides). Field screening results were used to identify areas requiring further remediation from those areas showing concentrations below determined closure criteria levels. Soils were removed to a depth of three feet bgs. Impacted soil was transported by a licensed waste hauler and disposed of at an approved waste management facility. Field screening results are included in Table 3 (Attachment 2).

Notification that confirmatory samples were being collected was provided to the NMOCD on November 17, 2022, and is included in Attachment 6. Confirmatory composite samples were collected from the base and walls of the excavation in 200 square foot increments. A total of 28 samples were collected for laboratory analysis following NMOCD soil sampling procedures. Samples were submitted to Hall Environmental Analysis Laboratory under chain-of-custody (COC) protocols and analyzed for BTEX (EPA Method 8021B), total petroleum hydrocarbons (GRO, DRO, MRO – EPA Method 8015D) and total chlorides (EPA Method 300.0). Laboratory results are presented in Table 3 (Attachment 2) and the laboratory data report is included in Attachment 7. All confirmatory samples collected and analyzed were below closure criteria for the site.

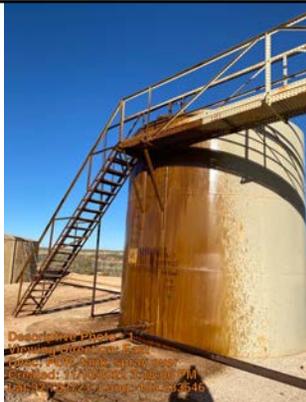
Viewing Direction: East

POR, tank, spray over

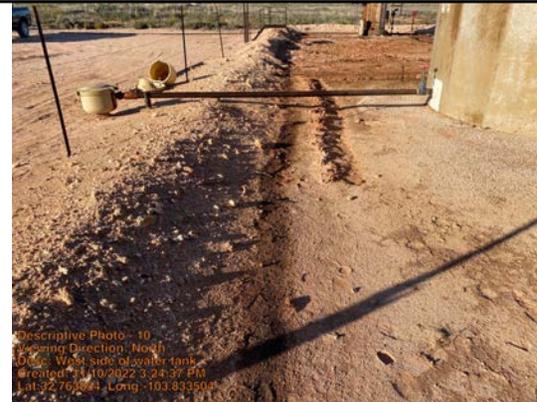
Viewing Direction: North

West side of water tank

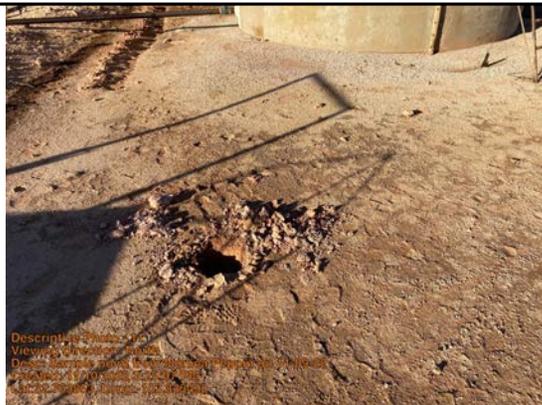
Viewing Direction: North

Sample point from Monica Peppin on 11-09-22.
Approximately 6" deep.

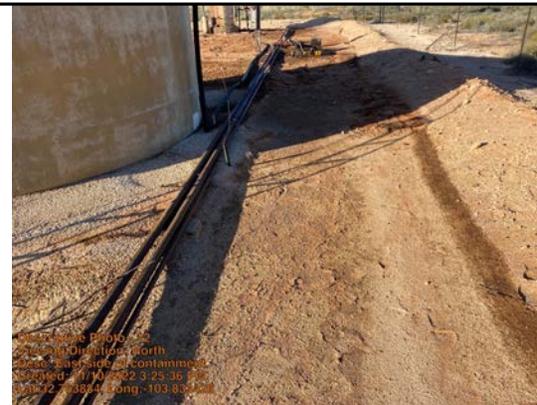
Viewing Direction: North

East side of containment

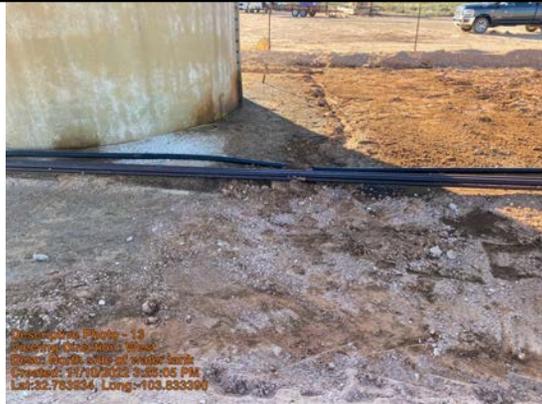
Operative Photo - 19
Viewing Direction: West
Desc: North side of water tank
Created: 11/10/2022 3:05:05 PM
Lat:32.783834, Long:-103.833397

North side of water tank

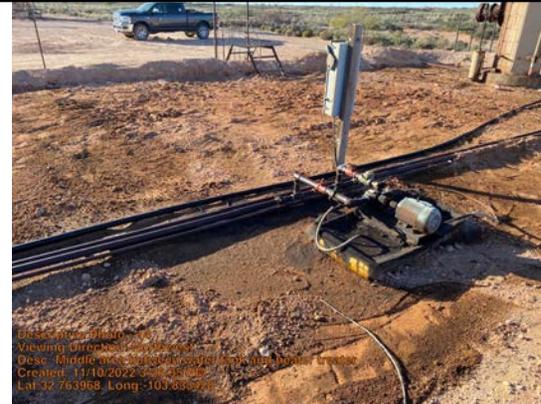
Operative Photo - 20
Viewing Direction: Northwest
Desc: Middle area between water tank and heater treater
Created: 11/10/2022 3:07:21 PM
Lat:32.763968, Long:-103.833726

Middle area between water tank and heater treater

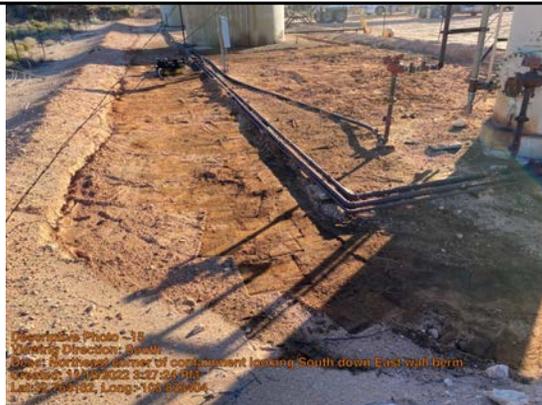
Operative Photo - 35
Viewing Direction: South
Desc: Northeast corner of containment looking South down East wall berm
Created: 11/10/2022 3:27:24 PM
Lat:32.784102, Long:-103.833604

Northeast corner of containment looking South down East wall berm

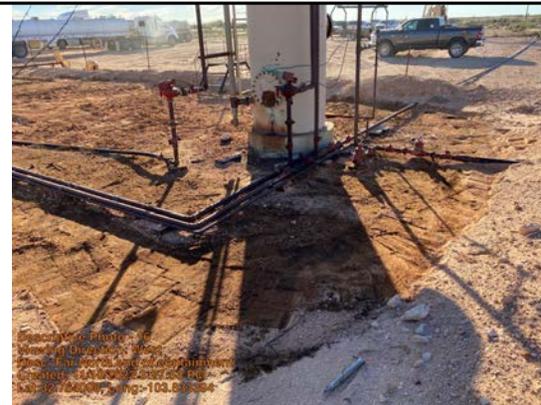
Operative Photo - 36
Viewing Direction: West
Desc: Far North end of containment
Created: 11/10/2022 3:28:14 PM
Lat:32.784007, Long:-103.833604

Far North end of containment

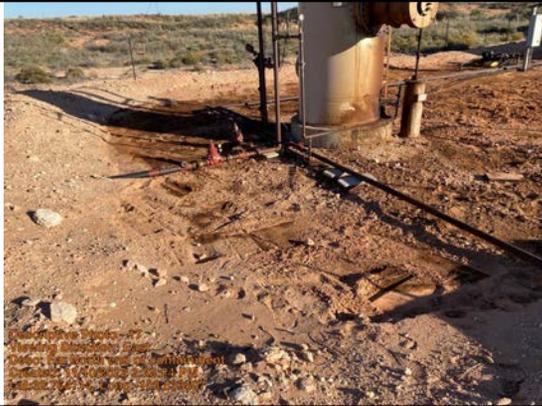
Viewing Direction: East

Far North end of containment

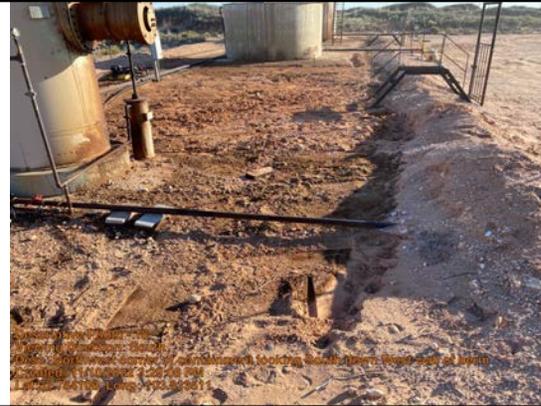
Viewing Direction: South

Northwest corner of containment looking South down West wall of berm

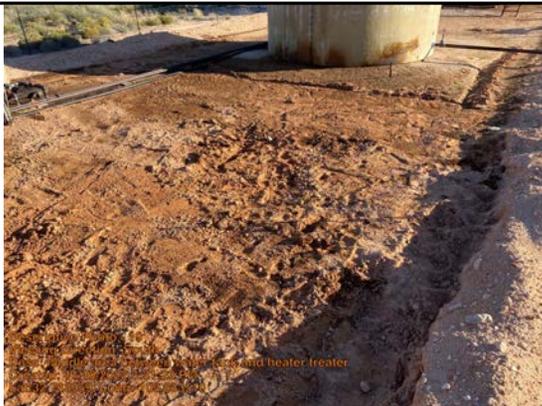
Viewing Direction: South

Middle area between water tank and heater treater

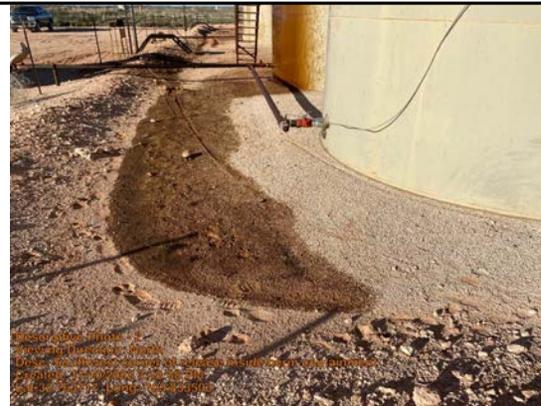
Viewing Direction: North

Southwest corner of release inside berm containment

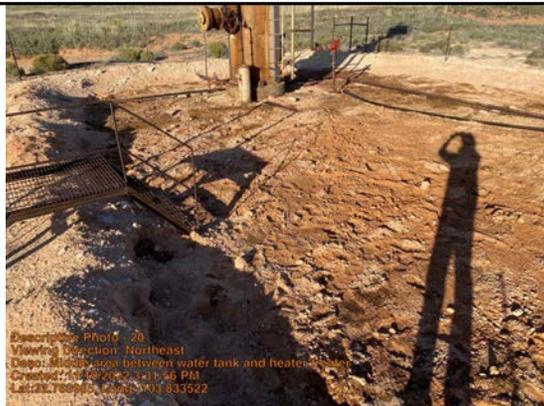
Descriptive Photo - 20
Viewing Direction: Northeast
Date: 11/11/2022 3:15:36 PM
Created: 11/11/2022 3:15:36 PM
Latitude: 32.8841 Longitude: 103.833522

Middle area between water tank and heater treater

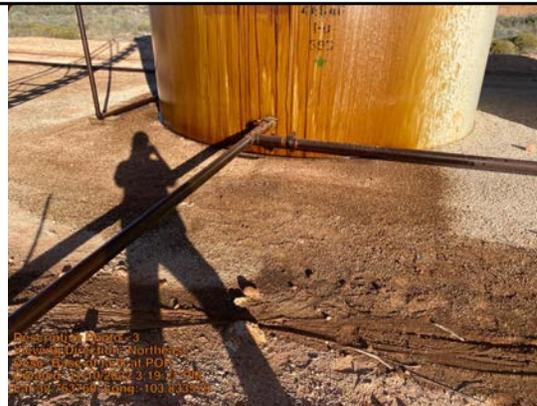
Descriptive Photo - 2
Viewing Direction: Northeast
Date: 11/11/2022 3:19:23 PM
Created: 11/11/2022 3:19:23 PM
Latitude: 32.8841 Longitude: 103.833522

Base of tank at POR

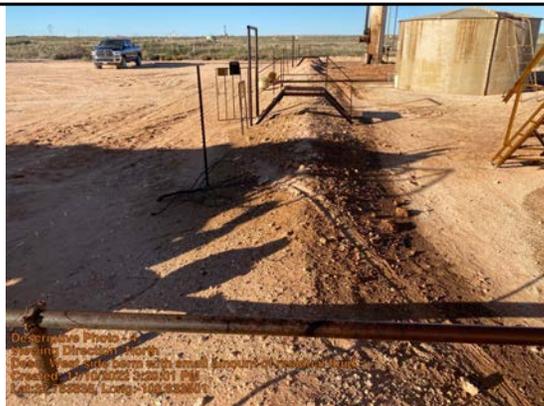
Descriptive Photo - 4
Viewing Direction: North
Date: 11/11/2022 3:20:01 PM
Created: 11/11/2022 3:20:01 PM
Latitude: 32.8841 Longitude: 103.833522

West side berm with small amount of residual fluid

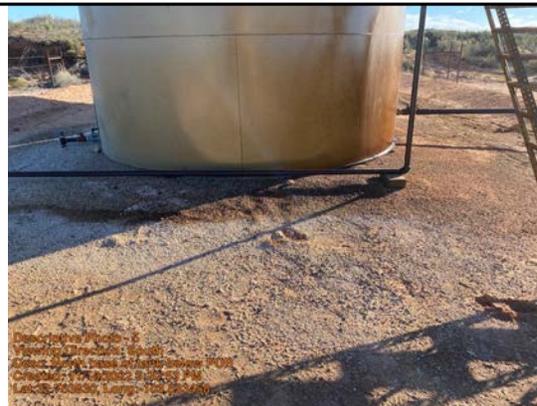
Descriptive Photo - 1
Viewing Direction: South
Date: 11/11/2022 3:20:01 PM
Created: 11/11/2022 3:20:01 PM
Latitude: 32.8841 Longitude: 103.833522

North base of tank below POR

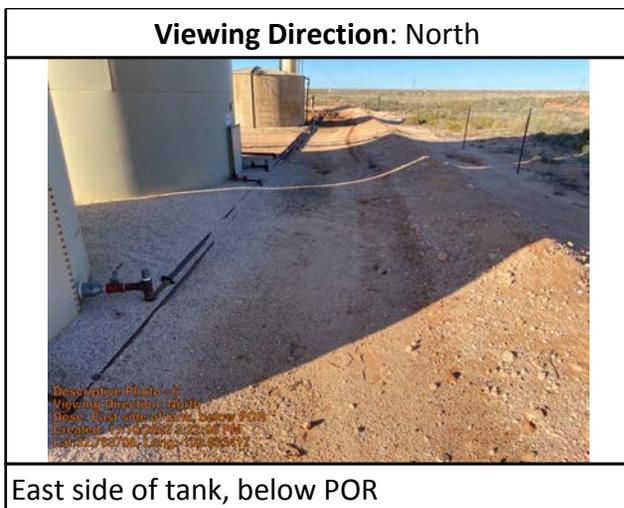
East side of tank, below POR

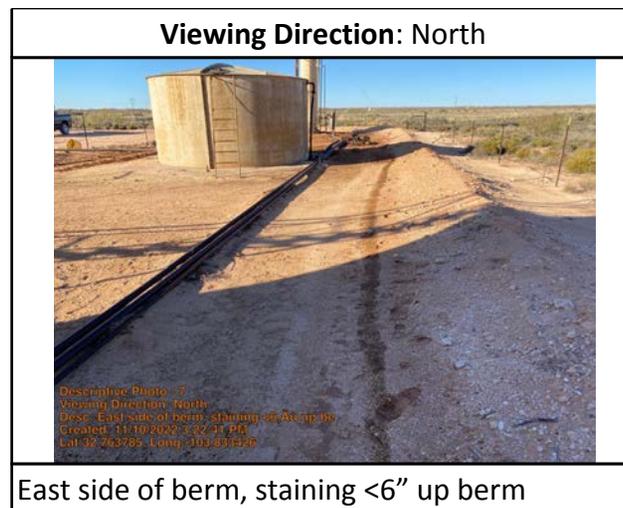
East side of berm, staining <6" up berm

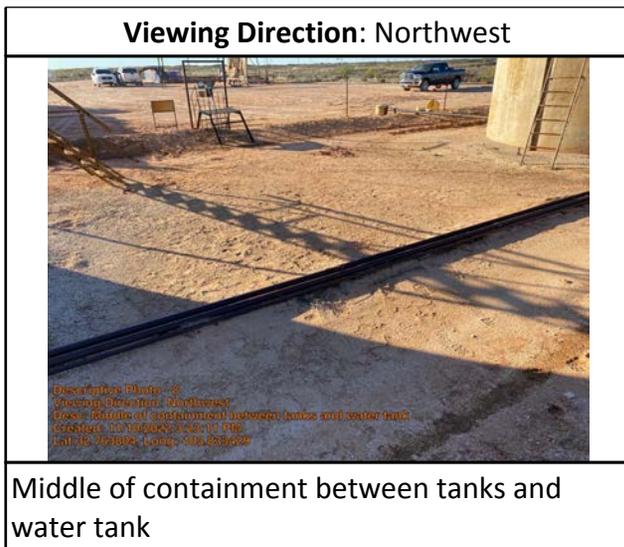
Middle of containment between tanks and water tank

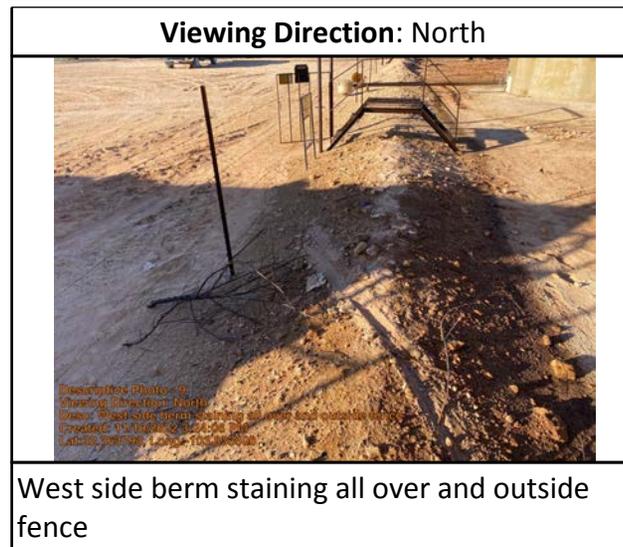
West side berm staining all over and outside fence

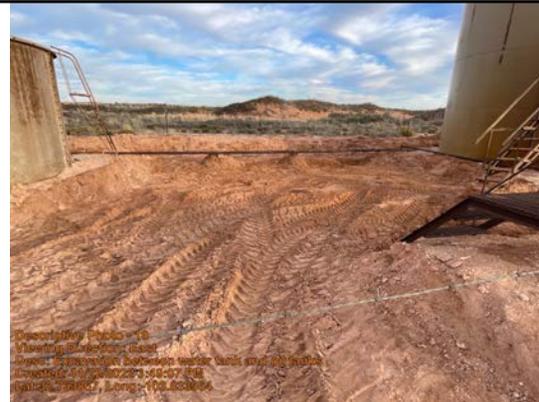
Descriptive Photo - 10
Viewing Direction: East
Place: Excavation between water tank and oil tanks
Created: 11/28/2022 3:50:07 PM
Latitude: 34.260223, Longitude: -103.823857

Excavation between water tank and oil tanks

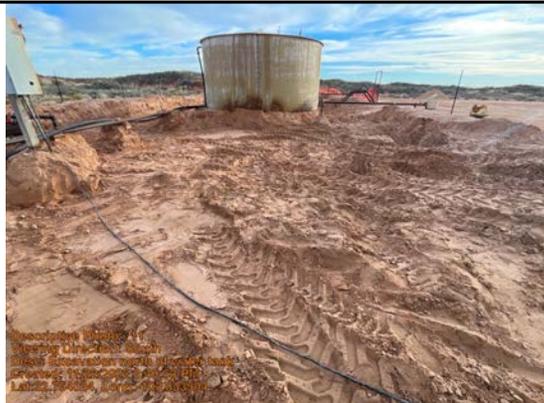
Descriptive Photo - 11
Viewing Direction: South
Place: Excavation north of water tank
Created: 11/28/2022 3:50:07 PM
Latitude: 34.260223, Longitude: -103.823857

Excavation north of water tank

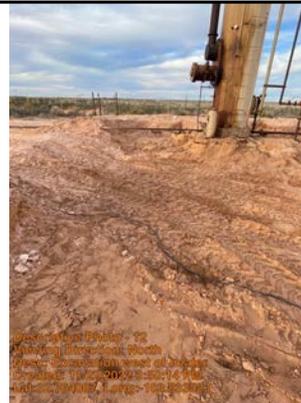
Descriptive Photo - 12
Viewing Direction: North
Place: Excavation west of heater
Created: 11/28/2022 3:50:07 PM
Latitude: 34.260223, Longitude: -103.823857

Excavation west of heater

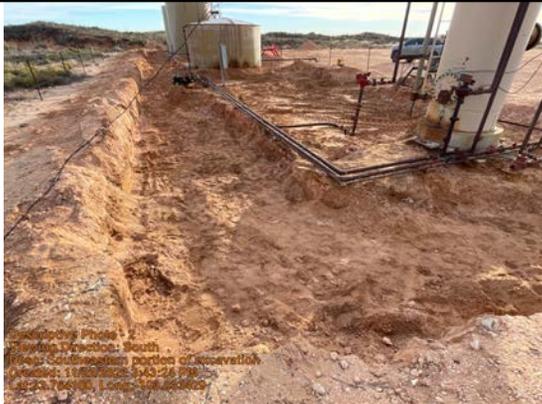
Descriptive Photo - 1
Viewing Direction: South
Date: Northeast portion of excavation
Created: 11/22/2022 3:43:24 PM
Lat:32.765976, Long:-103.833623

Northeastern portion of excavation

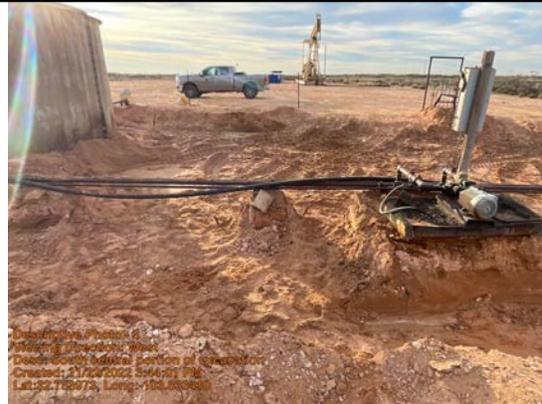
Descriptive Photo - 2
Viewing Direction: West
Date: North central portion of excavation
Created: 11/22/2022 3:44:01 PM
Lat:32.765973, Long:-103.833620

North central portion of excavation

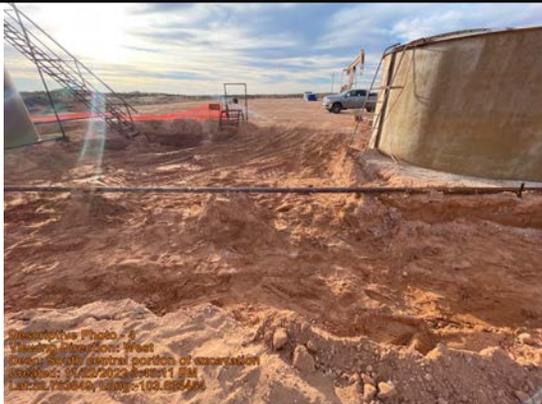
Descriptive Photo - 3
Viewing Direction: West
Date: South central portion of excavation
Created: 11/22/2022 3:45:11 PM
Lat:32.765949, Long:-103.833484

South central portion of excavation

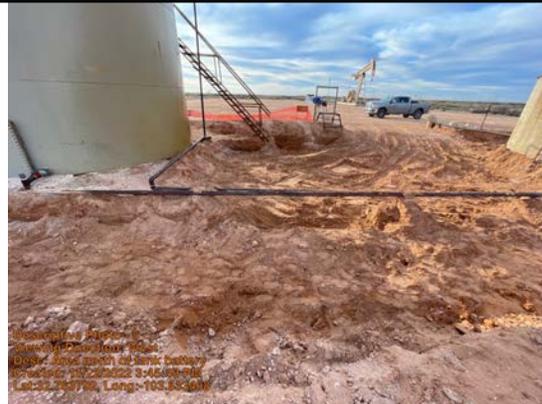
Descriptive Photo - 4
Viewing Direction: West
Date: Area north of tank battery
Created: 11/22/2022 3:45:49 PM
Lat:32.765759, Long:-103.833609

Area north of tank battery

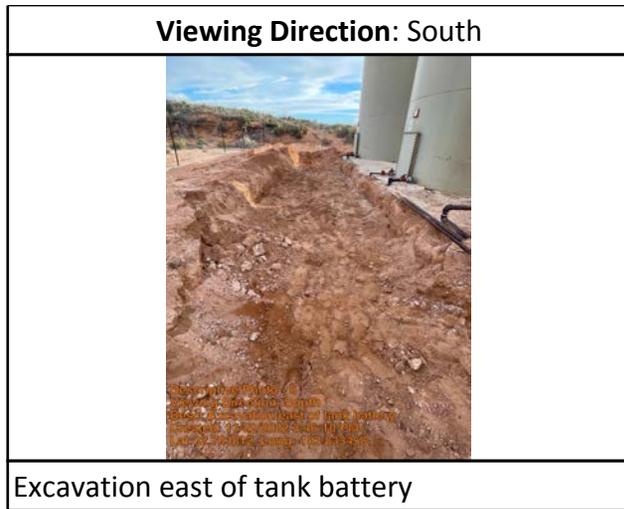
Excavation east of tank battery

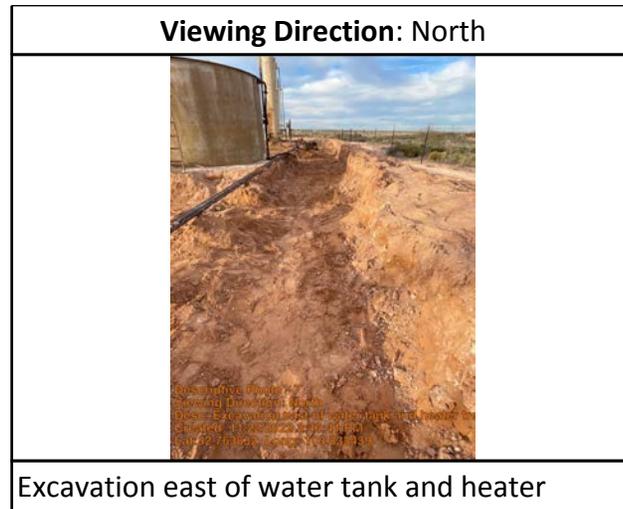
Excavation east of water tank and heater treater

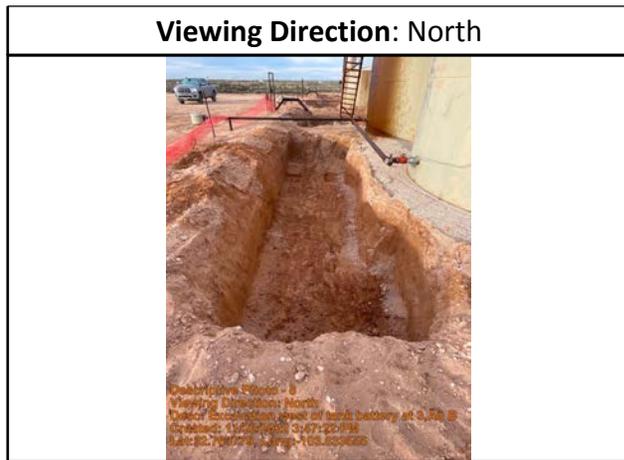
Excavation west of tank battery at 3' BGS

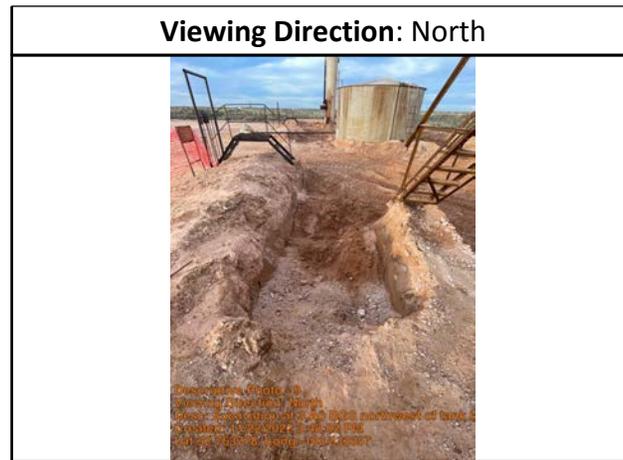
Excavation at 3' BGS northwest of tank battery
