**Subject: Closure Letter Report  
ConocoPhillips  
1RP-2295  
EVGSAU Satellite #1 Release  
Unit Letter J, Section 19, Township 17 South, Range 35 East  
Lea County, New Mexico**

**EVGSAU SATELLITE # 1 LINE RELEASE  
 SITE LOCATION MAP**

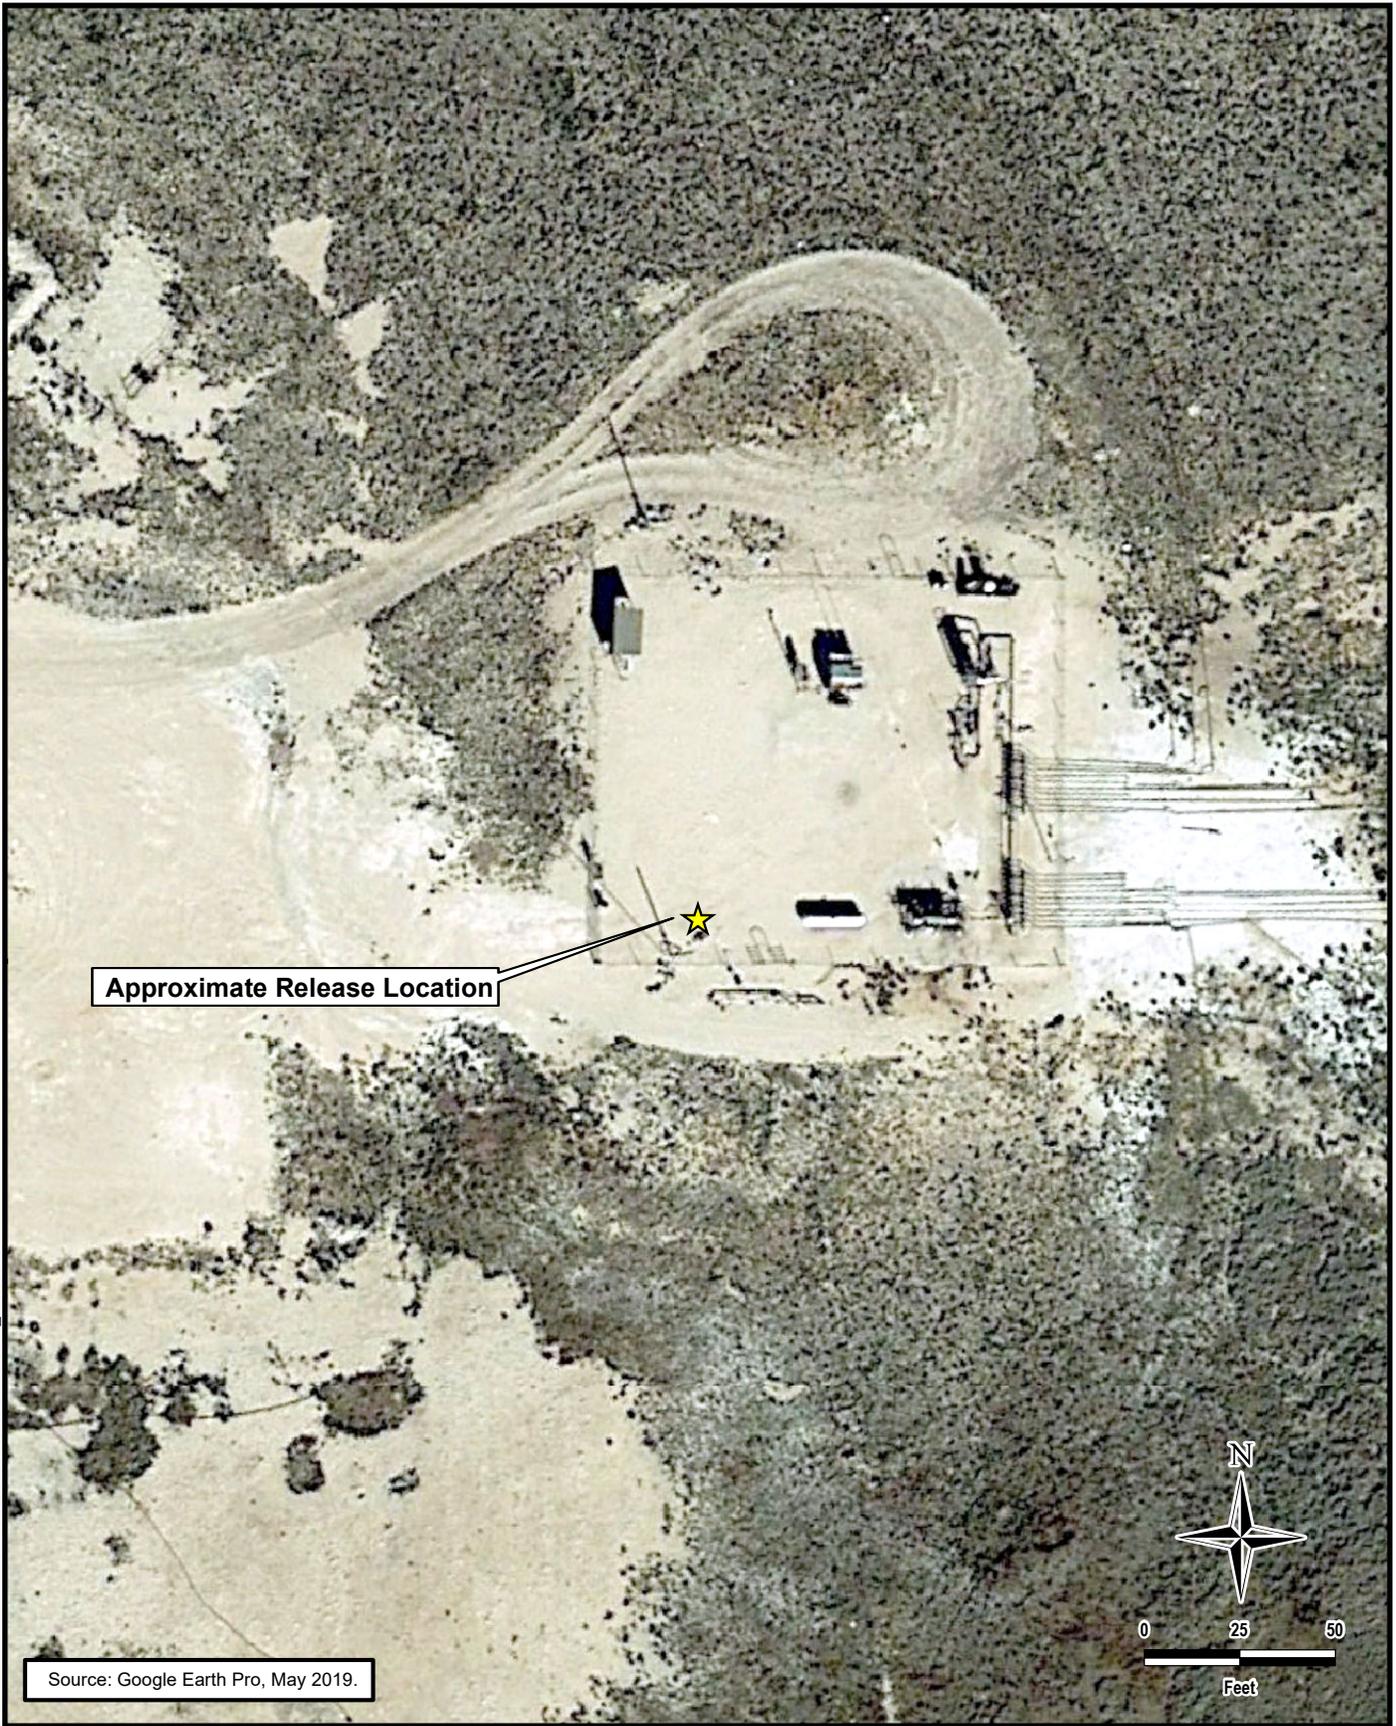
Approximate Release Location

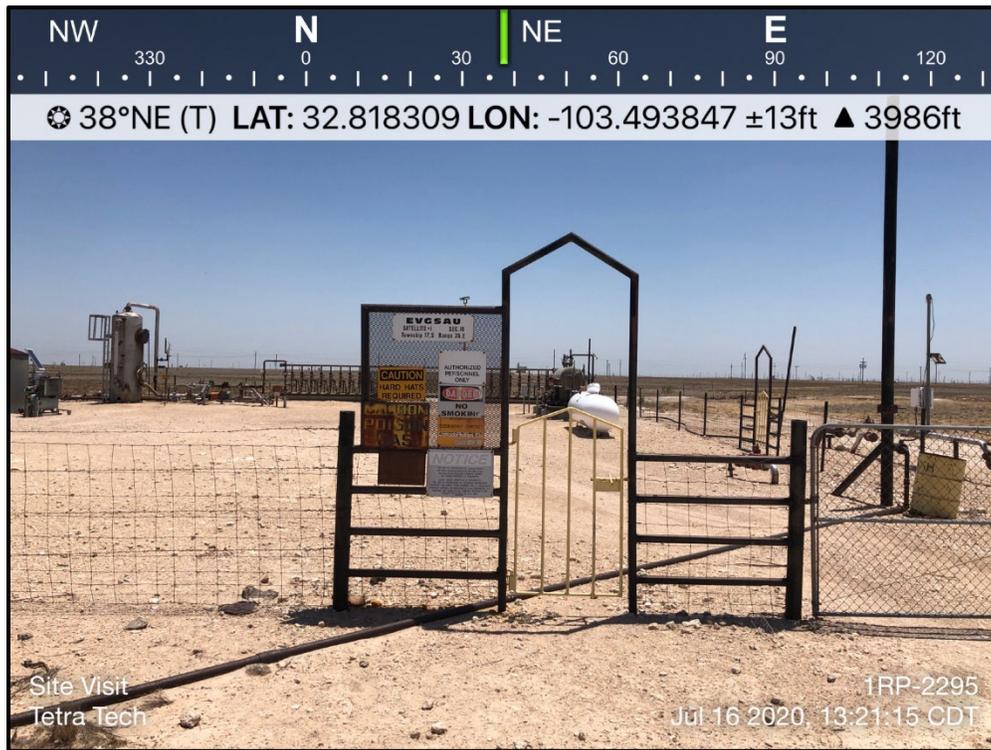
TETRA TECH, INC. PROJECT NO. 212C-MD-02152	DESCRIPTION	View facing northeast of site signage.	1
	SITE NAME	EVGSAU Satellite #1 Bypass Line Release	7/16/2020

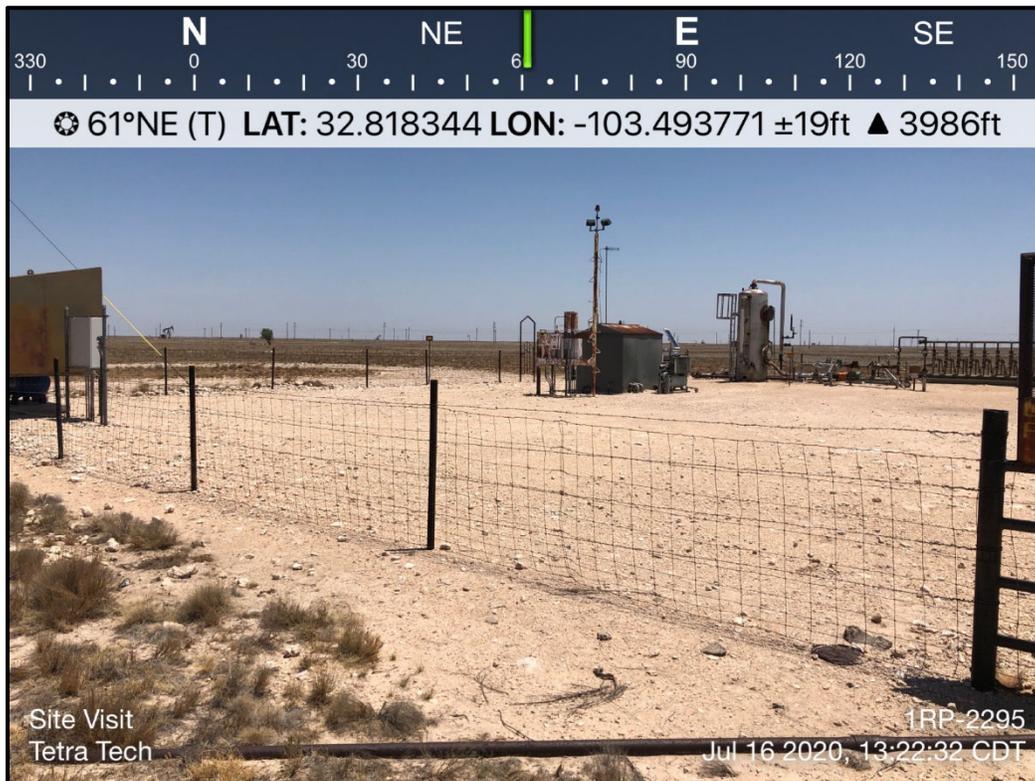
TETRA TECH, INC. PROJECT NO. 212C-MD-02152	DESCRIPTION	View facing northeast of well pad release area.	2
	SITE NAME	EVGSAU Satellite #1 Bypass Line Release	7/16/2020

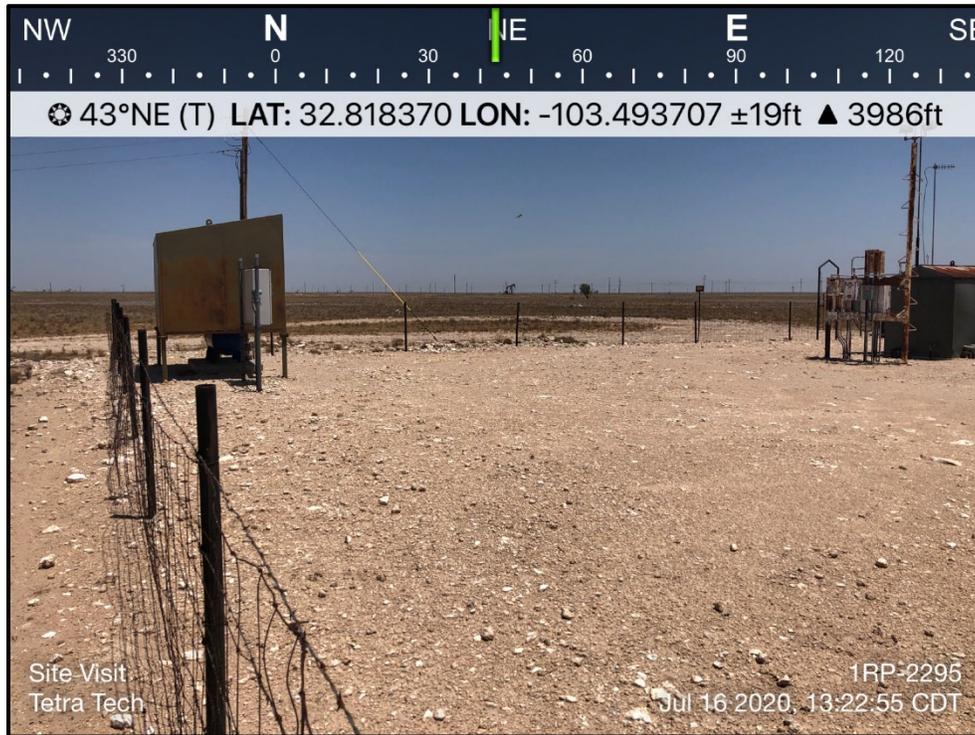
TETRA TECH, INC. PROJECT NO. 212C-MD-02152	DESCRIPTION	View facing northeast of well pad release area.	3
	SITE NAME	EVGSAU Satellite #1 Bypass Line Release	7/16/2020

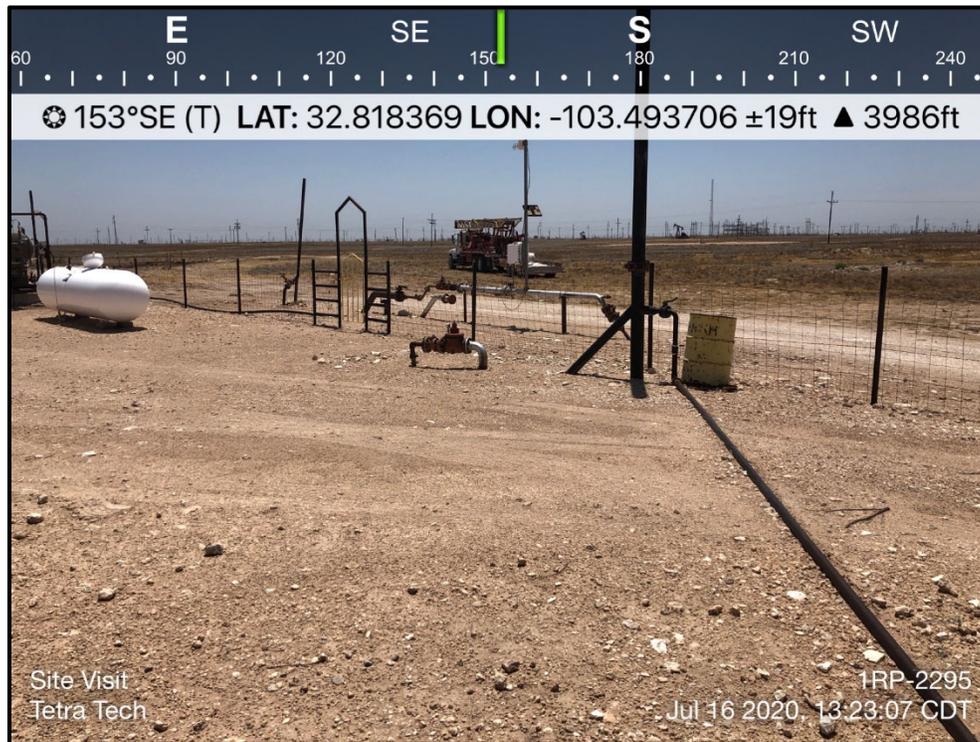
- No surficial staining was noted at the apparent point of release or the in the assumed release extent at the facility.

TETRA TECH, INC. PROJECT NO. 212C-MD-02152	DESCRIPTION	View facing southeast of apparent release area.	4
	SITE NAME	EVGSAU Satellite #1 Bypass Line Release	7/16/2020

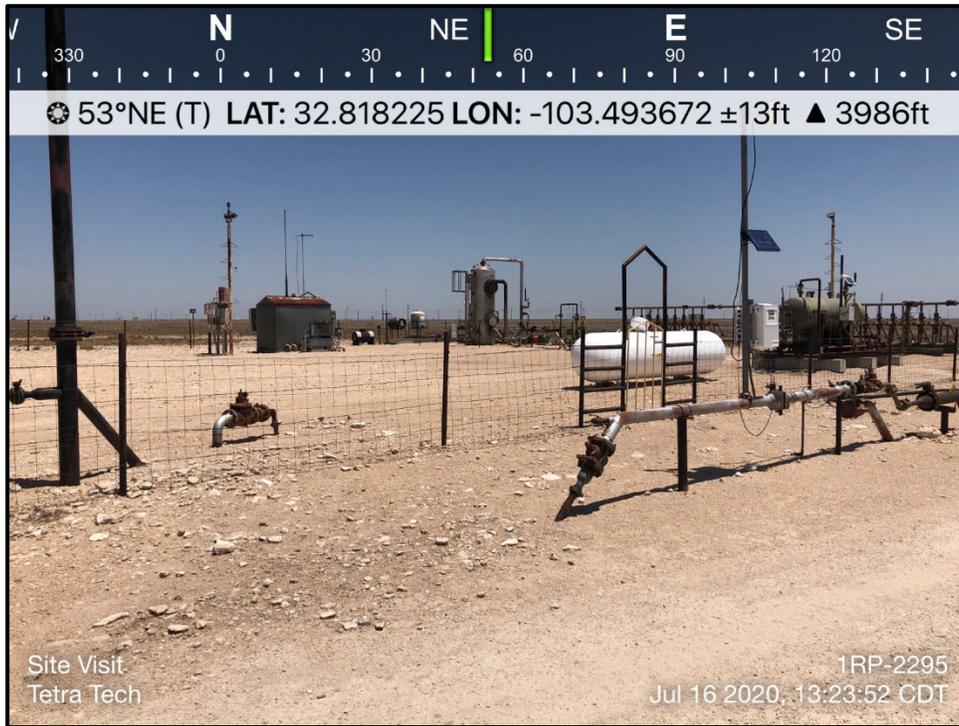
TETRA TECH, INC. PROJECT NO. 212C-MD-02152	DESCRIPTION	View facing northeast over release area.	5
	SITE NAME	EVGSAU Satellite #1 Bypass Line Release	7/16/2020

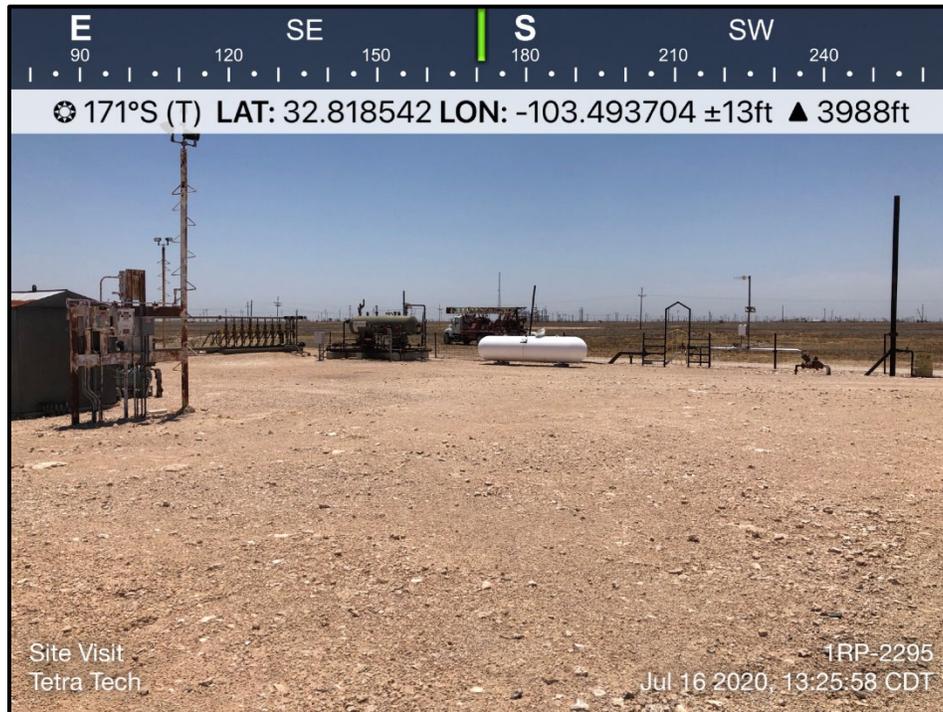
TETRA TECH, INC. PROJECT NO. 212C-MD-02152	DESCRIPTION	General view facing south of entire lease pad/release area.	6
	SITE NAME	EVGSAU Satellite #1 Bypass Line Release	7/16/2020
