Closure Report

| Site Name: | Vacuum Glorietta West Unit Battery |

Remediation Specifications

| Remediation Parameters: | Excavate the entire spill area to a depth of 1.75 feet. Backfill the site with clean soil. | |

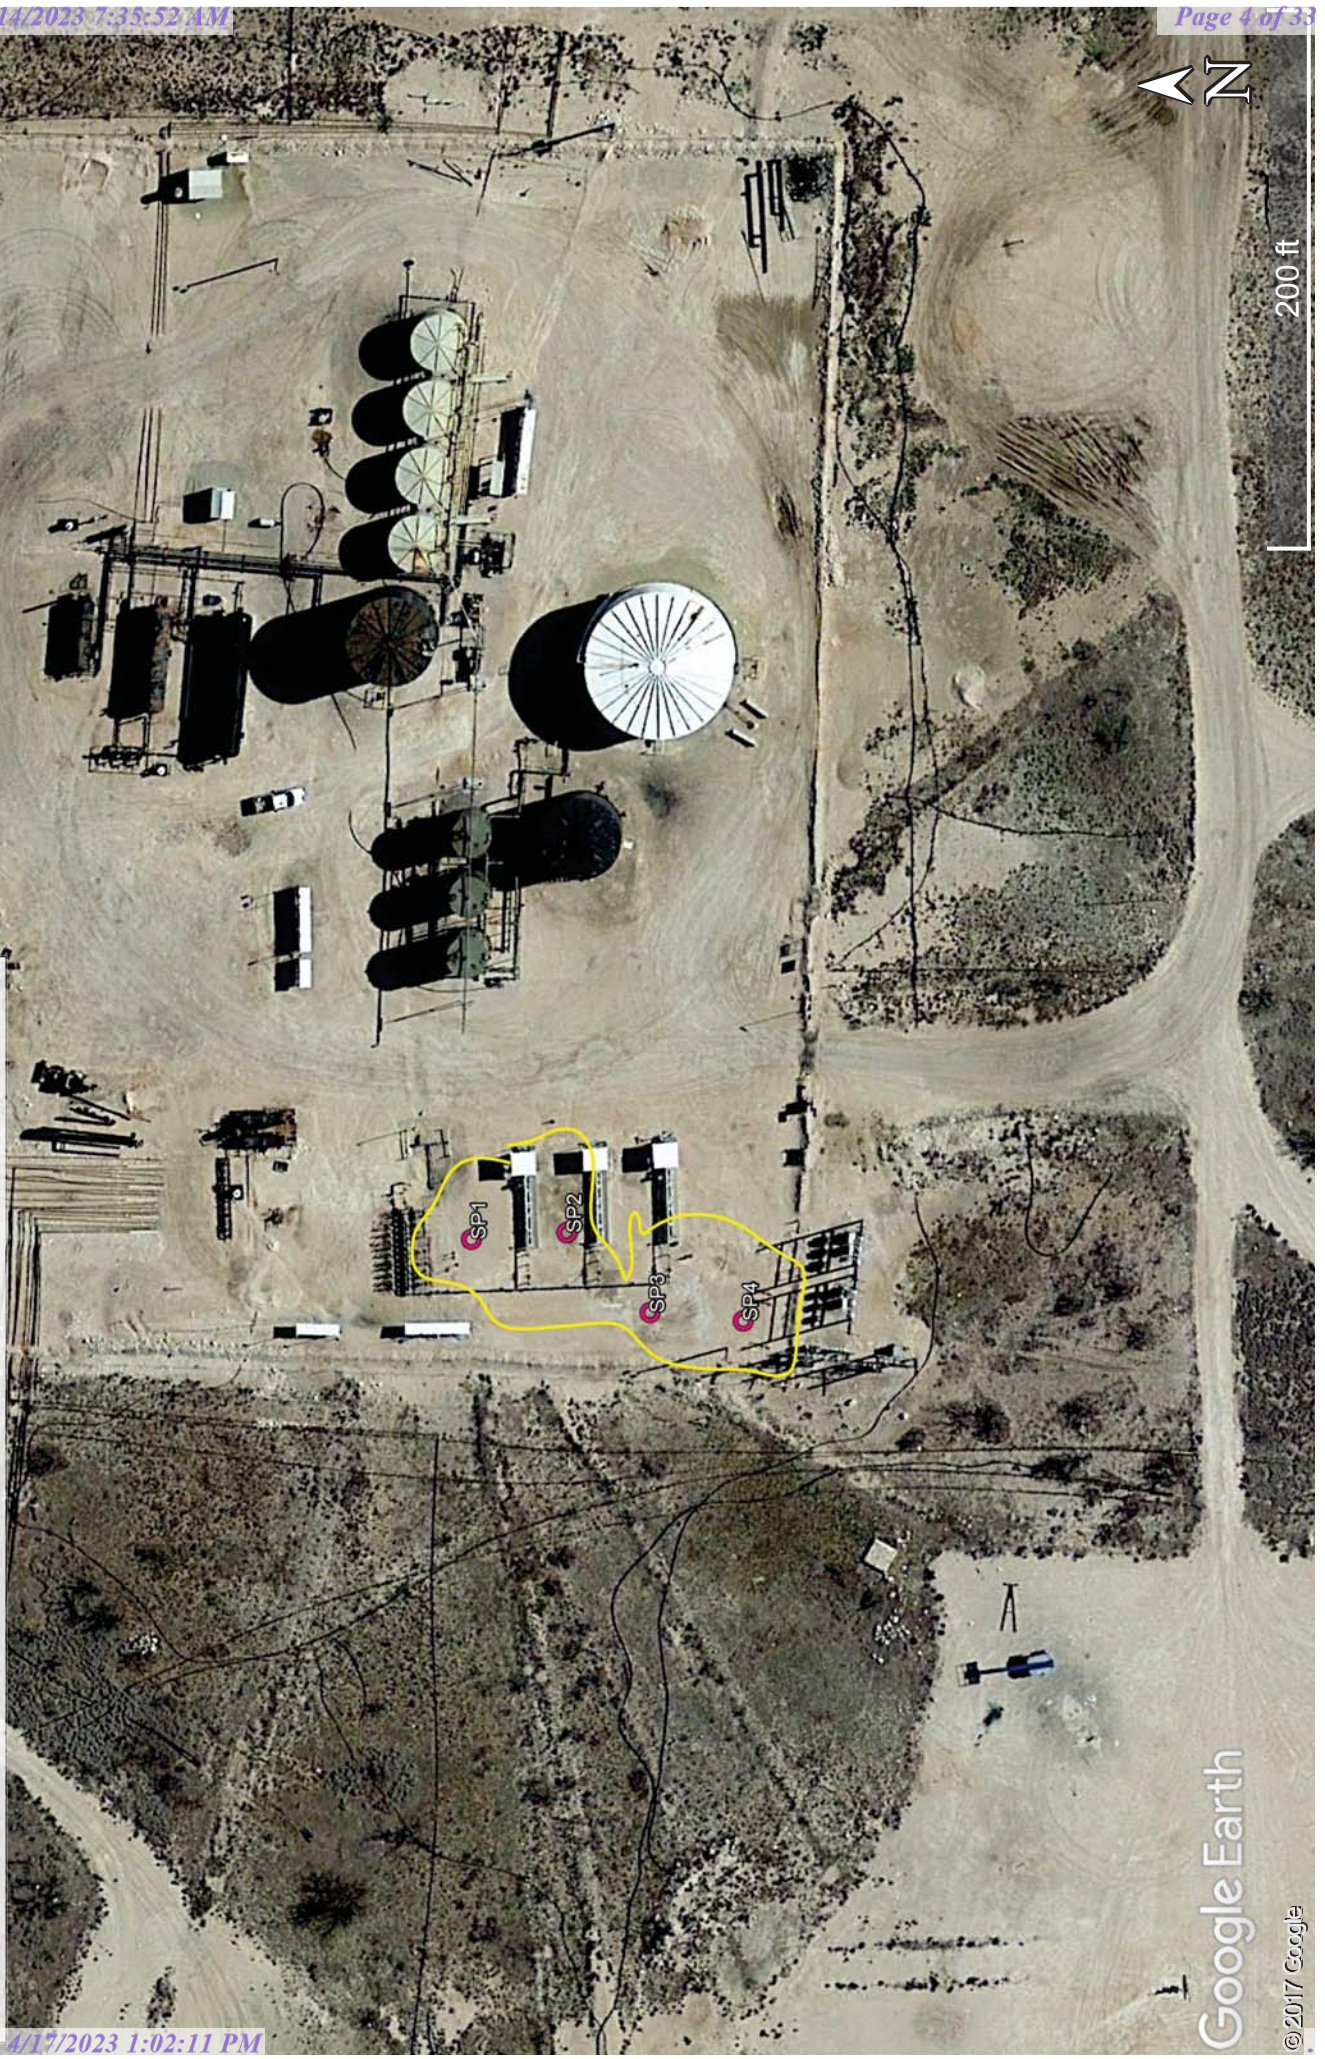
Chevron, Vacuum Glorietta West Unit Battery

Leak date: 09/24/2016
Lea County, NM
API# 30-025-30971
RP# 1RP-4465

Legend

- Sample points, hand auger
- Spill Area
