**Subject:            Closure Letter Report  
                          ConocoPhillips  
                          1RP-3216  
                          Wilder Federal #29-5H Frac Tank Release  
                          Lea County, New Mexico**

On behalf of ConocoPhillips (COP), Tetra Tech, Inc. (Tetra Tech) submits the following Closure Report for review. The ConocoPhillips Wilder Federal #29-5H well (API No. 30-025-41509) is located approximately 42 miles southeast of Carlsbad in Lea County, New Mexico (Figure 1). The well is located in the Public Land Survey System (PLSS) Unit Letter A, Section 29, Township 26 South, Range 32 East, and its coordinates are 32.018863°, -103.691442°. The release addressed in this report occurred from a clean brine frac tank that was located on the well lease pad (the Site).

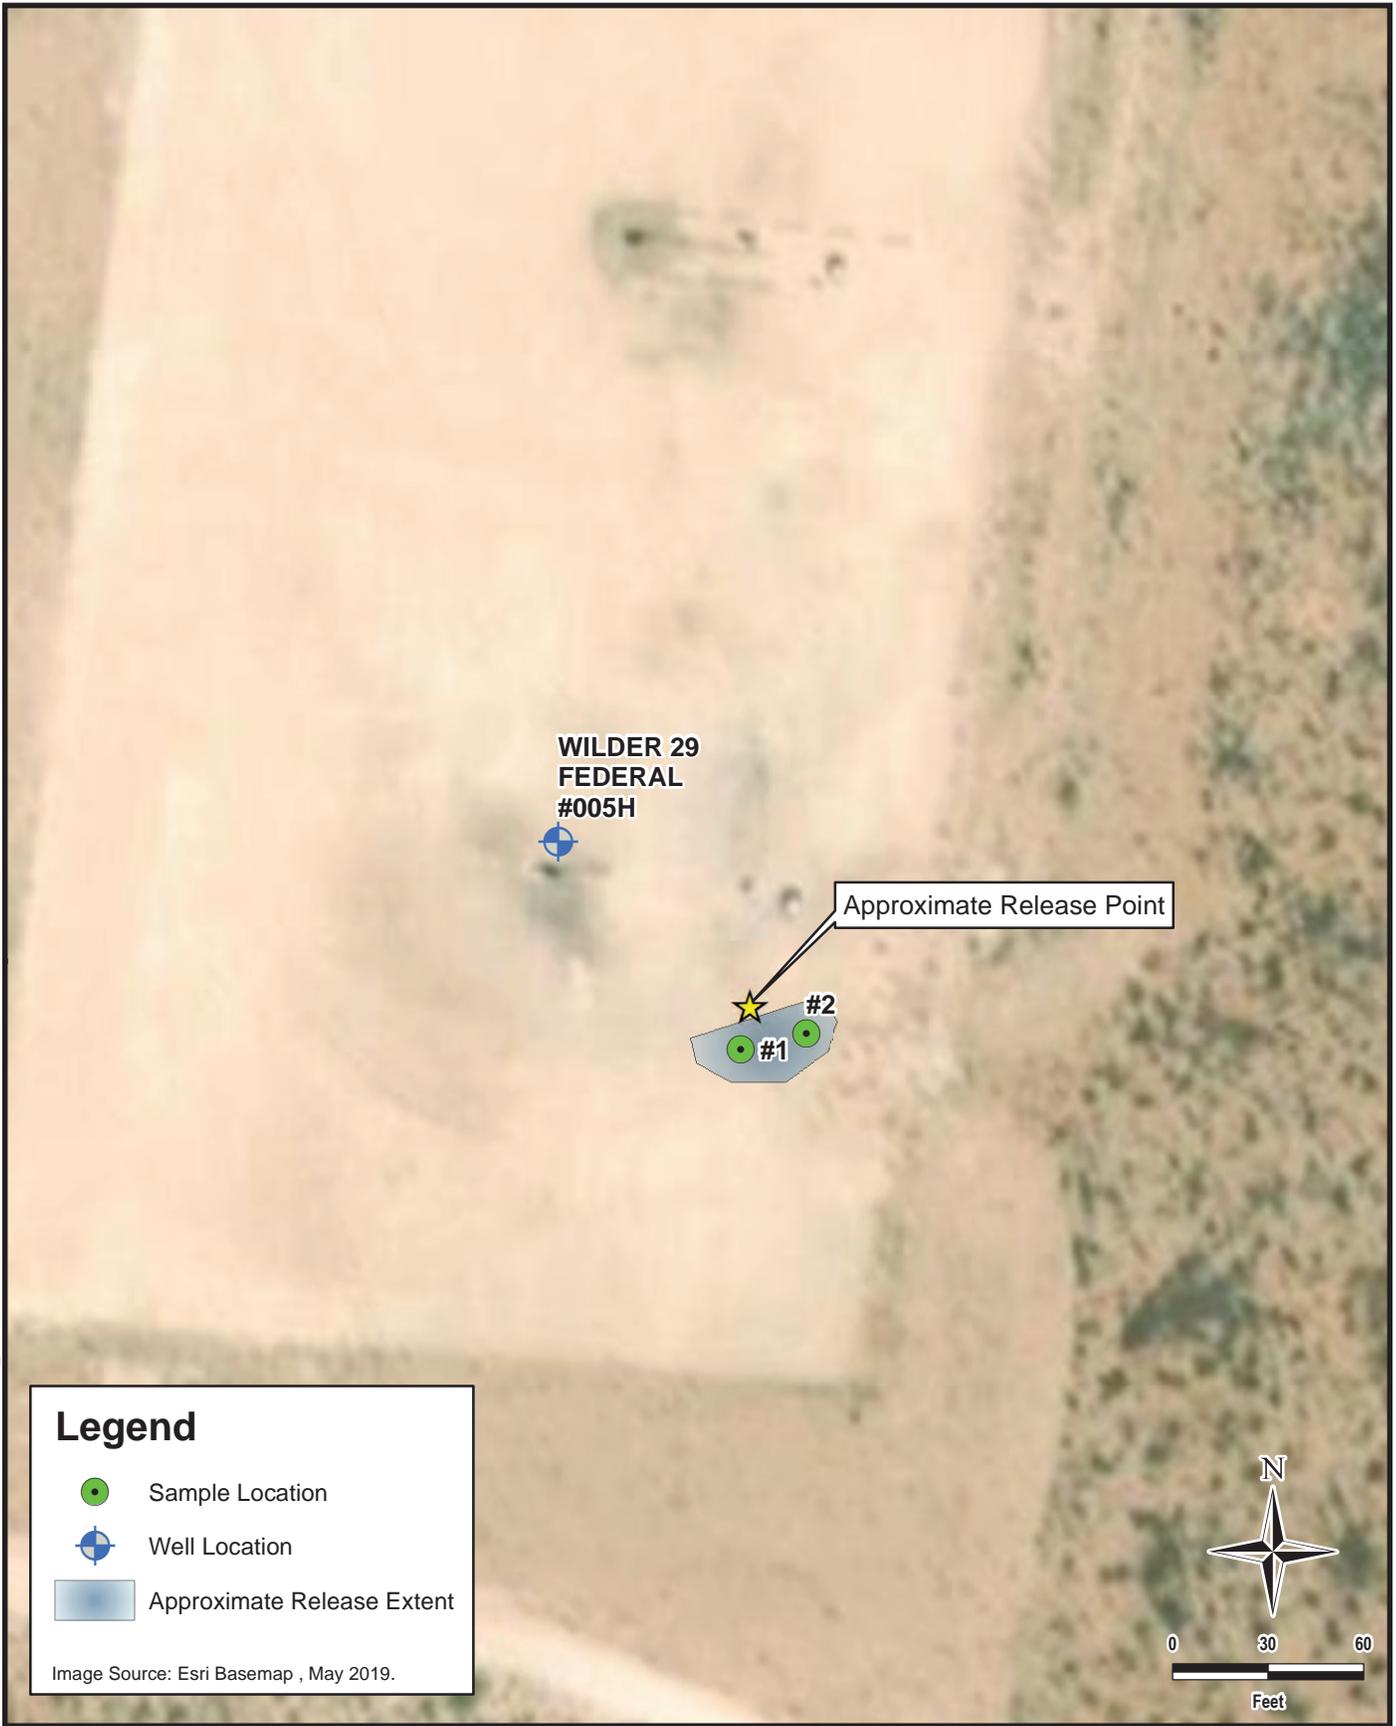
According to the C-141, the release footprint on the ground surface was estimated to be approximately 800 square feet. The C-141 stated that remediation would begin as soon as work on location ended. According to the NMOCD well files, the well was ready to produce January 14, 2015. On February 1, 2015, two soil samples were collected from the release area footprint and submitted to Xenco Laboratories in Odessa, Texas to be analyzed for chloride via EPA Method 300 and TPH via EPA Method SW8015 Mod. A copy of the analytical report is included as Attachment C.

The analytical results are summarized in Table 1. Analytical results associated with both soil samples were below the respective RRALs listed in Table 1 of the NMOCD Spill Rule (19.15.29 NMAC), and no further remediation occurred at the Site.

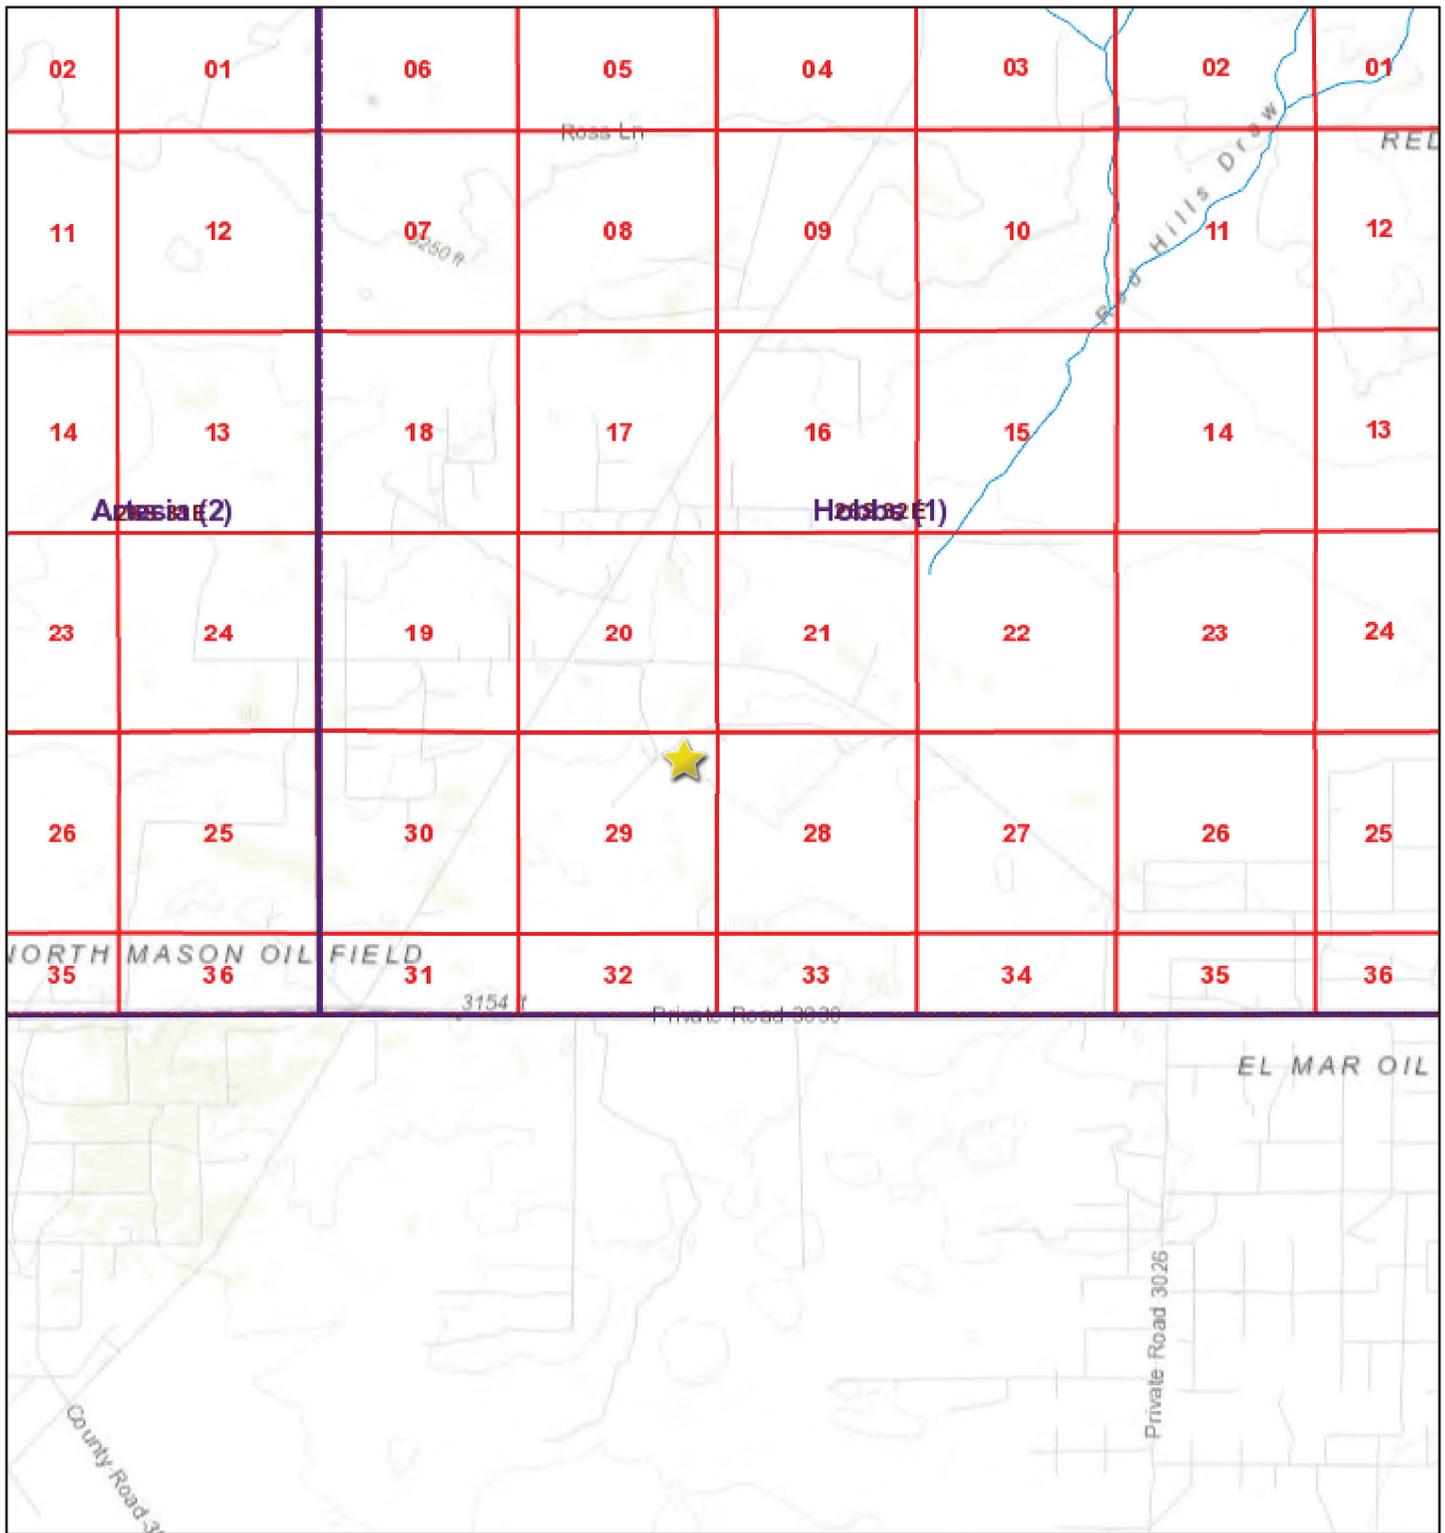
# Water Bodies

A site characterization was performed and no watercourses, lakebeds, sinkholes, playa lakes, residences, schools, hospitals, institutions, churches, springs, public or private domestic water wells, springs, wetlands, incorporated municipal boundaries, subsurface mines, or floodplains are located within the specified distances. However, the Site is located in an area of high karst potential.

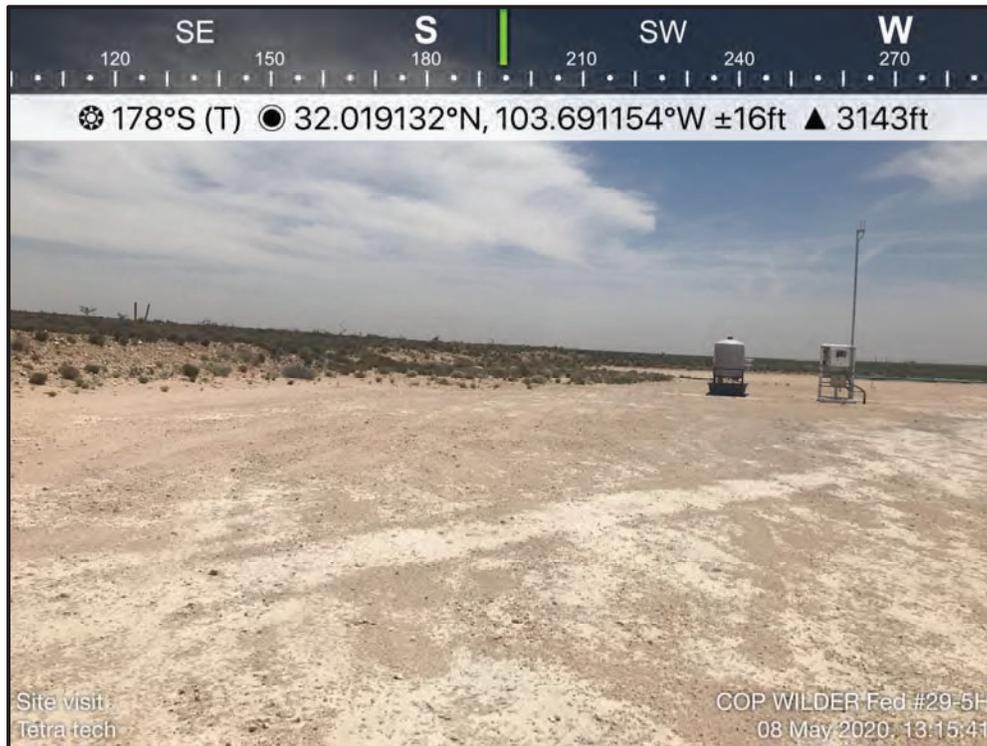
TETRA TECH, INC. PROJECT NO. 212C-MD-01796	DESCRIPTION	View facing south-southwest of site well pad and well equipment in background.	2
	SITE NAME	Wilder Federal 29-5H Frac Tank Release	5/8/2020

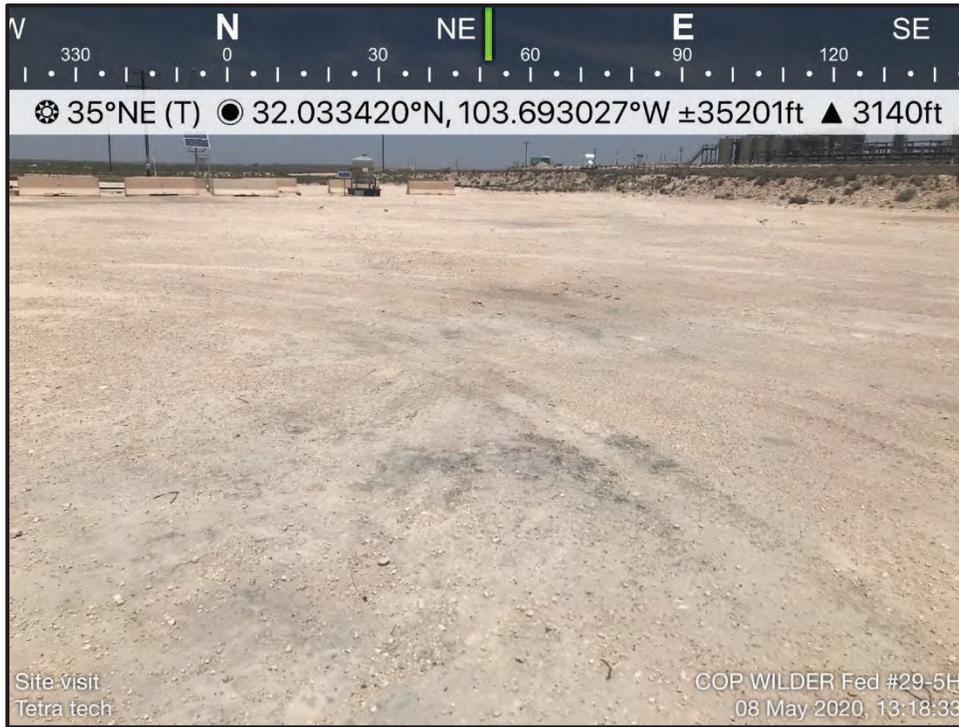
- The clean brine frac tank has been removed from the well pad.
- No staining was noted in the vicinity of the approximate release point.

TETRA TECH, INC. PROJECT NO. 212C-MD-01796	DESCRIPTION	View facing northeast of vicinity of former frac tank location on well pad.	3
	SITE NAME	Wilder Federal 29-5H Frac Tank Release	5/8/2020

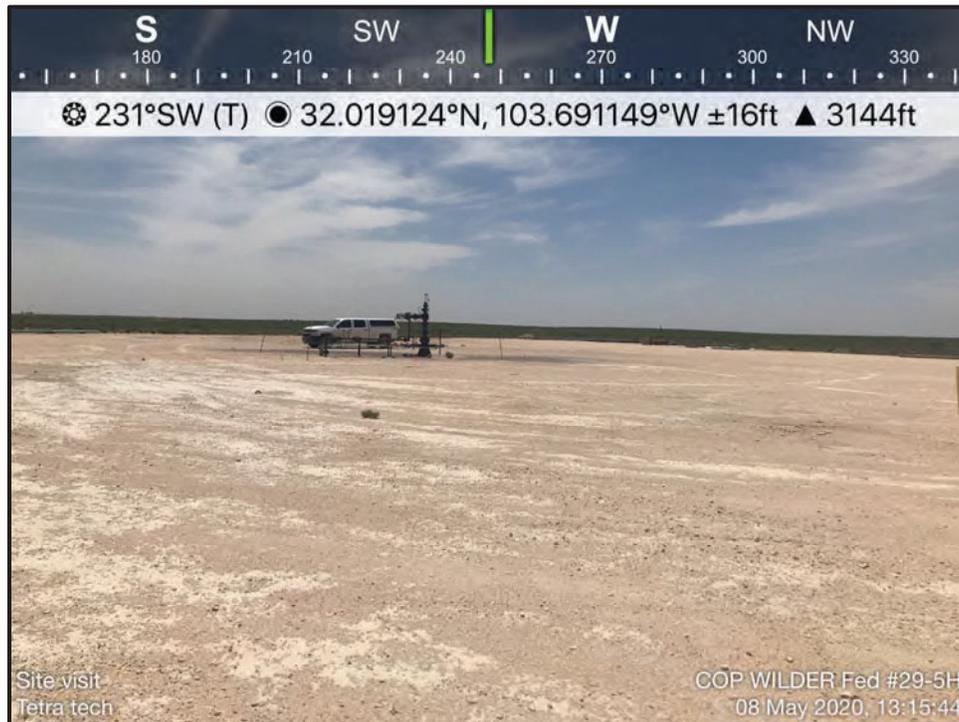
TETRA TECH, INC. PROJECT NO. 212C-MD-01796	DESCRIPTION	View facing southwest of wellhead location on well pad.	4
	SITE NAME	Wilder Federal 29-5H Frac Tank Release	5/8/2020
