**Re: Closure Request
Big Eddy Unit 158
Incident Number NAPP2230548752
Eddy County, New Mexico**

Ensolum, LLC (Ensolum), on behalf of XTO Energy, Inc (XTO), has prepared this *Closure Request* to document assessment and soil sampling activities performed at the Big Eddy Unit 158 (Site). The purpose of the Site assessment and soil sampling activities was to assess for the presence or absence of impacts to soil resulting from a release of produced water within lined containment at the Site. Based on field observations, field screening activities, and laboratory analytical results, XTO is submitting this *Closure Request* and requesting closure for Incident Number NAPP2230548752.

XTO Energy, Inc
Big Eddy Unit 158
NAPP2230548752
Unit J, Sec 04, T22S, R28E
Eddy County, New Mexico

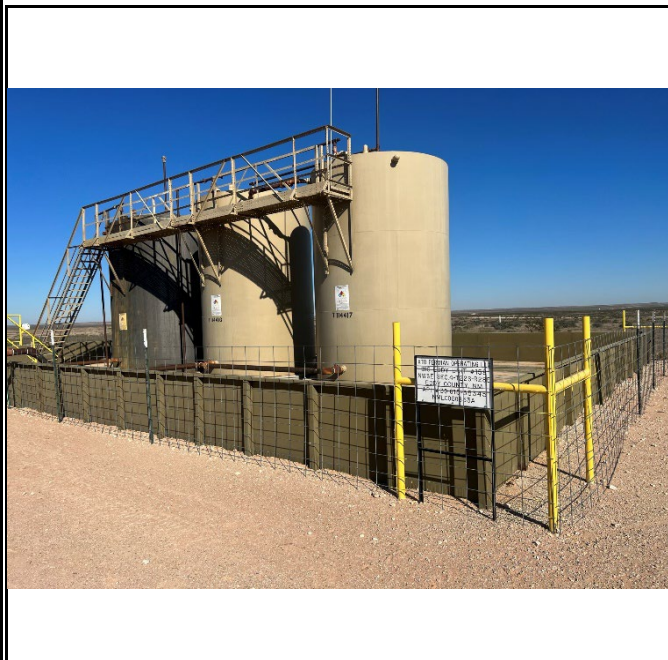
Photograph 1 Date: Nov. 21, 2022

Description: Tank battery/containment area.

Direction: Northeast

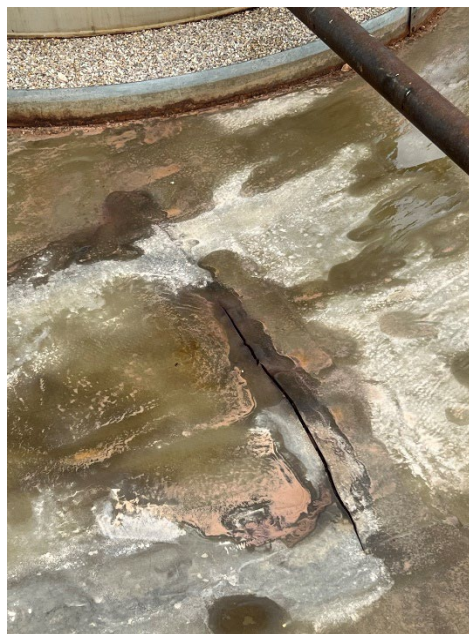
Photograph 2 Date: Nov. 21, 2022

Following the failed liner integrity inspection at the Site, Ensolum personnel advanced one borehole (BH01) at the location of the tear in the liner to assess for the presence or absence of impacted soil resulting from the October 19, 2022, produced water release within lined containment. Laboratory analytical results for all delineation soil samples indicated all COC concentrations were compliant with the Site Closure Criteria. The release was contained laterally by the lined containment and all released fluids were recovered during initial response activities. The tear in the liner was subsequently repaired. NMOCD notifications are included in Appendix E.

Description: Liner tear in containment area.

Direction: East

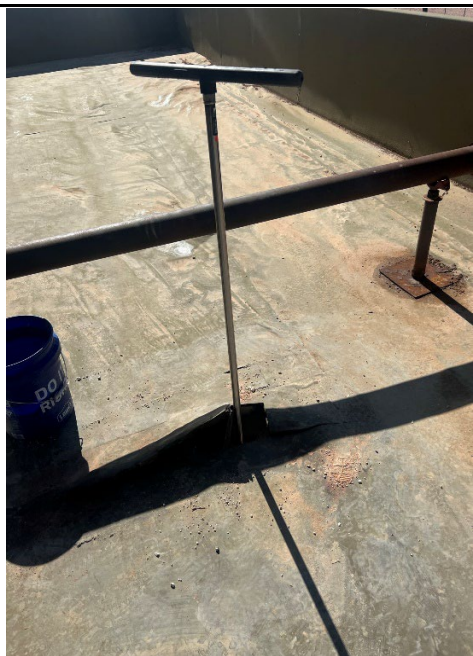
Photograph 3 Date: Nov. 21, 2022

Description: Delineation activities, BH01.

Direction: South

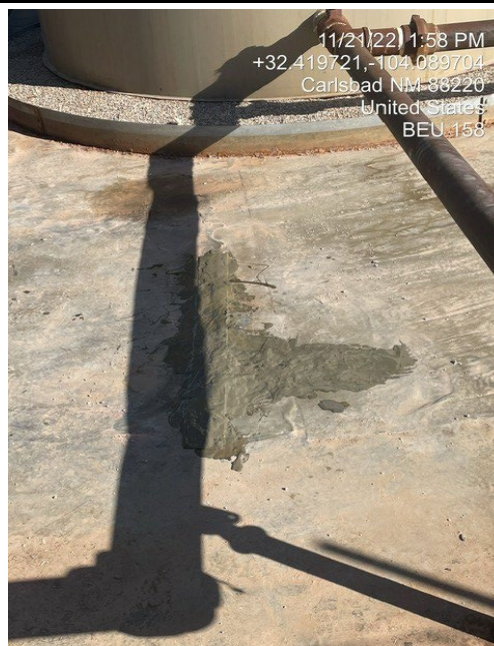
Photograph 4 Date: Nov. 21, 2022

Description: Liner patch, BH01.

Direction: East
