## Site Assessment/Characterization

## Closure

**Re: Site Assessment, Remediation, and Closure Report**  
**Cotton Draw Unit 250H (Cotton Draw Unit 7 CTB)**  
**API No. 30-025-42589**  
**GPS: Latitude 32.151797 Longitude -103.715336**  
**UL -- C, Sec. 7, T25S, R32E**  
**Lea County, NM**  
**NMOCD Ref. No. NOY1816949521**

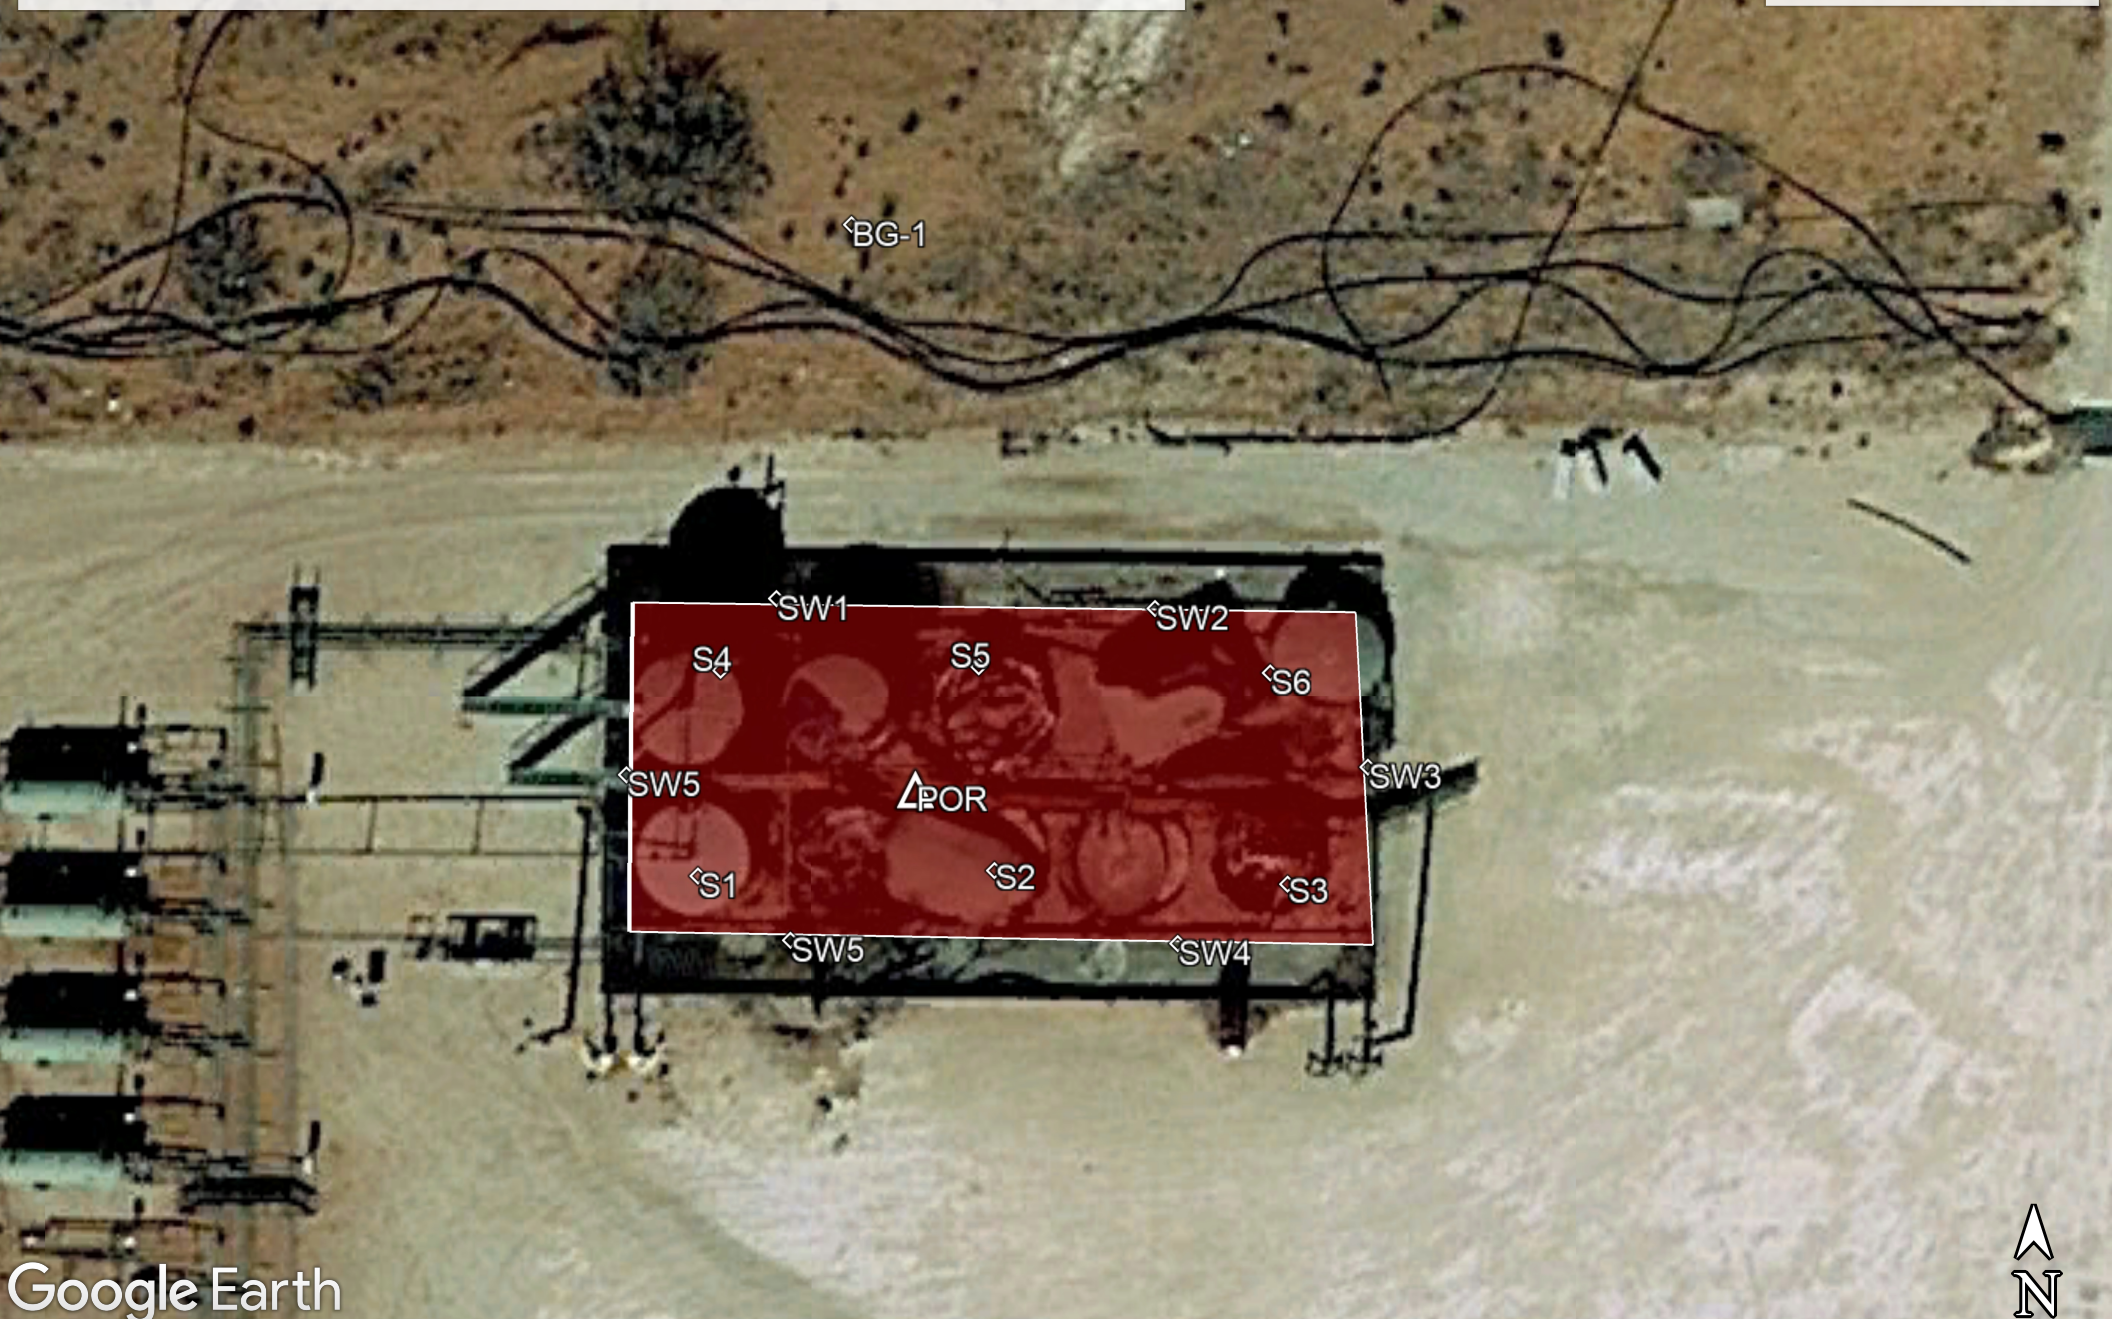
4-Site Map

On March 6<sup>th</sup>, 2023, Pima Environmental mobilized personnel to assess the impacted area. Pima sampled the areas surrounding and underlining the removed tank battery and collected a total of twenty-five soil samples for laboratory analysis. Six bottom samples (S1-S6) were collected at depths of 1, 2 and 4 feet to determine vertical delineation. Additionally, side wall samples (SW1-SW6) were collected at a depth of 6 inches to determine horizontal delineation. One background sample was collected to obtain a representation of naturally occurring chlorides surrounding the Cotton Draw. An initial site map can be found in Figure 4.

Site Map

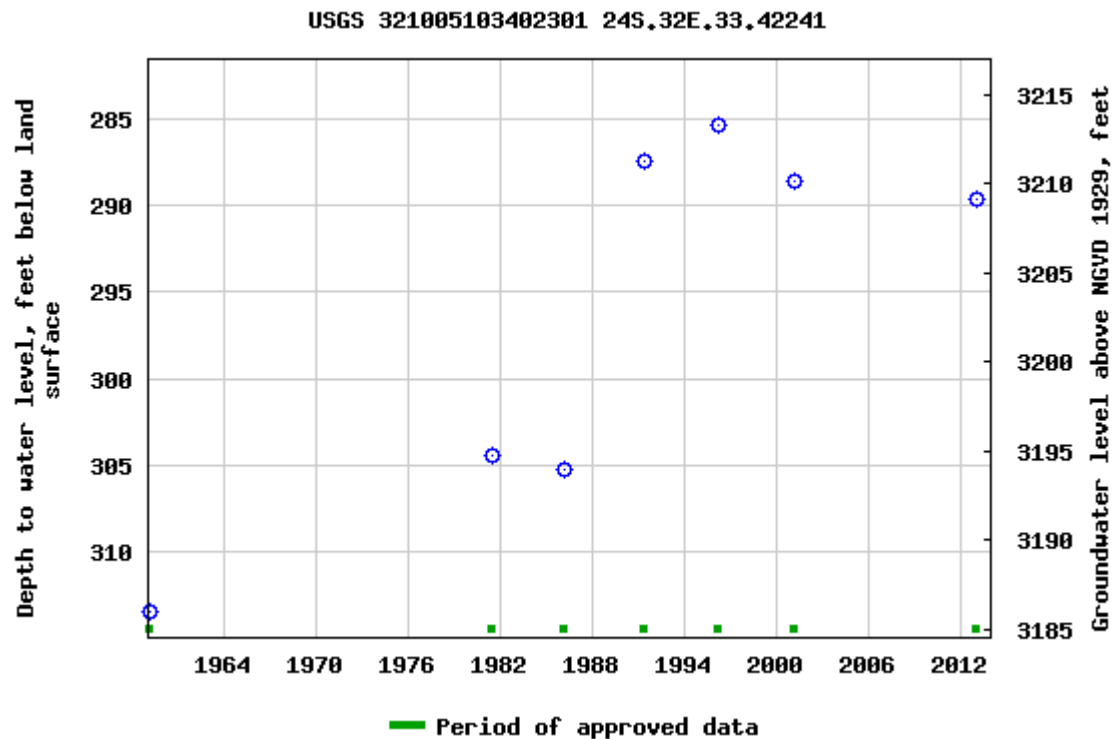
## USGS 321005103402301 24S.32E.33.42241

The depth of the well is 367 feet below land surface.

According to the New Mexico Office of the State Engineer, depth to the nearest groundwater in this area is 135 feet below grade surface (BGS). According to the United States Geological Survey (USGS), the nearest groundwater is greater than 289 feet BGS. The closest waterway is the Pecos River, located approximately 15.02 miles to the northwest of this location. See Appendix A for referenced water surveys.

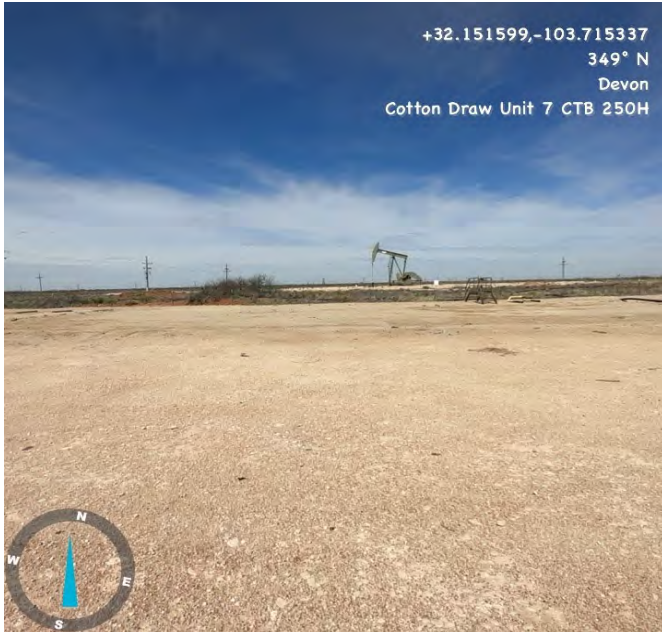
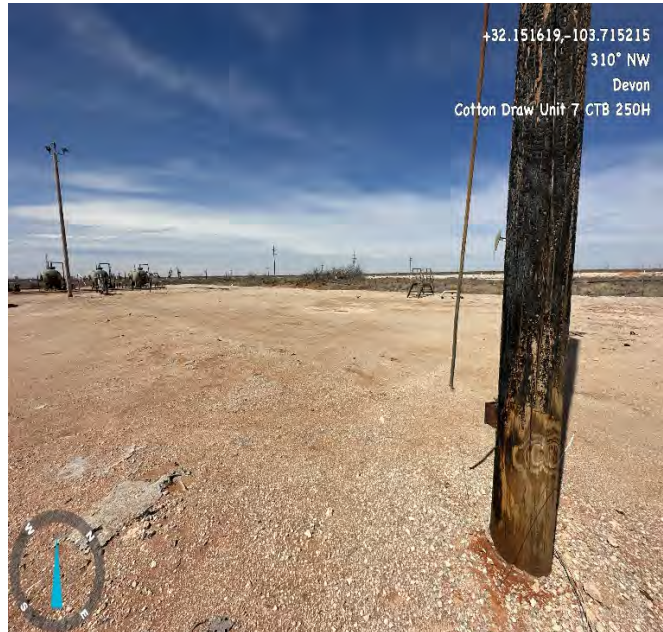
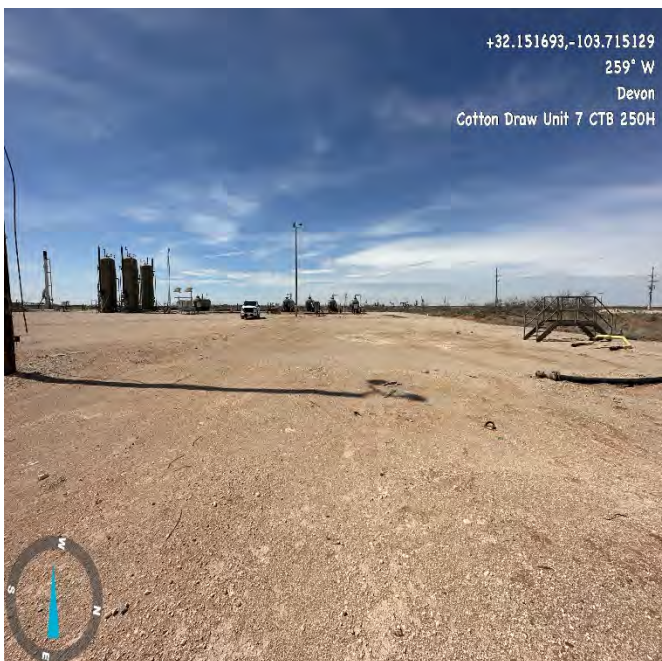
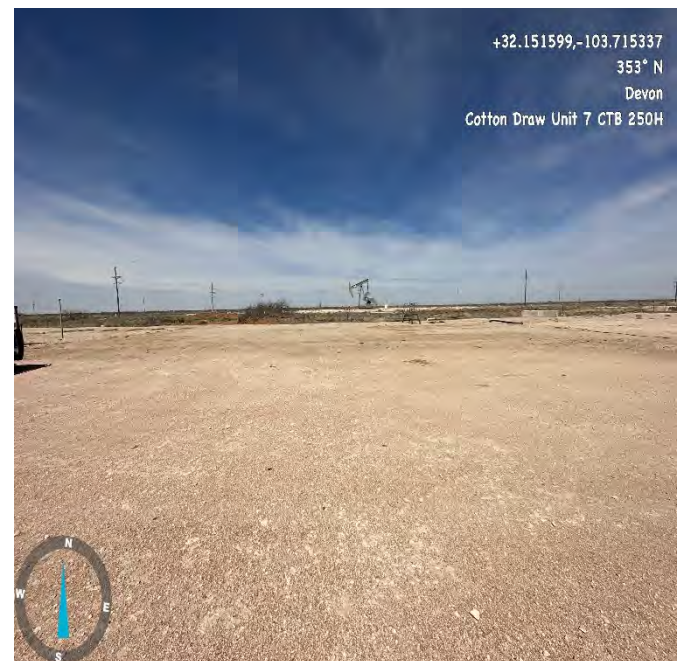
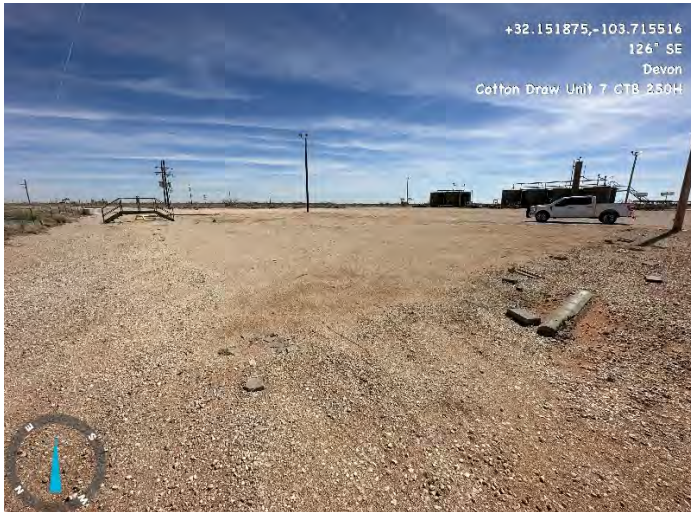
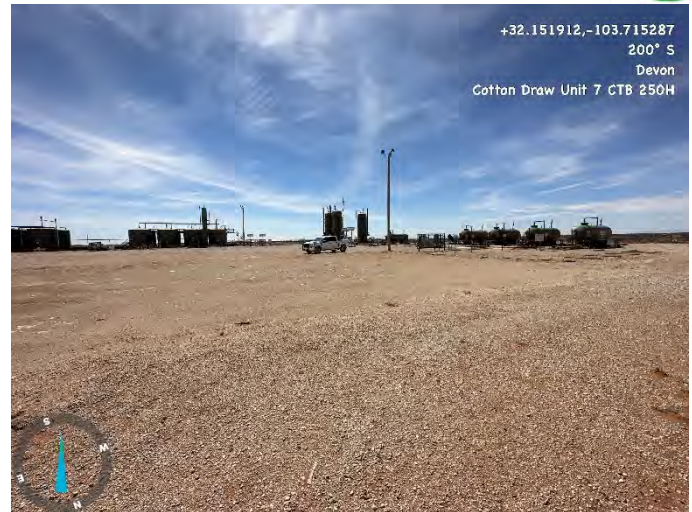
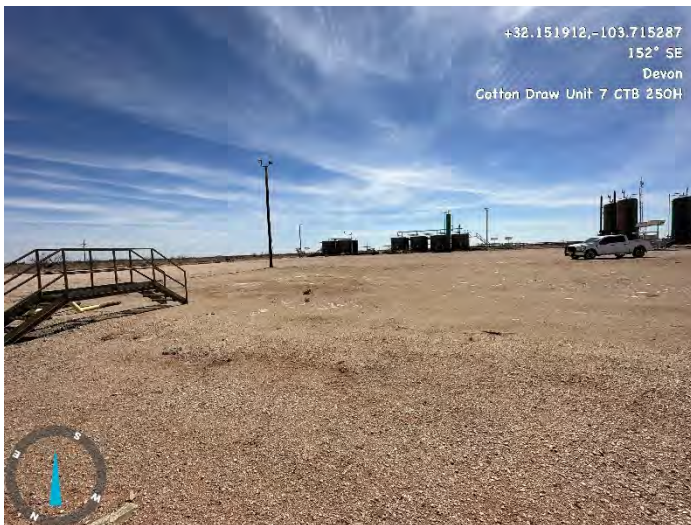
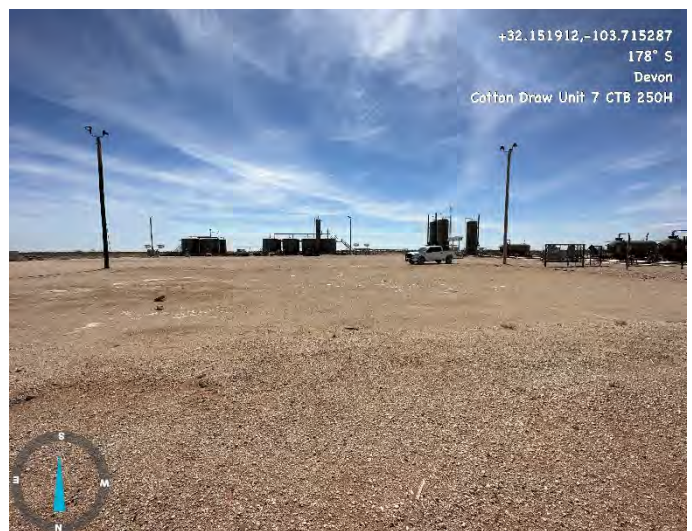
**SITE PHOTOGRAPHS  
PIMA ENVIRONMENTAL**

Based on the sample results, the bottoms and sidewalls are below NMOCD Closure Criteria 19.15.29 NMAC. See Appendix D for Photographic Documentation.
