Incident ID	NAPP227234168
District RP	
Facility ID	
Application ID

## Site Assessment/Characterization

Based on laboratory analytical results and field activities conducted to date, Etech recommends H.L. Brown Operating, LLC, provide copies of this Amended Remediation Summary and Soil Closure Request to the appropriate agencies and request closure be granted to the Federal H 002 Site.

**HL Brown Sites**  
 Inferred Depth to Groundwater Map  
 H.L. Brown Operating, LLC  
 Map GPS: 33.66350422, -103.15426221  
 Roosevelt County, NM

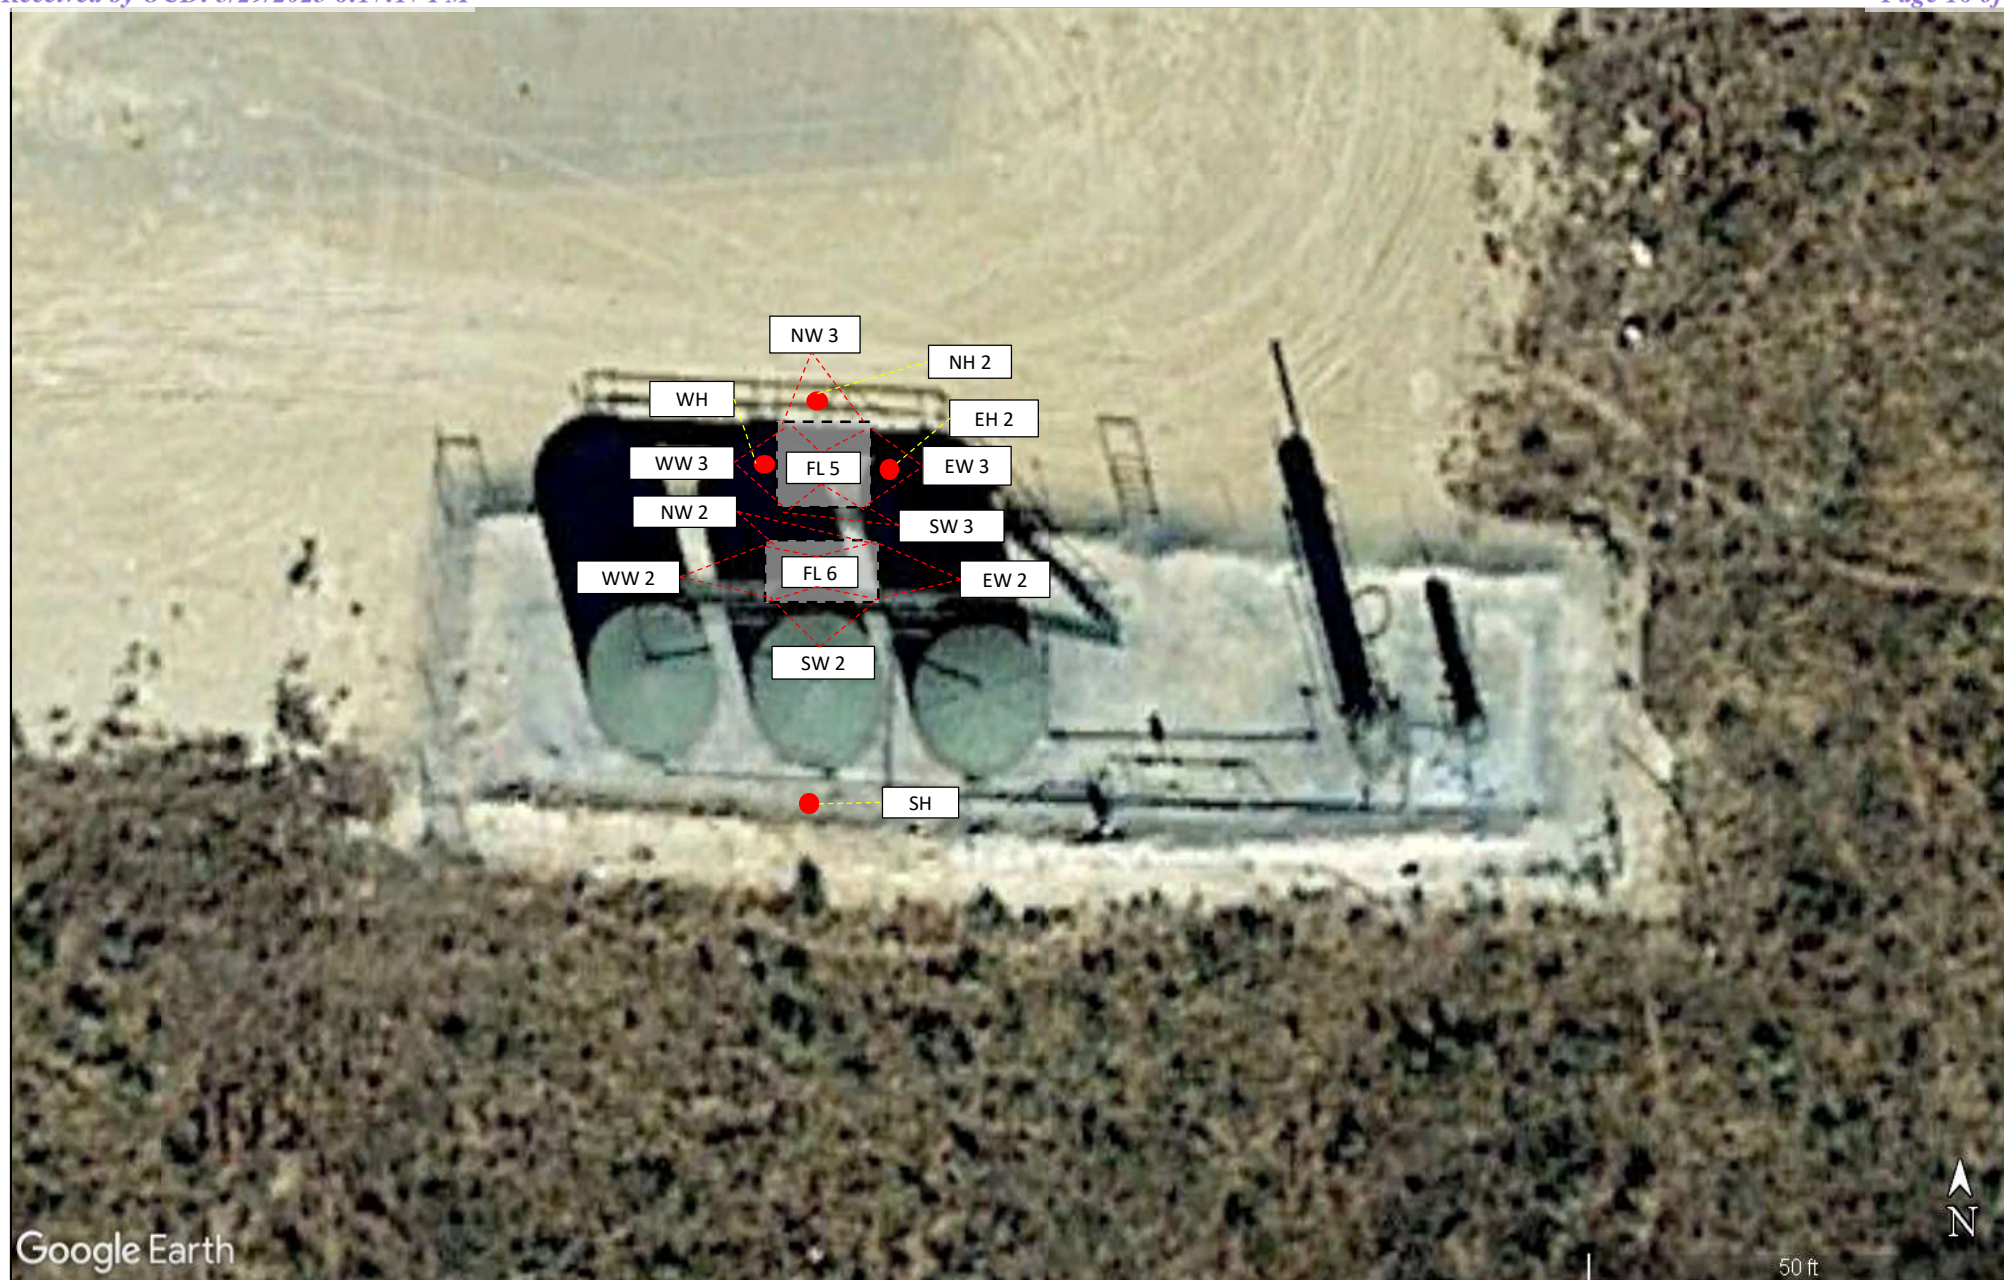
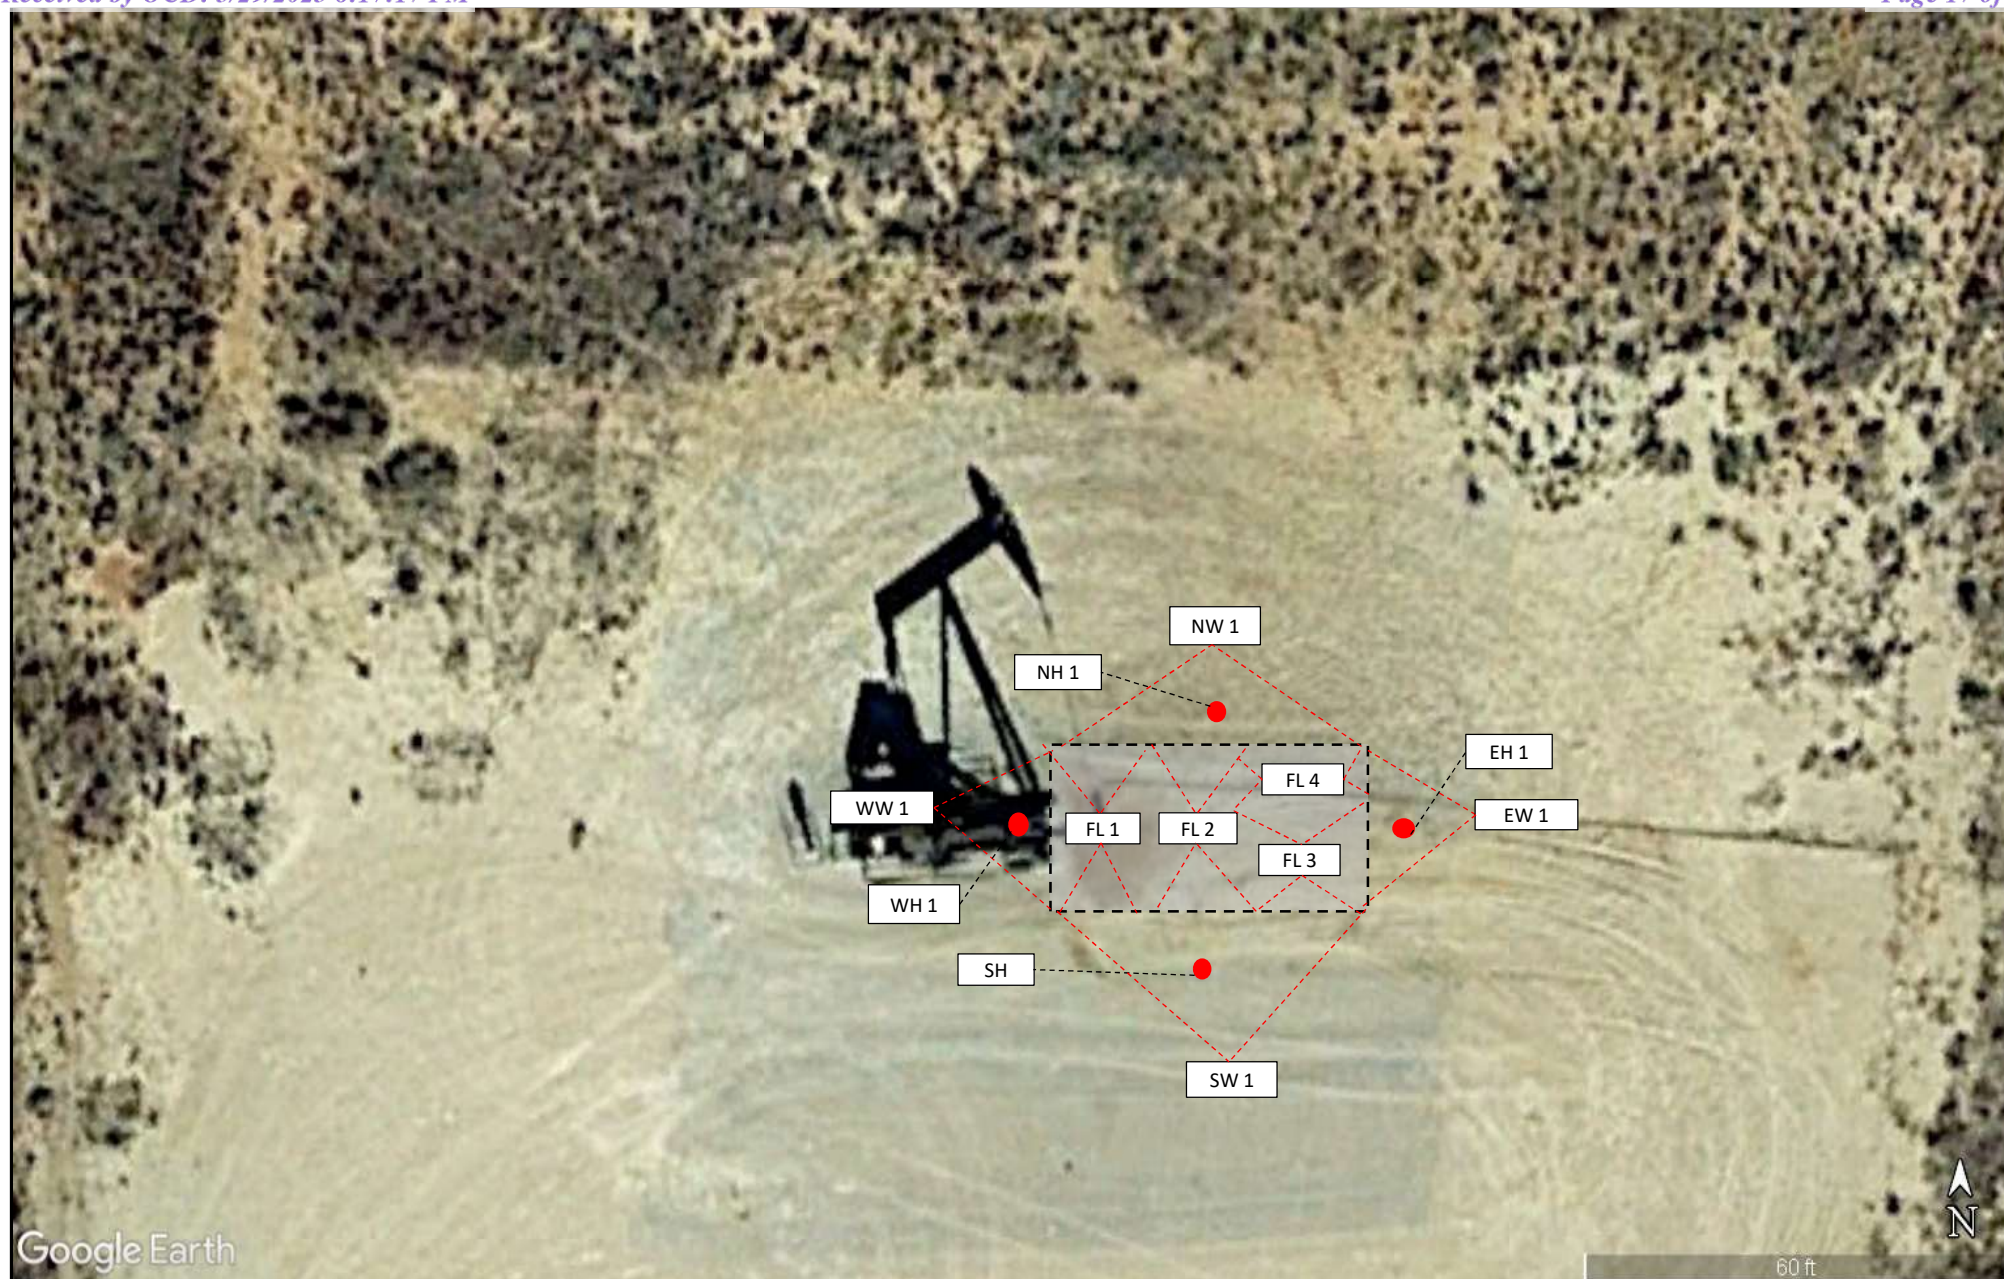
## **Figure 3A and Figure 3B Site and Sample Location Map**

- Confirmation Sample Location
- Horizontal Delineation Sample Point
- Excavated Area
