**Re: Revised Closure Report
ConocoPhillips
Heritage Concho
Gettysburg State Com #002H
Unit Letter C, Section 16, Township 23 South, Range 34 East
Lea County, New Mexico
Incident ID# nOY1726956579**

Revised Closure Report
May 15, 2023

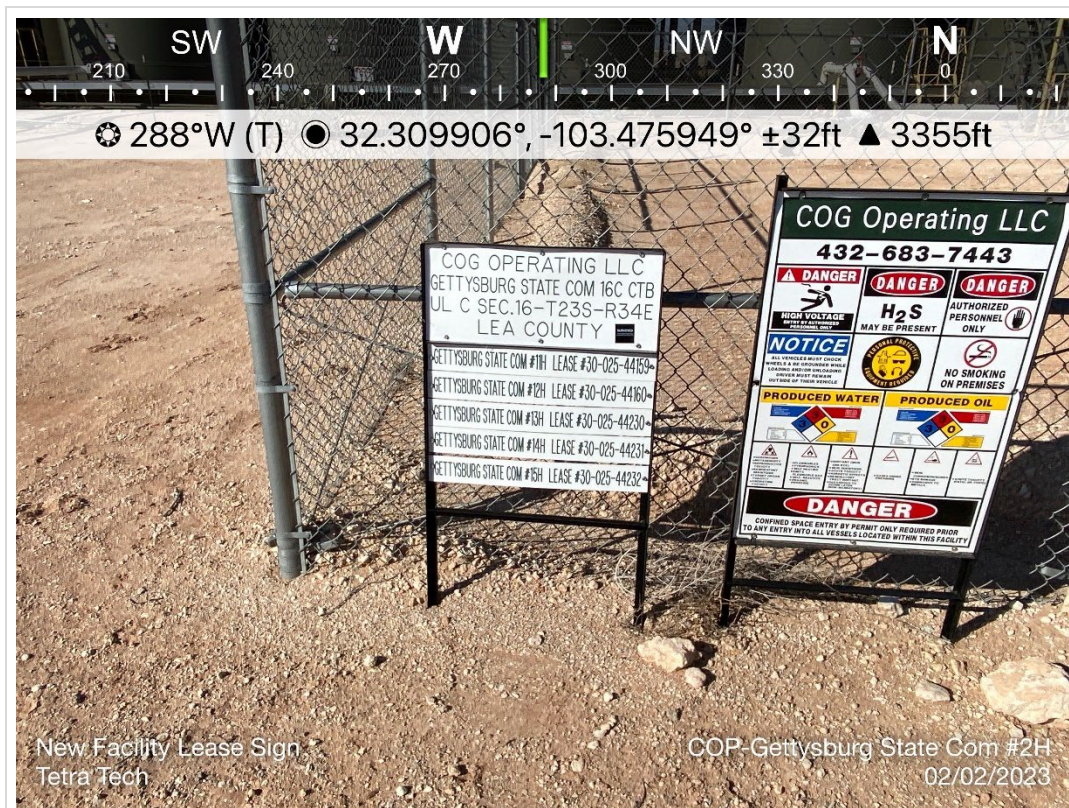
TETRA TECH, INC. PROJECT NO. 212C-MD-03001	DESCRIPTION	View west-northwest of site signage.	1
	SITE NAME	Gettysburg State #002H	2/2/2023

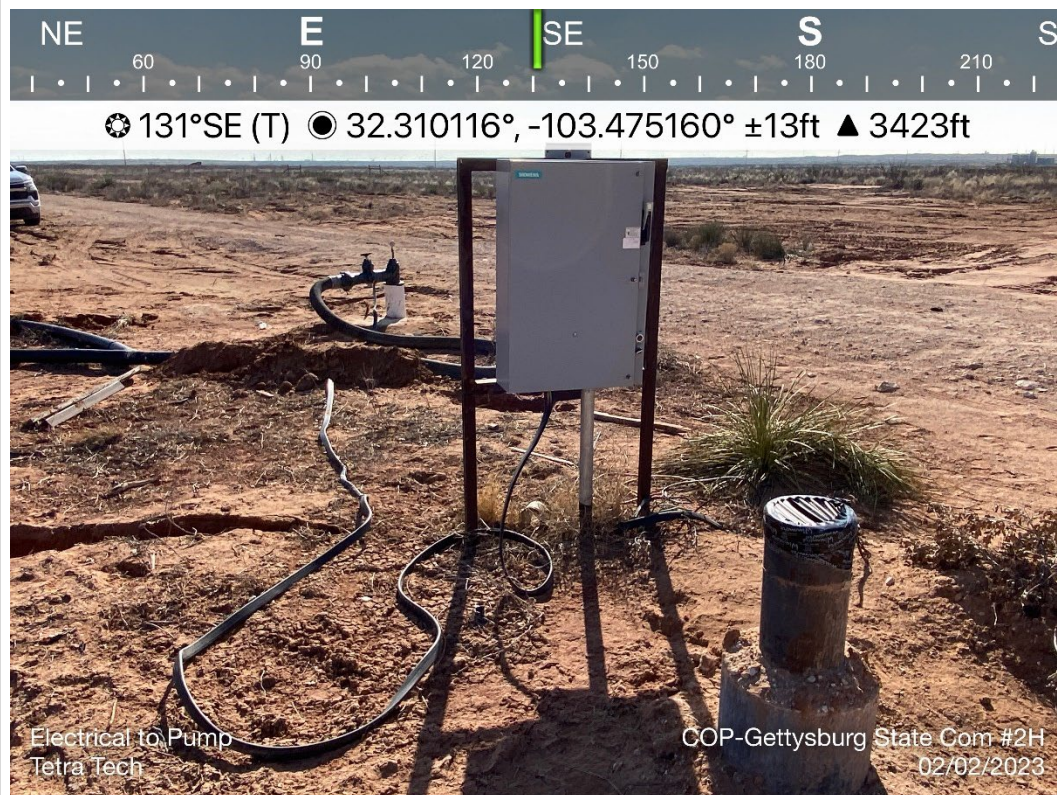
TETRA TECH, INC. PROJECT NO. 212C-MD-03001	DESCRIPTION	View southeast of electrical panel leading to pump.	2
	SITE NAME	Gettysburg State #002H	2/2/2023

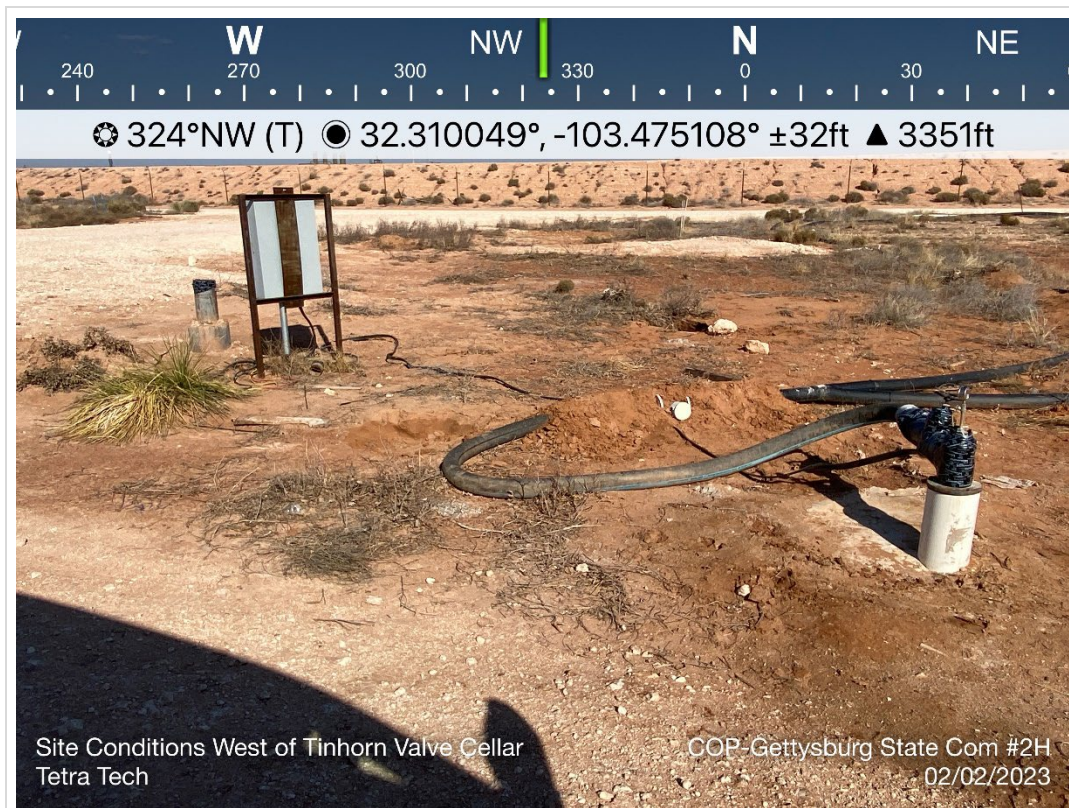
TETRA TECH, INC. PROJECT NO. 212C-MD-03001	DESCRIPTION	View northwest of site conditions. Pump and electrical panel rear view.	3
	SITE NAME	Gettysburg State #002H	2/2/2023

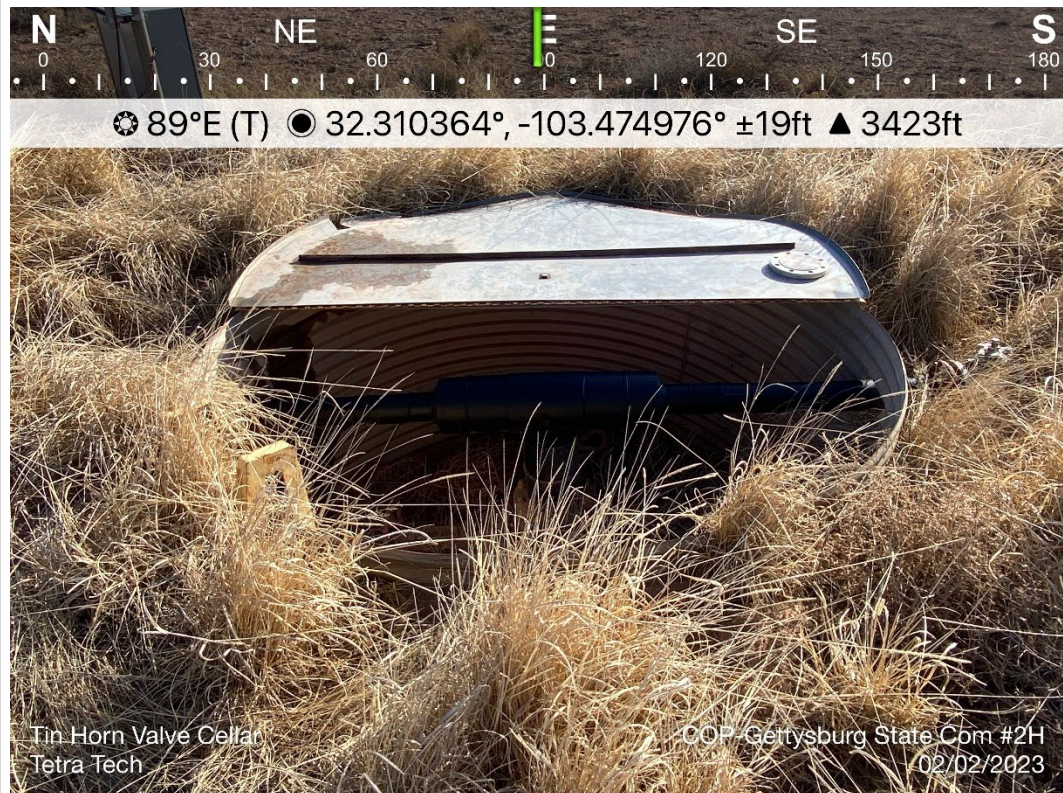
TETRA TECH, INC. PROJECT NO. 212C-MD-03001	DESCRIPTION	View east. Direct view of tin horn valve cellar.	4
	SITE NAME	Gettysburg State #002H	2/2/2023

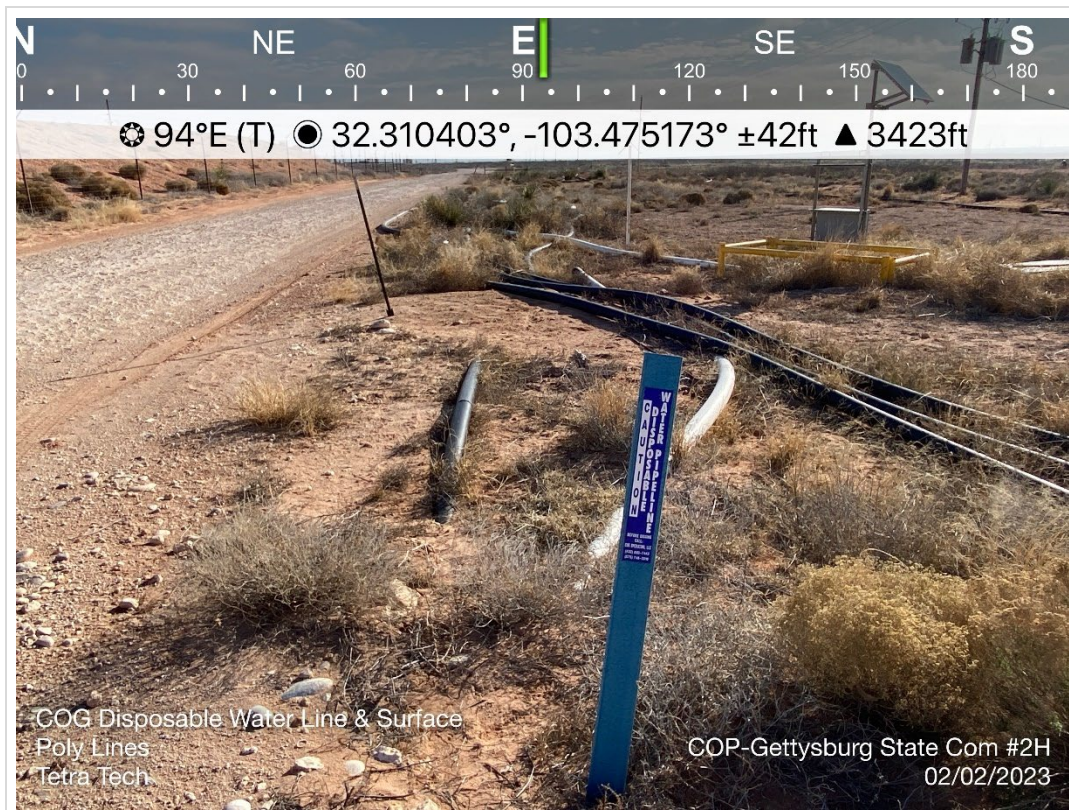
TETRA TECH, INC. PROJECT NO. 212C-MD-03001	DESCRIPTION	View east. COG signage for disposable water lines and surface poly lines present.	5
	SITE NAME	Gettysburg State #002H	2/2/2023

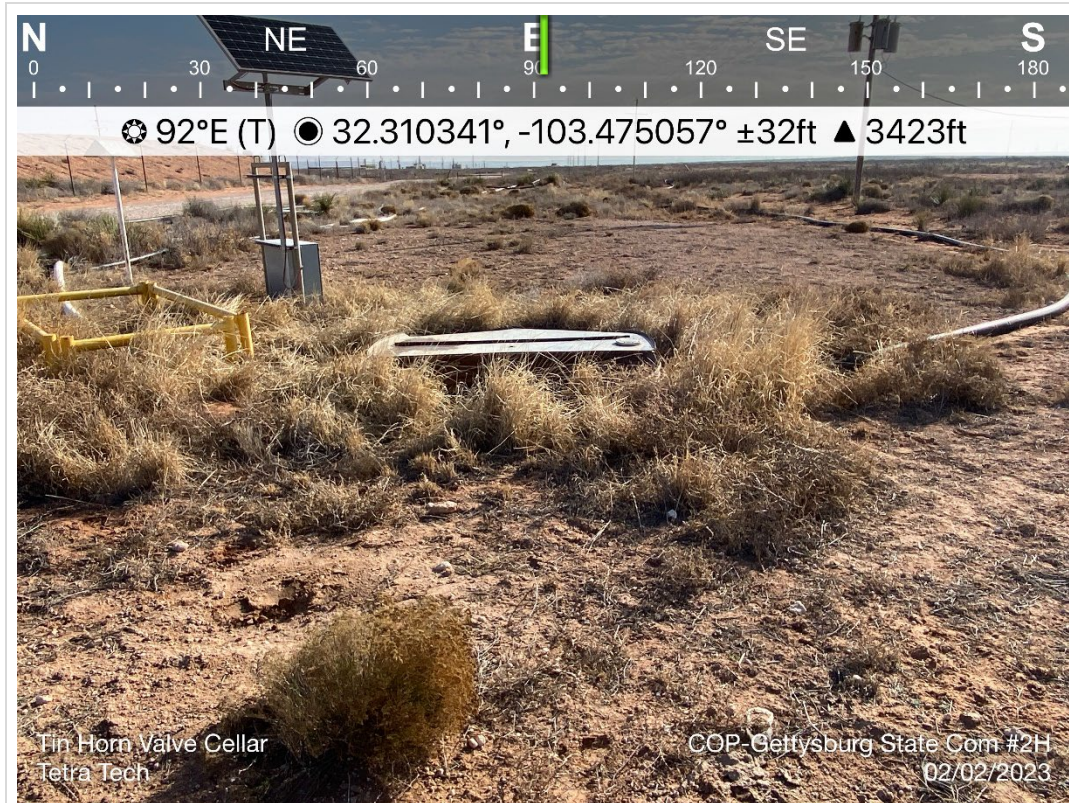
TETRA TECH, INC. PROJECT NO. 212C-MD-03001	DESCRIPTION	View east. Tin horn valve cellar and surrounding area.	6
	SITE NAME	Gettysburg State #002H	2/2/2023

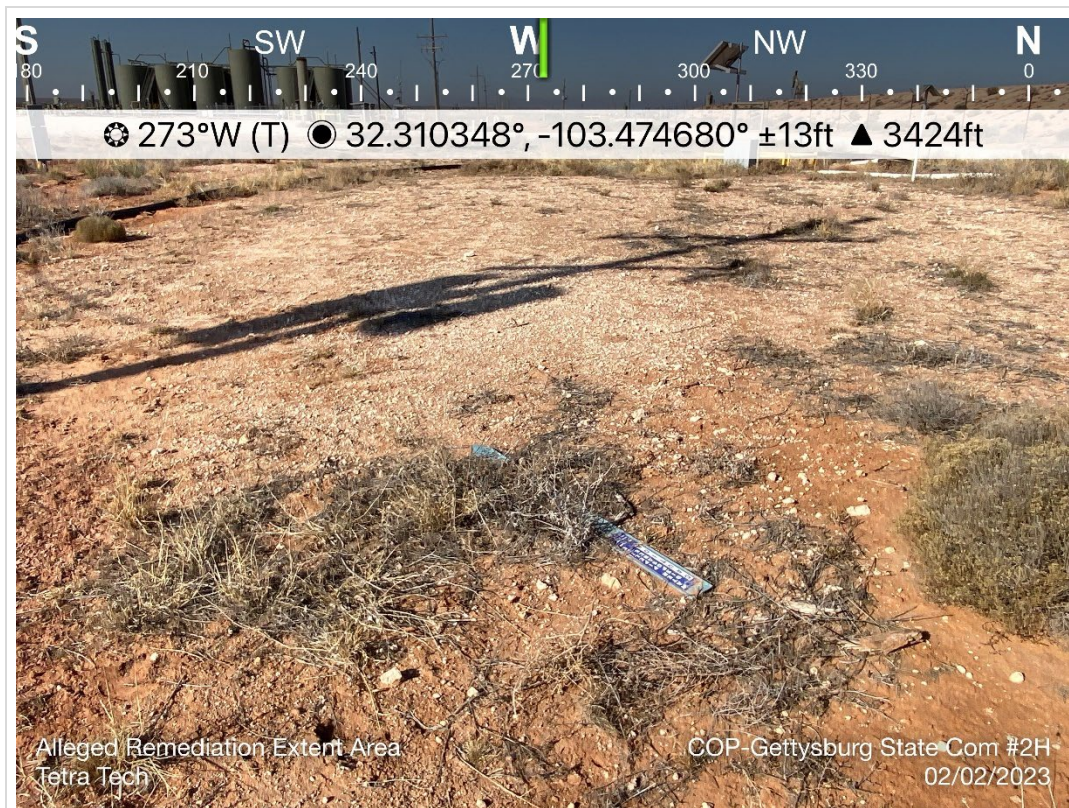
TETRA TECH, INC. PROJECT NO. 212C-MD-03001	DESCRIPTION	View west of reported remediation extent.	7
	SITE NAME	Gettysburg State #002H	2/2/2023

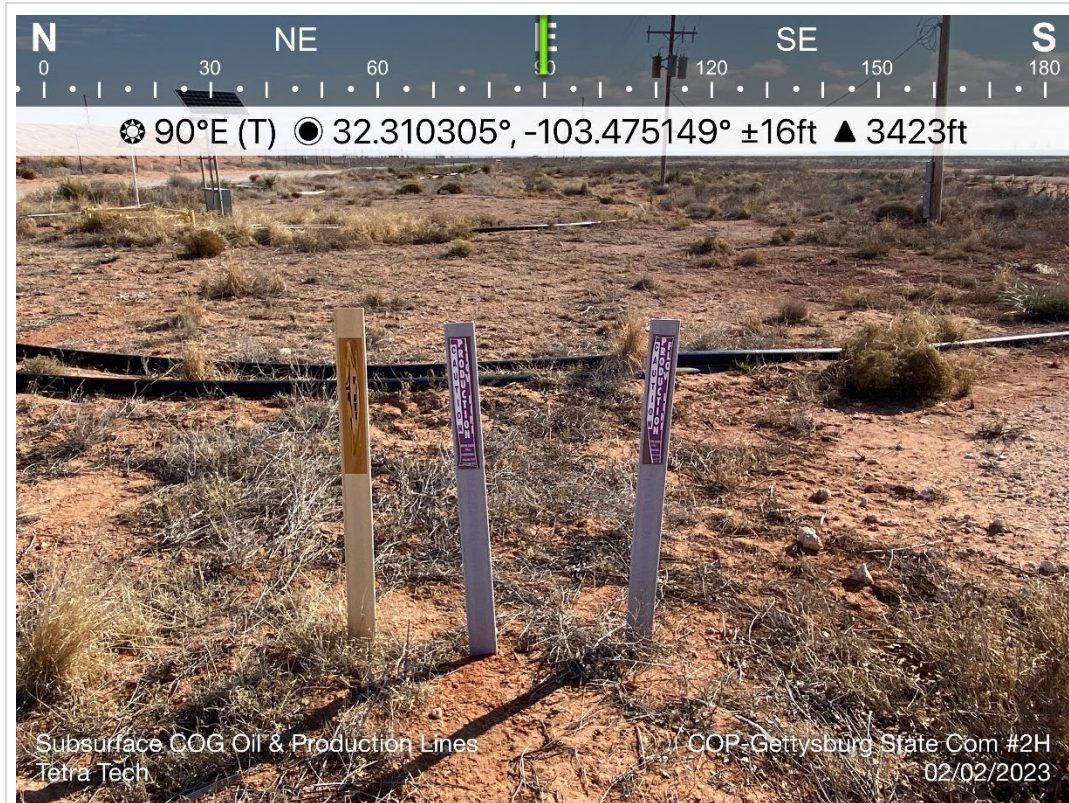
TETRA TECH, INC. PROJECT NO. 212C-MD-03001	DESCRIPTION	View east. Subsurface COP O&P lines, surface poly lines, and overhead electrical lines present.	8
	SITE NAME	Gettysburg State #002H	2/2/2023

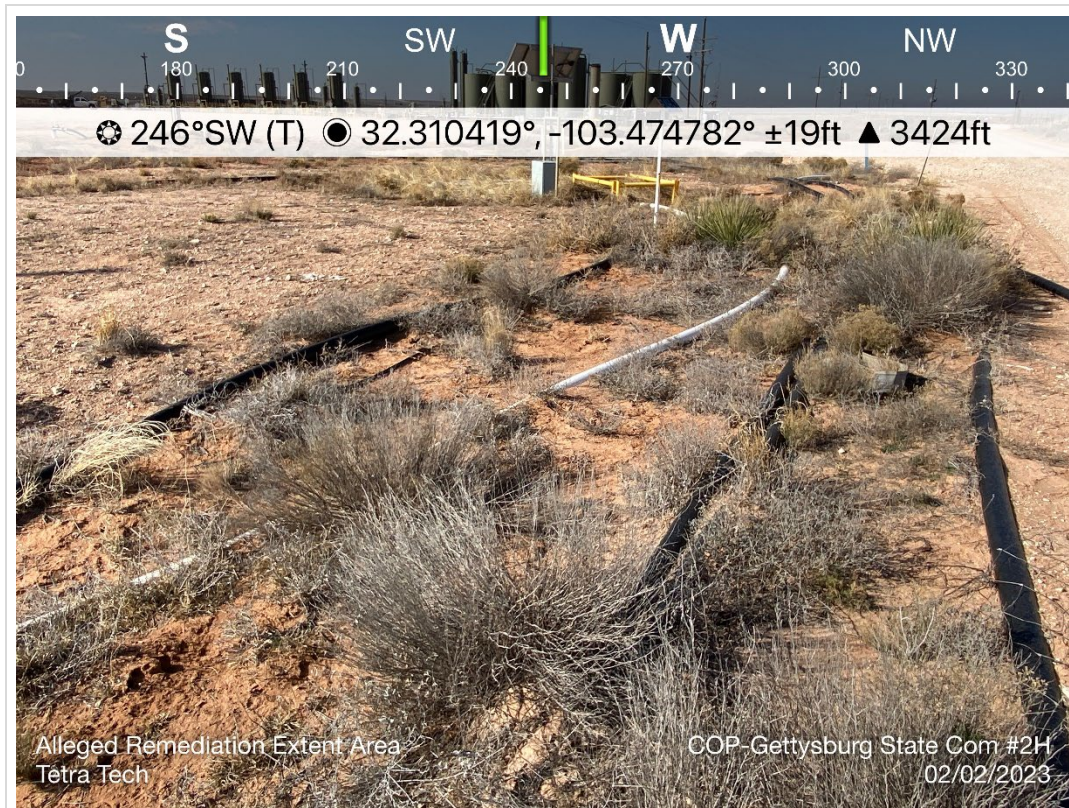
TETRA TECH, INC. PROJECT NO. 212C-MD-03001	DESCRIPTION	View west-southwest of alleged remediation extent.	9
	SITE NAME	Gettysburg State #002H	2/2/2023

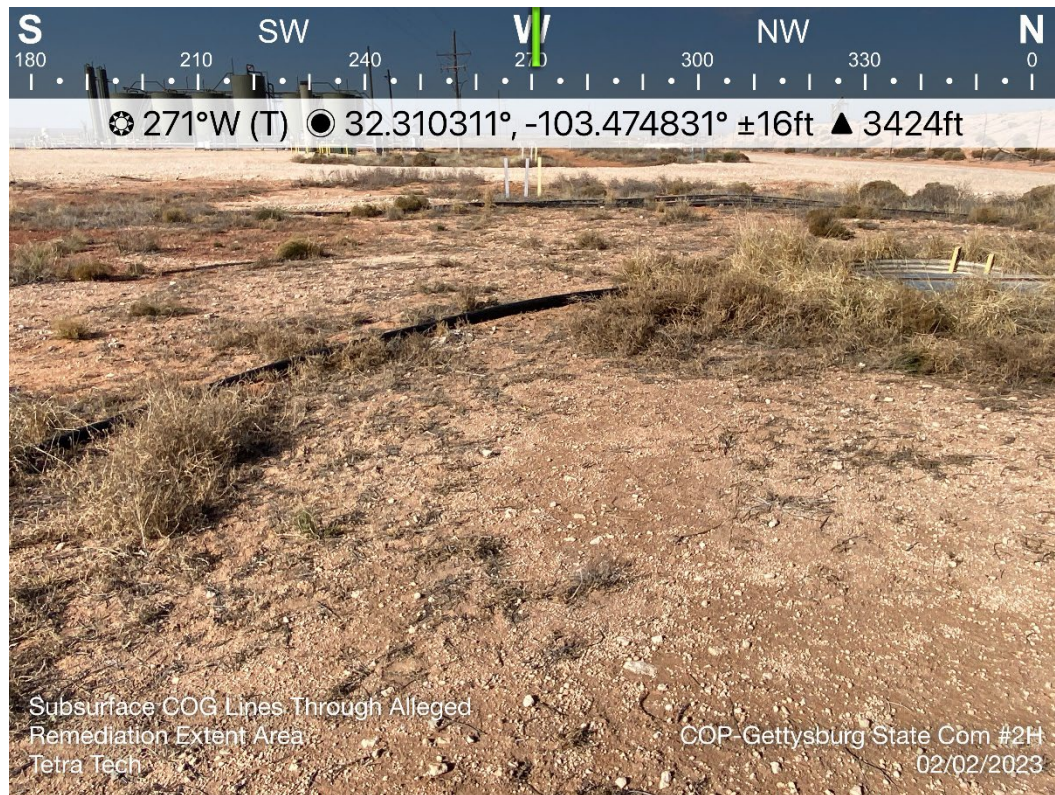
TETRA TECH, INC. PROJECT NO. 212C-MD-03001	DESCRIPTION	View west of tin horn valve cellar and area between excavation extents.	10
	SITE NAME	Gettysburg State #002H	2/2/2023

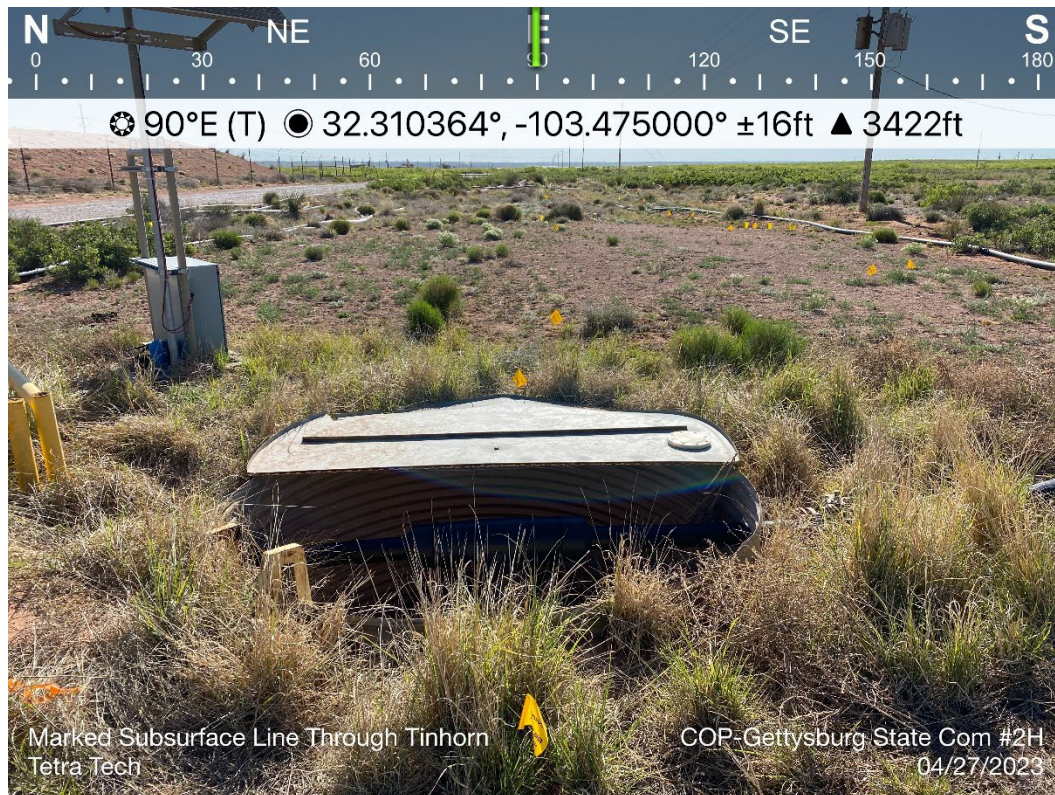
TETRA TECH, INC. PROJECT NO. 212C-MD-03001	DESCRIPTION	View east. View of Tin-horn and overhead powerlines.	12
	SITE NAME	Gettysburg State #002H	4/27/2023
