CLOSURE REPORT

Lateral 2B-24 (12/16/22)
Unit Letter F, S23 T28N R10W
San Juan County, New Mexico

New Mexico EMNRD OCD Incident ID No. NAPP2235329560

Ensolum Project No. 05A1226224

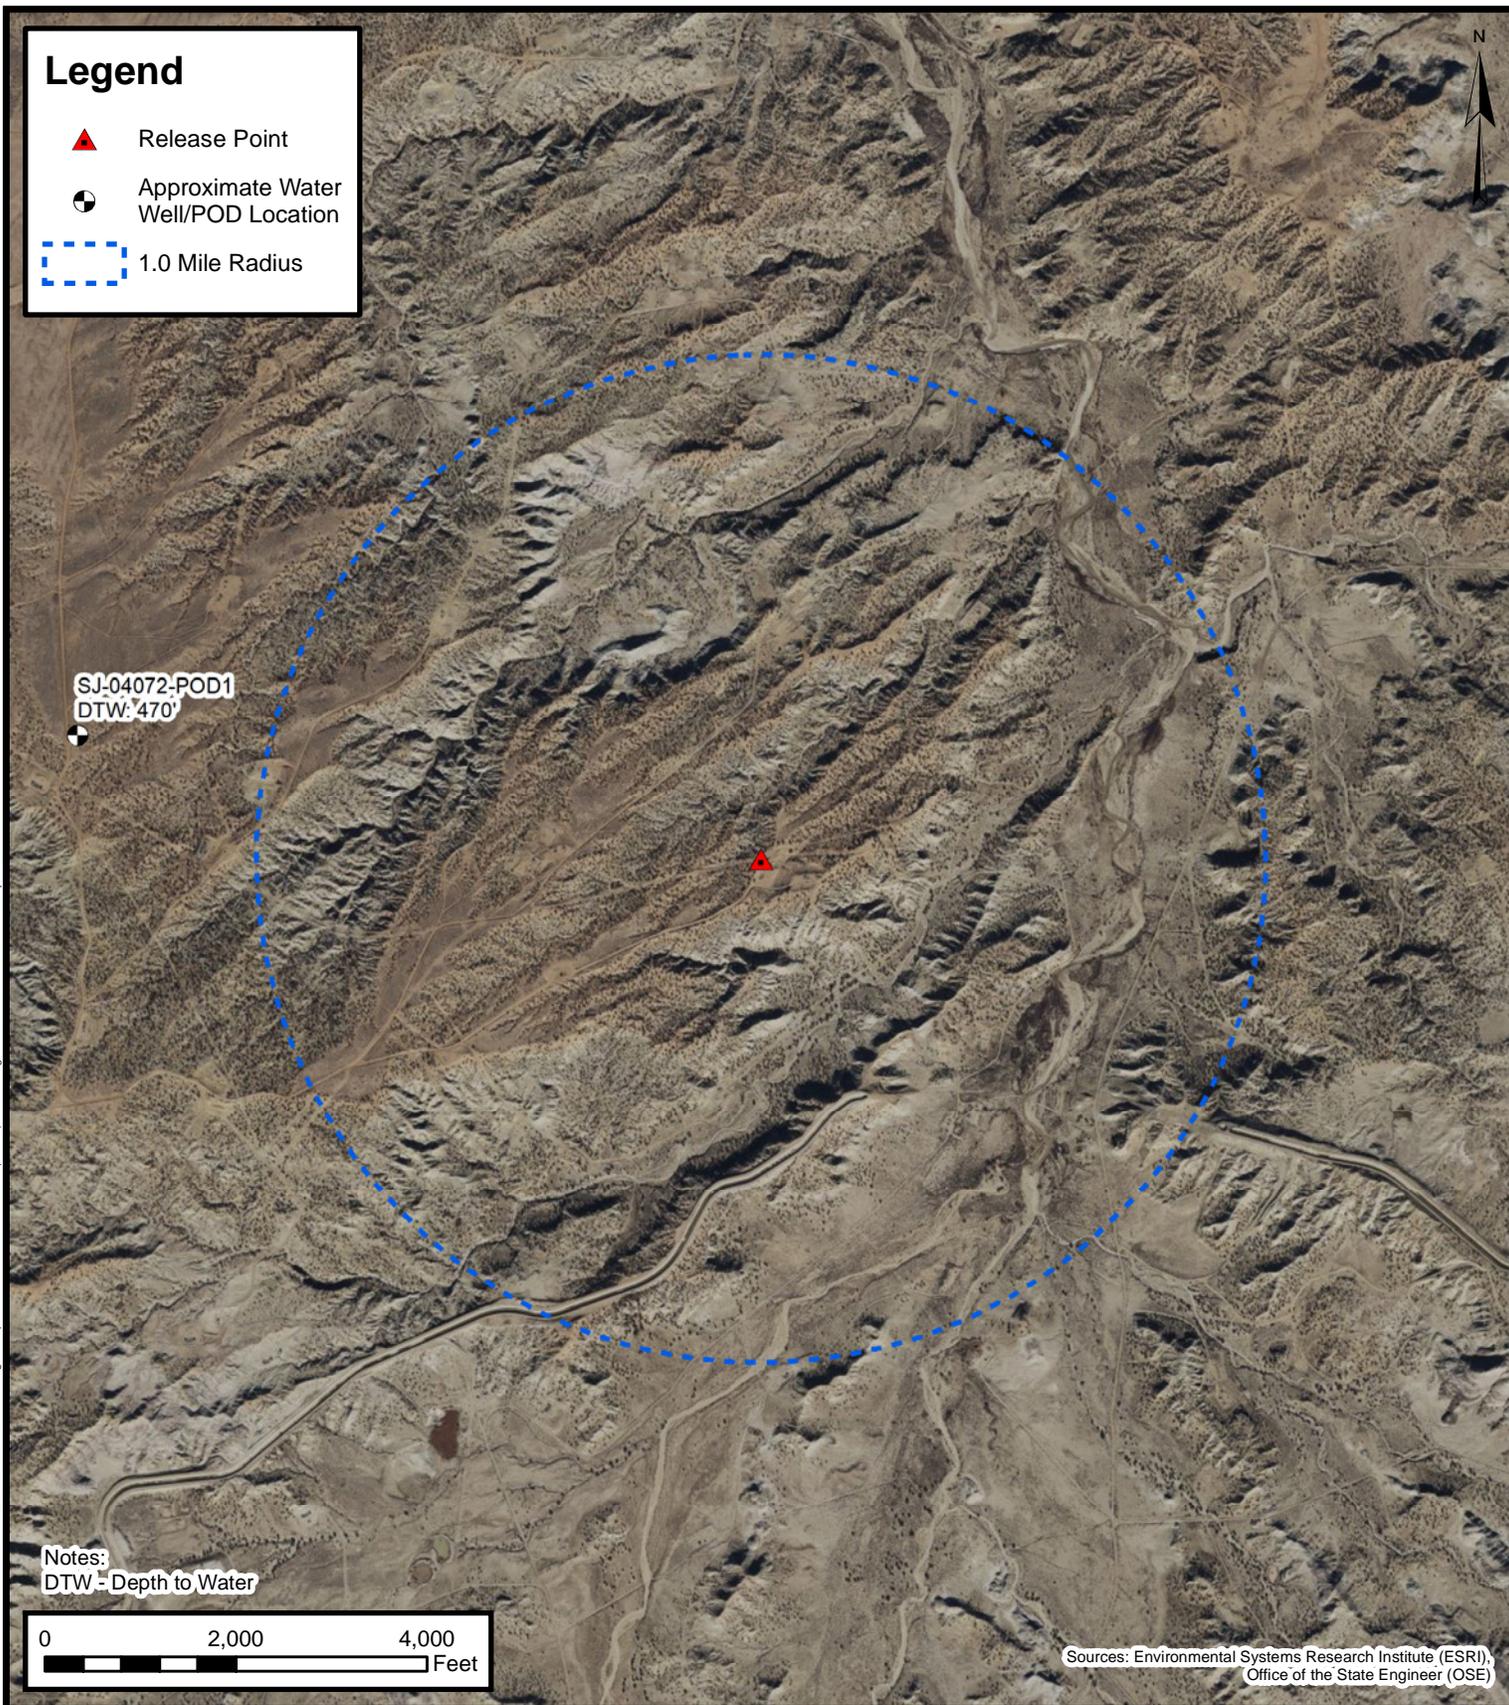
**FIGURE
A**

1.0 MILE RADIUS WATER WELL/ POD LOCATION MAP

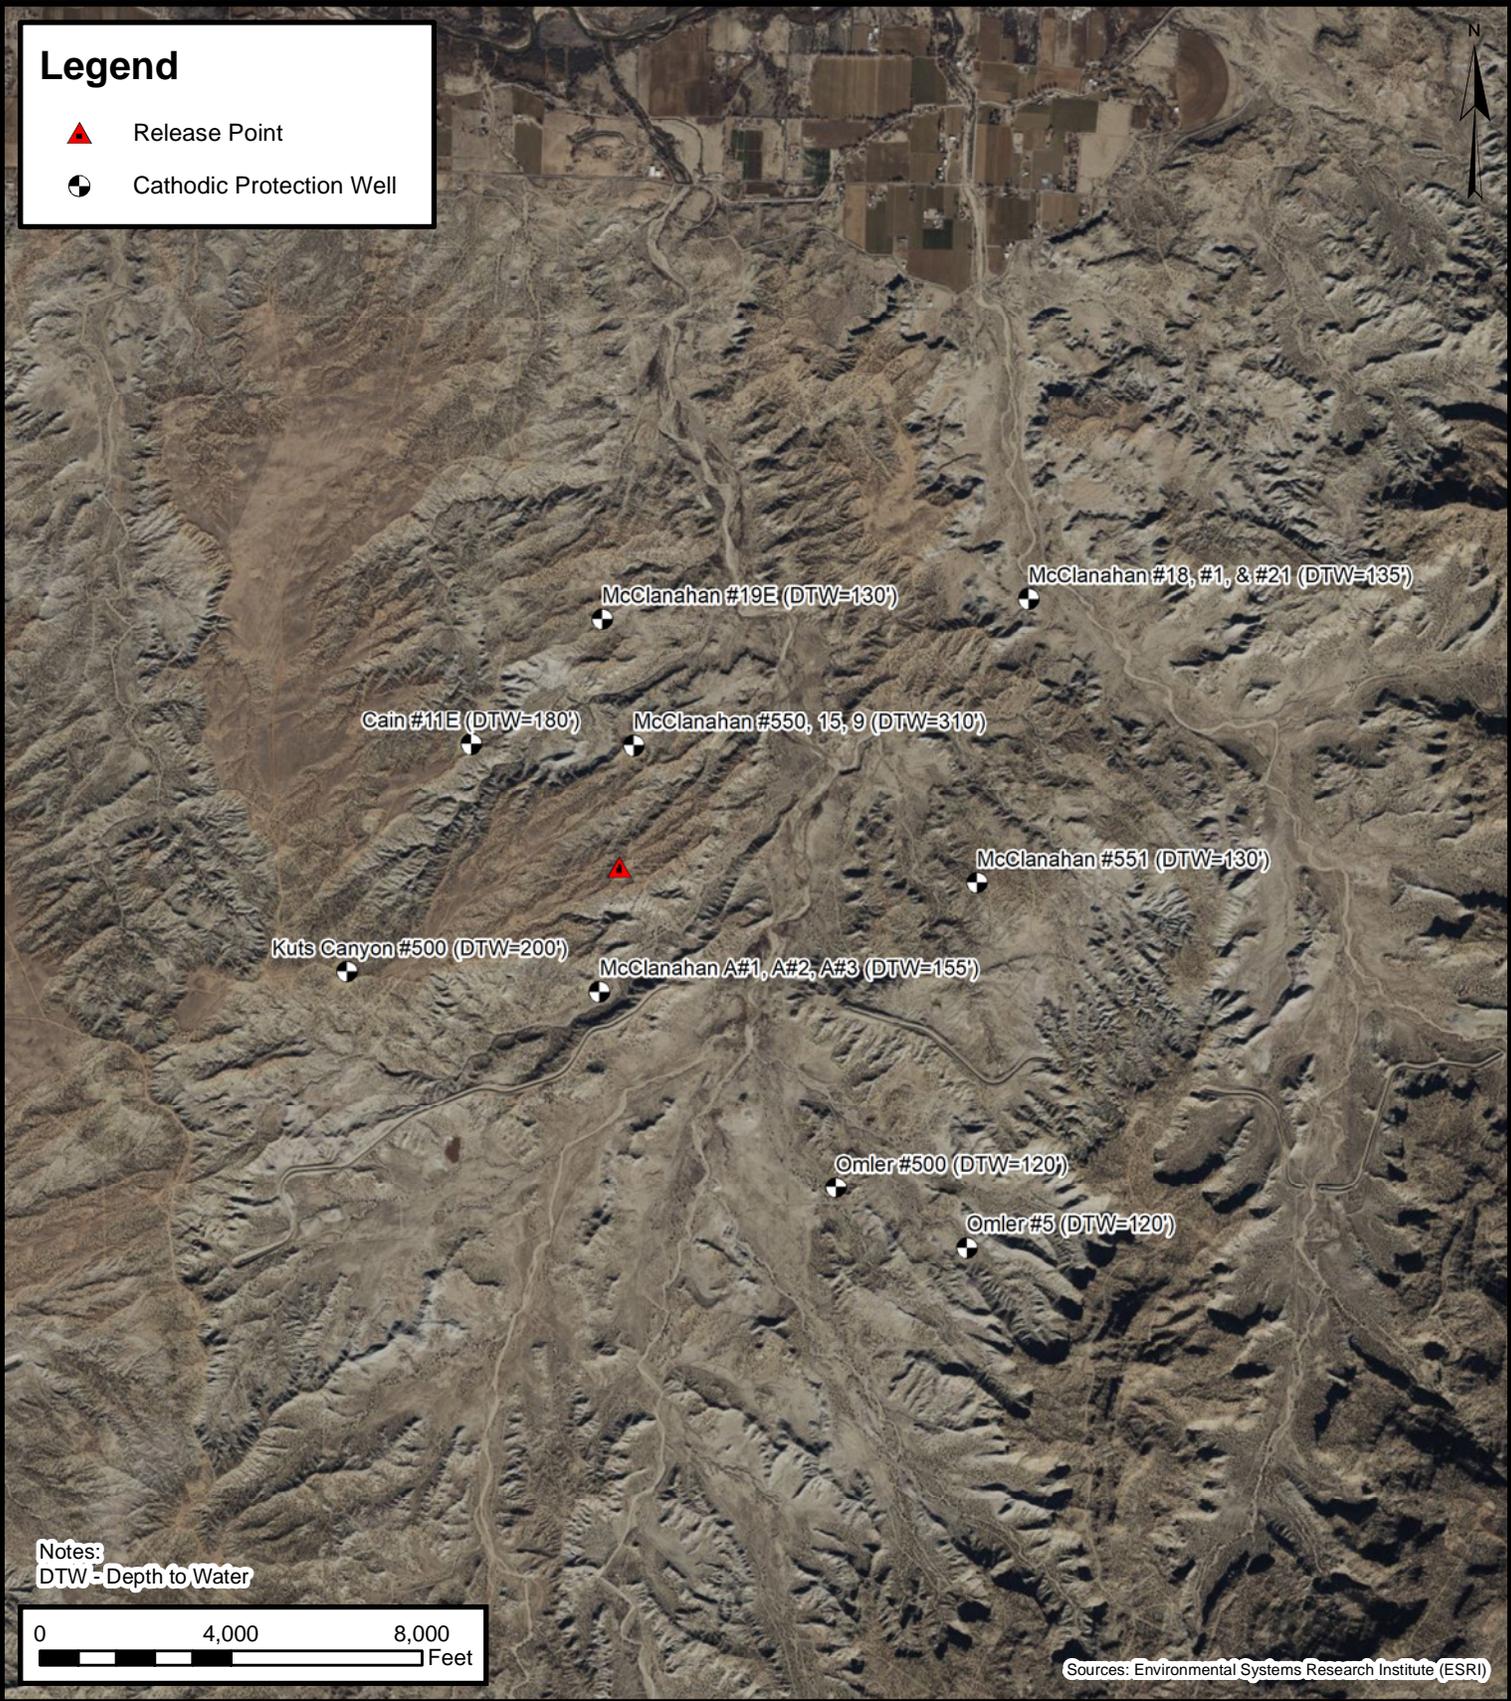
FIGURE B

PLSS sections. These nine CPWs are depicted on **Figure B (Appendix B)**. The four closest CPWs are located near the McClanahan A#1, A#2, and A#3, McClanahan #550, #15, and #9, Cain #11E, and Kutz Canyon #500 well locations. Documentation for the cathodic protection well located near the McClanahan A#1, A#2, and A#3 well locations indicates a depth to water of approximately 155 feet below grade surface (bgs). This cathodic protection well is located approximately 0.47 miles south of the Site and is approximately 112 feet lower in elevation than the Site. Documentation for the cathodic protection well located near the McClanahan #550, #15, and #9 well locations indicates a depth to water of approximately 310 feet bgs. This cathodic protection well is located approximately 0.50 miles north of the Site and is approximately 123 feet lower in elevation than the Site. Documentation for the cathodic protection well located near the Cain #11E well location indicates a depth to water of approximately 180 feet bgs. This cathodic protection well is located approximately 0.79 miles northwest of the Site and is approximately 23 feet lower in elevation than the Site. Documentation for the cathodic protection well located near the Kutz Canyon #500 well location indicates a depth to water of approximately 200 feet bgs. This cathodic protection well is located approximately 1.2 miles southwest of the Site and is approximately 33 feet lower in elevation than the Site.

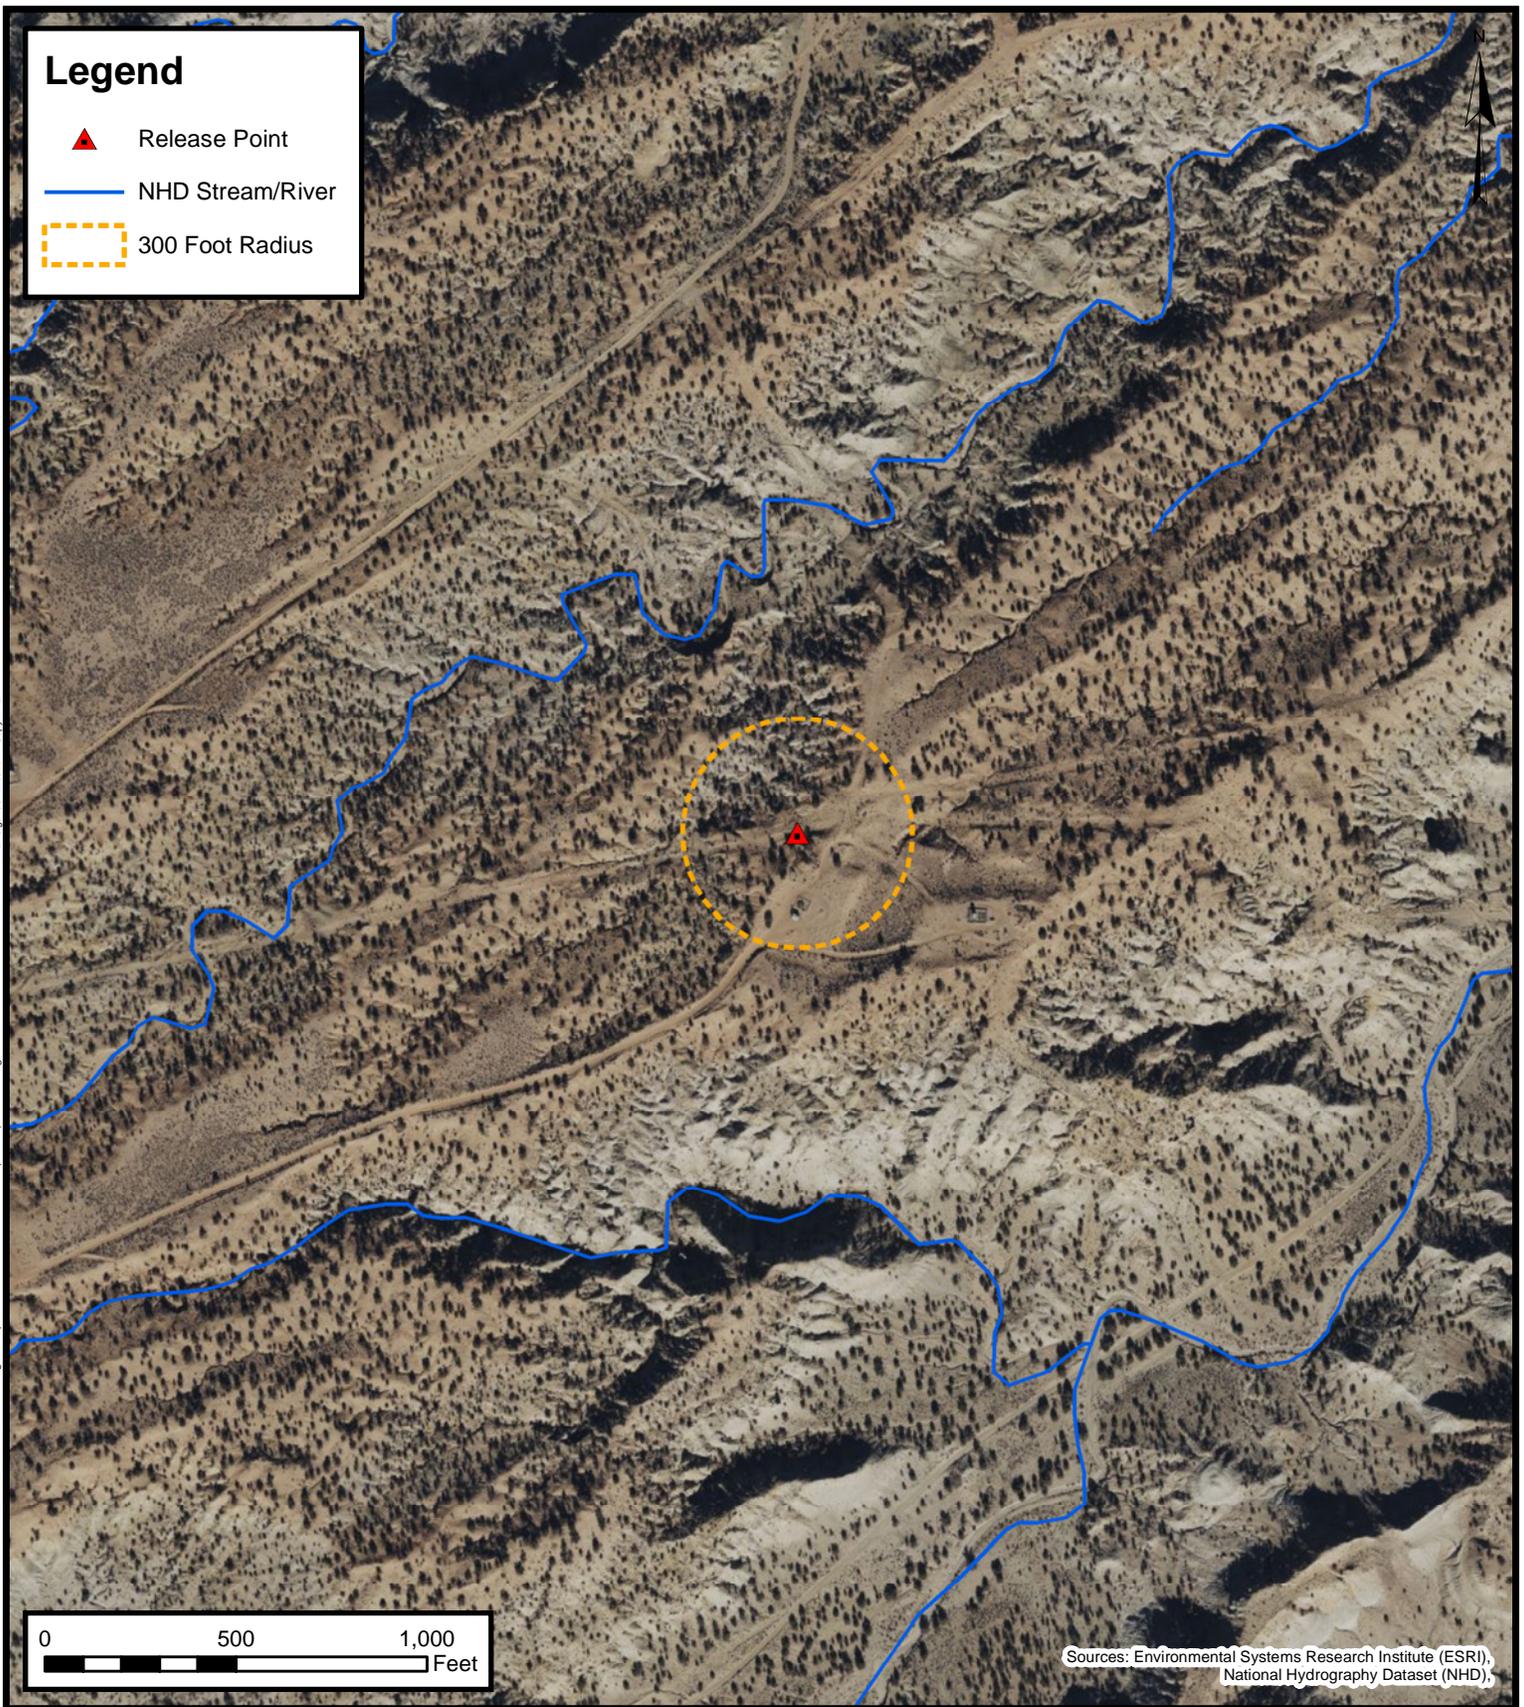
FIGURE C

- The Site is located within 300 feet of a NM EMNRD OCD-defined continuously flowing watercourse or significant watercourse (**Figure C, Appendix B**).

300 Foot Radius Watercourse and Drainage Identification
 Enterprise Field Services, LLC
 Lateral 2B-24 (12/16/22)
 Project Number: 05A1226224
 Unit Letter F, S23, T28, R10W, San Juan County, New Mexico
 36.650466, -107.869131

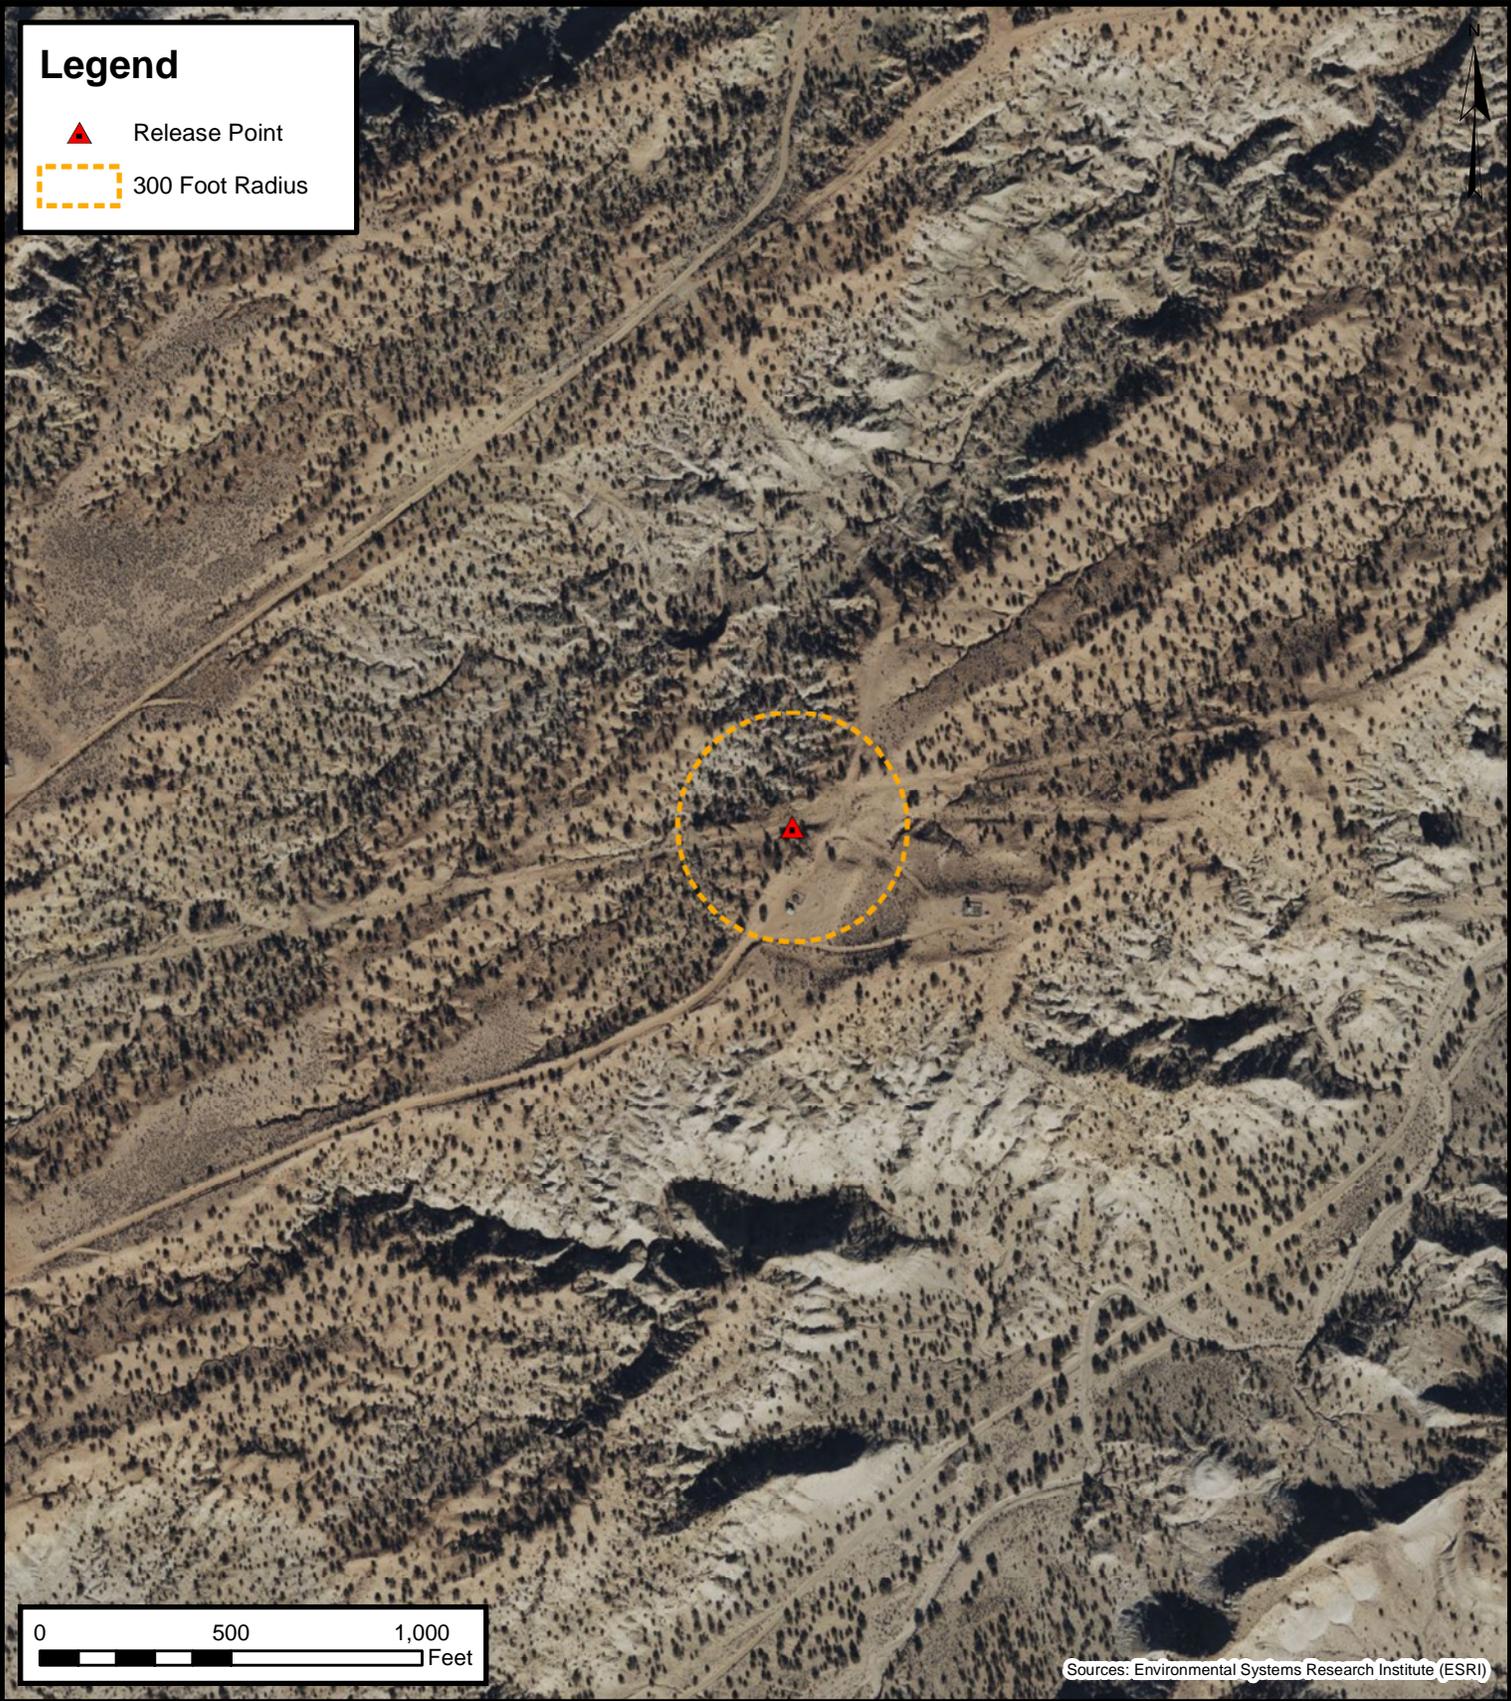
FIGURE

- The Site is not located within 200 feet of a lakebed, sinkhole, or playa lake.
- The Site is not located within 300 feet of a permanent residence, school, hospital, institution, or church (**Figure D, Appendix B**).

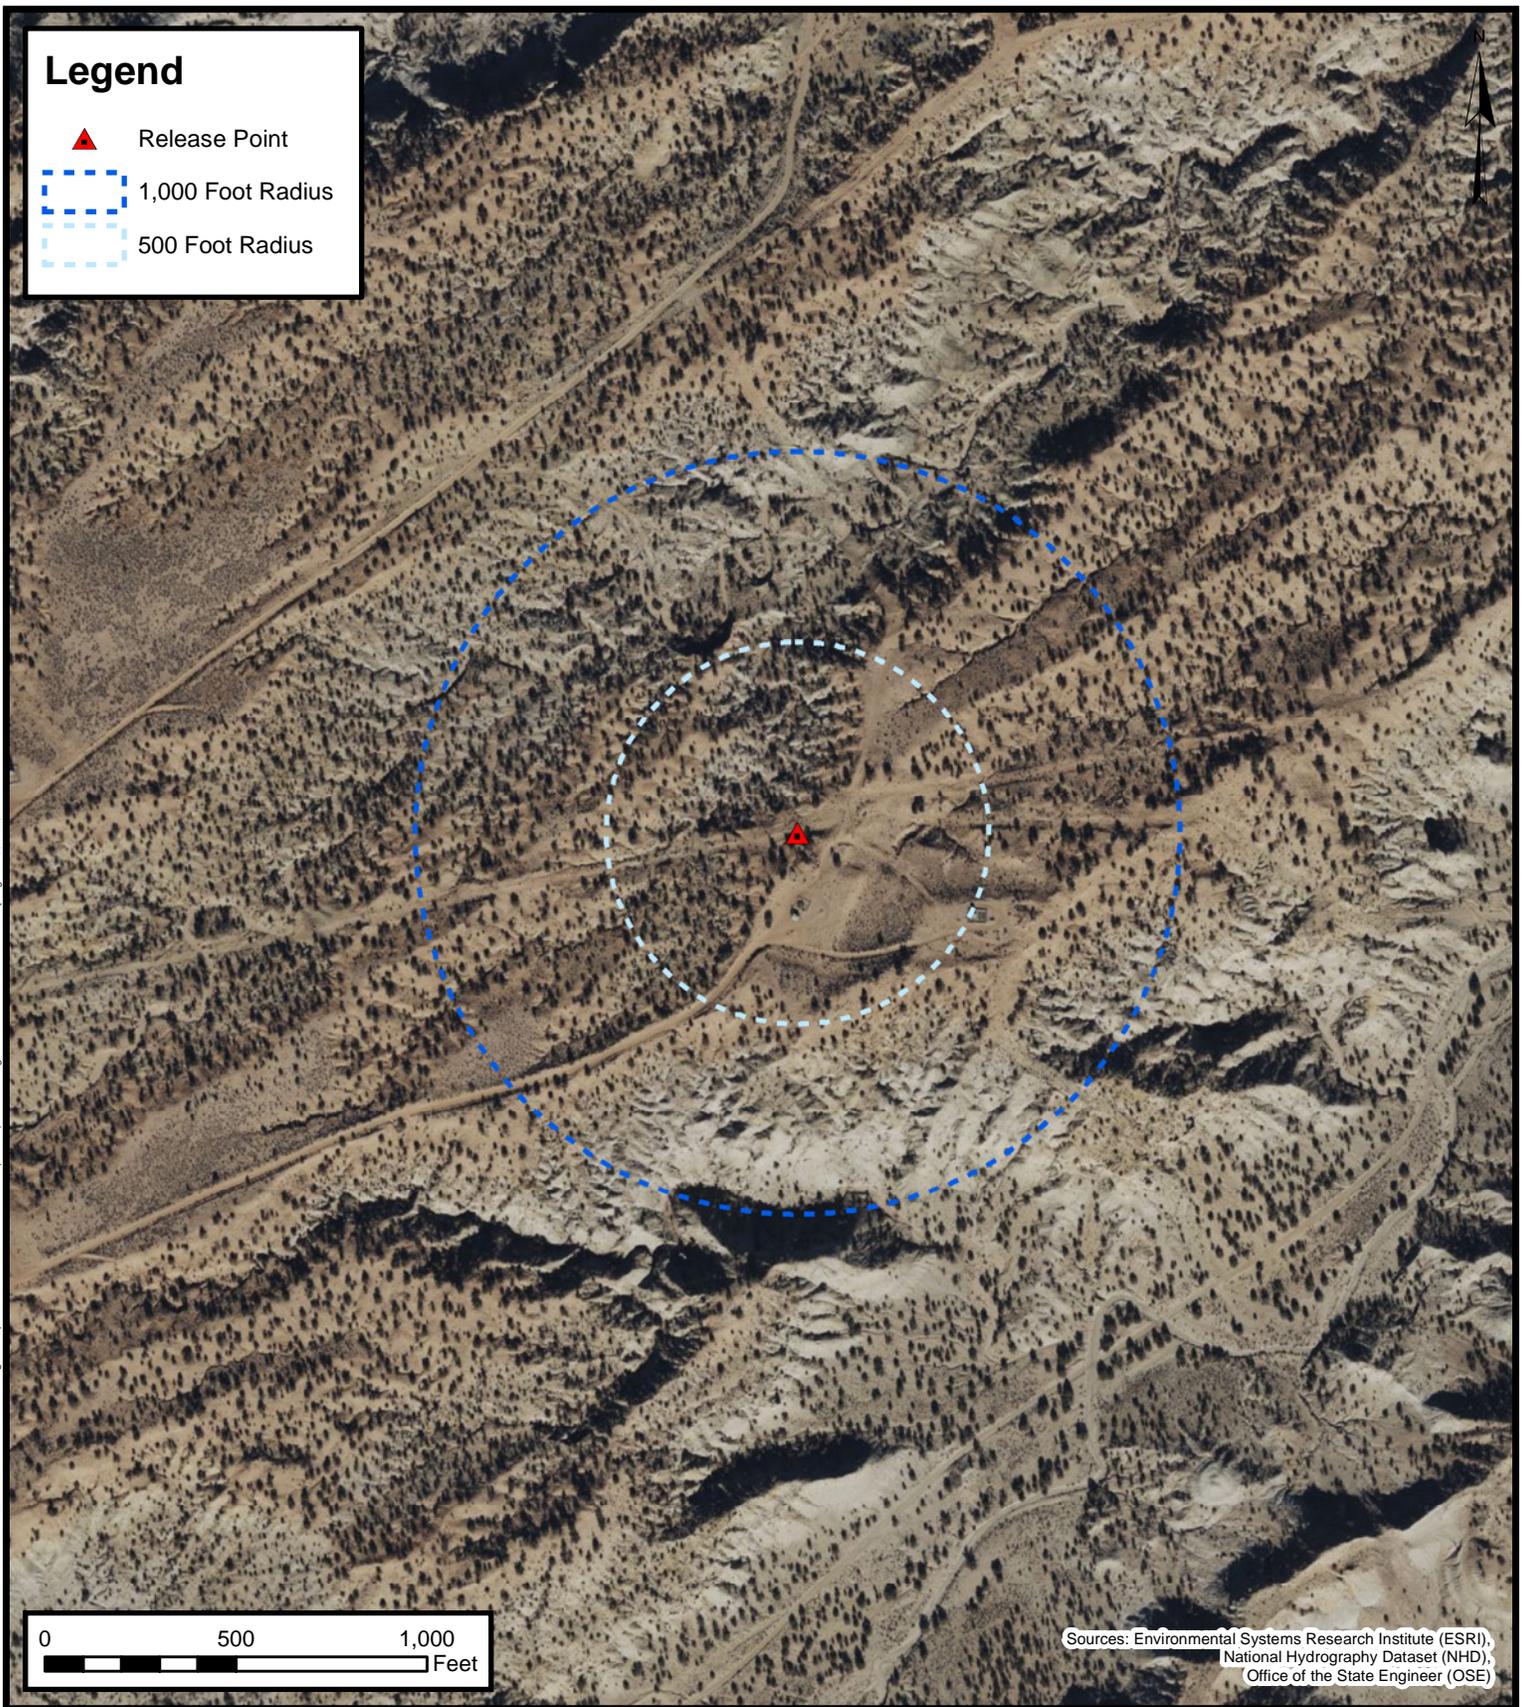
FIGURE E

- No springs, or private domestic freshwater wells used by less than five households for domestic or stock watering purposes were identified within 500 feet of the Site (**Figure E, Appendix B**).

Water Well and Natural Spring Location
 Enterprise Field Services, LLC
 Lateral 2B-24 (12/16/22)
 Project Number: 05A1226224
 Unit Letter F, S23, T28, R10W, San Juan County, New Mexico
 36.650466, -107.869131

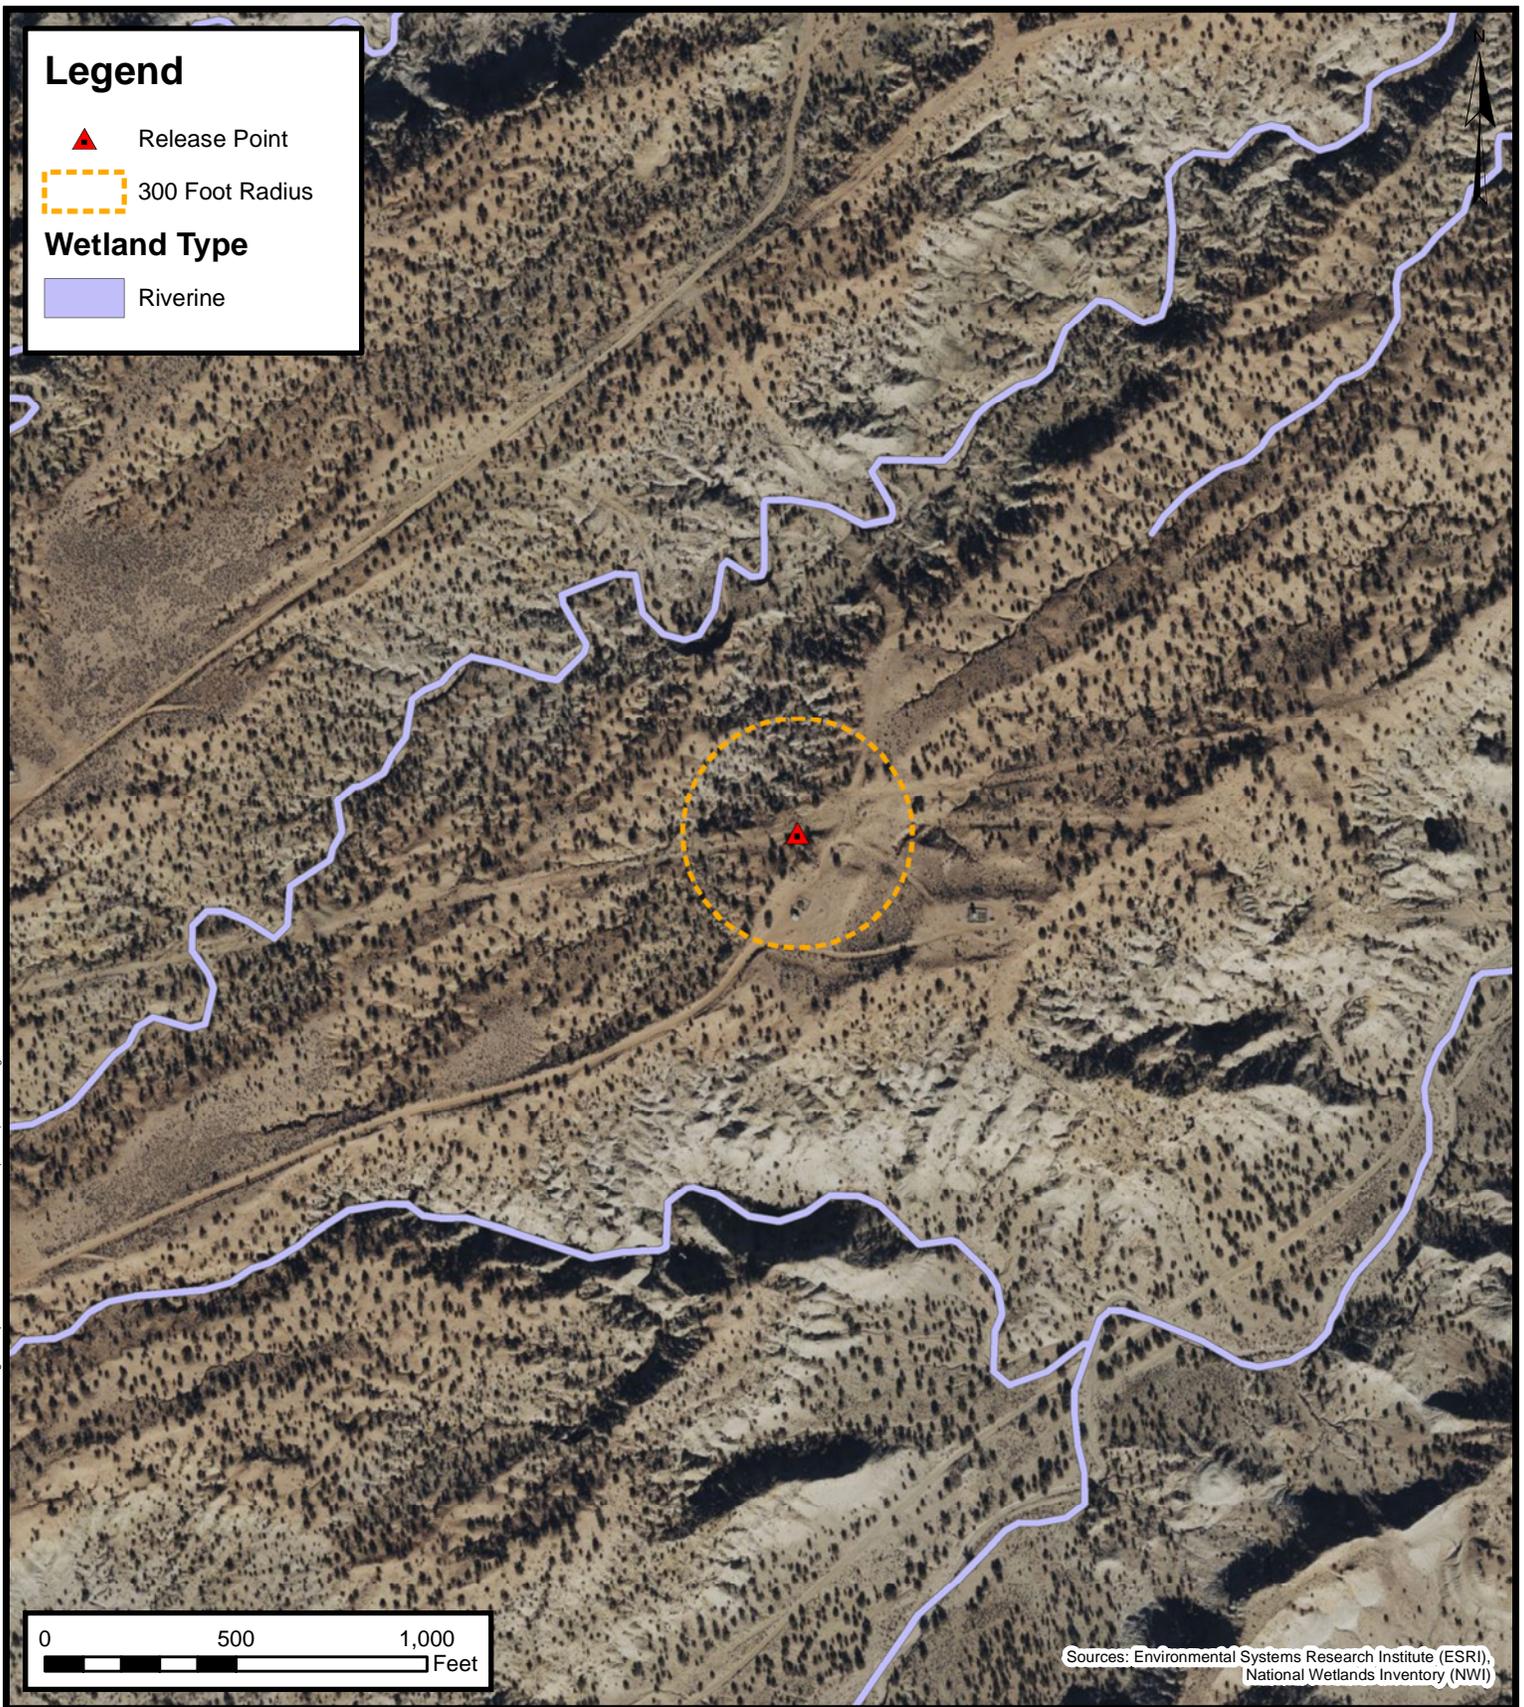
FIGURE
F

- Based on information identified in the U.S. Fish & Wildlife Service National Wetlands Inventory Wetlands Mapper, the Site is not within 300 feet of a wetland (**Figure F, Appendix B**).

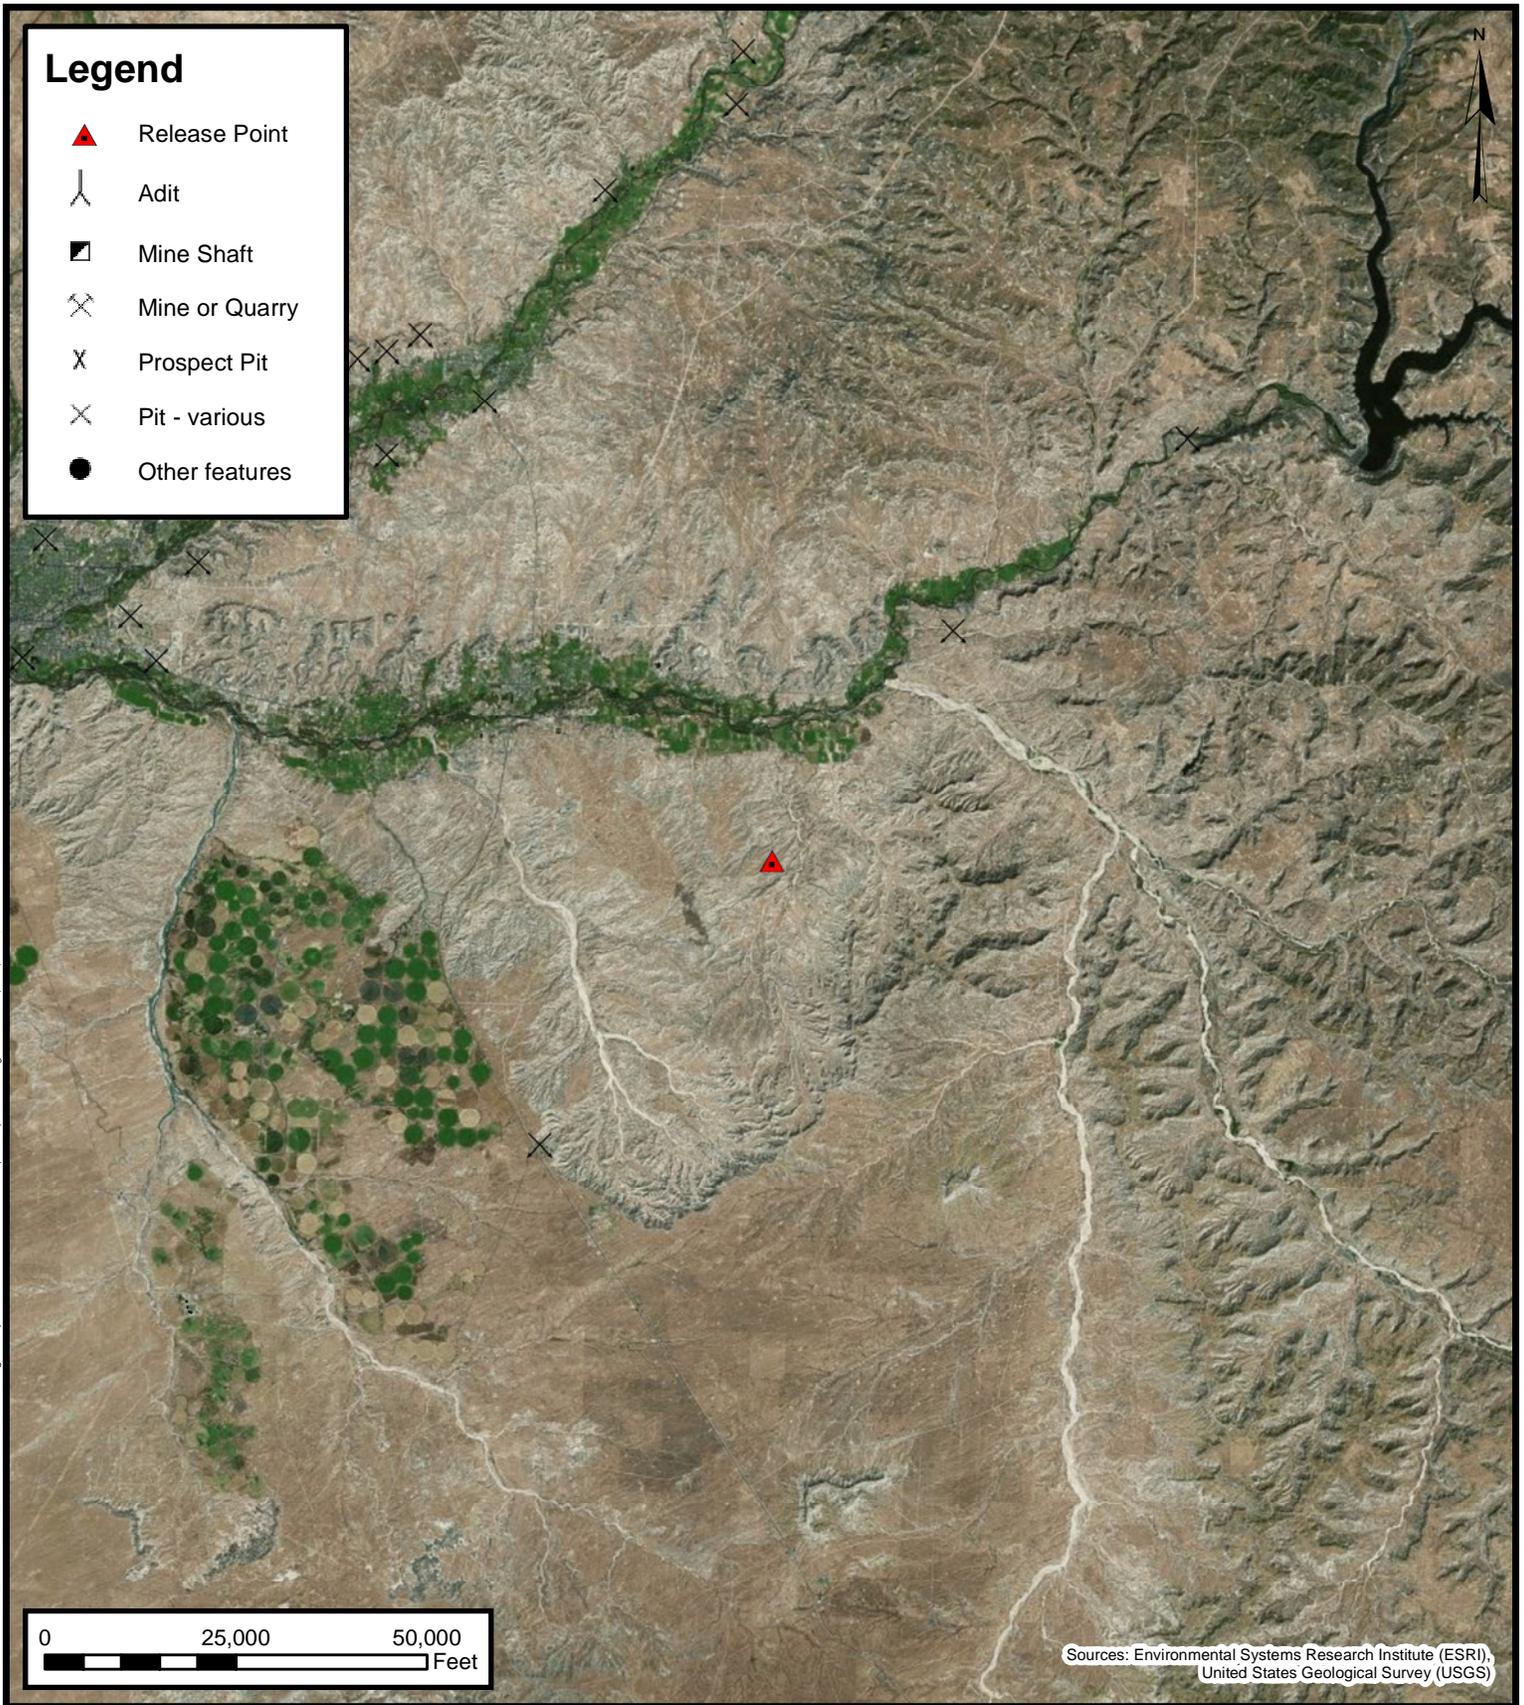
FIGURE
G

- Based on information identified in the NM Mining and Minerals Division's Geographic Information System (GIS) Maps and Mine Data database, the Site is not within an area overlying a subsurface mine (**Figure G, Appendix B**).

Mines, Mills, and Quarries
 Enterprise Field Services, LLC
 Lateral 2B-24 (12/16/22)
 Project Number: 05A1226224
 Unit Letter F, S23, T28, R10W, San Juan County, New Mexico
 36.650466, -107.869131

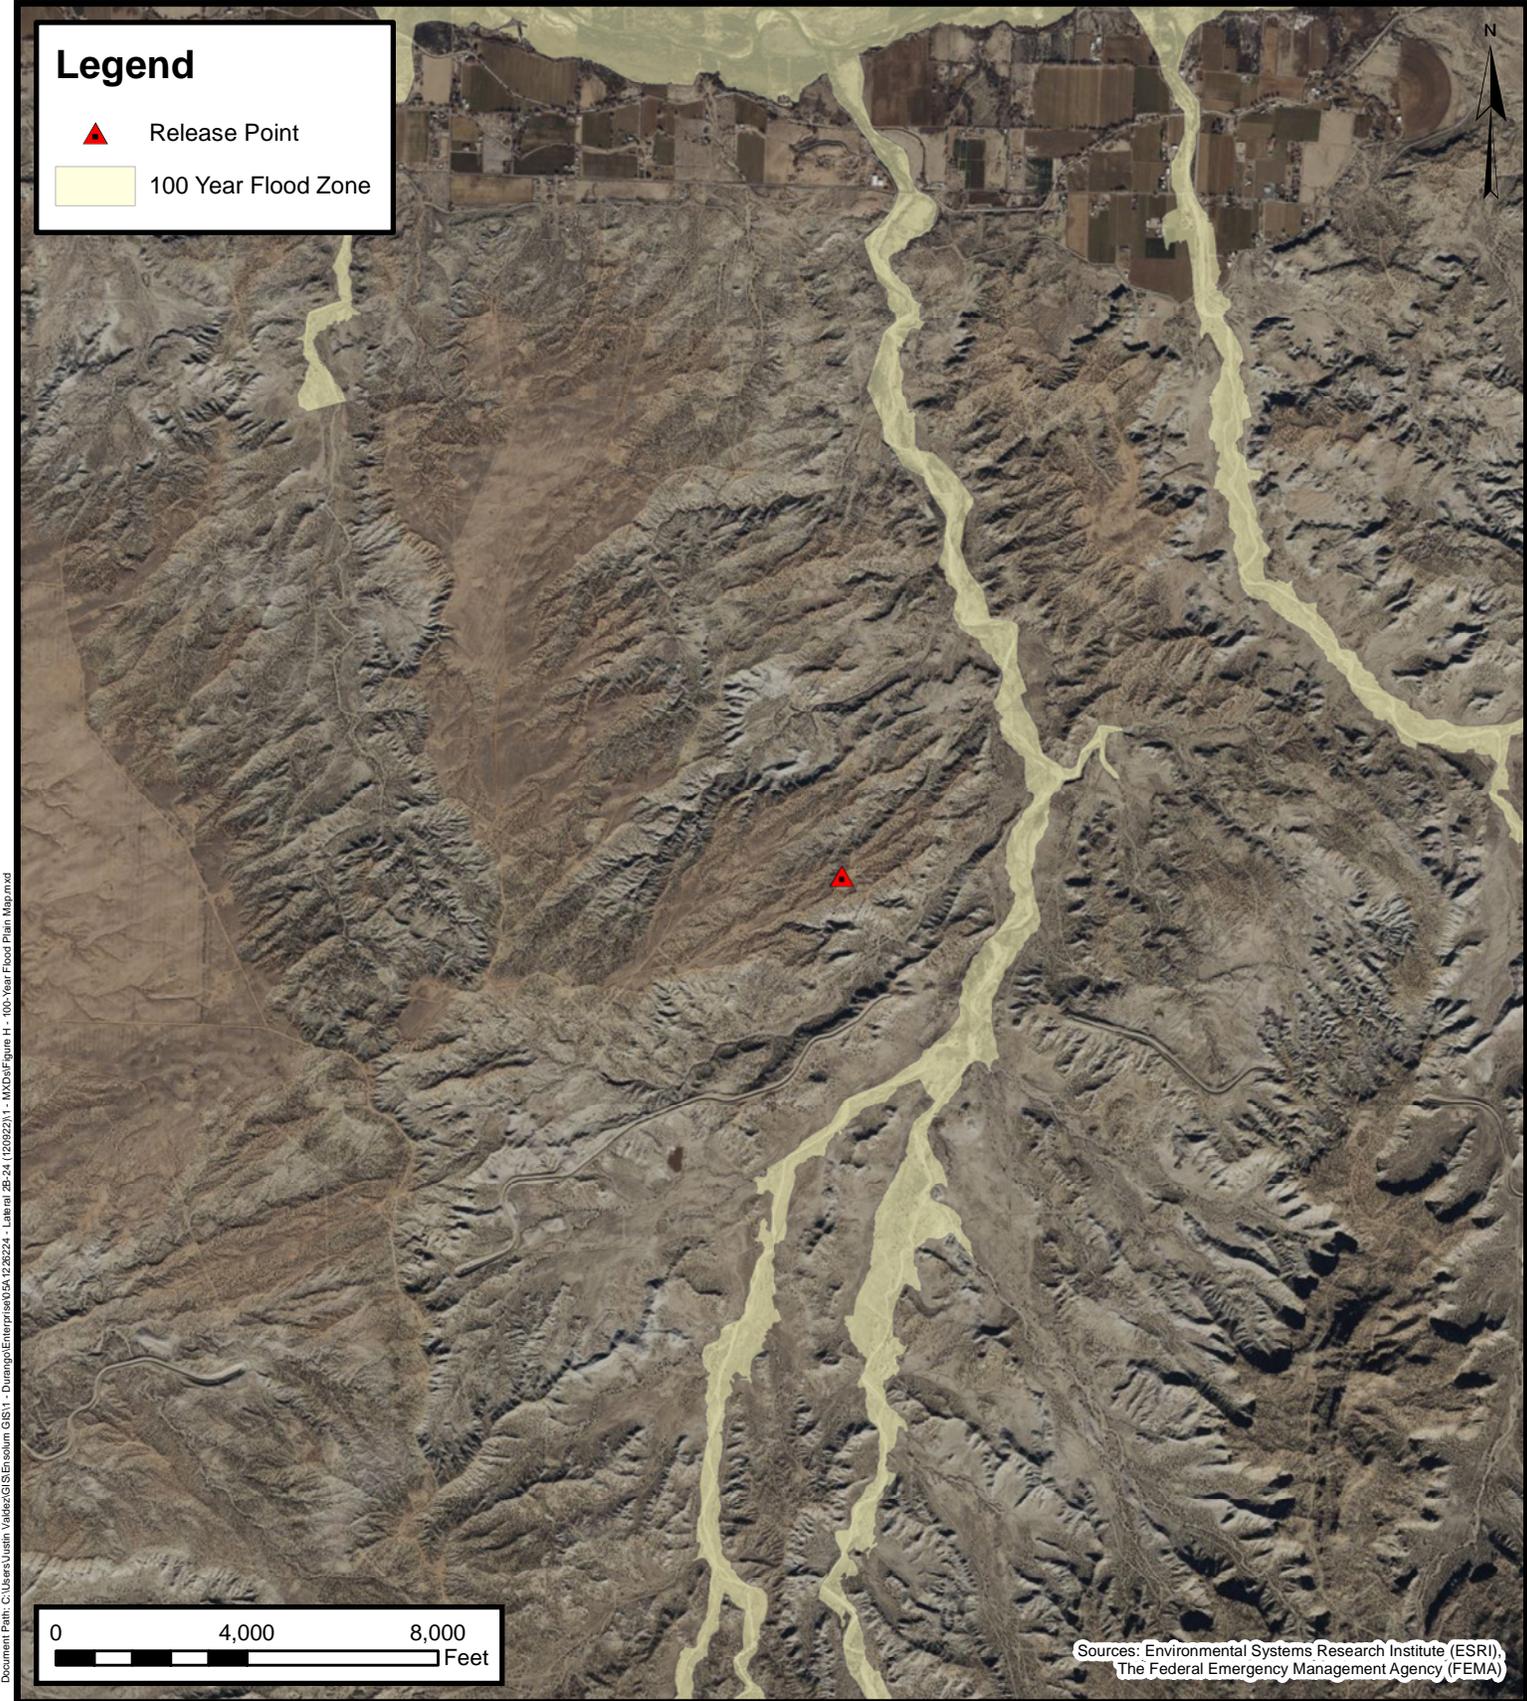
- The Site is not located within an unstable area per Paragraph (6) of Subsection U of 19.15.2.7 NMAC.
- Based on information provided by the Federal Emergency Management Agency (FEMA) National Flood Hazard Layer (NFHL) geospatial database, the Site is not within a 100-year floodplain (**Figure H, Appendix B**).

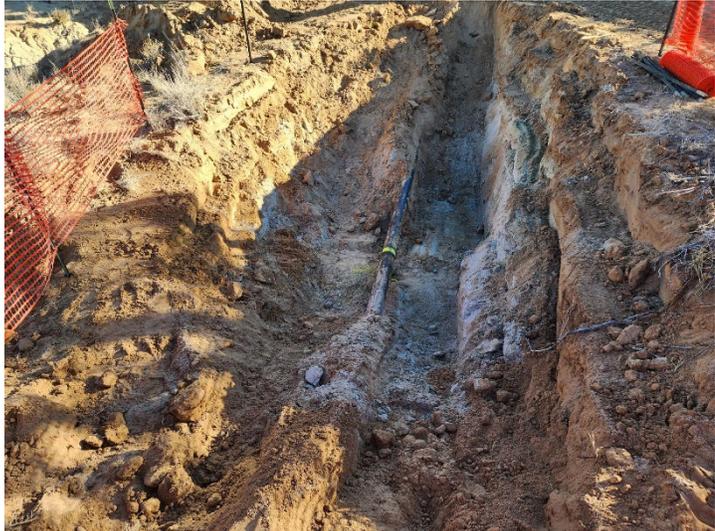
<p>Photograph 1</p> <p>Photograph Description: View of the excavation (first sampling event).</p>

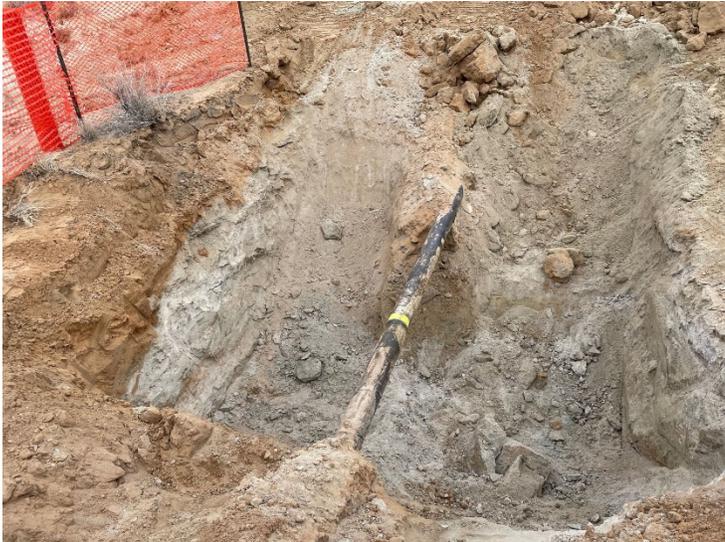
A photograph showing a deep, narrow excavation site. A blue pipe with a yellow band is visible in the center of the trench. The soil is reddish-brown and appears to be layered. An orange safety fence is visible on the left side of the excavation.
<p>Photograph 2</p> <p>Photograph Description: View of the excavation (second sampling event).</p>

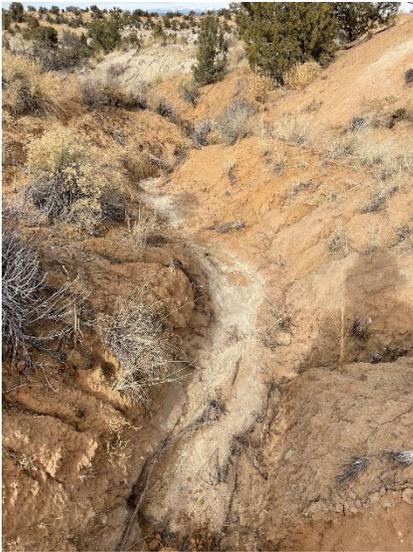
A photograph showing a different view of the excavation site. The blue pipe with the yellow band is again visible, extending into the trench. The soil is light-colored and appears to be a different layer or composition. An orange safety fence is visible on the left side.
<p>Photograph 3</p> <p>Photograph Description: View of the flow path (second sampling event).</p>

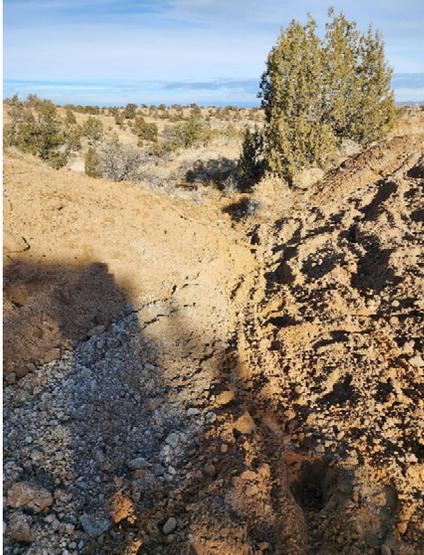
<p>Photograph 4</p> <p>Photograph Description: View of the final flow path excavation.</p>
