CLOSURE REPORT

Lateral 2B-24 (12/16/22)
Unit Letter F, S23 T28N R10W
San Juan County, New Mexico

New Mexico EMNRD OCD Incident ID No. NAPP2235329560

Ensolum Project No. 05A1226224

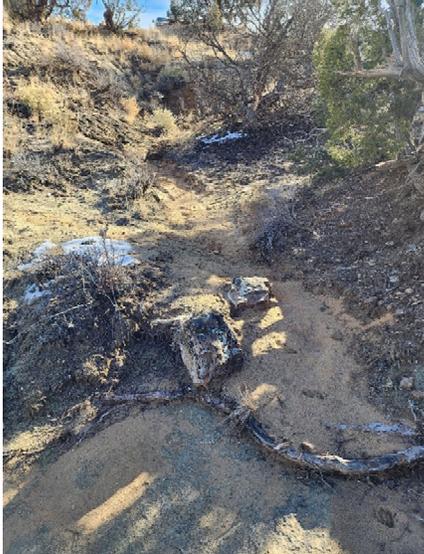
<p>Photograph 5</p> <p>Photograph Description: View of the final flow path excavation.</p>

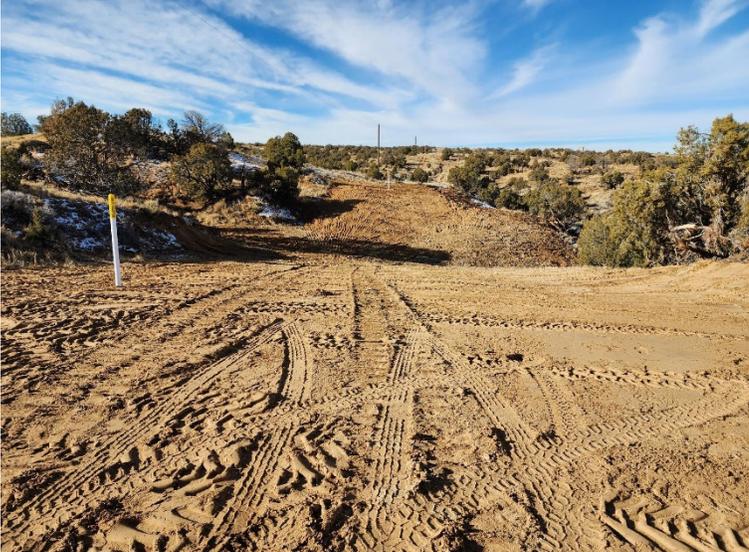
<p>Photograph 6</p> <p>Photograph Description: View of the site after initial restoration.</p>

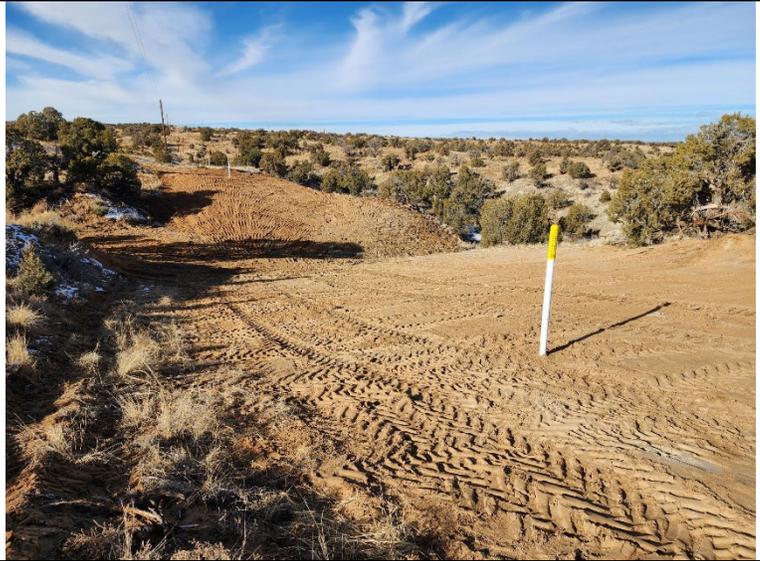
Photograph 7

Photograph Description: View of the site after initial restoration.
