Re: Closure Documentation
NMOCD Reference No. nAPP2226942465
8" Fadeaway to Southern Union
NW ¼ of NW ¼ Section 34, Township 17 South, Range 27 East
32.79622°, -104.27278°
Eddy County, New Mexico
Terracon Project No. KH227022

Closure Documentation

8" Fadeaway to Southern Union Site | Eddy County, New Mexico

January 24, 2023 | Terracon Project No. KH227022

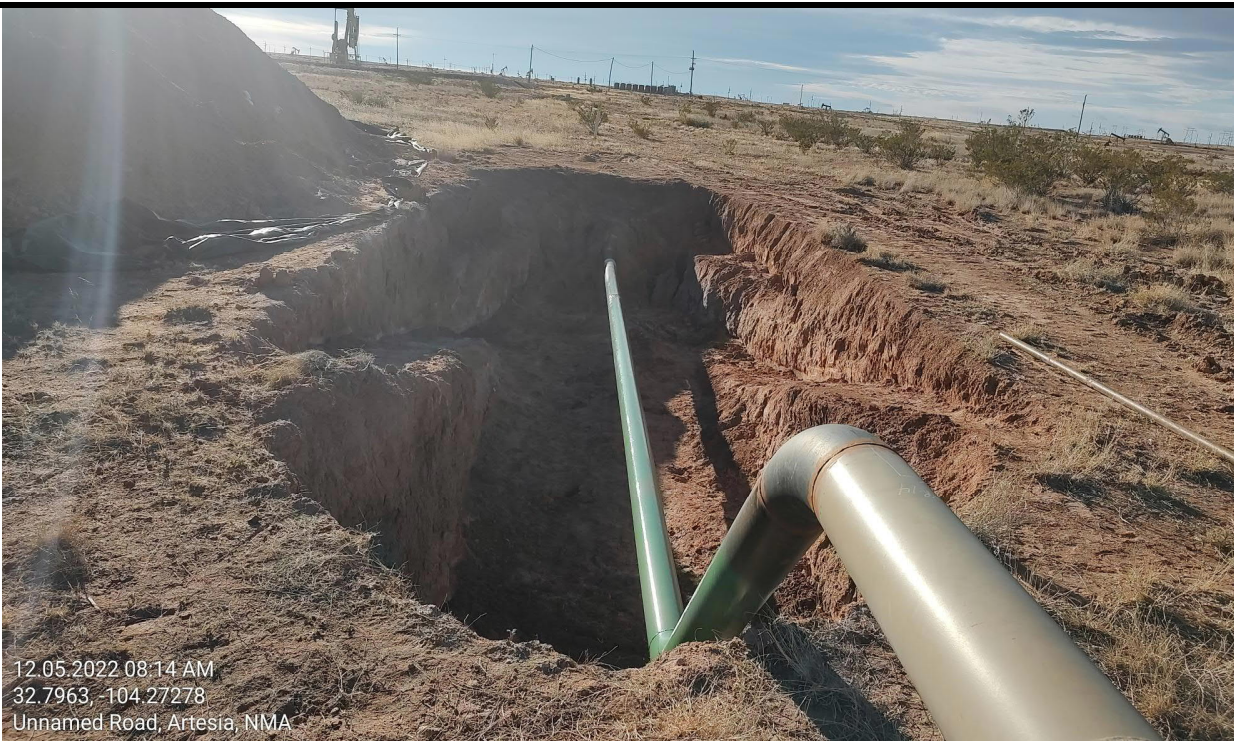
PHOTO 1: View of area prior to Excavation from the North

On November 29, 2022, Terracon mobilized to the site to meet Gandy Corporation (Gandy) personnel, who were to perform soil remediation activities. Areas exhibiting visual impact were excavated to a depth of approximately 5 feet bgs on each side of the pipeline. A total of 6 composite soil samples (N-SW, E-SW, S-SW, W-SW, FS-01, and FS-02) were collected at 200 square foot intervals from the excavation, placed in laboratory provided sample

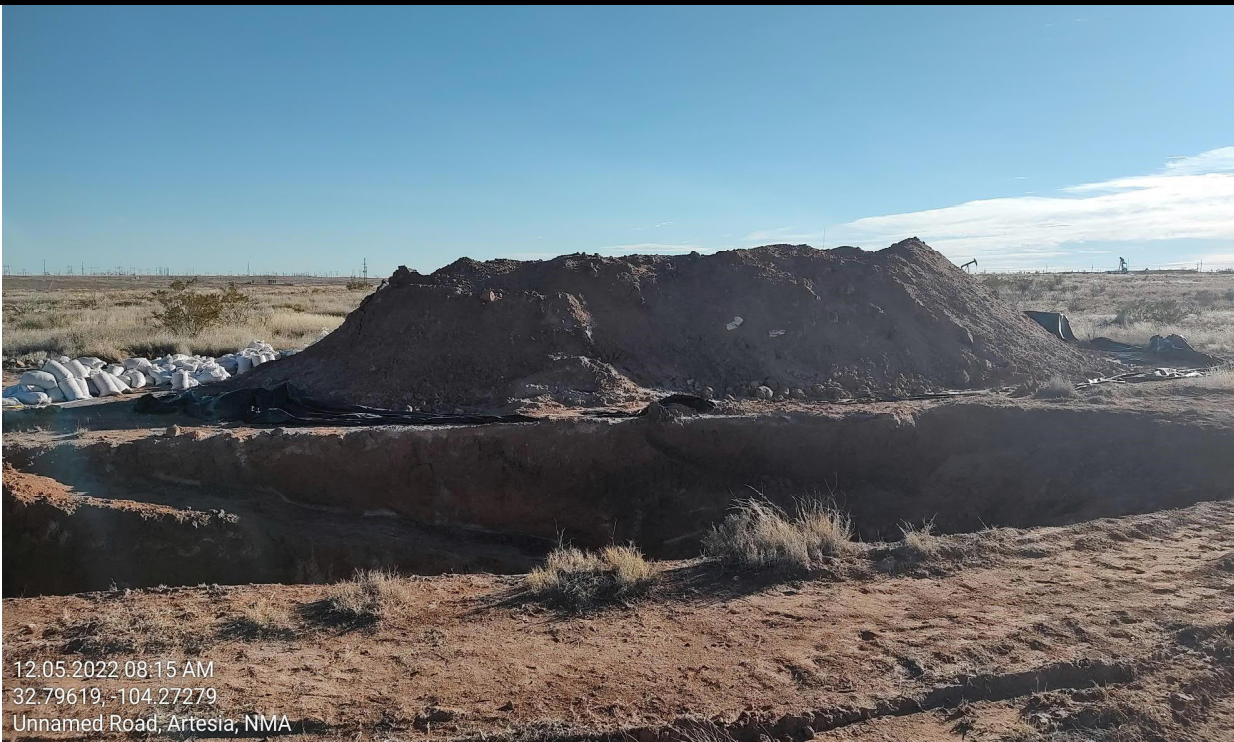
PHOTO 2: View of area prior Excavation from the West

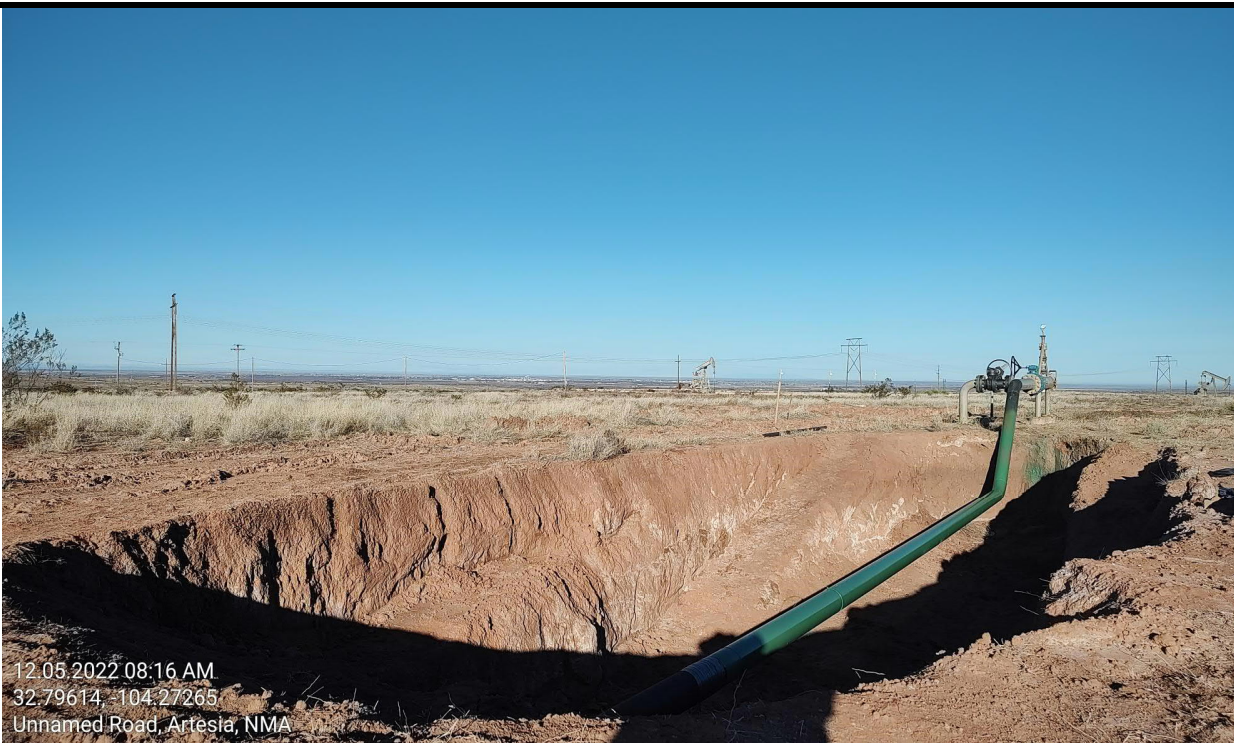
PHOTO 3: View of area prior Excavation from the South

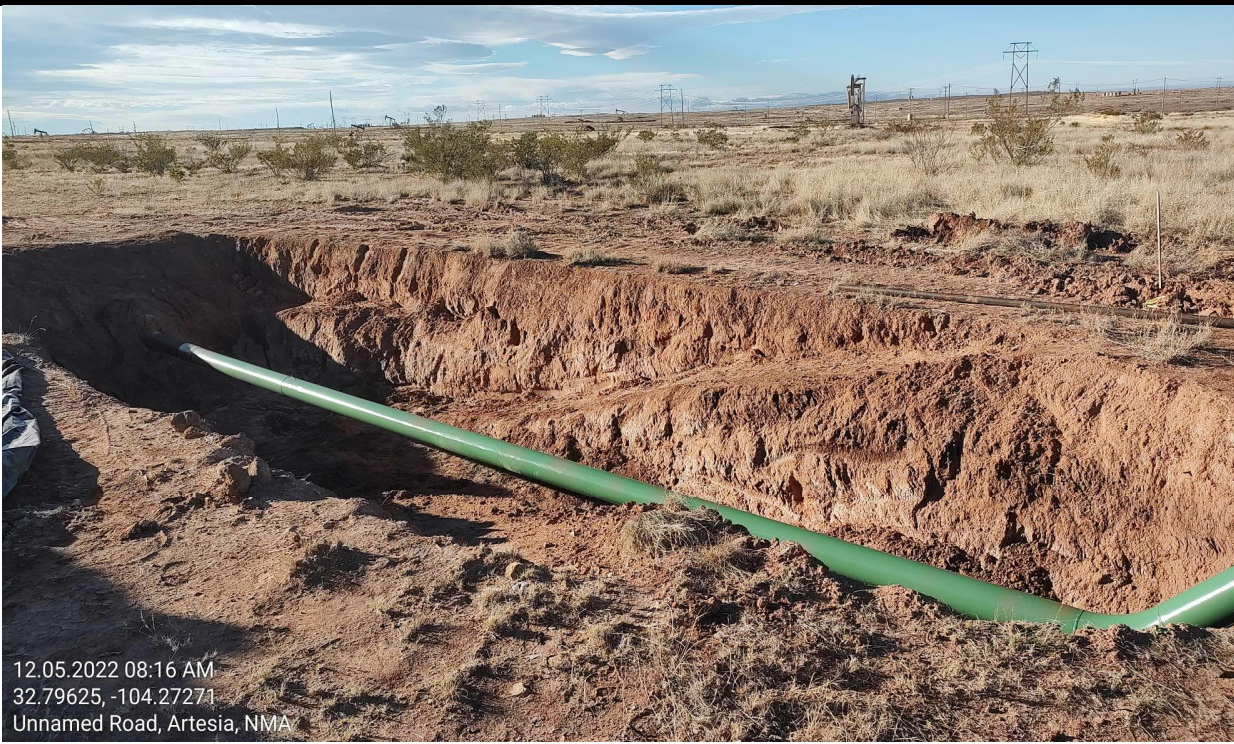
PHOTO 4: View of area prior Excavation from the Northeast
