**Raybaw Operating, LLC.
2626 Cole Ave., Suite 300
Dallas, TX 75204
214-800-2301**

**RE: Site Assessment, Remediation, and Closure Report
McKay West Federal #001
API No. 30-025-24931
GPS: Latitude 32.7057343 Longitude -103.7562866
UL "F", Section 34, Township 18S, Range 32E,
Lea County, NM
NMOCD Reference No. nOY1720255014**

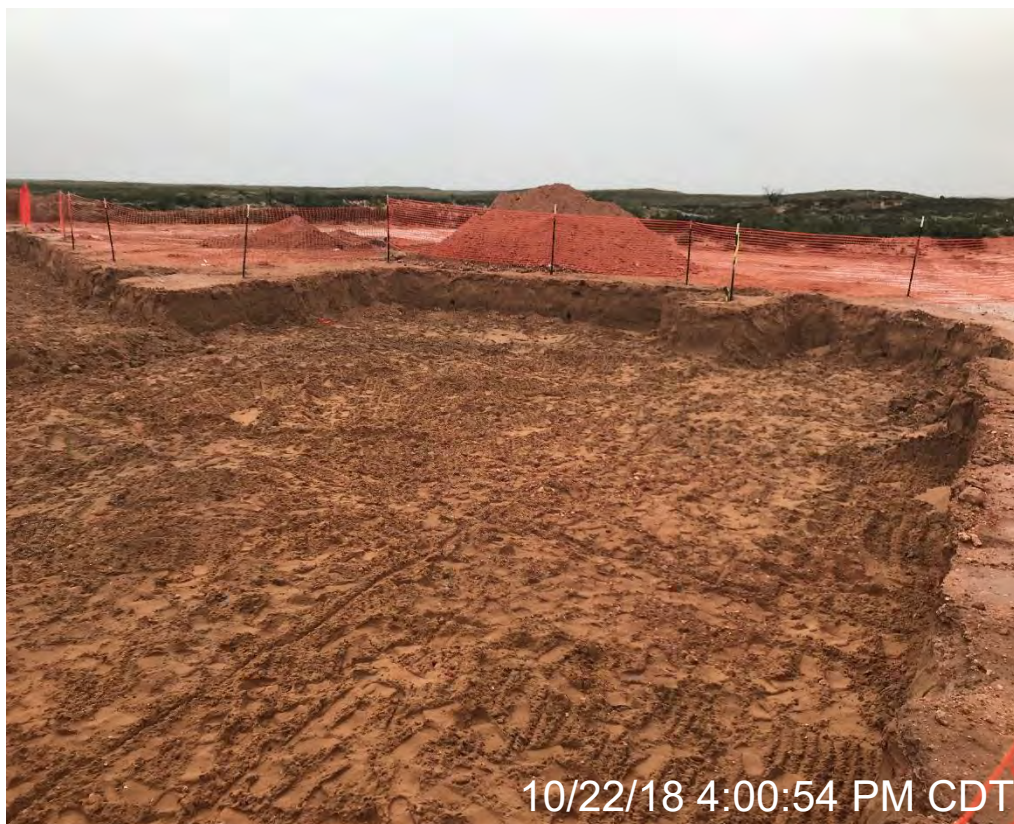
View East Excavated area of T-1

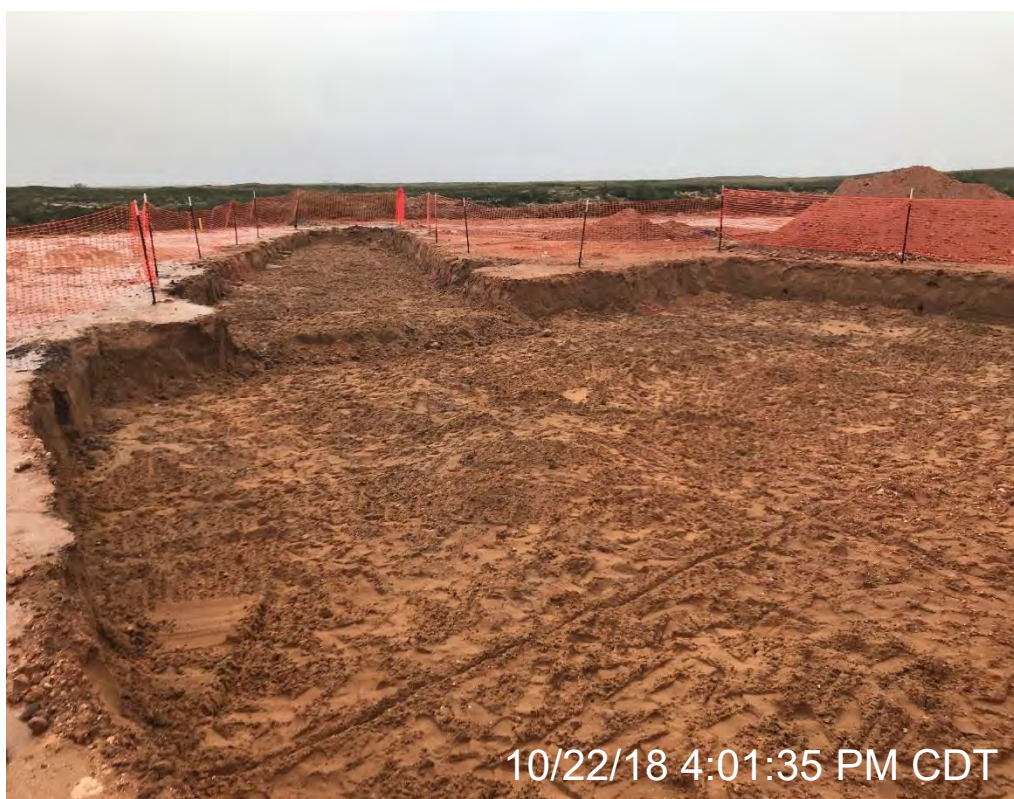
View Northeast Excavated area of T-1

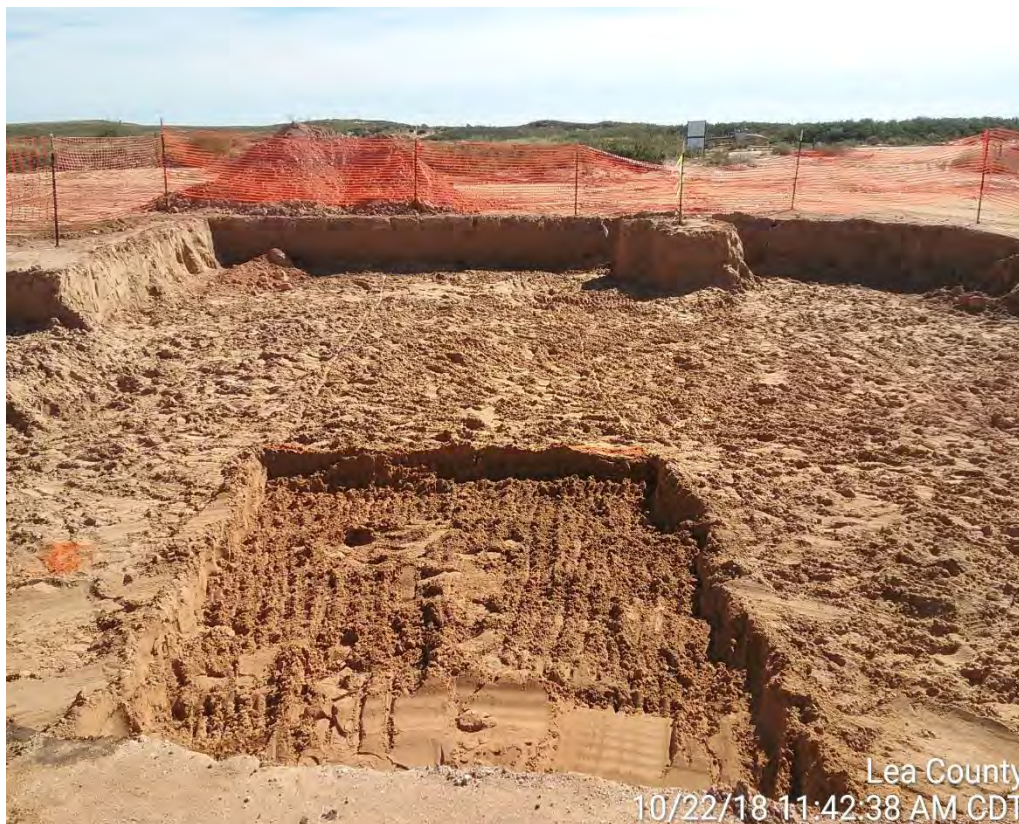
View East Excavated area of T-1 Bottom Hole 4 (3.5')

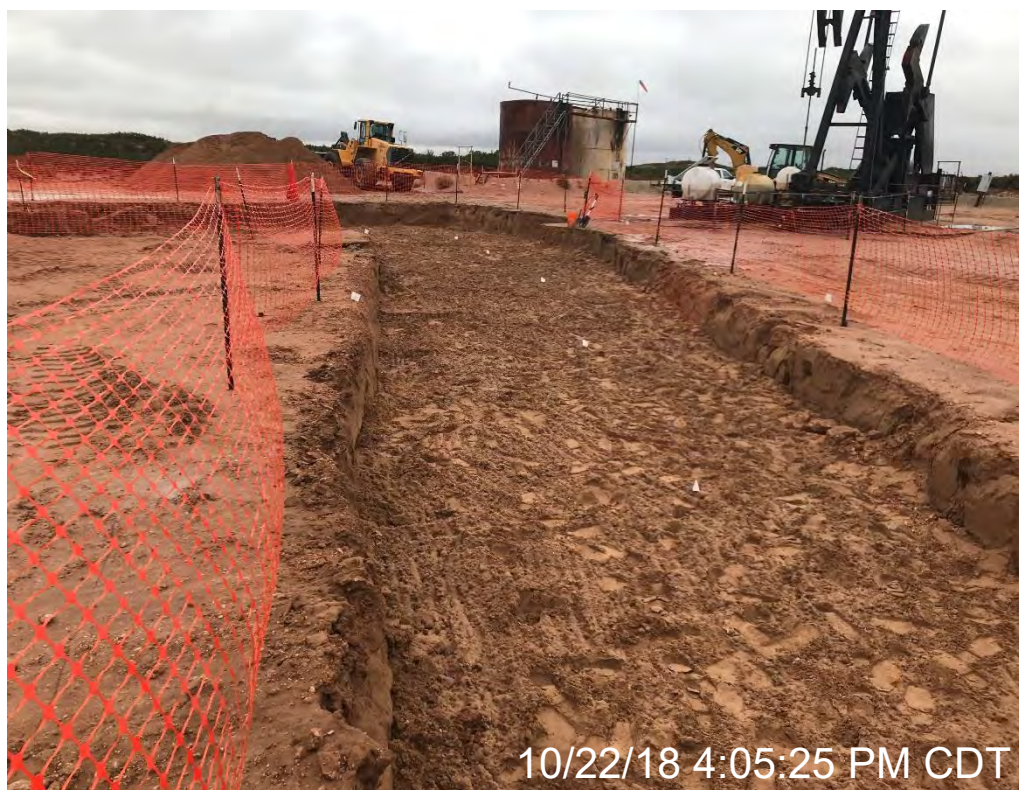
View South excavated area of T-2

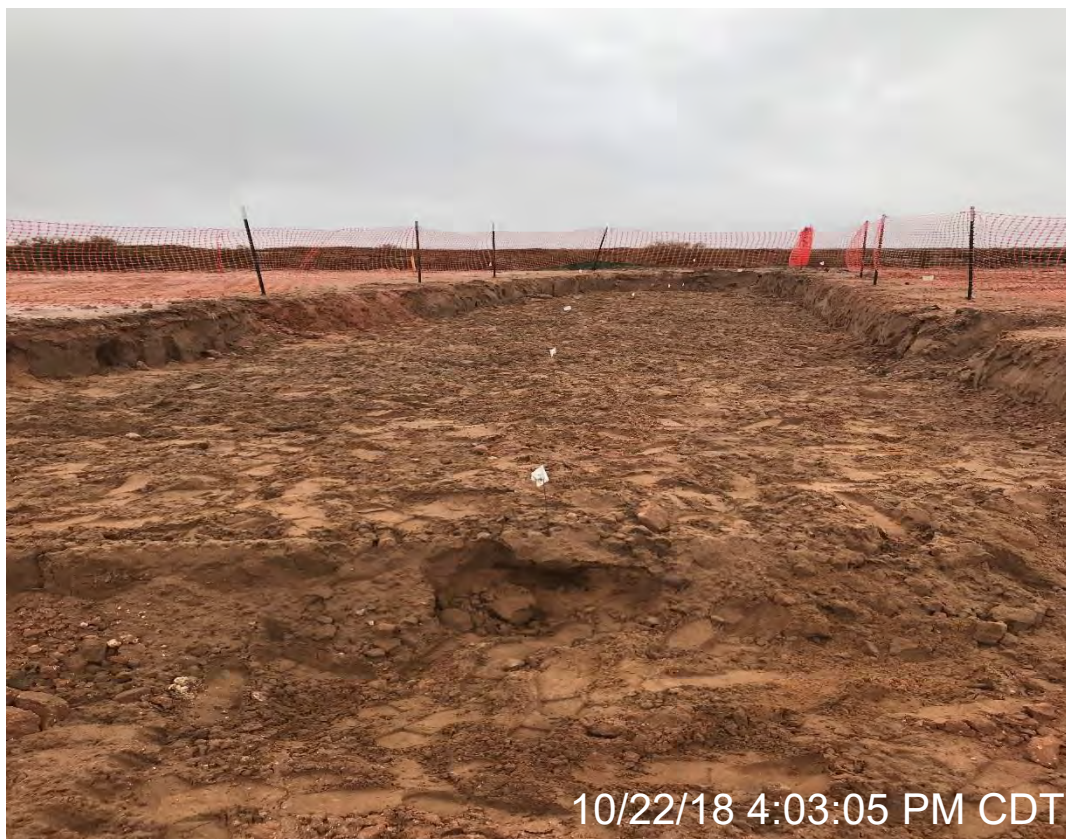
View North Excavated area of T-2

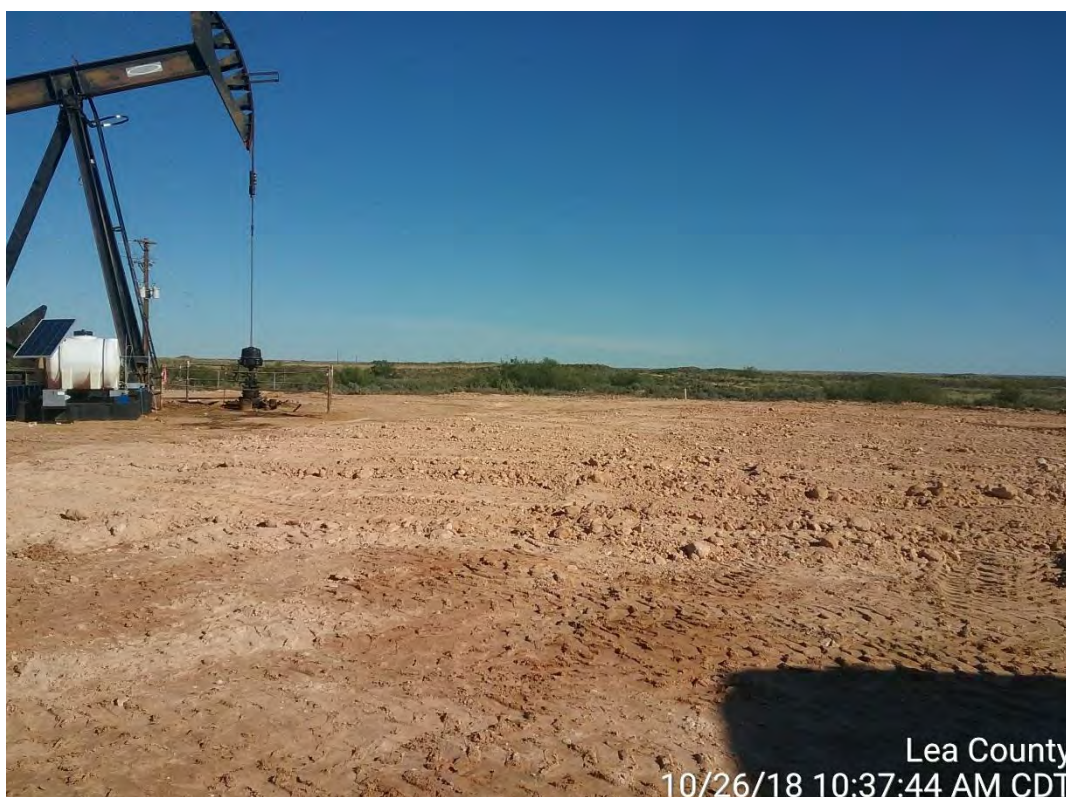
View North Backfilled area of T-1 and T-2
