CLOSURE REPORT

Lateral 3B-12 (11/16/22)
Unit Letter F, S29 T30N R11W
San Juan County, New Mexico

New Mexico EMNRD OCD Incident ID No. NAPP2232045496

Ensolum Project No. 05A1226221

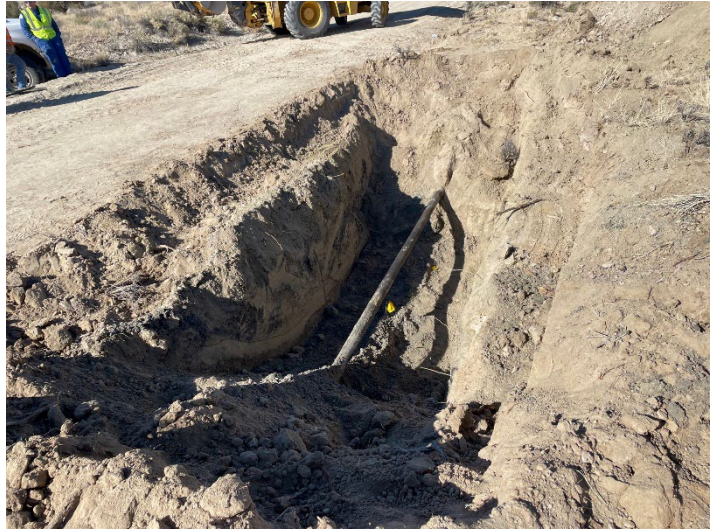
**Photograph 1**

Photograph Description: View of the in-process excavation activities.

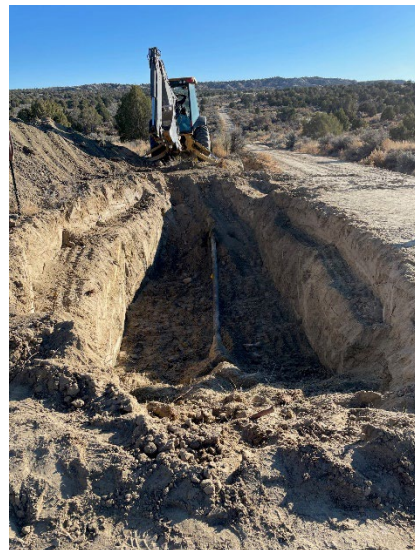
**Photograph 2**

Photograph Description: View of the final excavation.

The final pipeline excavation measured approximately 27 feet long and 12 feet wide at the maximum extents. The maximum depth of the excavation measured approximately 8 feet bgs. The flow path excavation measured approximately 179 feet long and 2 feet wide at the maximum extents, with a depth of approximately 1 feet bgs. The lithology encountered during the completion of remediation activities consisted primarily of silty sand and silty clay.

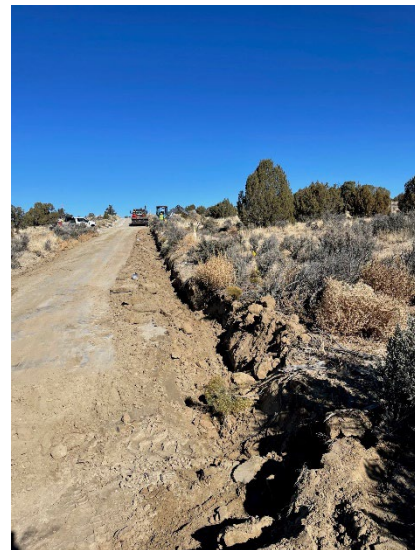
**Photograph 3**

Photograph Description: View of the final flow path excavation.

On November 17, 2022, sampling was performed at the Site. The NM EMNRD OCD was notified of the sampling event although no representative was present during sampling activities. Composite soil sample S-1 (8') was collected from the floor of the excavation. Composite soil samples S-2 (0'-8'), S-3 (0'-8'), S-4 (0'-8'), and S-5 (0'-8') were collected from the walls of the excavation. Composite soil samples FP-1 (0'-1'), FP-2 (0'-1'), FP-3 (0'-1'), and FP-4 (0'-1') were collected from the floor and walls of the flow path.

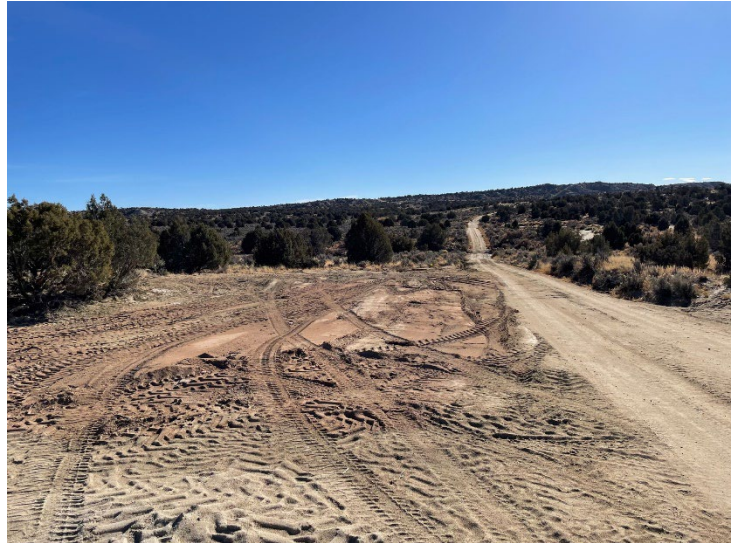
Photograph 4

Photograph Description: View of the site after initial restoration.

The excavation was backfilled with imported fill and then contoured to the surrounding topography. Enterprise will re-seed the Site with an approved seeding mixture.

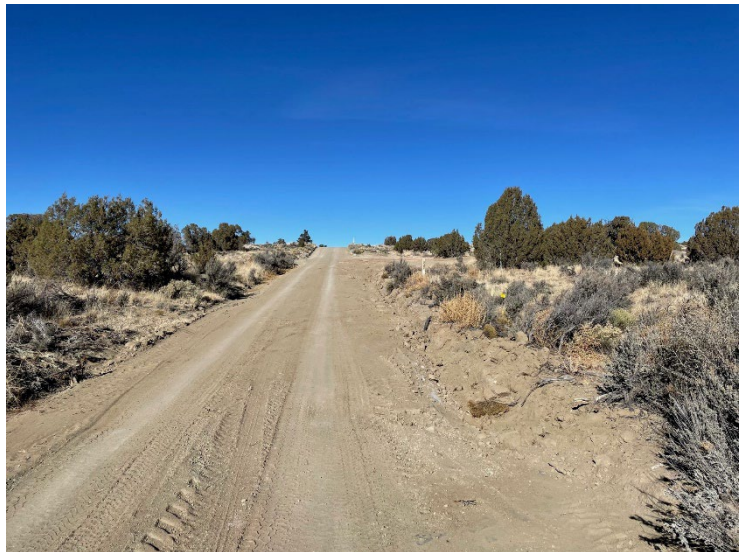
Photograph 5

Photograph Description: View of the site after initial restoration.
