## I Release Notification

Site Name: Huerfano Unit 309	Site Type: Well Site
Date Release Discovered: 4/19/2023	API# (if applicable) 30-045-34772

## Closure

## Executive Summary – Incident #nAPP2312251224

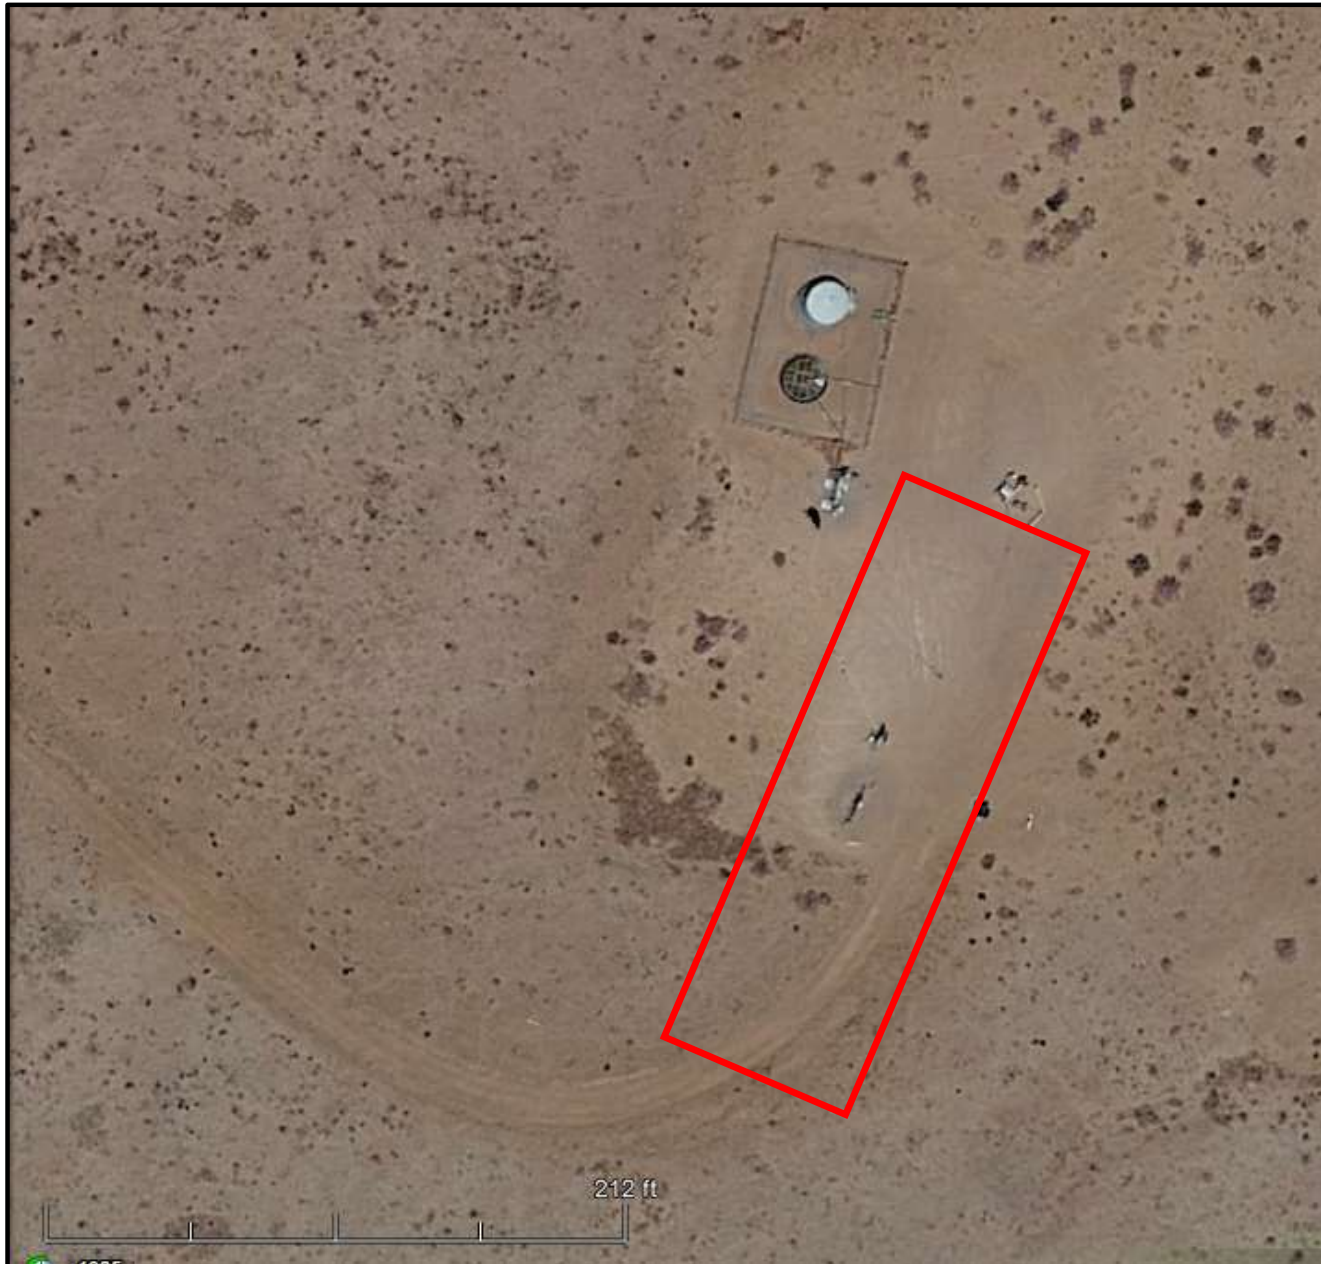
# Scaled Site Map

Lat: 36.428289  
Long: -107.764403

Huerfano 309 Wellsite  
API: 30-045-34472

Release Area

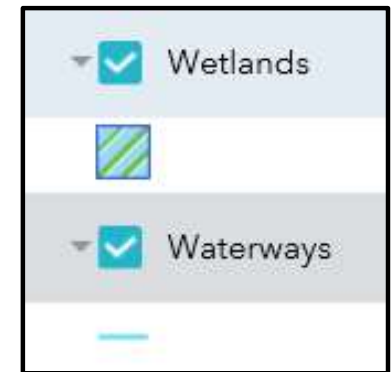
## Determination of water sources and significant watercourses within ½ mile of the lateral extent of the release

**Note 1:** Release point is not within 300 ft of a continuously flowing watercourse or other significant water course.

**Note 2:** The lateral extents of the release point are not shown to be within 300 feet of a mapped wetland.
