Site Assessment and Closure Report

C K 7 Federal #001
Incident# 2RP-1291/nJMW1225739545
Eddy County, New Mexico

Subject: **Site Assessment and Closure Report**
C K 7 Federal #001
Eddy County, NM

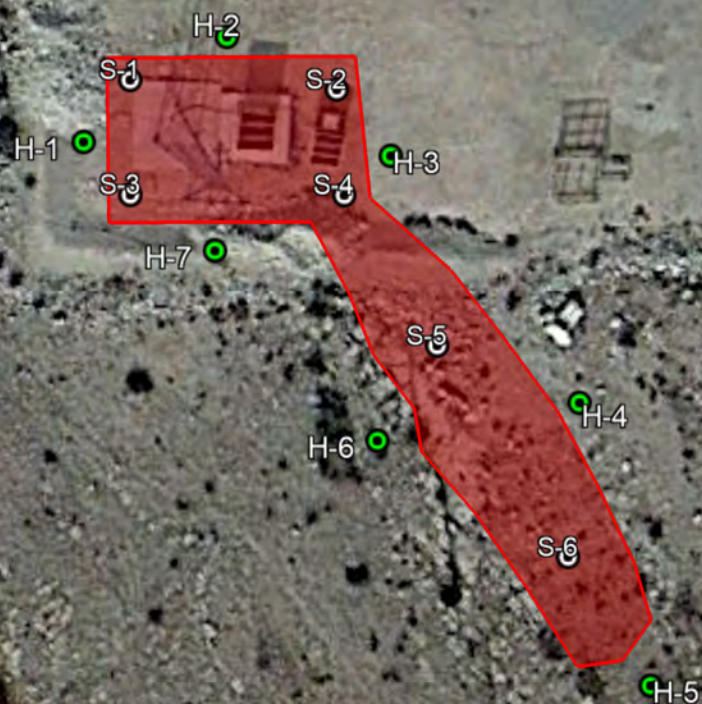
Cimarex Energy Co. of Colorado
Incident# 2RP-1291
Eddy County, NM
Site Assessment Map

H&R mobilized personnel to begin site assessment activities of the location. Grab samples were obtained by way of hand auger. Hard rock refusal was encountered. Initial site assessment sampling locations are illustrated on Site Assessment Map, [Appendix I](#). Samples collected were transported to Cardinal Laboratory for analysis. The results of that analysis are presented in Table 1 below. Photographs of the sampling locations as well as of the historical spill path are attached in [Appendix IV](#). Complete laboratory reports can be found in [Appendix V](#).

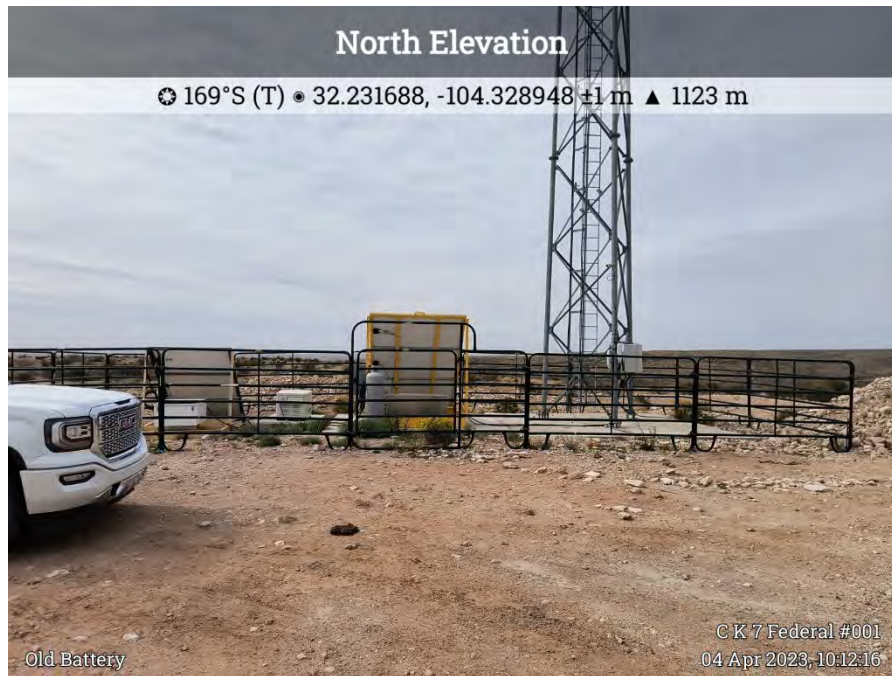
Based on the results of our site assessment it was determined that remediation was completed during deconstruction and relocation of the tank battery. A radio tower now sits where the old tank battery sat.

OLD BATTERY LOCATION/RADIO TOWER LOCATION

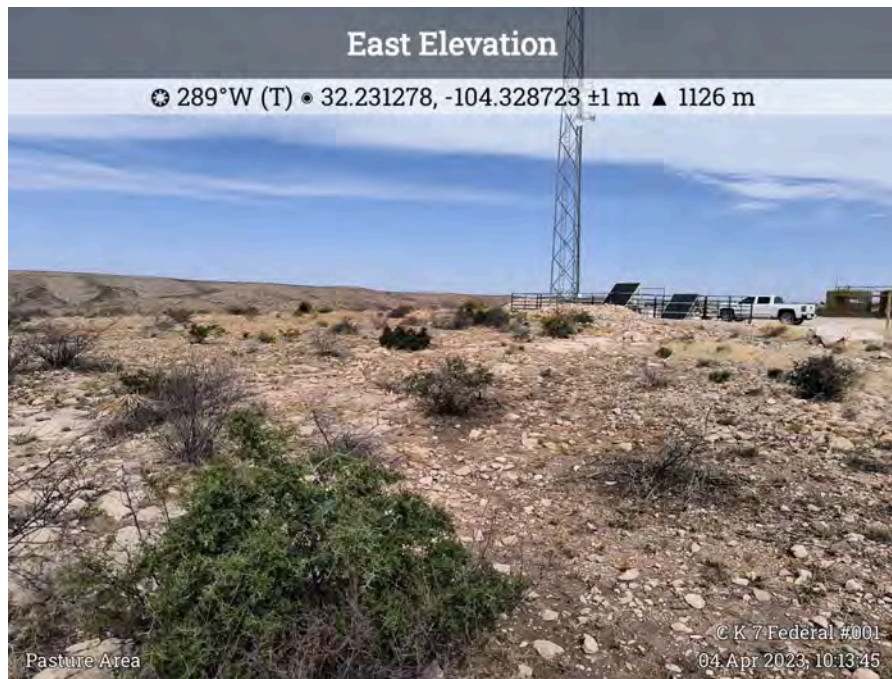
On September 02, 2012, during the process of blowing the separator to the fiberglass, tank the bottom of the tank came apart allowing approximately 35 barrels of produced water to be released into the unlined containment as well as under the berms into the pasture to the South.

PASTURE SPILL AREA
