Site Assessment/Characterization

Closure

Re: Site Assessment, Remediation, and Closure Report
WEST CORBIN 19 FEDERAL BATTERY
API No. 30-025-33468
GPS: Latitude 32.7382889 Longitude -103.7090836
UL -- D, Sec. 19, T18S, R33E
Lea County, NM
NMOCD Ref. No. NPAC0730336794

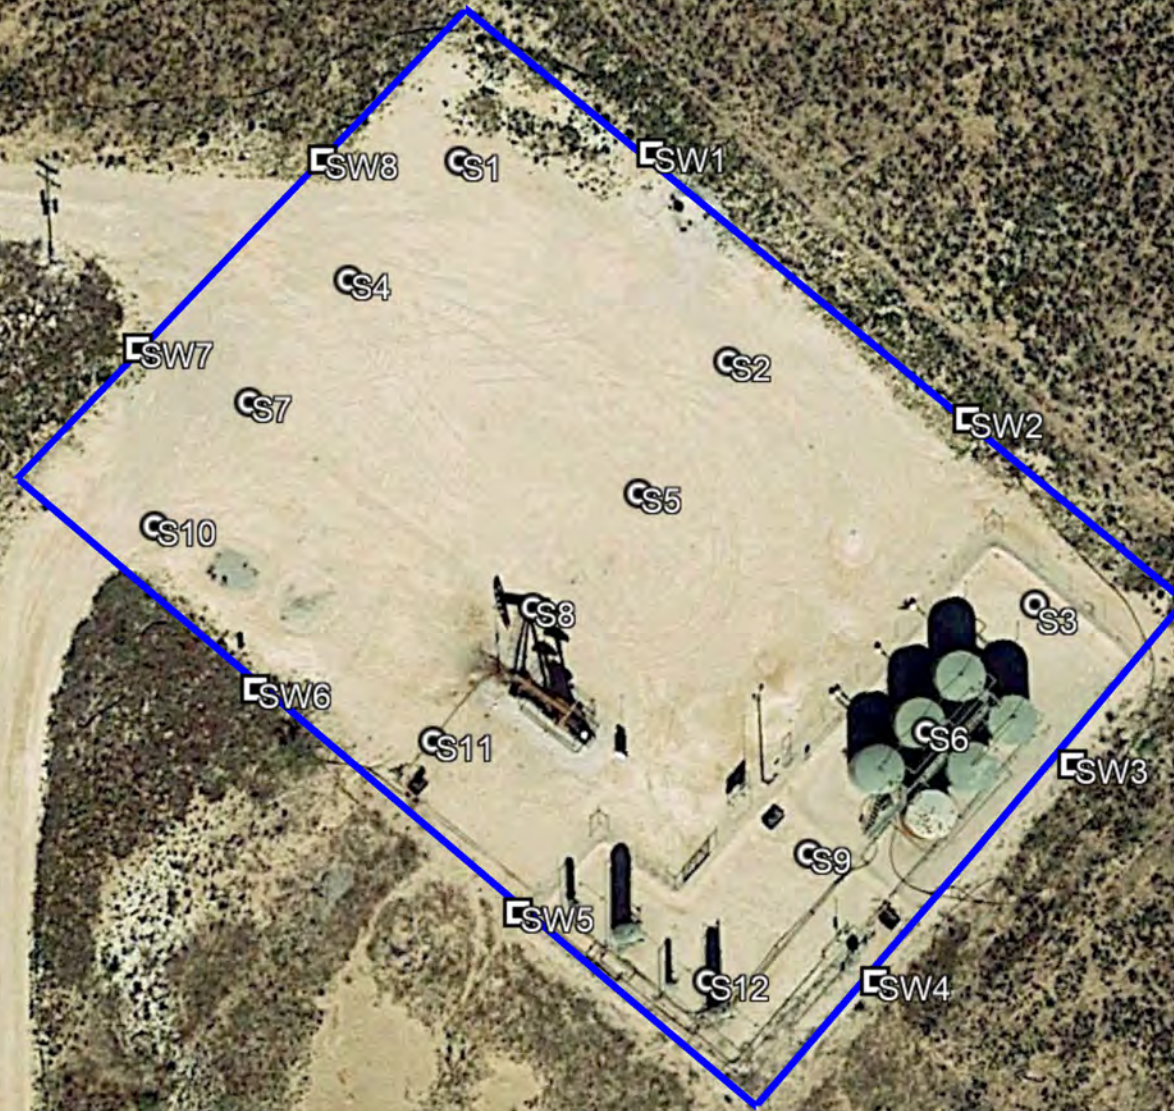
Devon Energy
NGRL0936542434
32.7382889,-103.7090836
Lea County, NM
Initial Site Map

On May 16th, 2023, Pima Environmental mobilized personnel to assess the impacted area. Upon arriving at the location Pima discovered the engineered pad had been reclaimed. Pima collected a total of thirty-two soil samples for laboratory analysis. Twelve bottom samples (S1-S12) were collected at depths of 1 and 4 feet to determine vertical delineation. Additionally, side wall samples (SW1-SW8) were collected at a depth of 6 inches to determine horizontal delineation. An initial site map can be found in Figure 4.

- Bottom Sample
- Reclaimed Pad
- Side Wall Sample

Based on the sample results, the bottoms and sidewalls are below NMOCD Closure Criteria 19.15.29 NMAC. See Appendix D for Photographic Documentation.

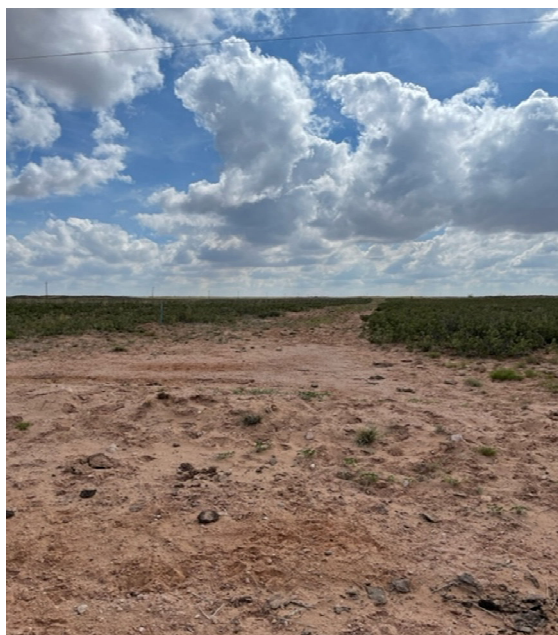
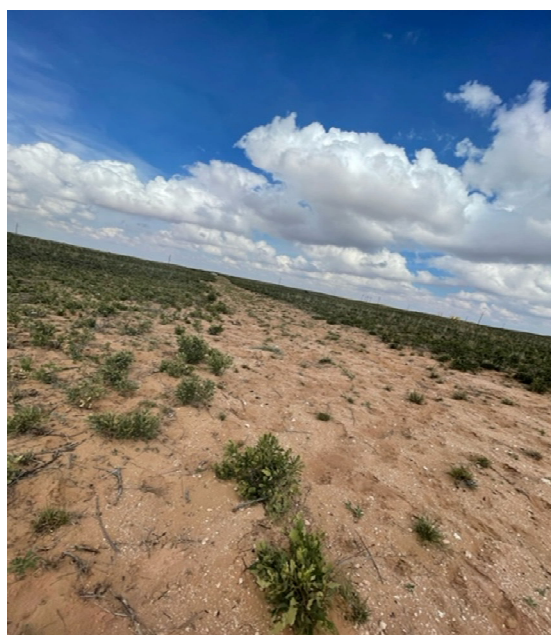
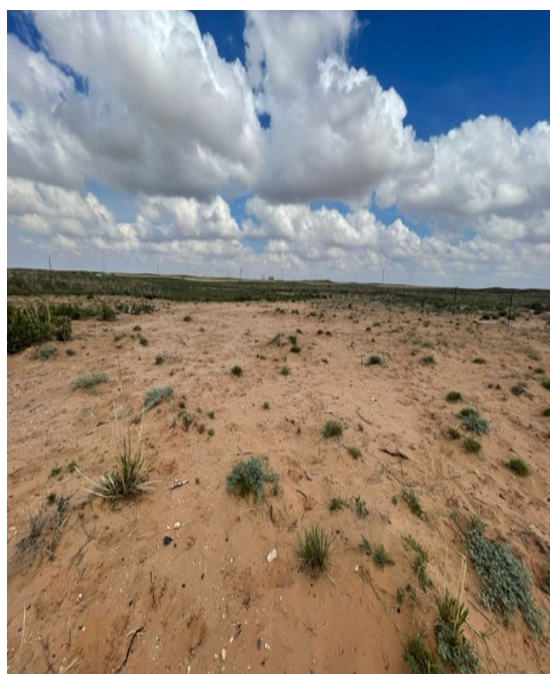
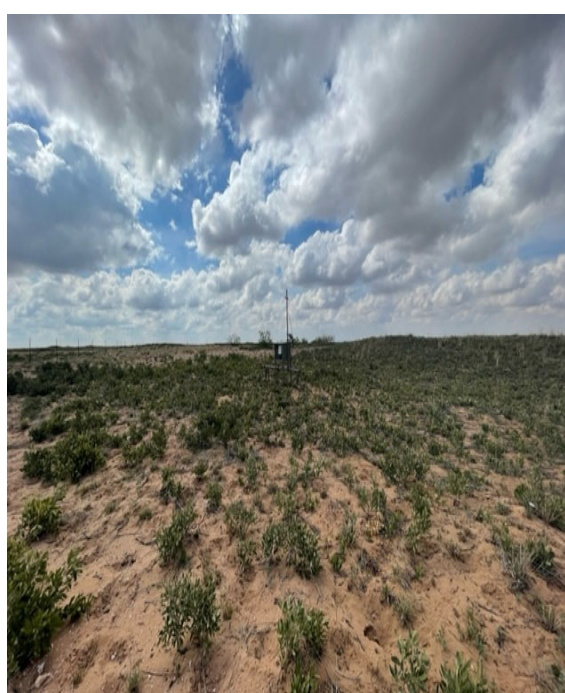
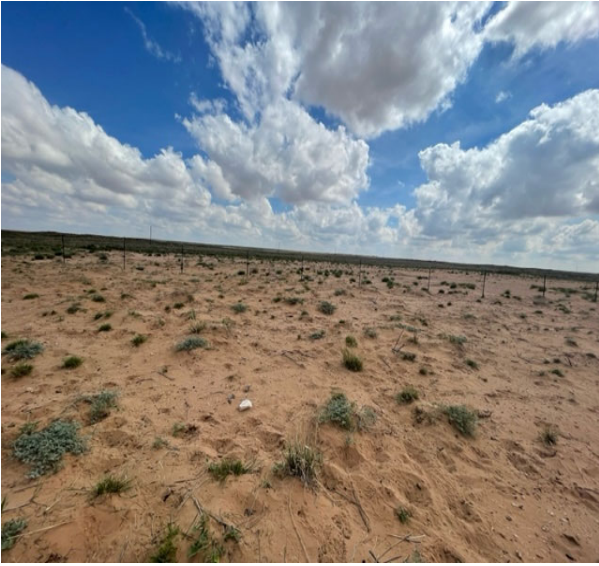
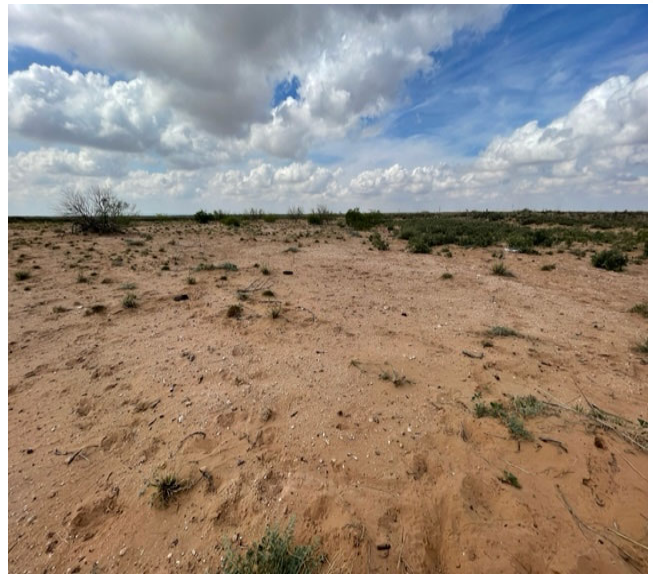
**SITE PHOTOGRAPHS
DEVON ENERGY
West Corbin 19 Federal #001**

Site Assessment
