## Closure Report

Mitchell SWD #2  
Eddy County, New Mexico  
API ID # 30-015-22242  
**Incident #** nKMW0800235934, nSEB0813056099,  
nSEB0826247749, nAB1526132368, nAB1529255081

Subject: **Closure Report**  
Mitchell SWD # 2  
Eddy County, New Mexico  
API # 30-015-22242  
Incident # nKMW0800235934, nSEB0813056099, nSEB0826247749,  
nAB1526132368, nAB1529255081

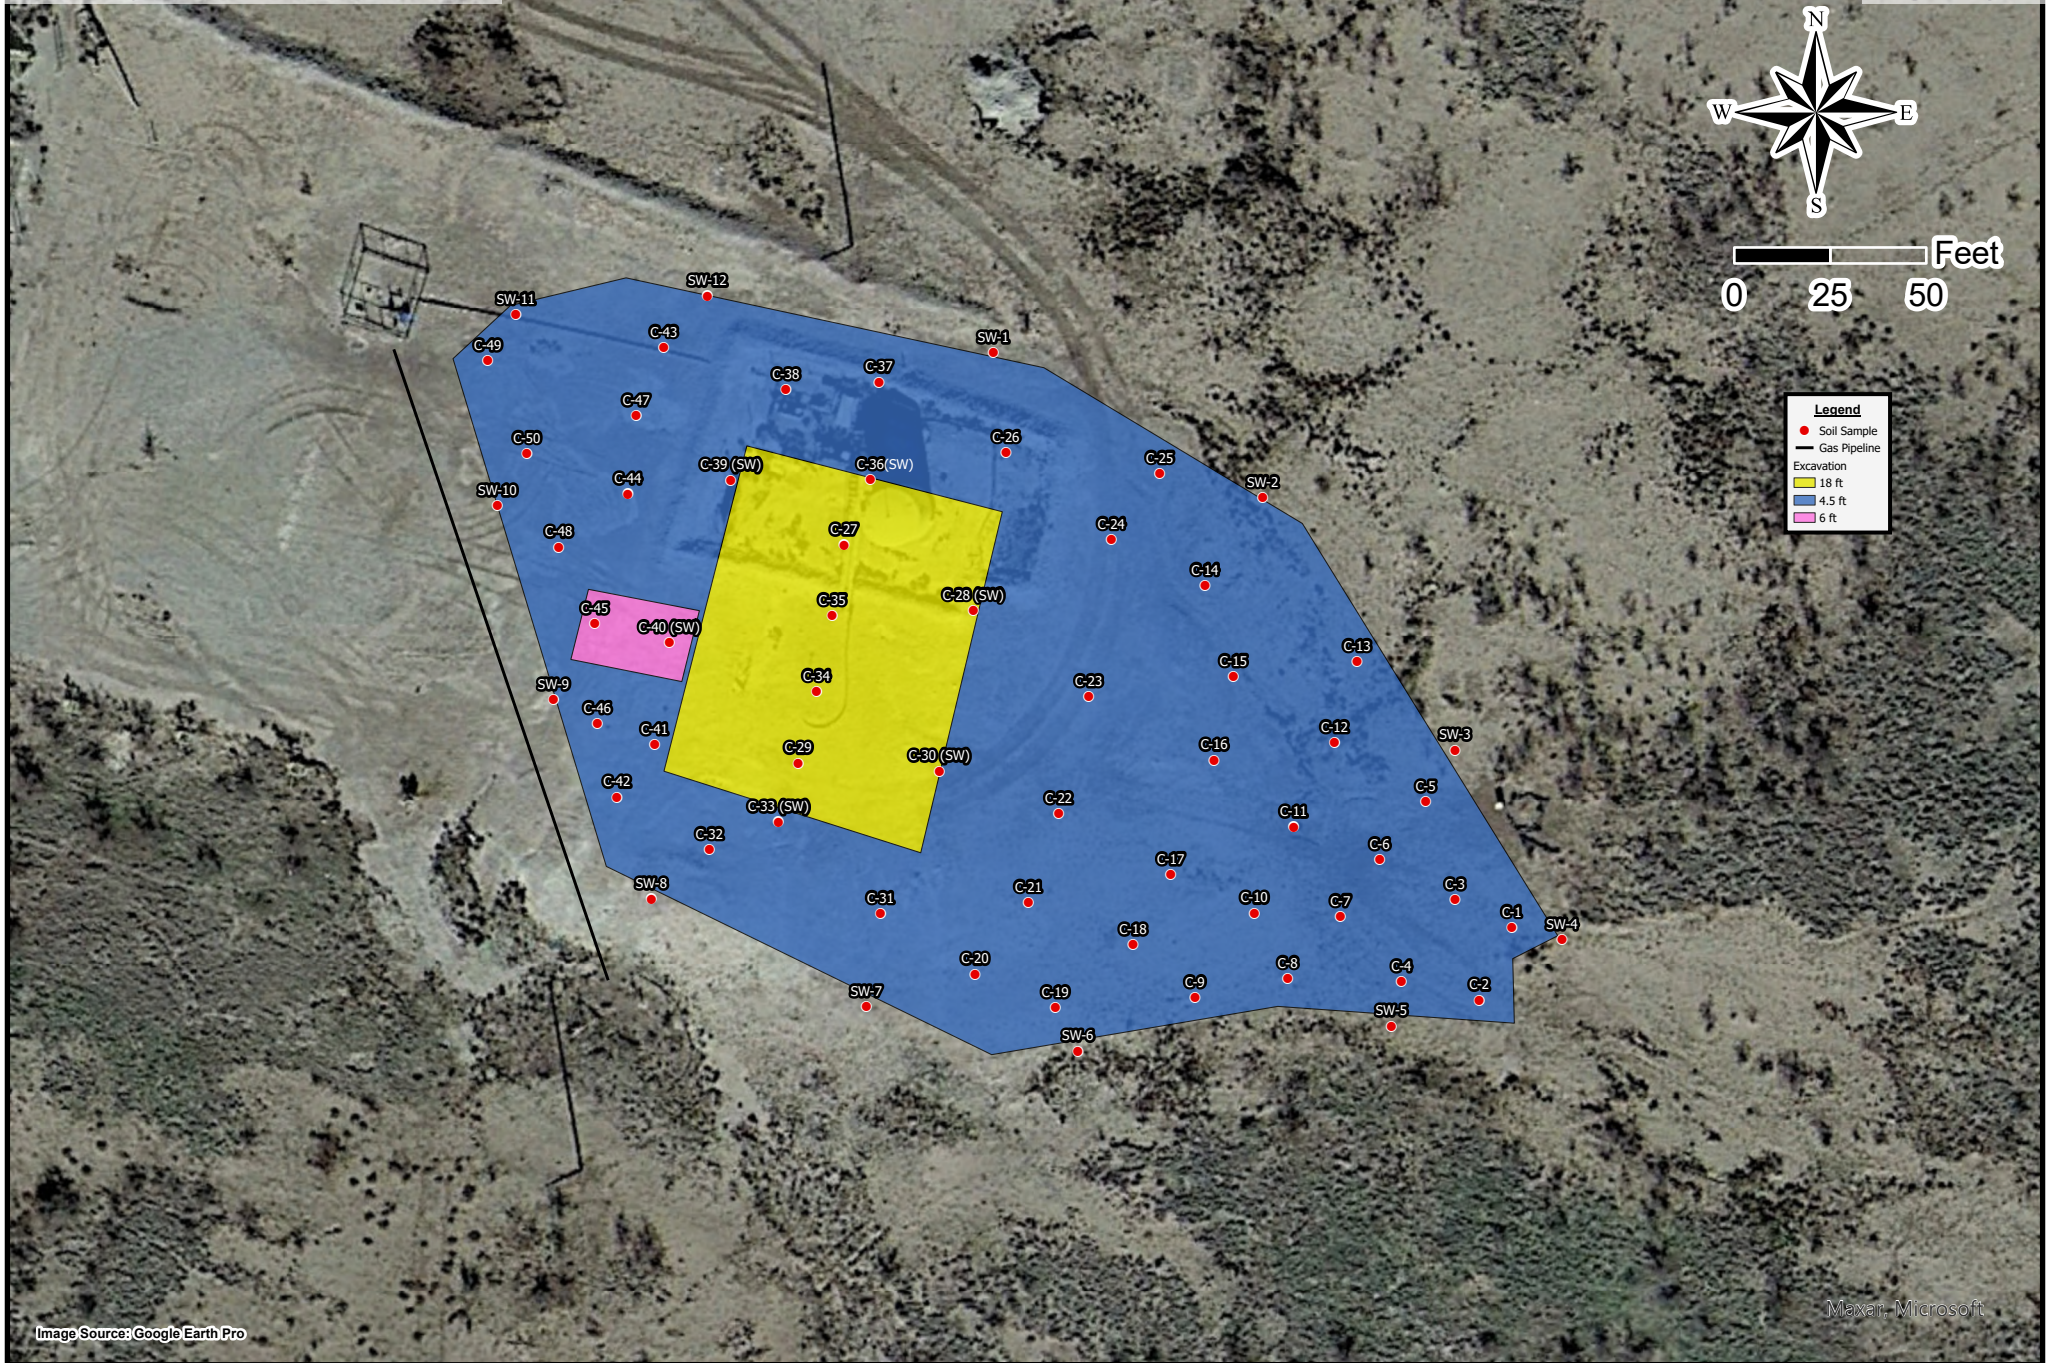
Figure 1

EOG  
 Mitchell SWD #2  
 Eddy County, NM  
 Confirmation Map

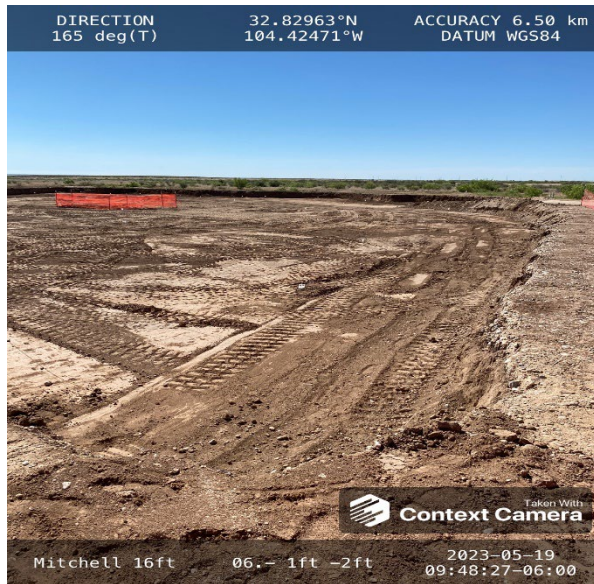
**Photograph No.1 Description:**

Initial excavation of site to 4.5 ‘

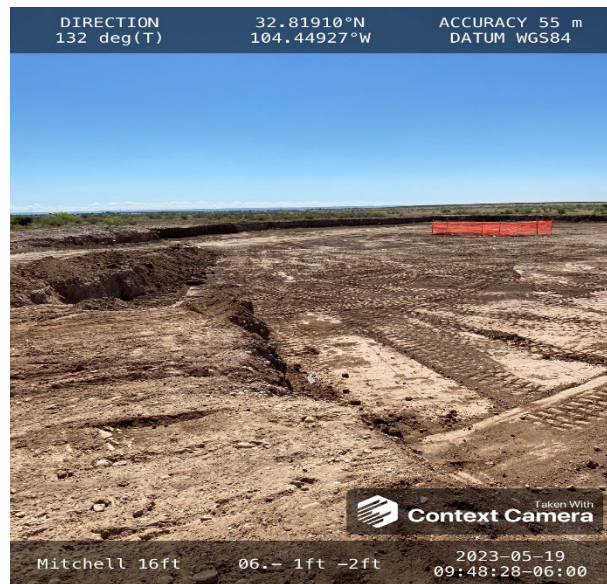
**Photograph No.2 Description:**

Initial excavation of site to 4.5 ‘

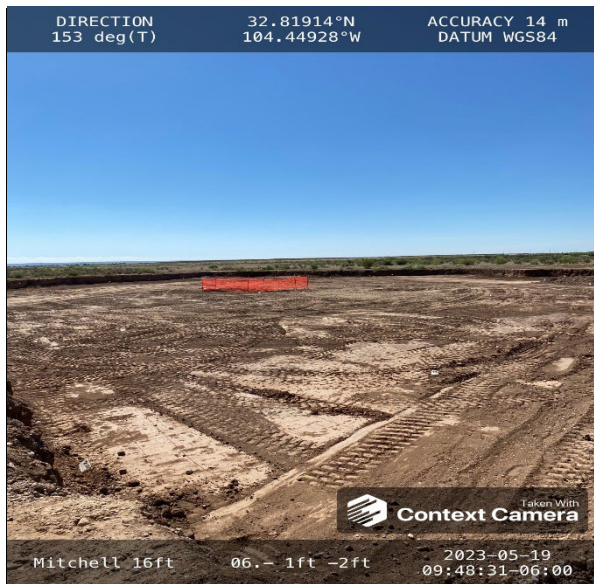
**Photograph No.3 Description:**

Initial excavation of site to 4.5 ‘

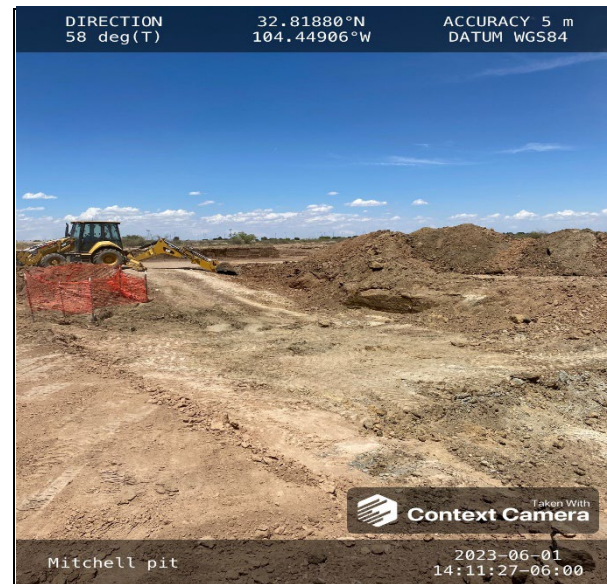
**Photograph No.4 Description:**

Initial excavation of site to 4.5 ‘

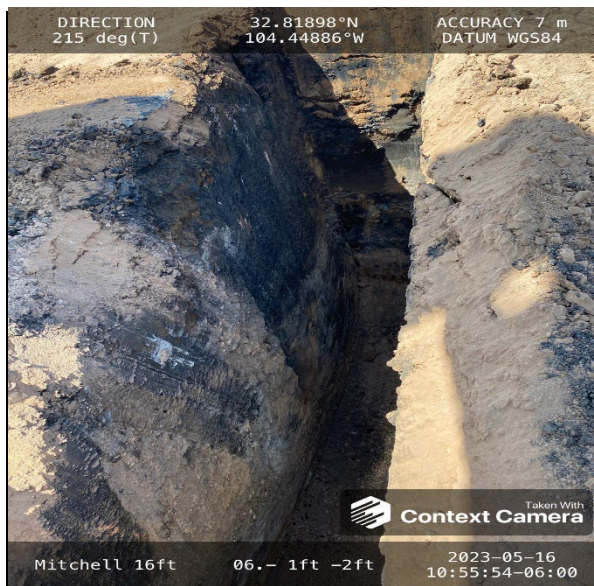
**Photograph No.6 Description:**

Discovery of contaminates to 18'

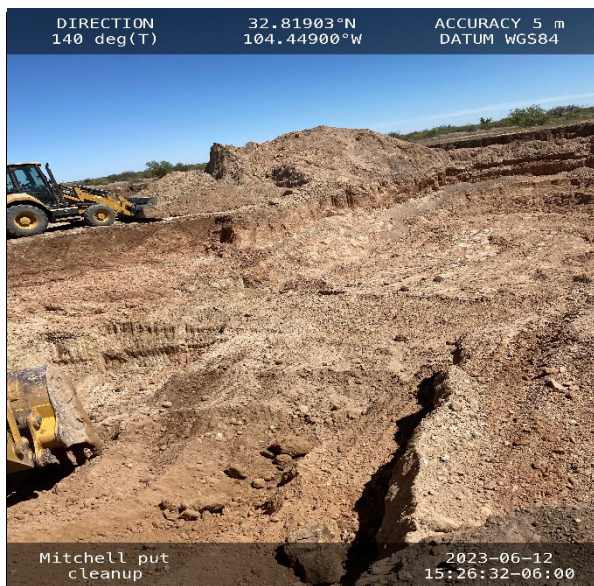
**Photograph No.7 Description:**

Excavation to 18' under tank battery area.

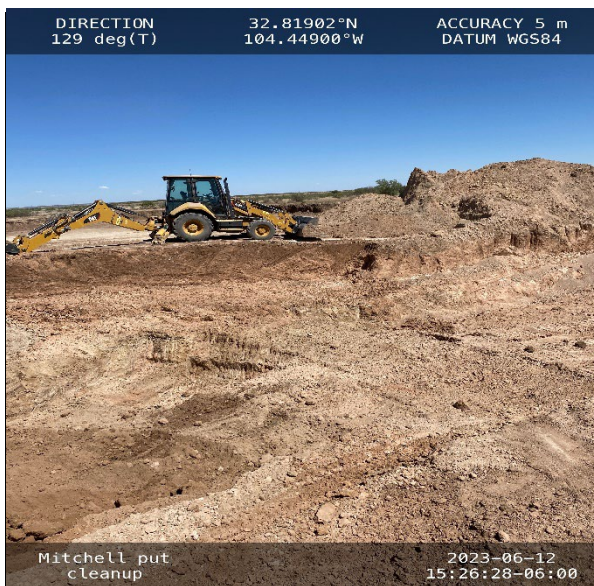
**Photograph No.8 Description:**

Excavation to 18' under tank battery area.

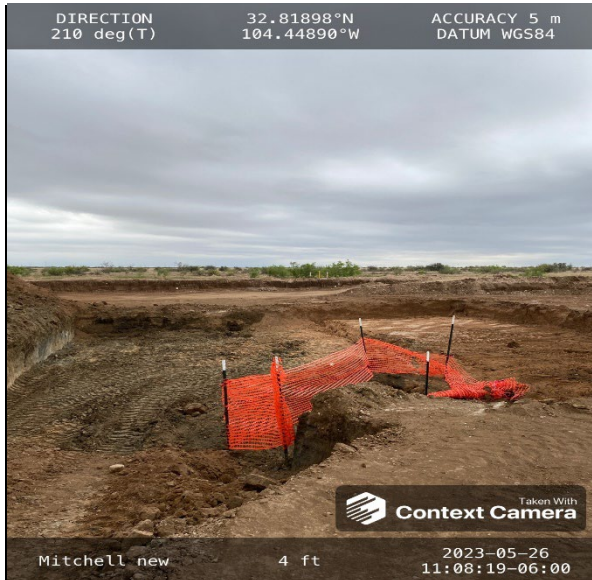
**Photograph No.9 Description:**

Excavation to 18' under tank battery area.

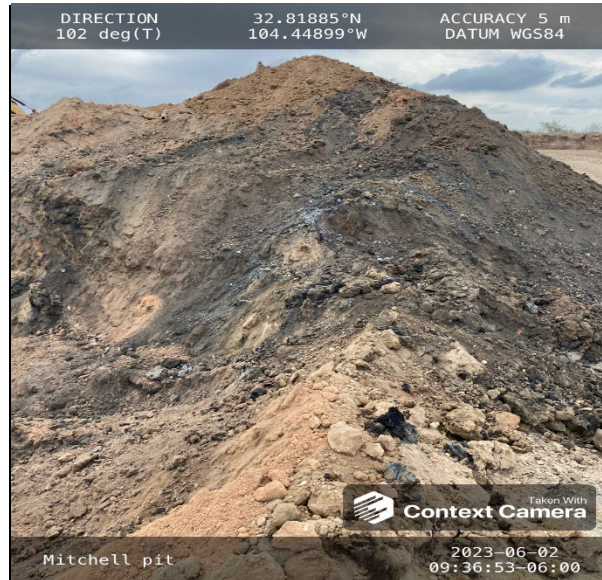
**Photograph No.10 Description:**

Excavation to 18' under tank battery area.

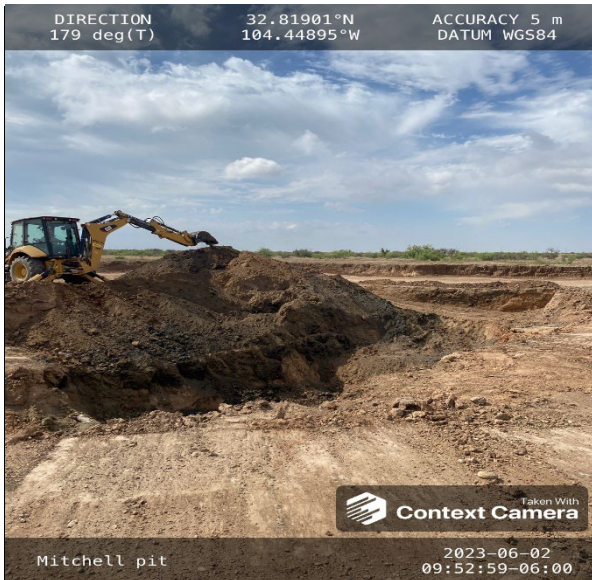
**Photograph No.11 Description:**

Excavation to 18' under tank battery area.

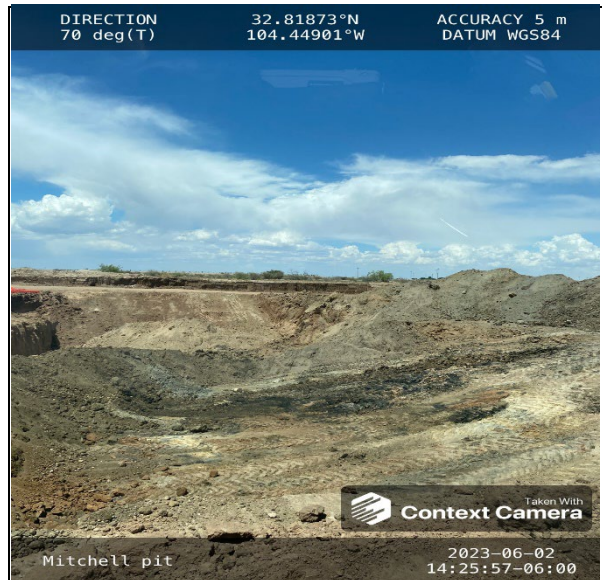
**Photograph No.12 Description:**

Excavation to 18' under tank battery area.
