Release Notification and Corrective Action

**Re: Closure Request Addendum
Los Medanos 36-23-30 State Battery
Incident Number NAB1704456898
Eddy County, New Mexico**

Ensolium, LLC (Ensolium), on behalf of XTO Energy, Inc. (XTO), has prepared the following addendum to the original *Closure Request* dated February 5, 2019. This addendum provides an update to the soil sampling activities completed at the Los Medanos 36-23-30 State Battery (Site) in response to the denial of the original *Closure Request* by the New Mexico Oil Conservation Division (NMOCD). In the denial, NMOCD indicated that it was unclear if two excavation sidewall samples met the reclamation requirement in the top four feet. Based on the additional soil sampling activities described below, XTO is submitting this *Closure Request Addendum* and requesting closure for Incident Number NAB1704456898.

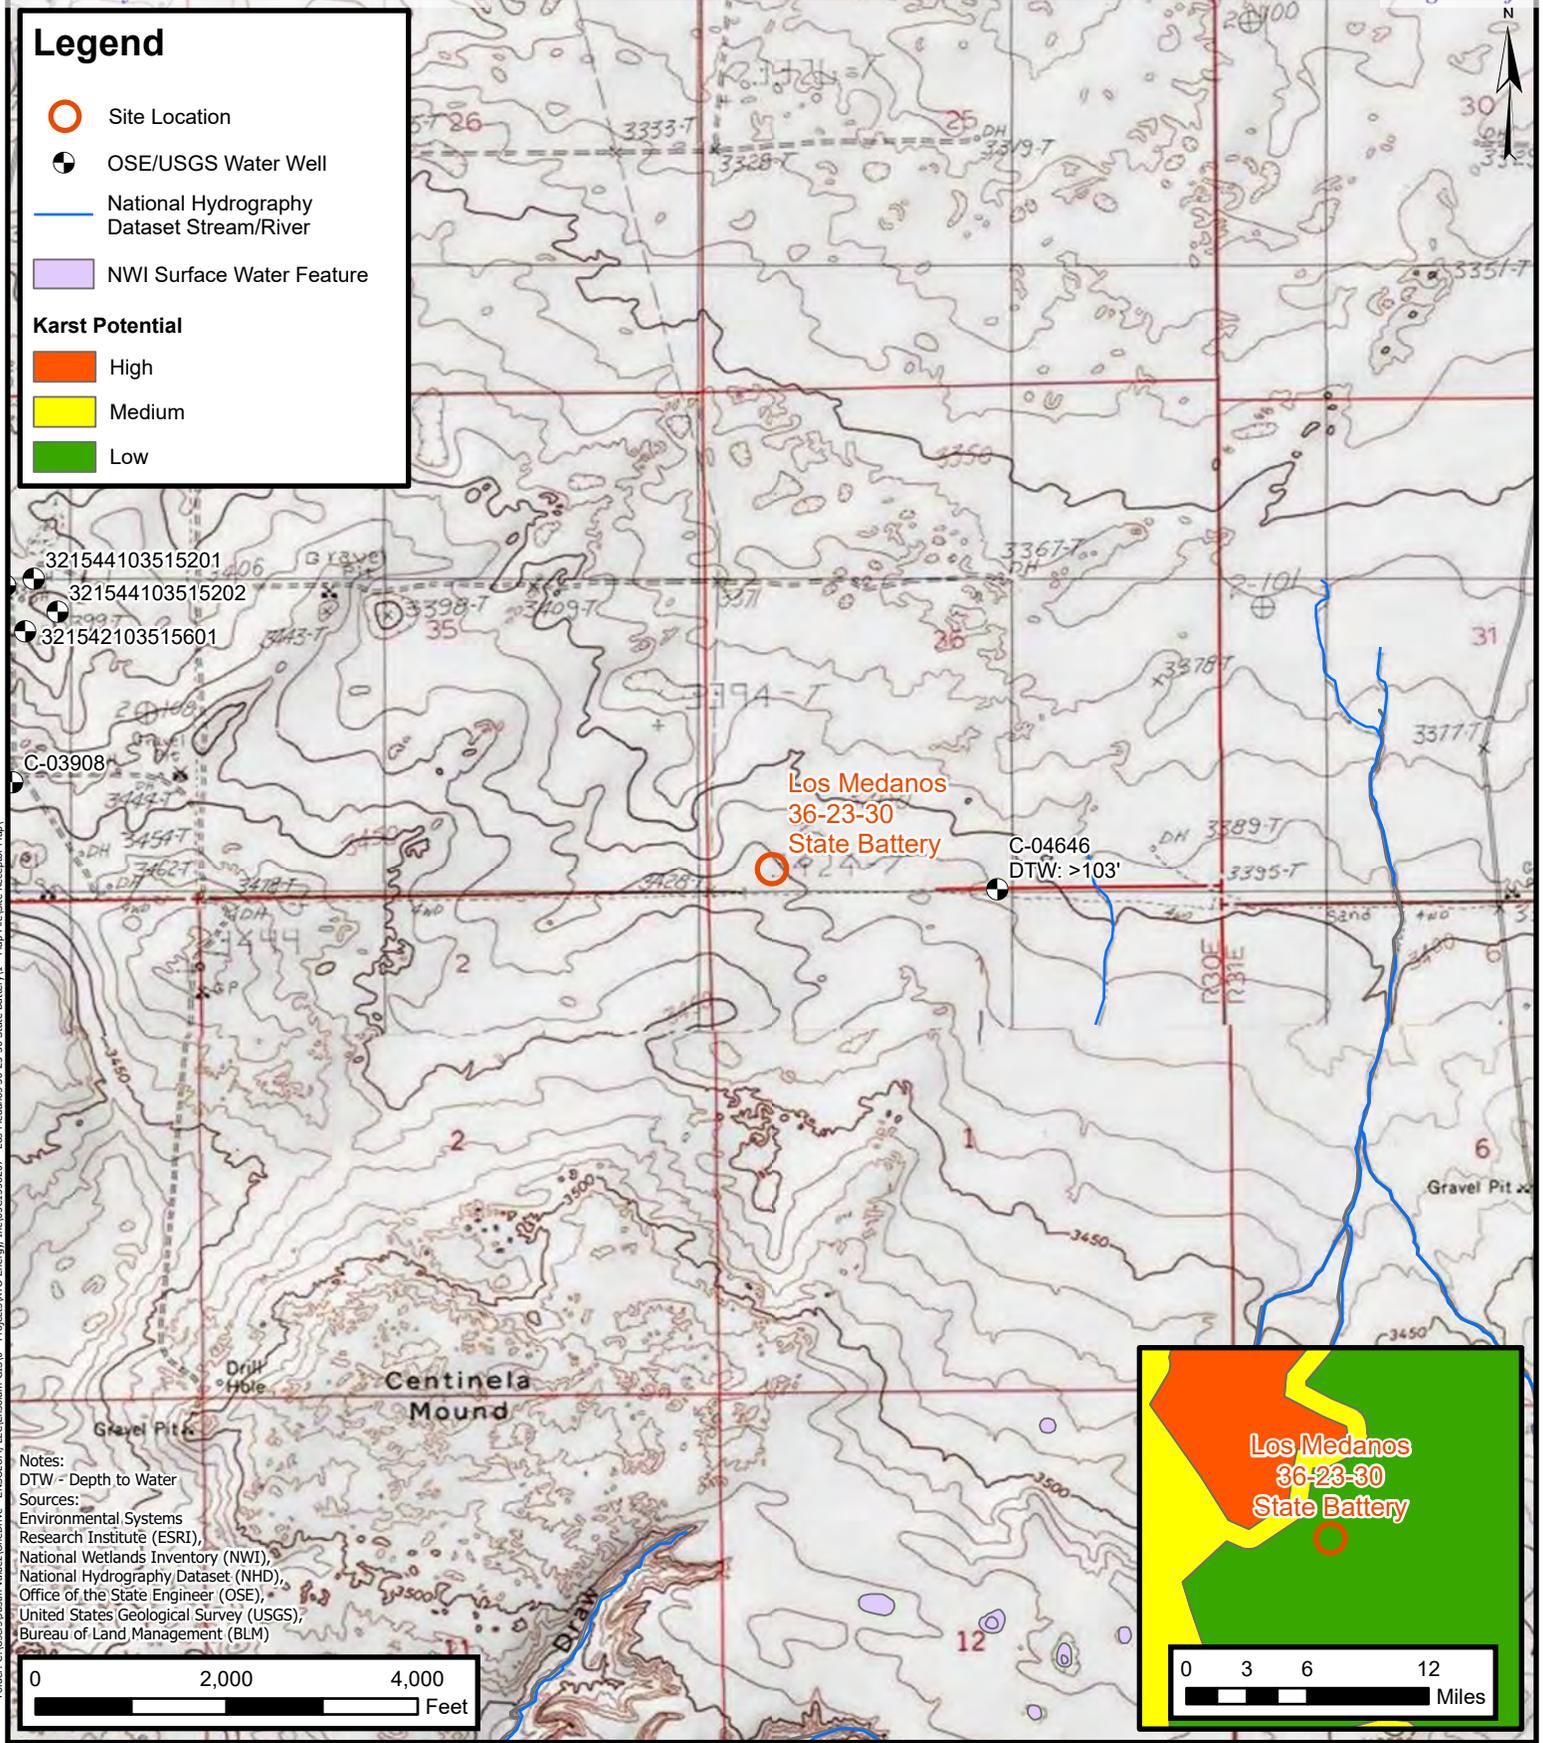
FIGURE
1

Site Receptor Map
XTO Energy, Inc.
Los Medanos 36-23-30 State Battery
Incident Number: NAB1704456898
Unit M, Section 36, Township 23 South, Range 30 East
Eddy County, New Mexico

Depth to groundwater at the Site is estimated to be greater than 100 feet below ground surface (bgs) based on the nearest groundwater well data. The closest permitted groundwater well is New Mexico Office of the State Engineer (NMOSE) well C-04646, located approximately 0.44 miles east of the Site. The well was drilled to a depth of 103 feet during August 2022, and no groundwater was encountered. The well record is provided in Appendix A. Potential site receptors are identified on Figure 1. Based on the results of the Site Characterization, the following NMOCD Table I Closure Criteria (Closure Criteria) were applied:

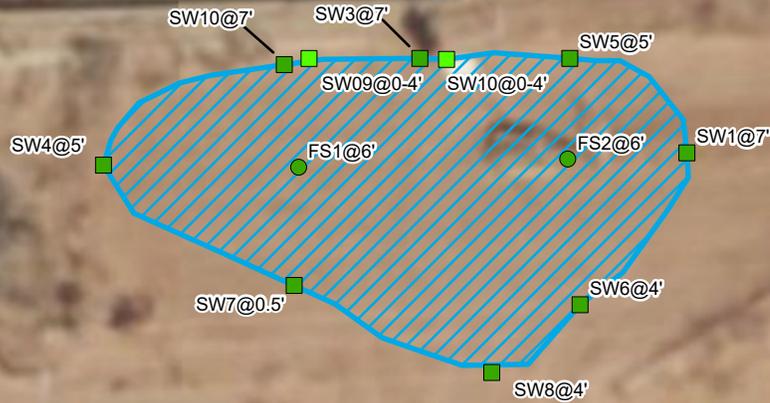
FIGURE

Notes:
 Sample ID @ Depth Below Ground Surface.

Excavation Soil Sample Locations

On April 7, 2023, Ensolum personnel were at the Site to complete soil sampling activities to confirm the absence of chloride impacted soil in the top four feet of the historical excavation in the areas around original sidewall samples SW2 and SW3. Composite sidewall samples SW09 and SW10 were collected via hand auger from depths ranging from the ground surface to 4 feet bgs at the original SW2 and SW3 excavation sidewall sample locations. The excavation soil sample locations are depicted on Figure 2. Photographic documentation was completed during the Site visit and a photographic log is included in Appendix B.

Laboratory analytical results for excavation sidewall samples SW09 and SW10 indicated that all COC concentrations were compliant with the Site Closure Criteria and the reclamation requirement for the top four feet. The soil sample analytical results are summarized on Table 1 and the laboratory analytical report is included as Appendix C.

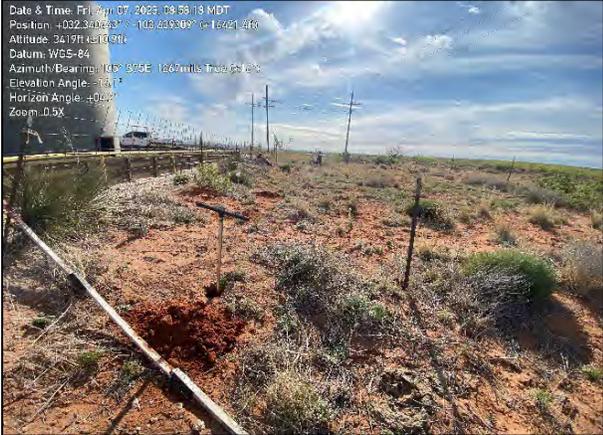
Photograph: 1 Date: 4/7/2023
Description: View of historical release area.

Initial response efforts and excavation of impacted soil have mitigated impacts at this Site. The excavation was backfilled, contoured, and re-seeded and is currently supporting vegetative growth. Depth to groundwater has been determined to be greater than 100 feet bgs within 0.5 miles of the Site and no other sensitive receptors were identified near the release extent. XTO believes the remedial actions completed are protective of human health, the environment, and groundwater and respectfully requests closure for Incident Number NAB1704456898.

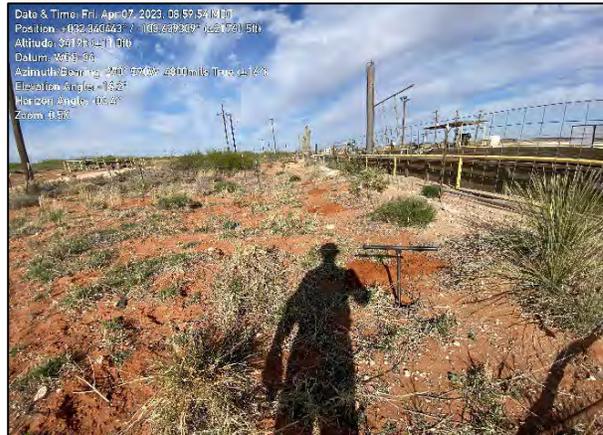
Photograph: 2 Date: 4/7/2023
Description: View of historical release area.

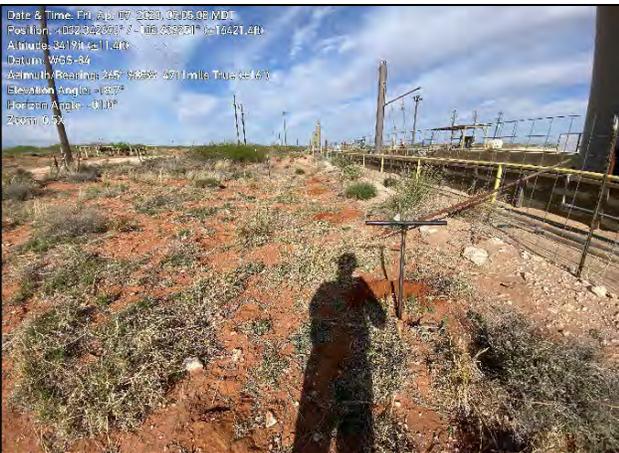
Photograph: 3 Date: 4/7/2023
Description: View of historical release area.

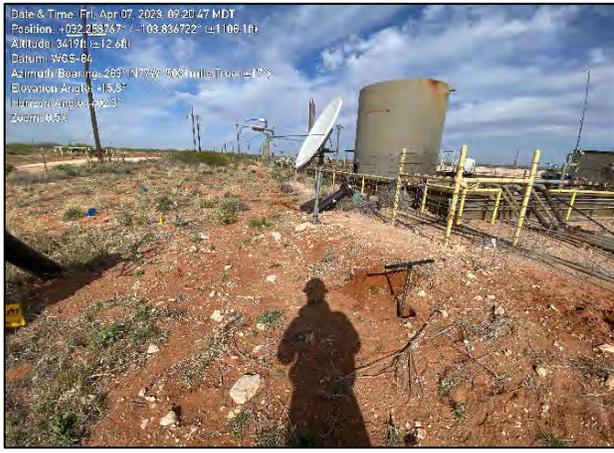
Photograph: 4 Date: 4/7/2023
Description: View of historical release area.
