CLOSURE REQUEST REPORT

**Benson Shugart Waterflood Unit #015
Eddy County, New Mexico
Incident Number nMLB0526441458**

**Prepared For:
Chevron USA, Inc.
6301 Deauville Blvd.
Midland, TX 79706**

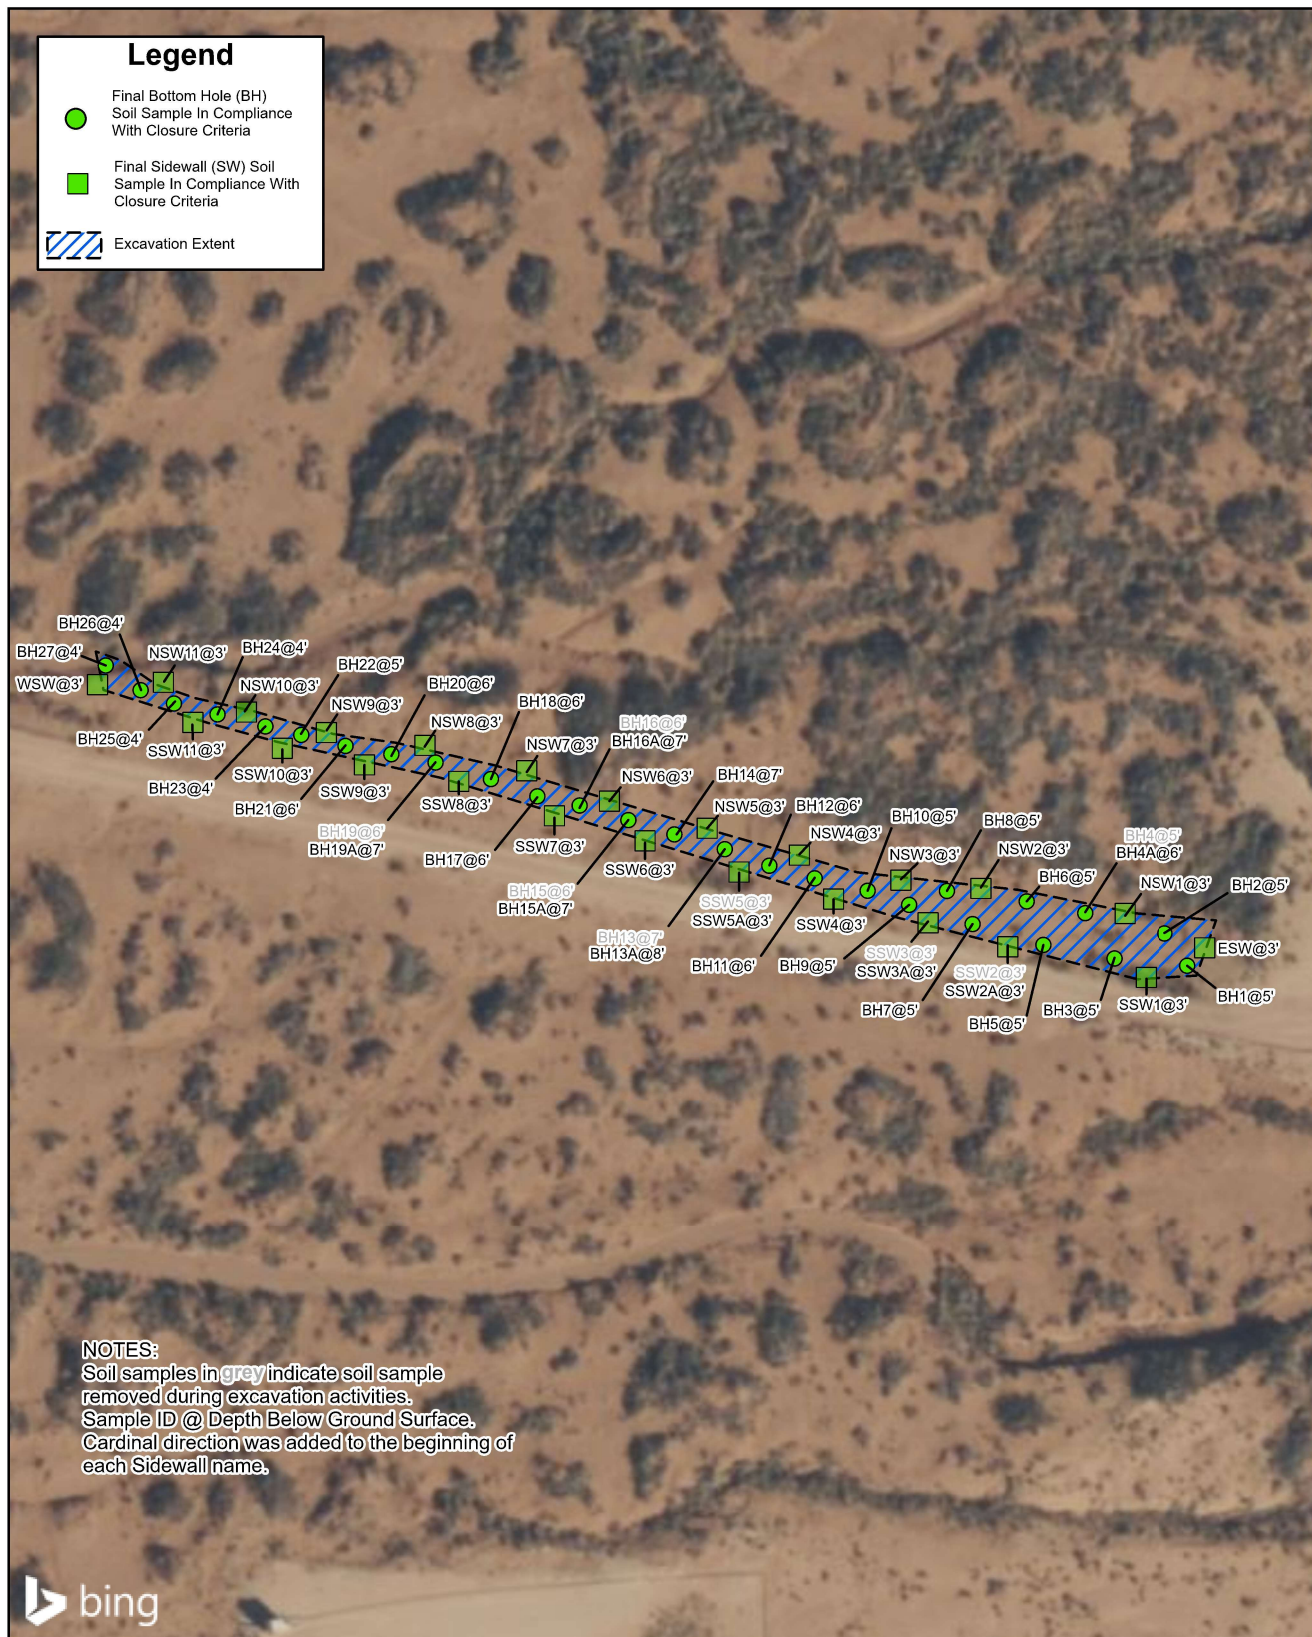
FIGURE 2

Excavation Soil Sample Locations

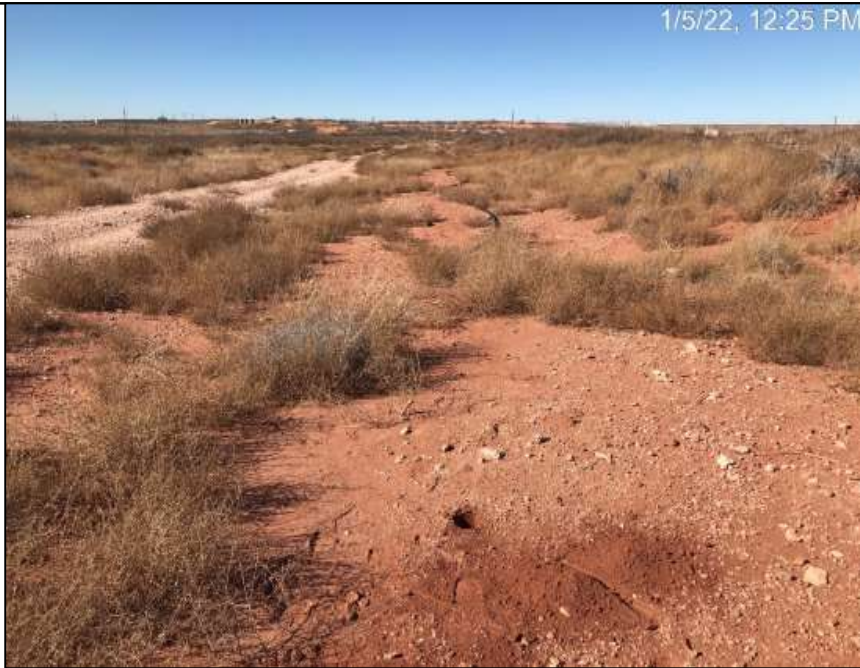
Photograph 1

Description: Western view during Site assesment and delineation event.

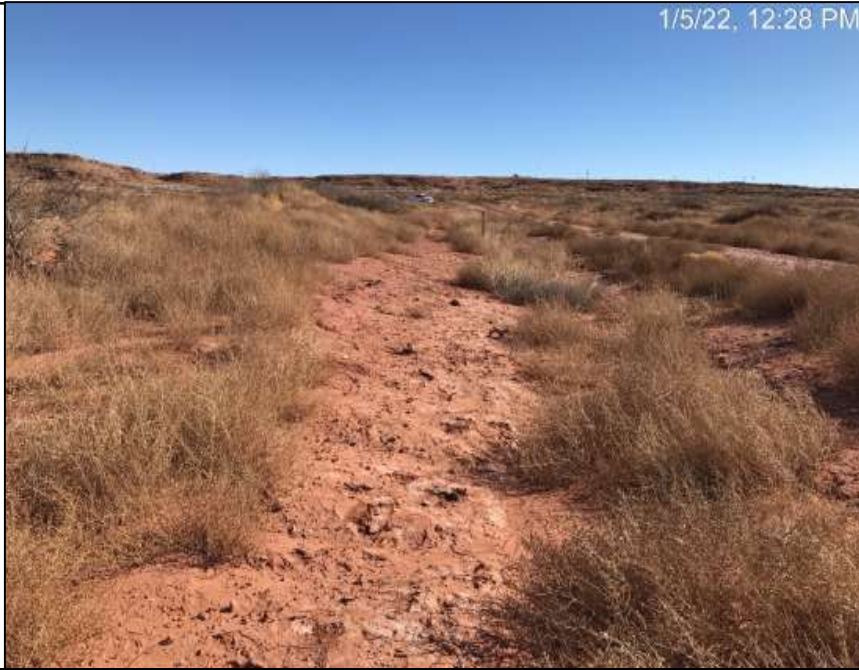
Photograph 3

Description: Eastern view during Site assessment and delineation event.

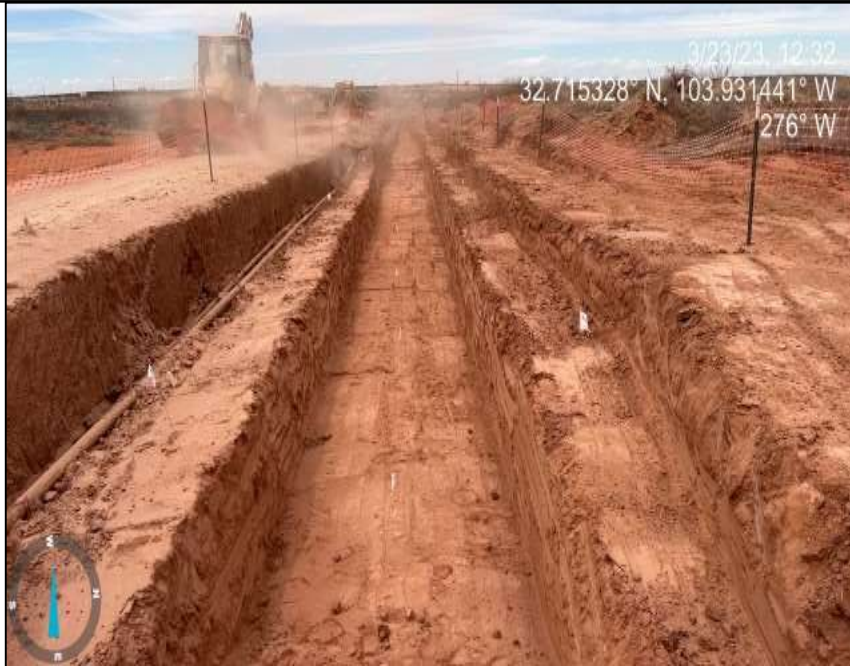
Photograph 5

Description: Western view during excavation activities.

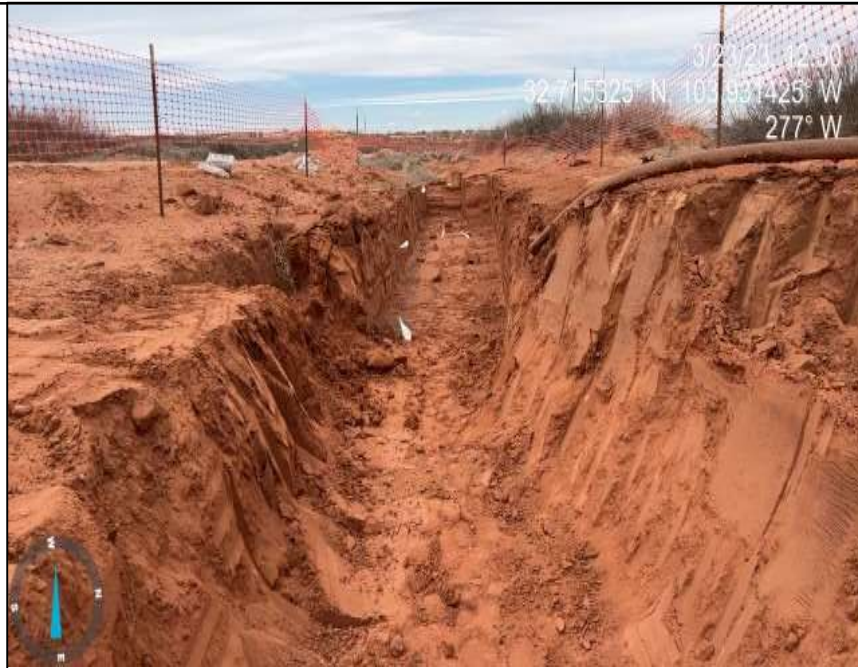
Photograph 7

Description: Western view during excavation activities.

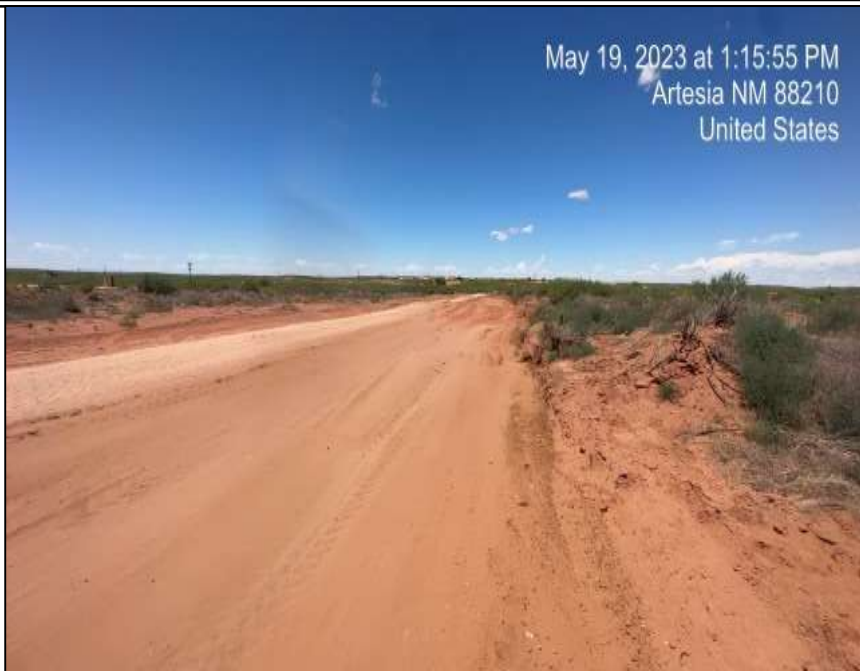
Photograph 9

Description: Western view following remediation activities.

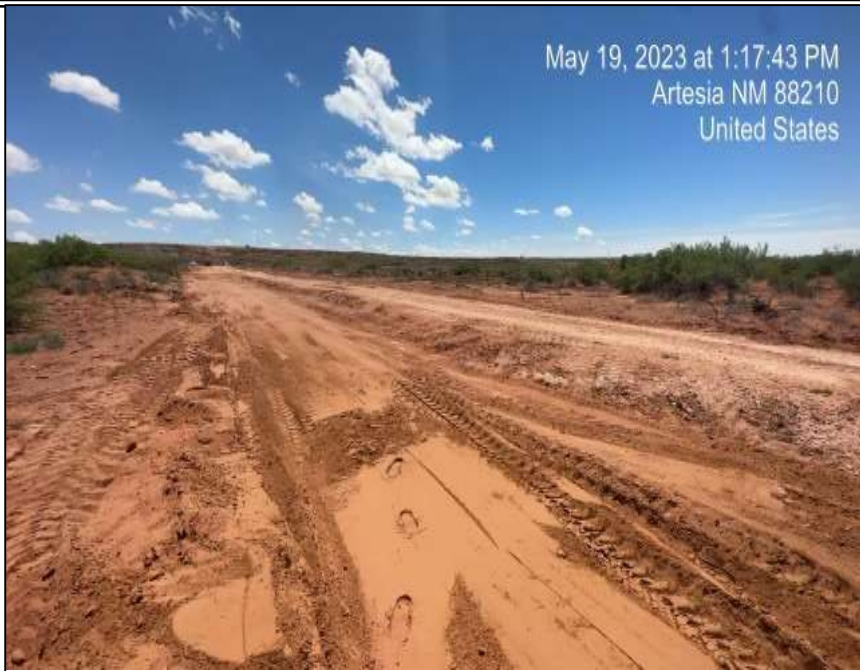
Photograph 11

Description: Eastern view following remediation activities.
