Elliot Fed 1 6" Steel Line 1  
32.719606°, -104.008138°  
NMOCD Reference # nAPP2303344256  
Terracon Project # KH237011

**RE: Release Investigation, and Closure Report**  
Elliot Fed 1 6" Steel Line 1  
Unit G, Section 30, Township 18 South, Range 30 East  
32.7109606°, -104.008138°  
Eddy County, New Mexico  
Terracon Project No. KH23011

Terracon Consultants, Inc. (Terracon) is pleased to submit our Release Investigation and Closure Report for the site referenced above. The scope of services was developed in accordance with the New Mexico Oil Conservation Division (NMOCD) regulations concerning clean-up actions required for releases of crude oil and produced water. The investigative response actions were taken as the result of a natural gas release from a suspected corroded lateral line. The below sections detail Terracon’s assessment and remediation actions in response to the noted release.

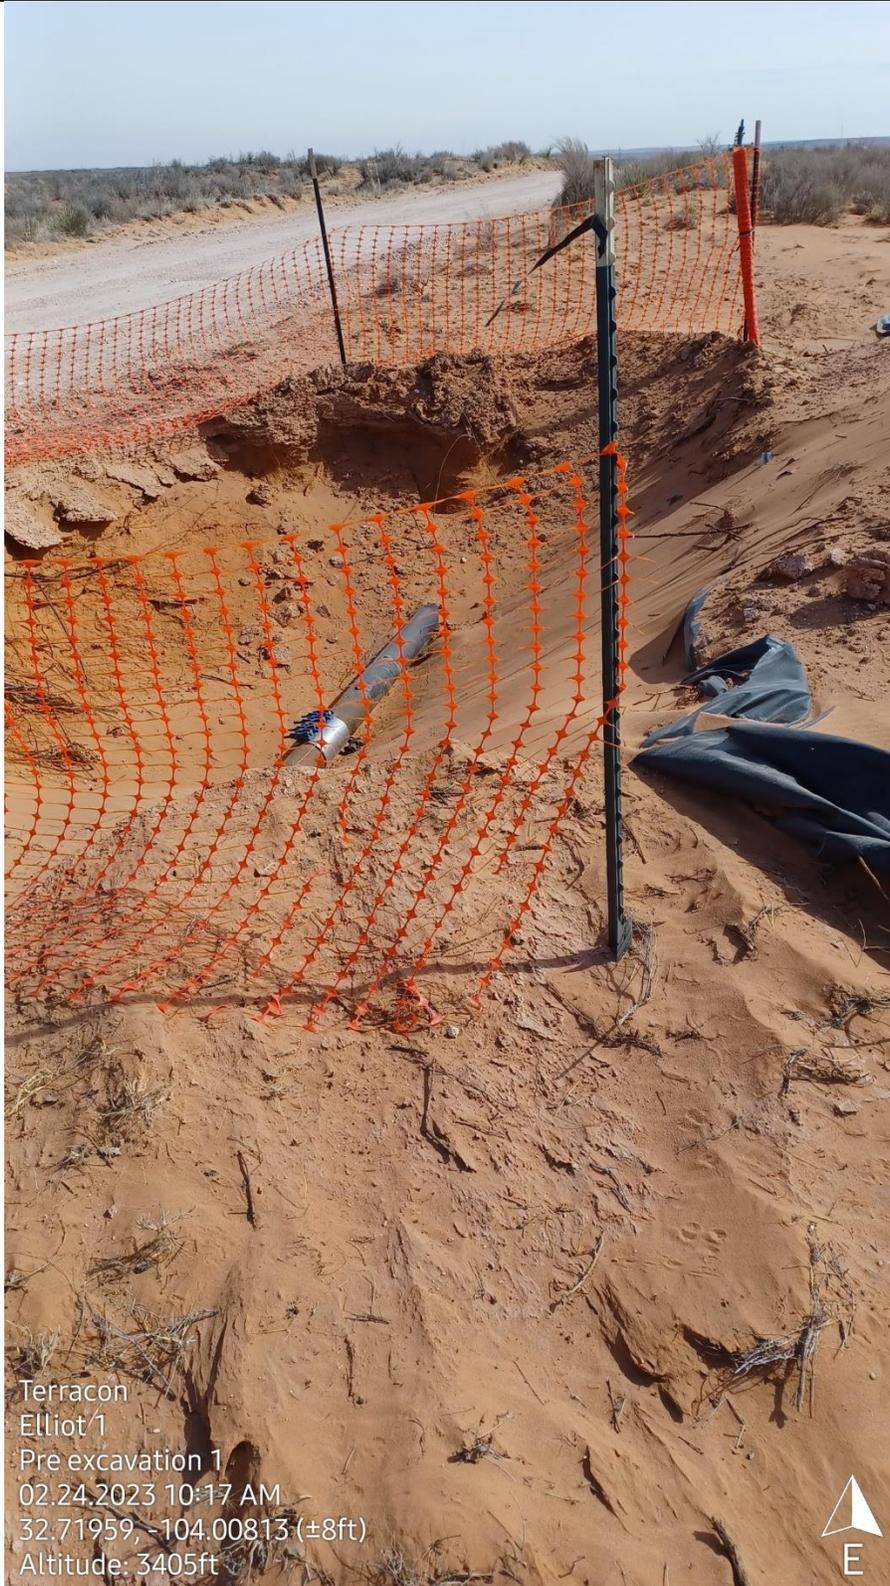
PHOTO 1: View of the area prior to excavation.

Terracon  
Elliot 1  
Pre excavation 1  
02.24.2023 10:17 AM  
32.71959, -104.00813 (±8ft)  
Altitude: 3405ft

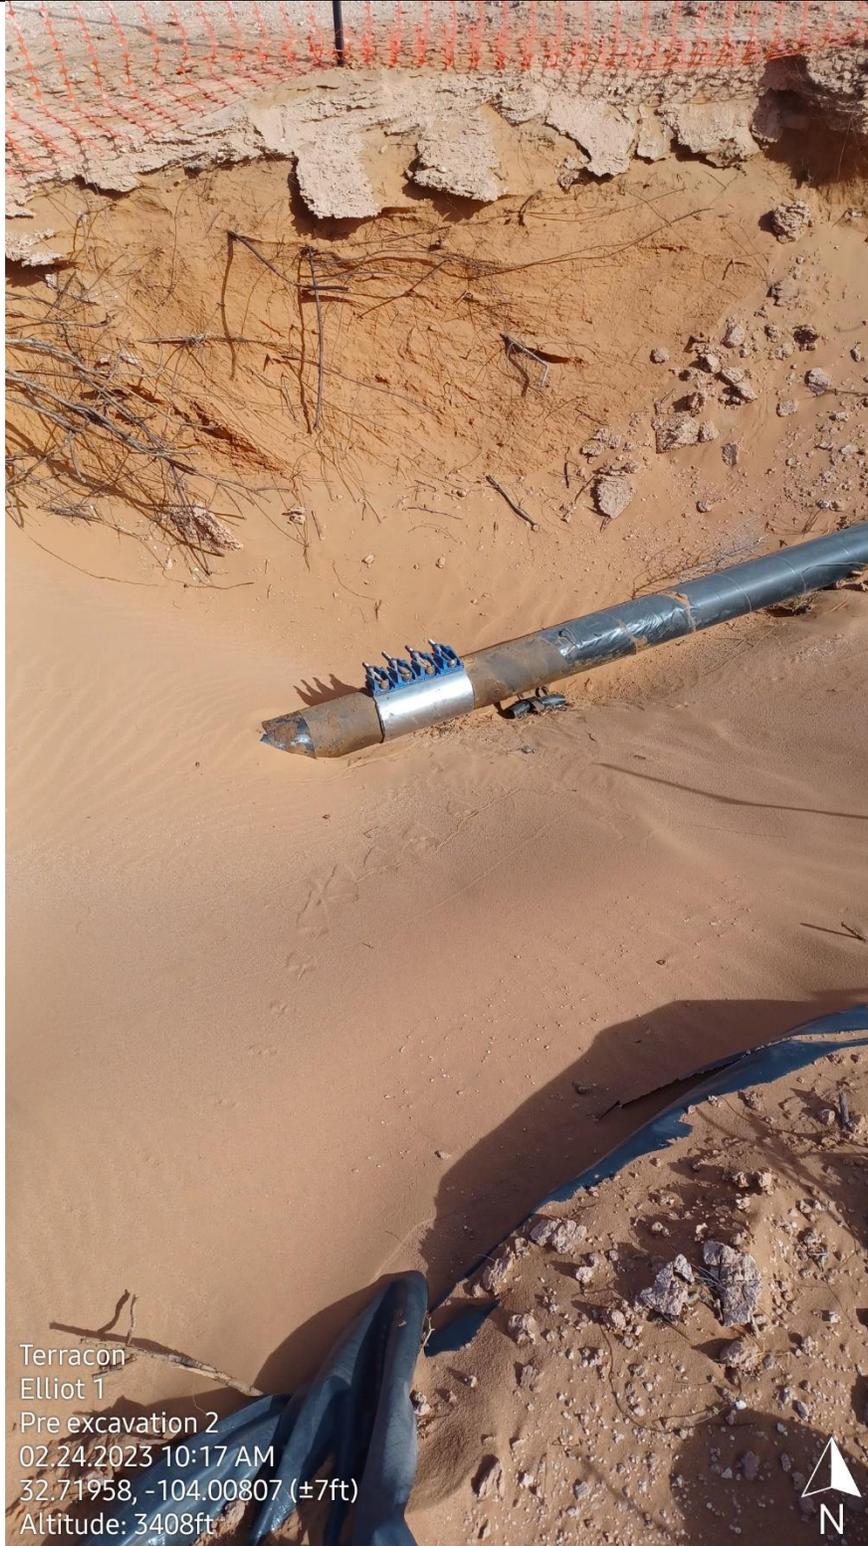
**PHOTO 2:** View of the area prior to excavation.

Terracon  
Elliot 1  
Pre excavation 2  
02.24.2023 10:17 AM  
32.71958, -104.00807 (±7ft)  
Altitude: 3408ft

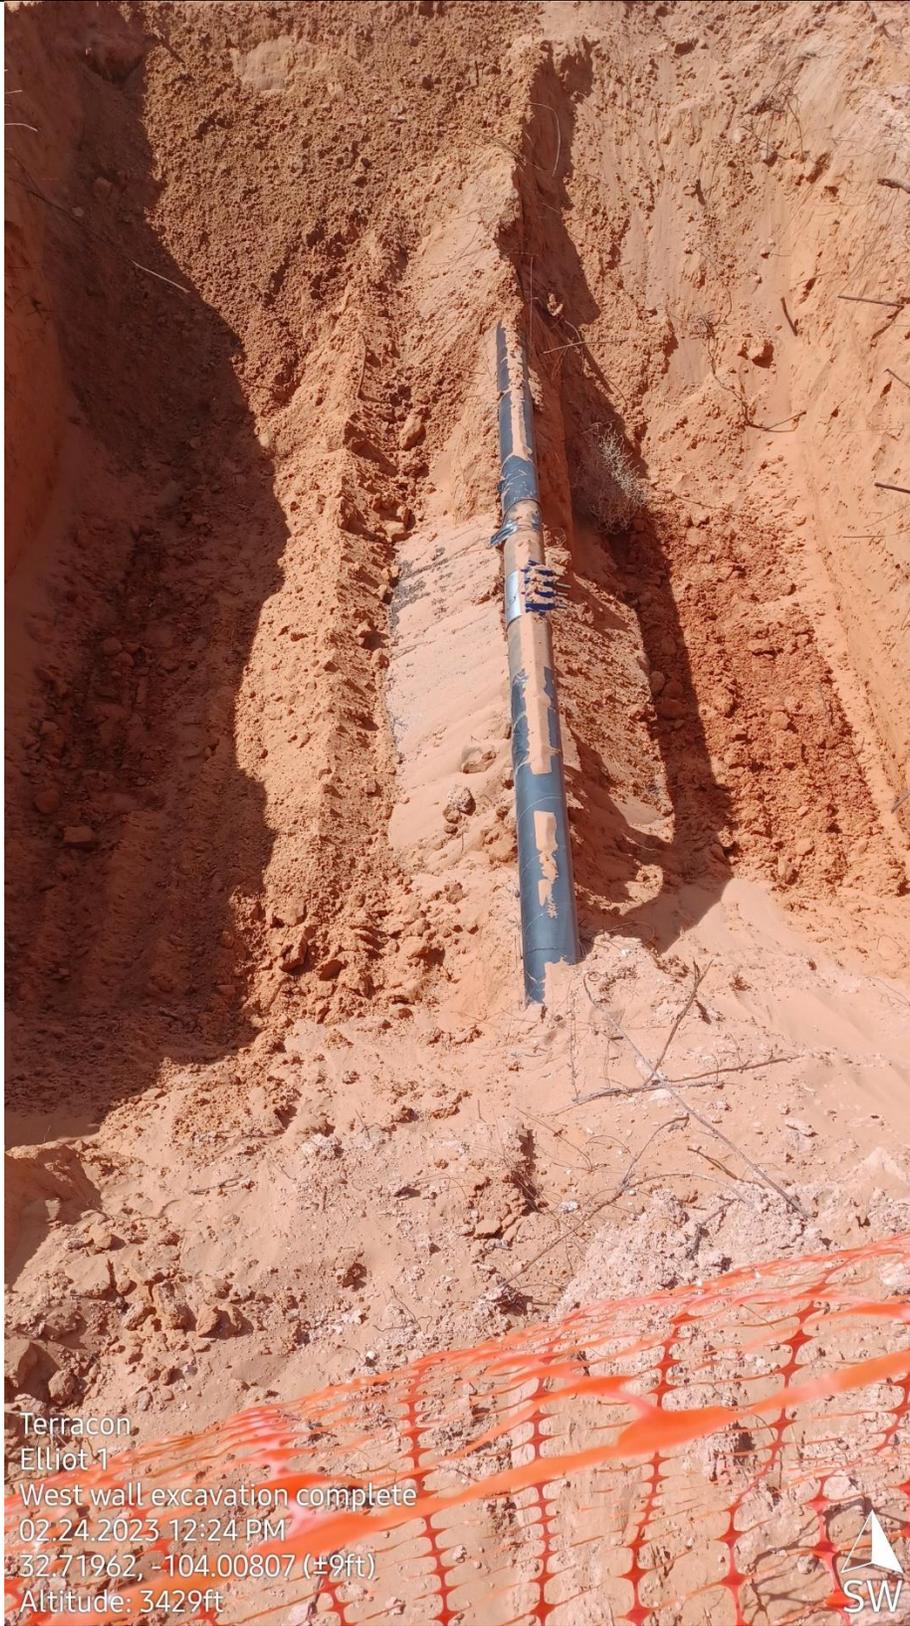
Terracon  
Elliot 1  
West wall excavation complete  
02.24.2023 12:24 PM  
32.71962, -104.00807 (±9ft)  
Altitude: 3429ft
