Incident ID	NAPP2224931263
District RP	
Facility ID	
Application ID

**Re: Site Assessment, Remediation, and Closure Report  
 Foster Eddy Battery  
 API No. N/A  
 GPS: Latitude 32.83435 Longitude -103.89111  
 UL "J", Sec. 17, T17S, R31E  
 Eddy County, NM  
 NMOCD Ref. No. nAPP2224931263**

Foster Eddy Tank Battery  
Eddy County, NM  
Site Map

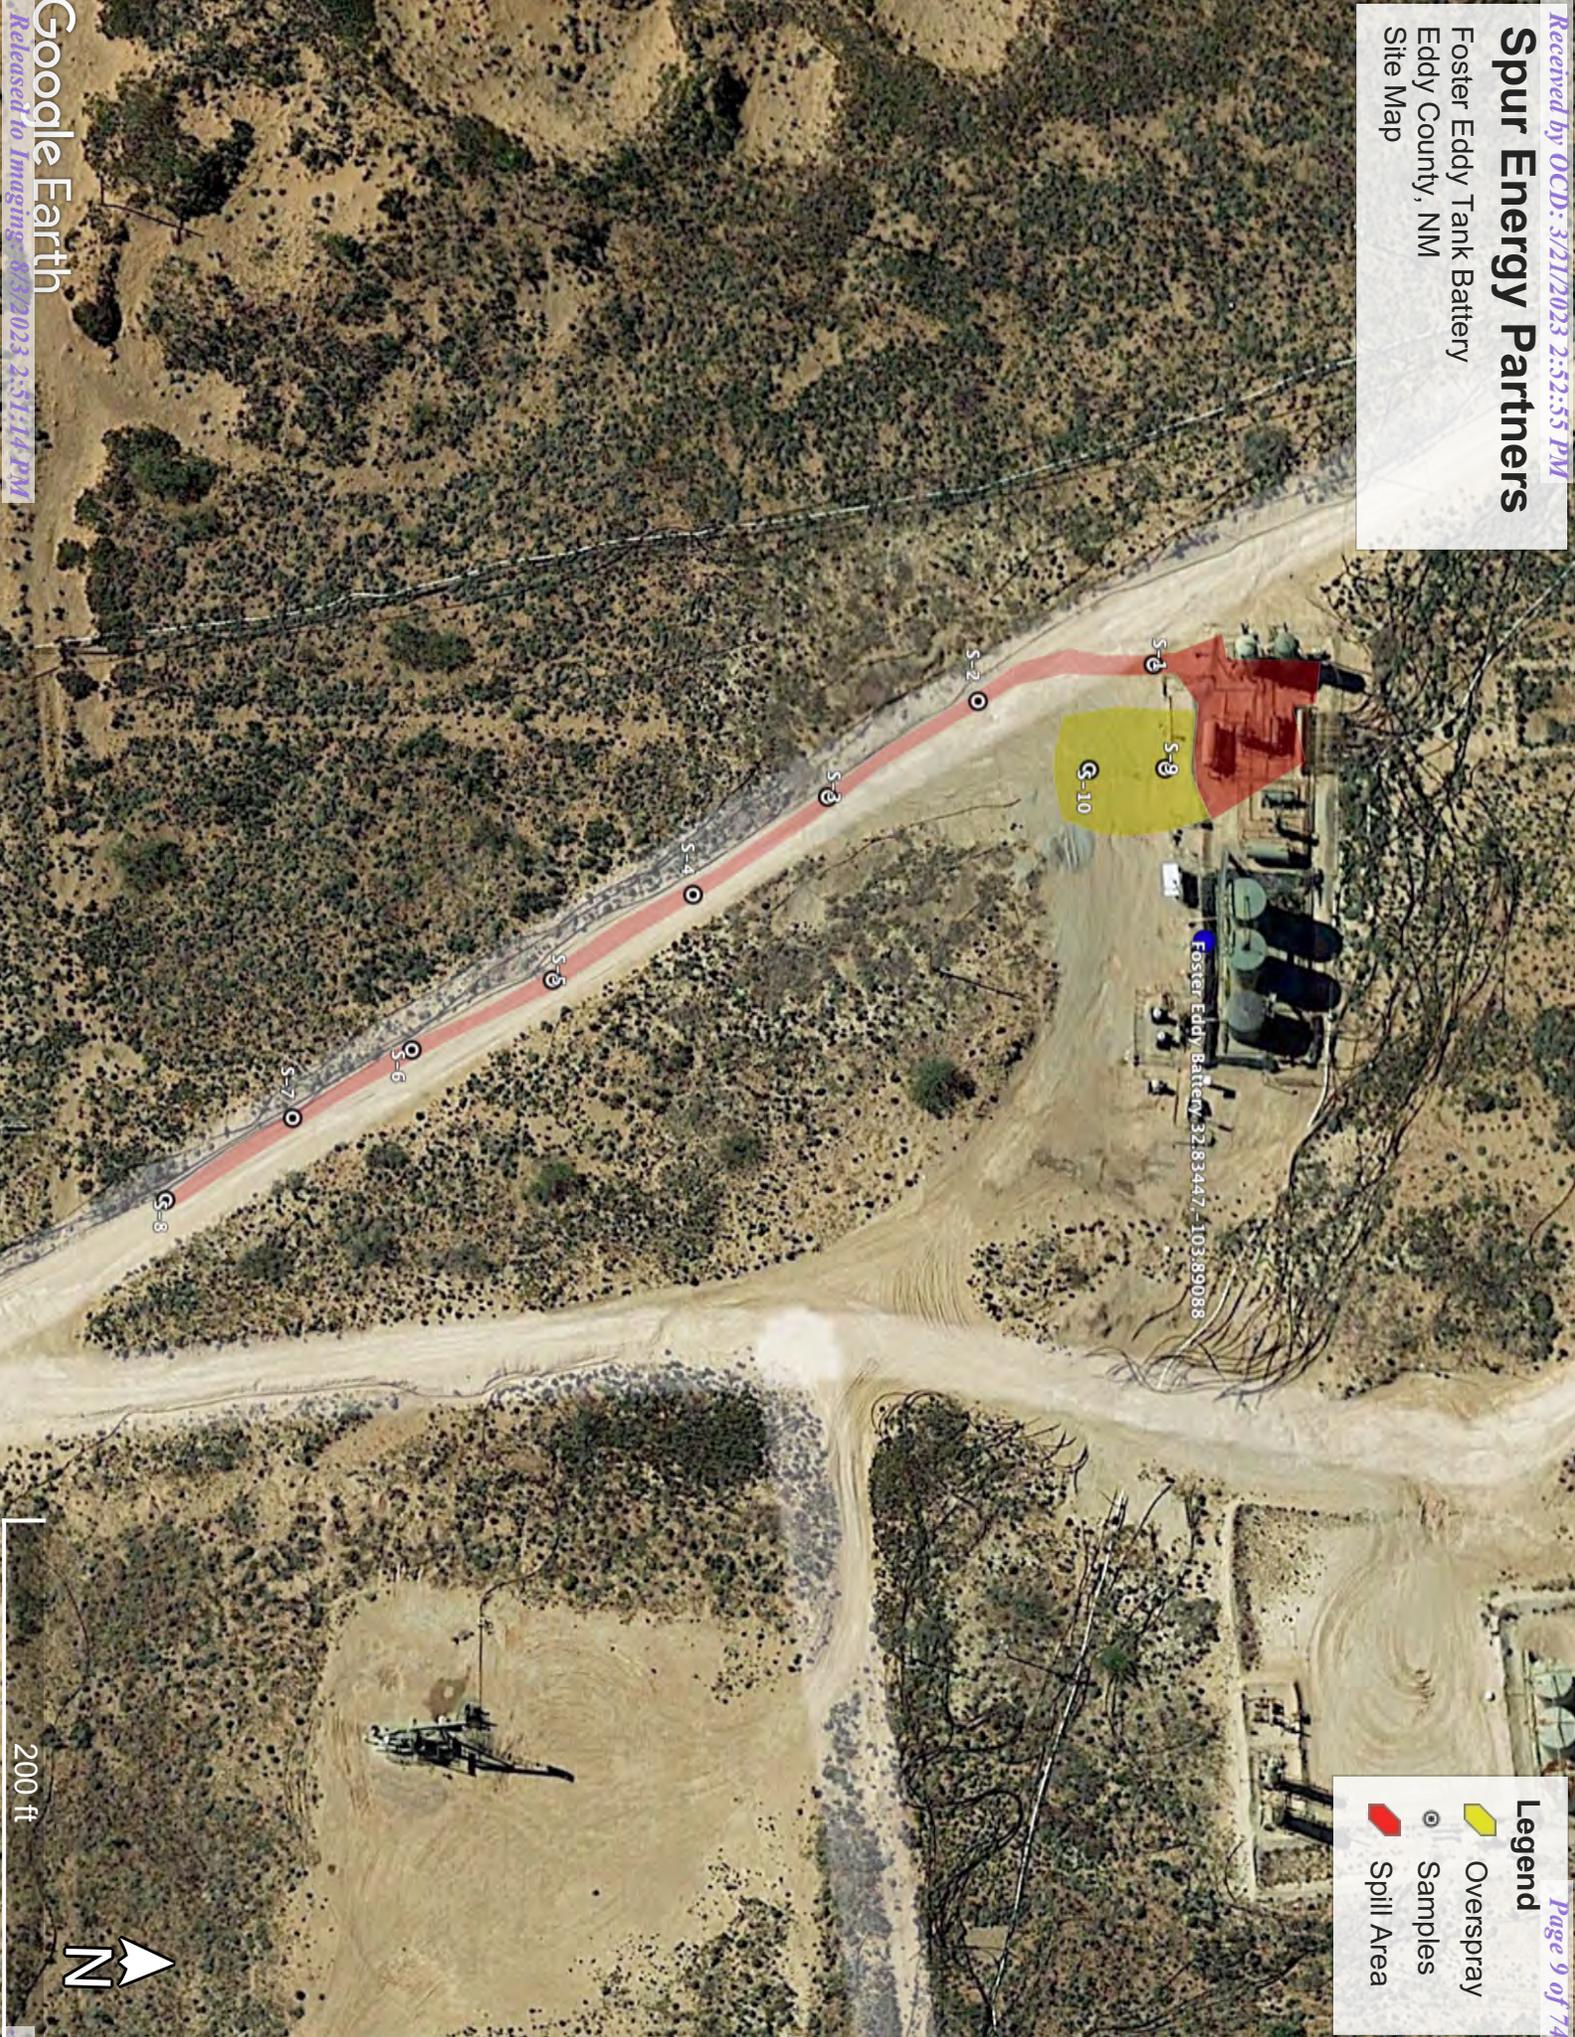
- Overspray
- Samples
- Spill Area

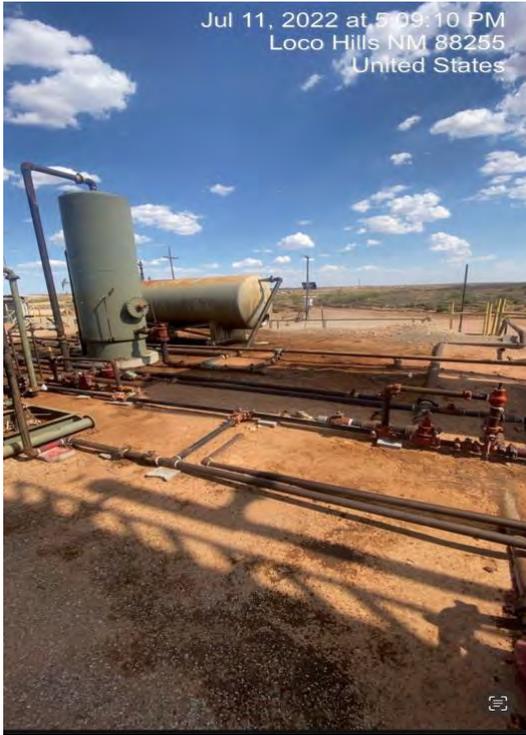
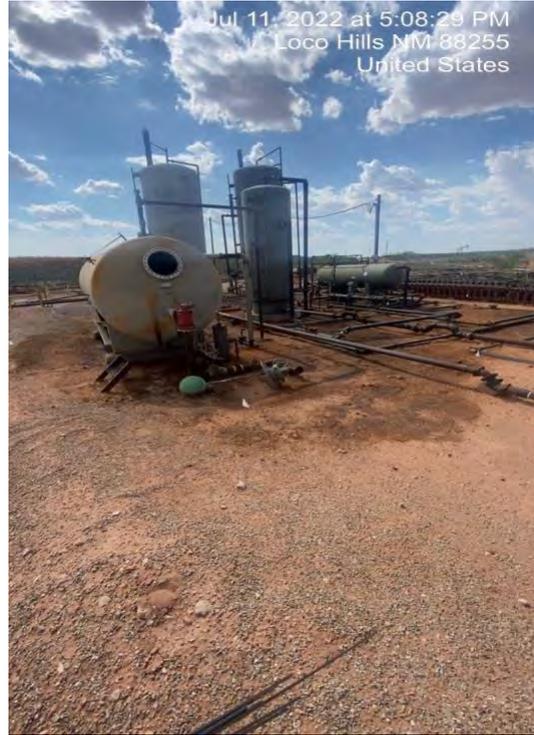
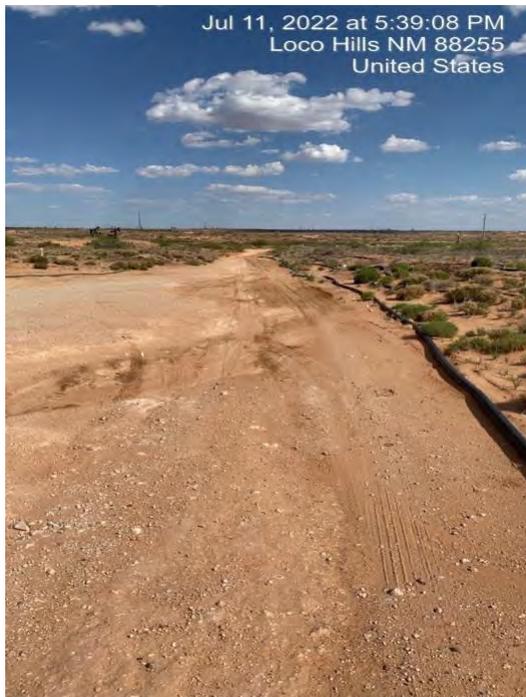
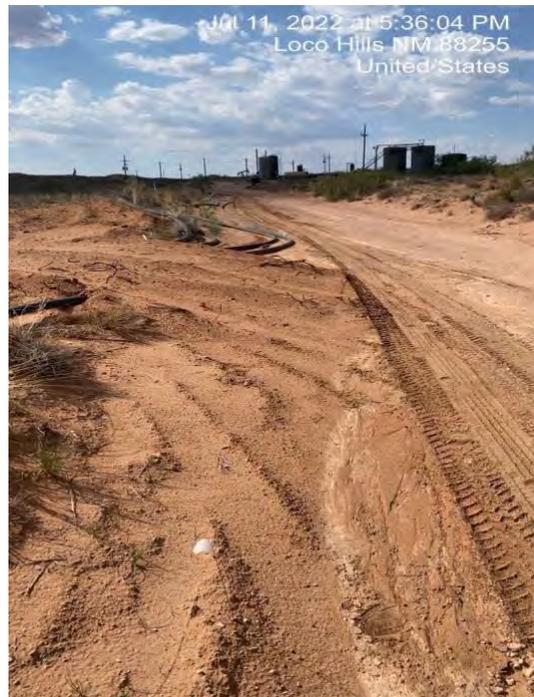
**Before Remediation**

Release Details			
<b>Type of Release:</b>	Produced Water	<b>Volume of Release:</b>	15 bbls
		<b>Volume Recovered:</b>	15 bbls
<b>Source of Release:</b>	Vent Line	<b>Date of Release:</b>	09/01/22
<b>Was Immediate Notice Given?</b>	No	<b>If, Yes, to Whom?</b>	N/A
<b>Was a Watercourse Reached?</b>	No	<b>If Yes, Volume Impacting Watercourse:</b>	N/A
<b>Surface Owner:</b>	State	<b>Mineral Owner:</b>	State
A 2" vent line coming from the vessels ruptured causing the release.
