Release Notification

Re: **Site Characterization and Soil Remediation Workplan**
ETC Texas Pipeline, Ltd.
HS-1 Release
Incident ID: NAPP2304144689
N-2-22S-34E, Lea County, New Mexico

ETC TEXAS PIPELINE, LTD.
EDDY COUNTY, NEW MEXICO
HS-1 RELEASE

SITE LOCATION MAP

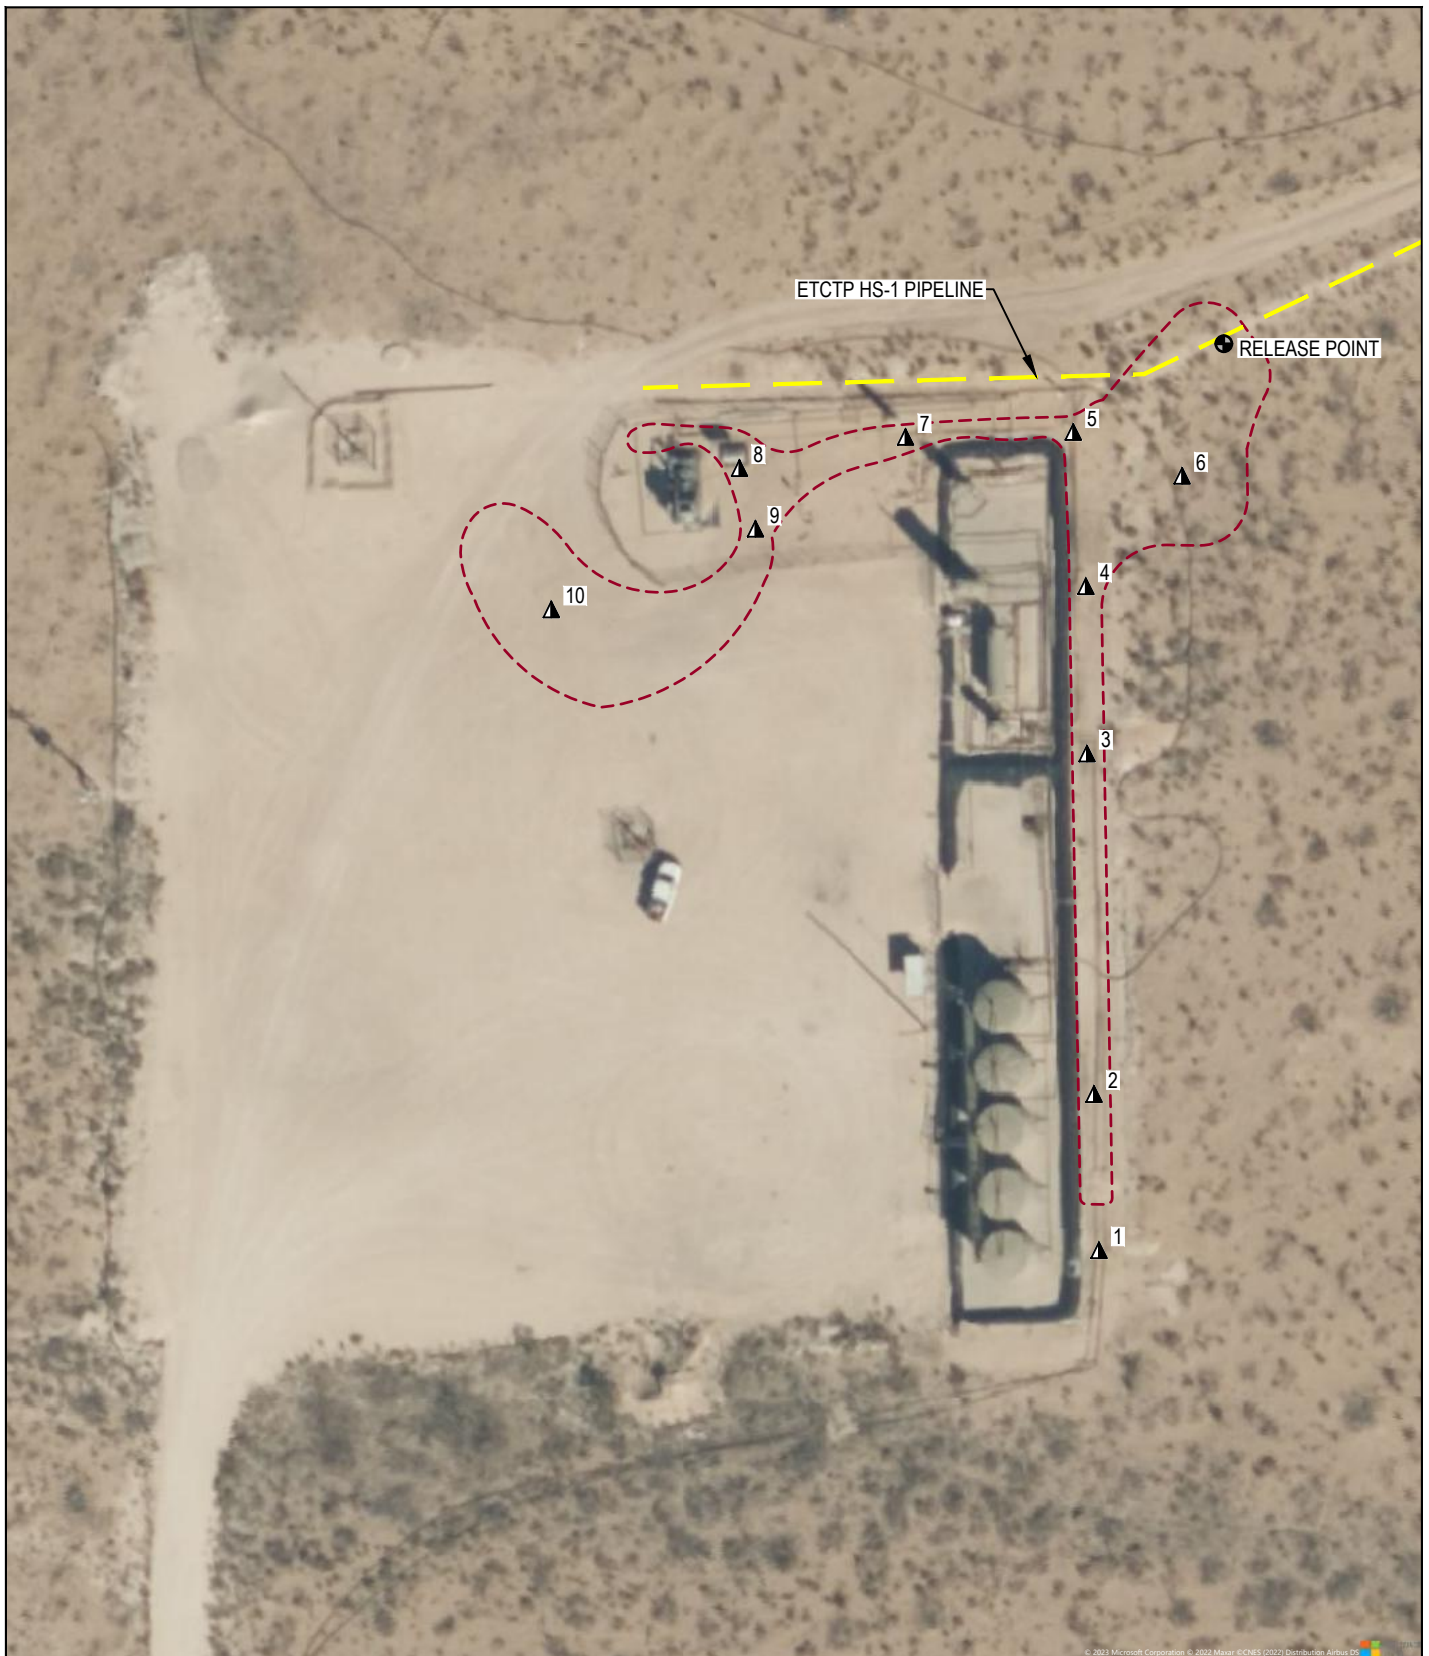
FIGURE 2

On February 9, 2023, ETCTP personnel collected soil samples from near surface soils (2-inches to 4-inches) in the release area (1-10). Samples were submitted to Cardinal Laboratories (Cardinal), located in Hobbs, New Mexico and analyzed for benzene, toluene, ethylbenzene, and xylenes (BTEX) by EPA SW846 Method 8021B, total petroleum hydrocarbons (TPH) by EPA SW846 Method 8015B Modified, and chloride by EPA Standard Method 4500CL-B. Analytical results indicated benzene and BTEX concentrations to be below the applicable NMAC Table I Closure Criteria. Analytical results indicated one (1) of the soil samples (9 2") exhibited TPH concentrations above NMAC Table I Closure Criteria. Analytical results indicated two (2) of the soil samples (9 2" and 10 2") exhibited chloride concentrations above NMAC Table I Closure Criteria. Sample locations are presented on Figure 2 and summarized in Table 1. The laboratory analytical report and chain of custody (COC) are attached as Attachment B.

- RELEASE AREA
▲ INITIAL SOIL SAMPLE (COLLECTED BY ET PERSONNEL)

SITE DETAILS MAP

Due to exceeding TPH and/or chloride concentrations, areas represented by samples 9 2" and 10 2" will be excavated with soil being transported and disposed of at an OCD permitted facility. Additional excavation and soil screening activities will be conducted in areas within the fenced-in portion of the ConocoPhillips/Concho pad and the immediate area around the pipeline release point. Surficial soil scraping will be conducted within the general release area as well. Field screening and Site observations will direct excavation activities and confirmation soil samples will be collected from the excavation to confirm final limits of the excavation and to ensure applicable NMAC Table I Closure Criteria is achieved. Those soil sampling areas that indicate exceeding concentrations of applicable NMAC Table I Closure Criteria will be excavated and managed in a similar manor as previously discussed. Details of the additional soil assessment and remedial excavation activities will be submitted to the OCD for review and approval following completion of the proposed activities.
